Oakford Place, Broxtowe, Nottingham

Report on an Archaeological Programme

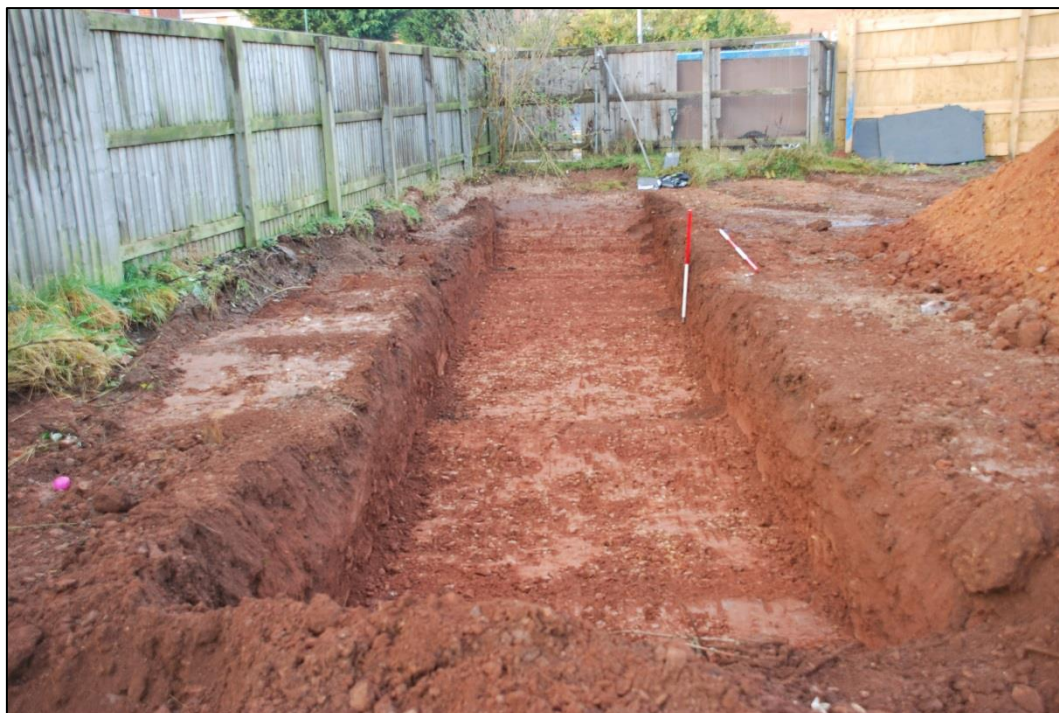
Figure 3
Trench 1 looking west-north-west

Trench 1 was excavated at the south of the site (Figure 2). Trench 1 was 12.5m long and 1.8m wide (Figure 3). Red brown clay silt topsoil up to 0.6m thick (100) overlay very weak natural sandstone deposits with bands of sand and gravel (101 and 402). The natural subsoil was recorded at approximately 81.56m AOD.

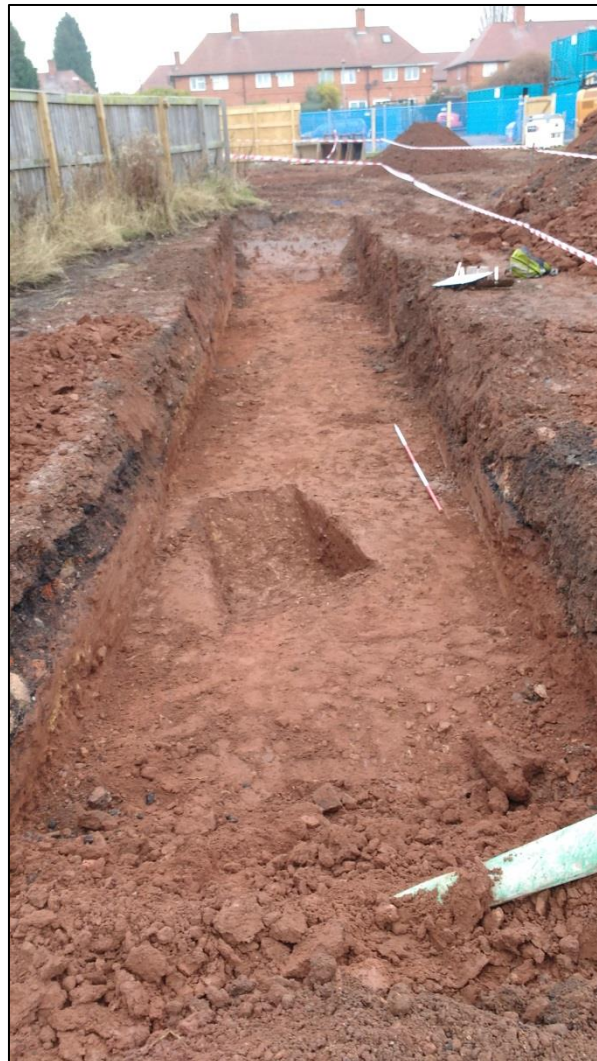
Figure 4
Trench 2 looking north west

Trench 2 was located at the south side of the site, to the east of the centre (Figure 2). It was 12.5m long and 1.8m wide (Figure 4). The natural subsoil (206), a weak sandstone with bands of sand and gravel was present at between 80.9m AOD at the east and 81.1m AOD at the west. It was overlain by two layers of made ground. The upper layer (200), a brown grey silt containing large quantities of rubble was 0.2m thick and covered (201), a black sand/bitumen mix which also contained a lot of rubble and was 0.3m thick. A very modern linear feature [202] was cut through the lower level of made ground and truncated the natural subsoil. Its fill (203) contained a single piece of plastic. A further ditch [204] cut through the natural subsoil towards the eastern end of the trench (Figure 5). This was orientated roughly north-south, was up to 1.8m wide and 0.5m deep and was filled by red brown clay silt (205). No dating evidence was recovered from a section excavated through this ditch although a small amount of animal bone was recovered.

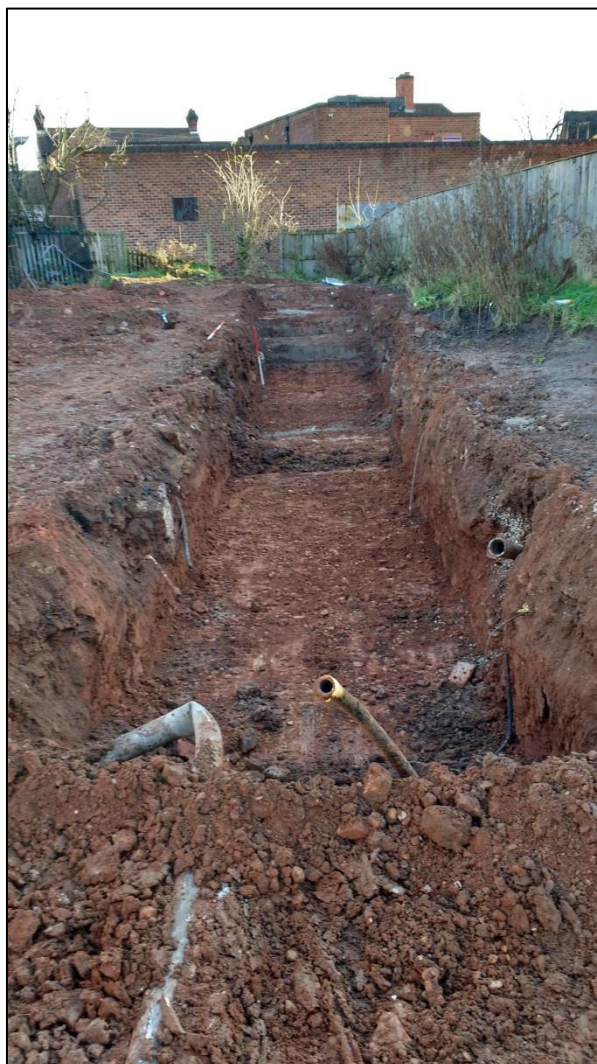
Figure 6
Trench 3 looking south east

Trench 3 was excavated at the south east corner of the site. It was 25m long and 1.8m wide (Figure 2). Two deposits of made ground overlay the natural subsoil which comprised weak bands of sand and gravel (Figure 6). The natural subsoil was recorded at between 80.35m AOD (west end) and 79.8m AOD (east end). The upper made ground deposit (300) comprised a grey sand silt which was approximately 40% rubble. This was 0.45m thick. Below this (301) was a grey brown silt clay which contained similar quantity of rubble and was 0.5m thick. A concrete foundation (Figure 7) supporting cavity-wall brickwork of 3in thickness (302) cut into the top of (301). This corresponds approximately with the east wall of a building first shown on the 1930 OS map, and also with a house in the 1930s development. No other contexts associated with the wall were identified.

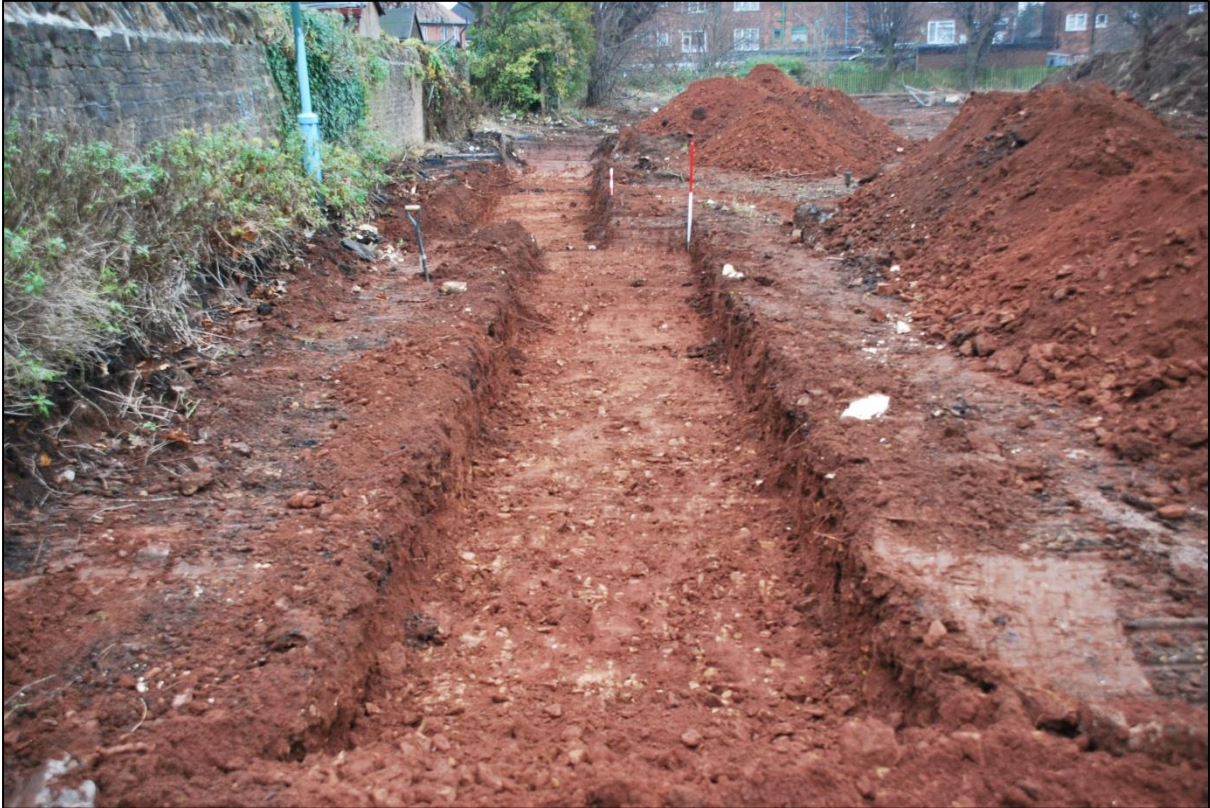
Figure 8
Trench 4 looking west-north-west

Trench 4 was excavated at the north edge of the site (Figure 2). Trench 4 was 25m long and 1.8m wide but was stepped due to services (Figure 8). Red brown clay silt topsoil up to 0.65m thick (401) overlay very weak natural deposits with bands of sand and gravel (101 and 402). The natural subsoil was recorded at between 81.85m (west end) and 81.15m AOD (east end).

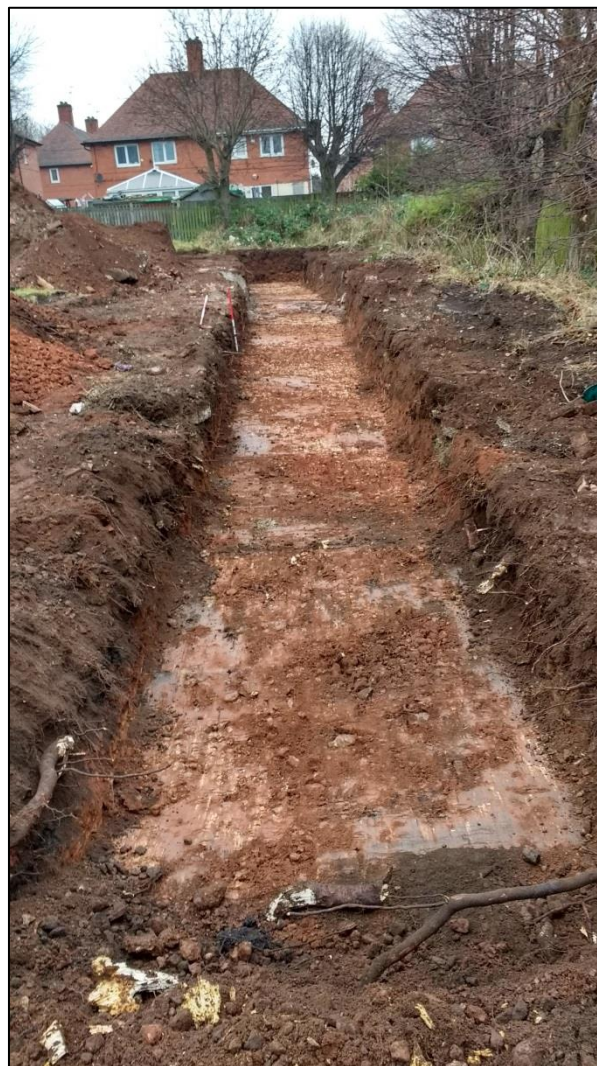
Figure 9
Trench 5 looking north east

Trench 5 was excavated at the north east of the site and was 25m long and 1.8m wide (Figure 2). The natural subsoil (510) was recorded at approximately 80.5m AOD, overlain by two layers of made ground (Figure 9). The upper layer, (500) was a red brown sandy silt comprising 10% rubble and was up to 0.45m thick. Below this was 0.15m of dark grey sandy silt (501). The footings of a modern house ((502); Figure 11) truncated all of the deposits recorded within the trench approximately half way along its length. Modern disturbance was also recorded at the very north of the trench. The base of a modern brick wall was also recorded in the western section of the trench. This may relate to houses which were built on the site in the late 1930s/early 1940s.

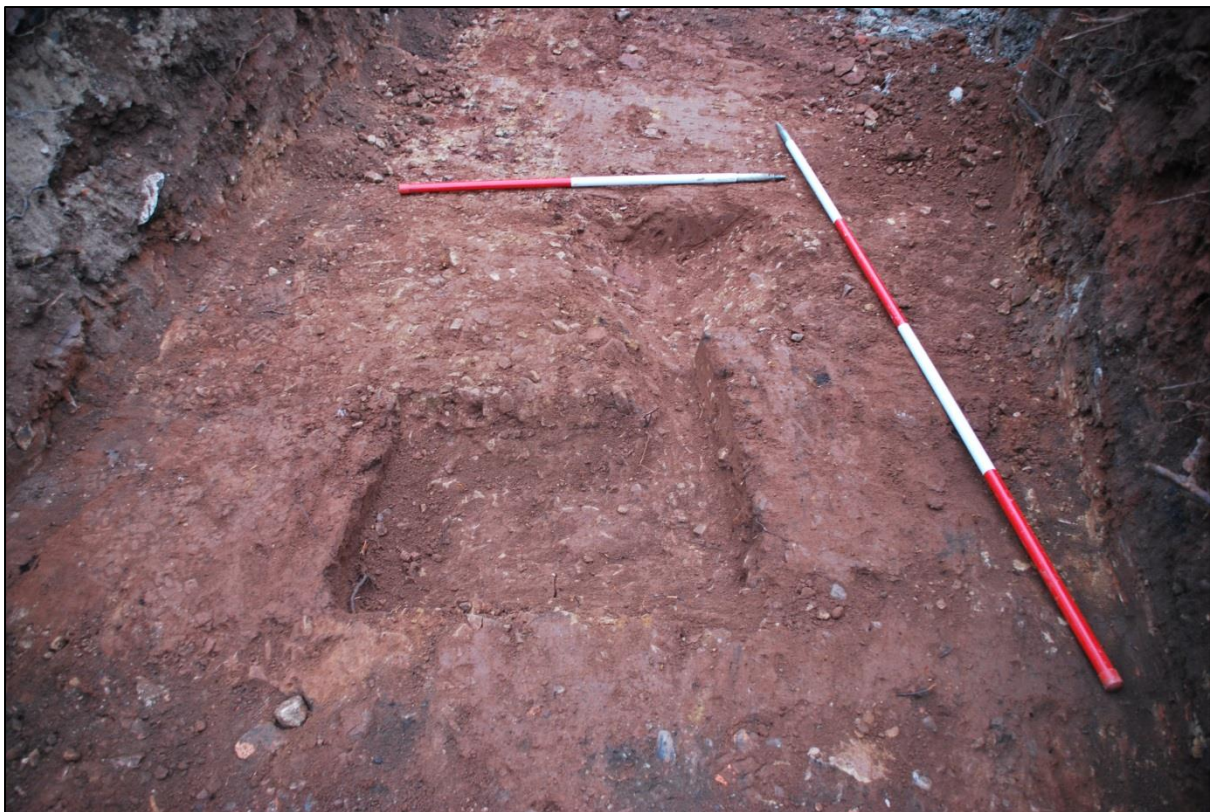
Figure 11
Trench 5:Section of gullies [504] and [506] looking south-west

Three shallow gullies ([504], [506], [508]) were recorded in Trench 5 (Figures 11 and 12). These were between 0.4m and 0.75m wide and 0.1m and 0.15m deep and were all filled by red brown clay silt (505, 507, 509) which was similar to (205), the fill of ditch [204]. No dating evidence was recovered from the sections excavated through these gullies.

An undated ditch was identified in Trench 2 while three undated gullies were identified in Trench 5. All four of these features were filled by red brown clay silt which was derived from the topsoil recorded across the west of the site. The similarity of the fills of these four features suggests that they may be contemporary but they are undated. Wall-foundations identified in Trench 3 and Trench 5 are thought to date to the early 20th century. No remains of either the medieval or post-medieval phases of Broxtowe Hall were identified during these works, with the possible exception of the wall in Trench 3 which corresponded in location and alignment with an outbuilding mapped in 1930, though the use of cavity walling makes it more likely to have been part of the subsequent housing development.

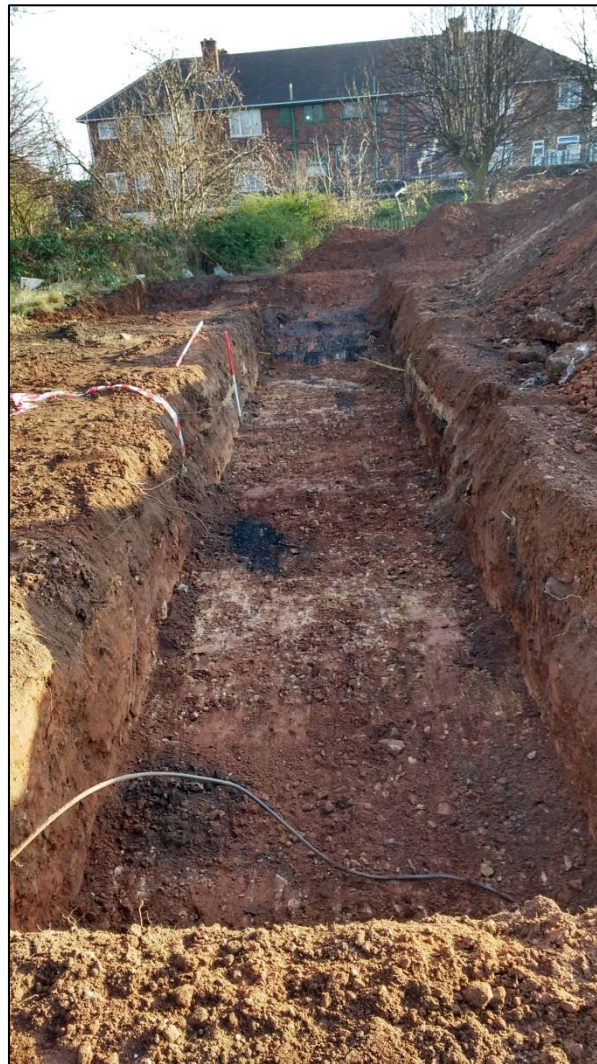
Figure 13
Trench 6 looking south east

Trench 6 was excavated at the north east of the site and measured 25m long and 1.8m wide (Figure 2). Up to 0.8m of mixed made ground (600) overlay natural weak sandstone (601) (Figure 13). This natural subsoil was recorded at between 80.9m AOD (west end) and 80.4m AOD (east end). The trench was stepped to protect trees under Tree Preservation Orders.

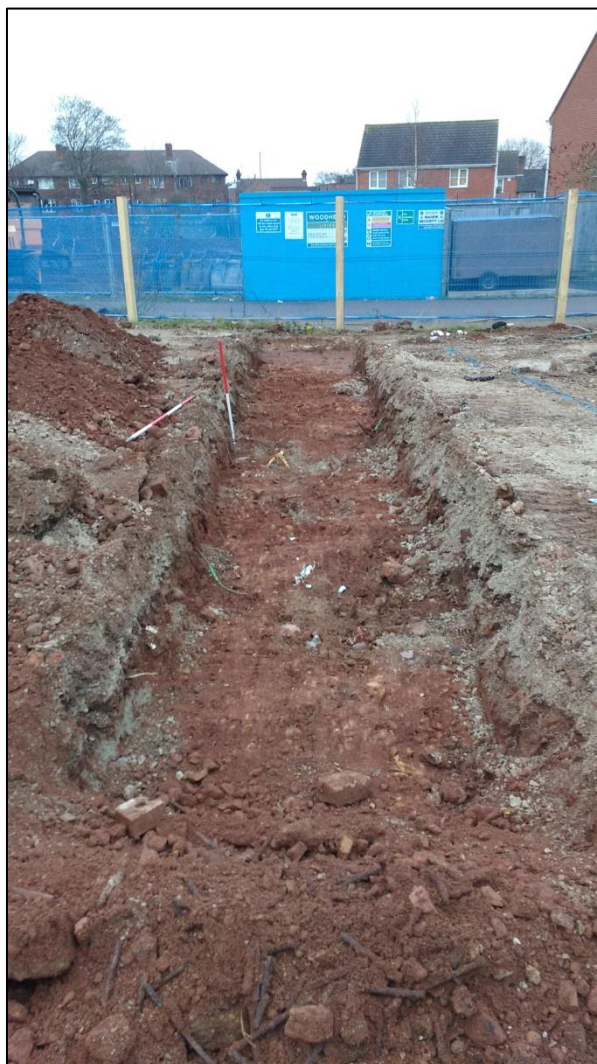
Figure 14
Trench 7 looking east-south-east

Trenches 7 and 8 were excavated at the west end of the site through the surface of a temporary car park/compound (Figure 2). Both trenches were 12.5m long and 1.8m wide. In both trenches between 0.1m and 0.2m of grey hardcore (700 and 800) overlay between 0.2m and 0.3m of red brown clay silt topsoil (701 and 801) (Figures 14 and 15). This covered very weak natural subsoil with bands of sand and gravel (702 and 802). The natural subsoil was recorded at approximately 82.8m AOD in Trench 7 and 83m AOD in Trench 8.
