**SOUTHMEAD POLICE STATION,
SOUTHMEAD ROAD, BRISTOL
BS10 5DW**

Report on Archaeological Fieldwork
Prepared for: Care UK

SLR Ref: 402.02498.00011.27
Version No:1
May 2018

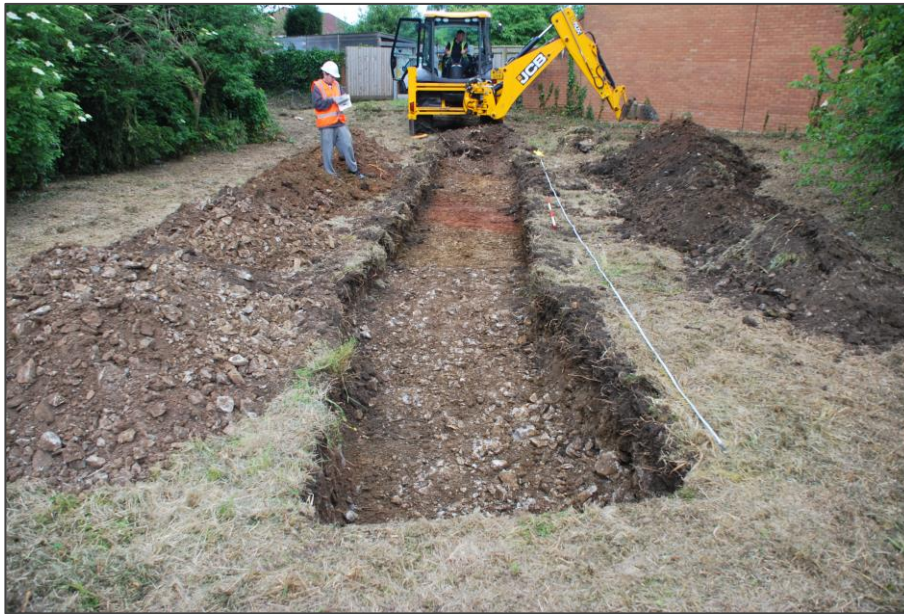
Figure 7
Trench 3 looking north

Trench 3 was located to the north of Trenches 1 and 2. It was orientated roughly north – south (Figure 2).

Dark brown silt clay topsoil overlay yellow brown silt clay natural subsoil comprising 50% limestone at the south while at the north the natural subsoil was a yellow silt clay with no limestone (Figure 7). The yellow brown silt clay containing the limestone is thought to underly the yellow silt clay. An area of in situ burning was observed approximately 8m from the northern end of the trench. There was no evidence of fire debris observed in any of the contexts above it. The natural subsoil was at between 53.72m and 53.92m AOD.

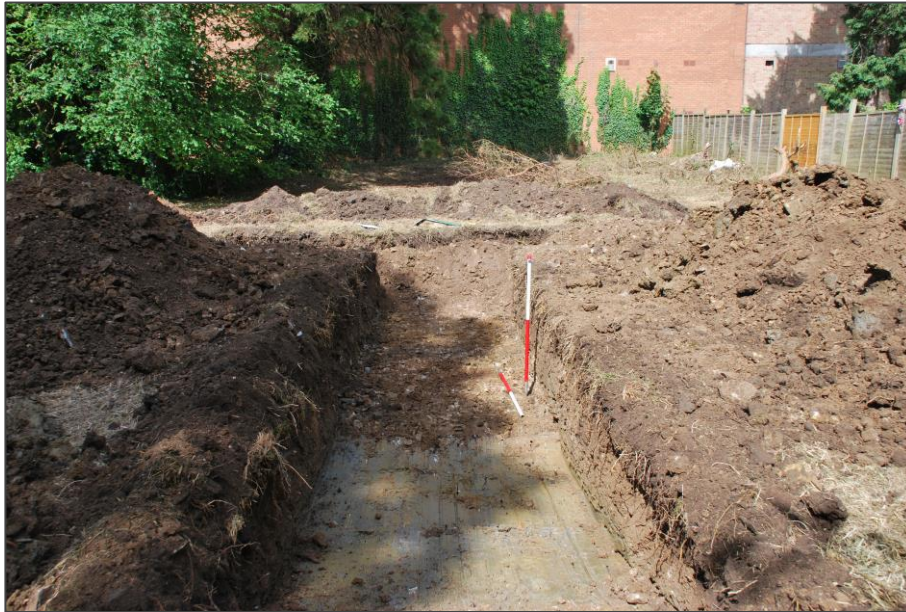
Figure 8
Trench 4 looking north east

Trench 4 was excavated directly to the south of Trench 2 (Figure 2). It was 7m long and orientated roughly north east – south west. It was dug to try and identify the line of the wall/landscaped step previously identified in Trench 1. This was recorded approximately 2.8m from its southern end as [403] and was filled by blue grey clay (404) (Figure 8). The stratigraphy of the trench was otherwise identical to Trench 2. The natural subsoil was identified at 53.62m AOD.

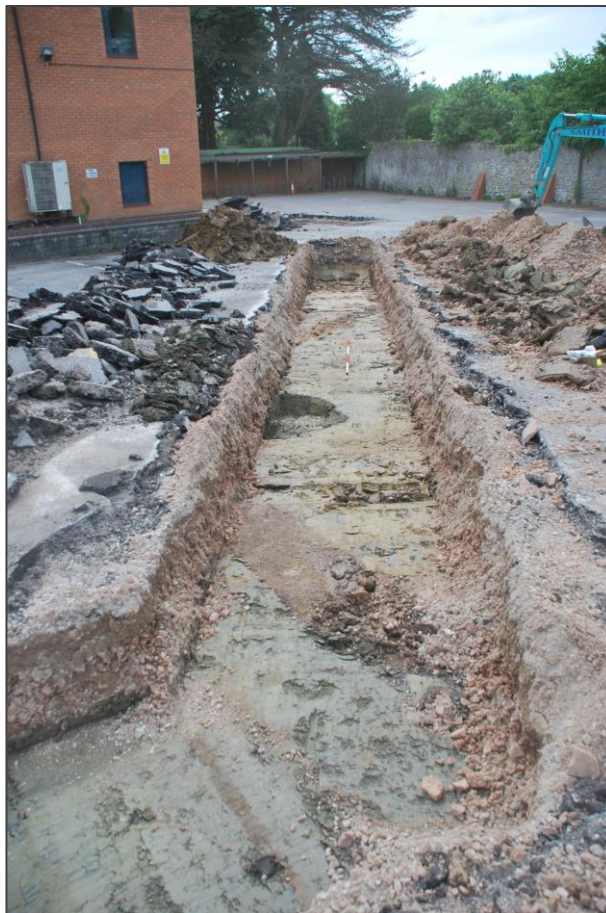
Figure 10
Trench 6 looking WSW

Trench 6 was a continuation of Trench 5 to the west, orientated ENE-WSW (Figure 2). The general stratigraphy was the same as Trench 5 with 0.2m of tarmac (602) overlying two layers of hard-core (601 and 602) with a green grey clay natural subsoil which became more yellow to the west (Figure 10). The natural subsoil was recorded at between 54.5m and 55.49m AOD.

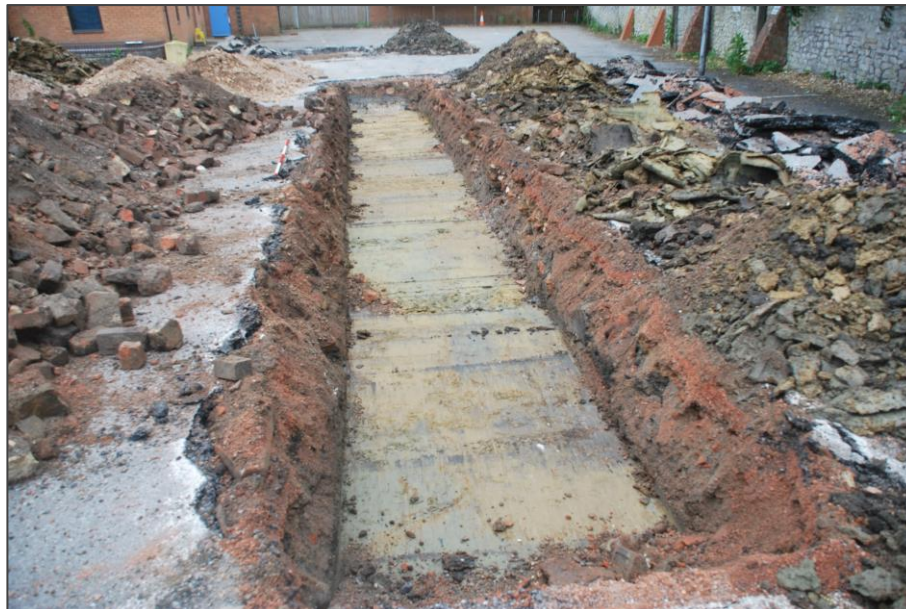
Figure 13
Trench 7A looking south west

Trench 7 was the most north westerly trench (Figure 2). It was split into two lengths due to services, the northern part was 16m long (7A) and the southern 4m long (7B). It was orientated north east – south west.

In Trench 7A up to 0.1m of tarmac (700) overlay 0.32m of rubble (701) comprising brick, tiles and stone (Figure 13). This covered black clay silt (702) which was up to 0.15m thick and overlay the grey yellow clay subsoil (703). Context (702) may represent buried topsoil. The natural subsoil was recorded at between 54.45m and 55.4m AOD.

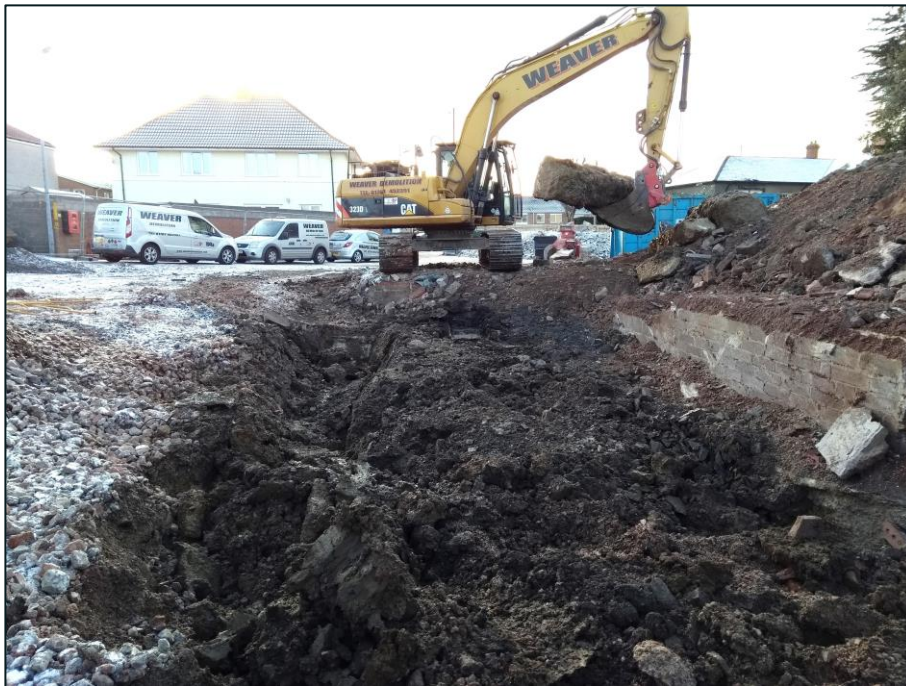
Figure 15
Removal of footings at north of former police station looking east

A watching brief was carried out on the removal of the police station footings and the construction of an access road between 27th February and 14th March 2018 (Figures 2 and 15-17). The watching brief identified similar stratigraphy to that identified in the trenches in the car park area to the north with an average of 0.15m of tarmac (1000) in areas outside the police station overlaying between 0.3m and 0.5m of dark grey hard-core/stony made ground (1001). This also ran below where the police station had stood. It covered grey yellow clay natural subsoil (1002).

The former police station stood on poured concrete strip footings that were up to 1m wide and 1m deep. These were cut into the underlying natural subsoil. Below the police station any soil appeared to have been removed with up to 0.5m of rubble/stony deposit (1001) lying directly on top of the natural clay. A diesel tank and a number of services relating to the police station were identified cut into the natural subsoil.

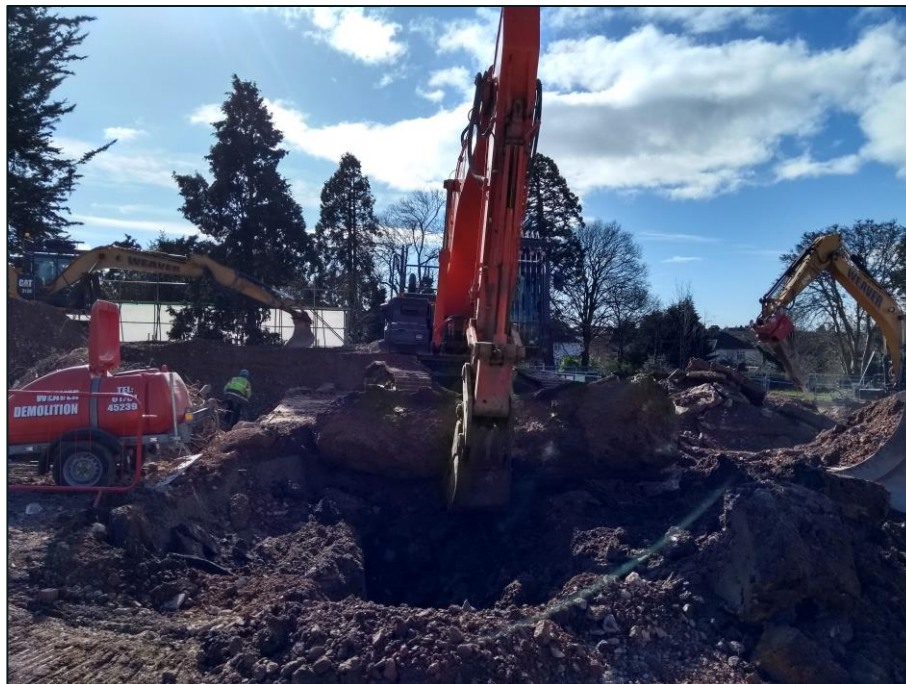
Figure 17
Removal of footings towards eastern end of former police station site looking south

No remains relating to Southmead Manor were identified nor were any other features of archaeological significance. It is thought any features would have been removed during the construction of the police station.
