# PATTERDOWN ROAD, CHIPPENHAM, WILTSHIRE

**Report on an Archaeological Evaluation**

Prepared for: Hollins Strategic Land

SLR Ref: 416.05627.00004  
Version No:1  
June / 2017

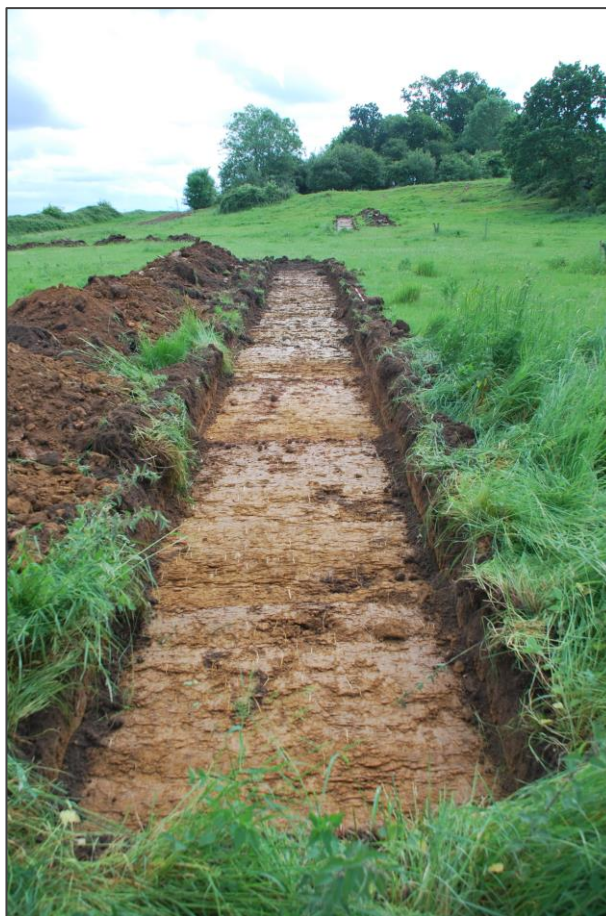
**Figure 3**  
**Trench 1 looking south**

Trench 1 was the most northerly trench excavated at the site and was orientated north – south (Figure 3). The natural subsoil in the area was a light yellow brown clay (100) which was overlain by reworked clay, derivative of the natural subsoil, which contained occasional pieces of burnt material and rubble (101). This suggested the northern area of the site had previously been stripped of topsoil. This material was overlain by imported dark grey peaty clay silt topsoil. Natural subsoil was recorded at between 55.68m and 56.17m AOD.

Trench 1 had targeted a curvilinear feature which appeared to be orientated roughly east – west. No evidence of this features were identified and no other features of archaeological significance were identified in the trench. A single north south orientated plough scrape contained material the same as (101). It was not clear what may have caused the geophysical anomaly.

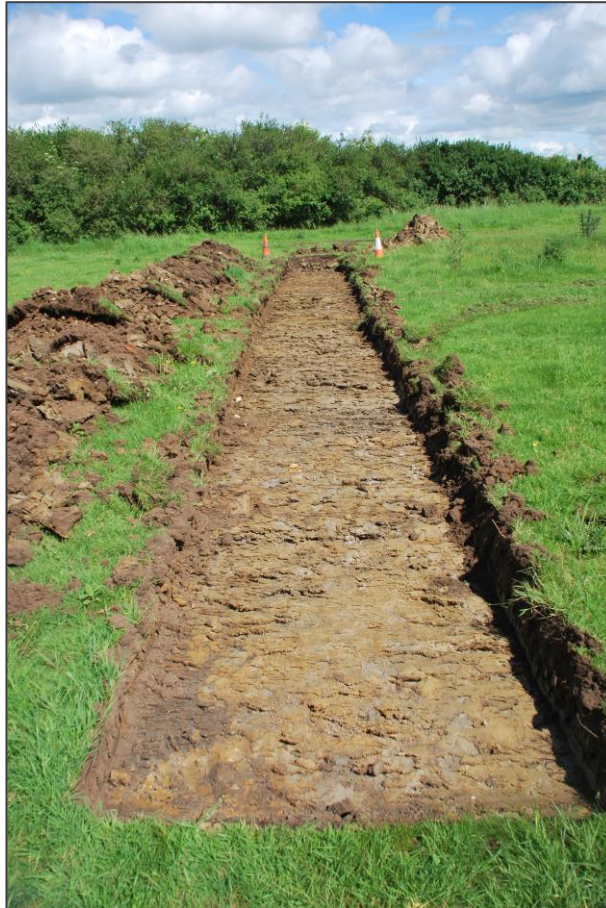
**Figure 4**  
**Trench 2 looking east**

Trench 2 was located approximately 25m south of Trench 1 and was orientated east – west (Figure 4). It was targeted on an area containing a number of substantial irregular geophysical anomalies. Brown grey clay natural subsoil (201) was overlain by 0.14m of mid grey peaty clay silt (200). The natural subsoil was recorded

at between 56.33m and 56.46m AOD. No features of archaeological significance were identified within the trench. It was not clear what may have caused the geophysical anomalies.

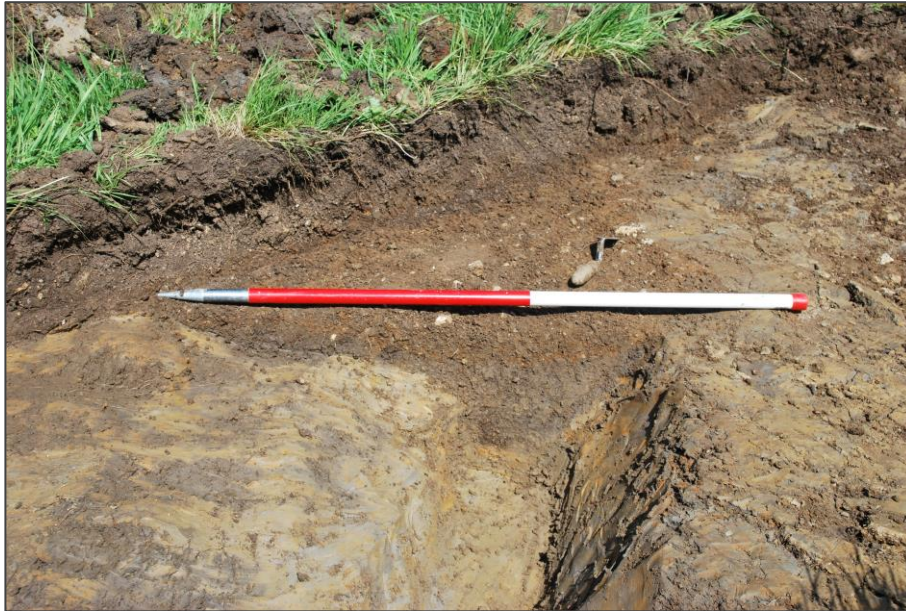
**Figure 5**  
**Trench 3 Ditch [302] looking north west**

Ditch [302] was the most northerly of the two features. It was orientated north west – south east and was up to 0.85m wide and 0.33m deep with a shallow step in its northern side (Figure 5). The ditch contained three fills. Primary fill (303) was a grey yellow sit clay, up to 0.13m deep, which appeared derivative of the surrounding natural subsoil. It may represent the falling back into the ditch of a shallow bank from the north of the ditch. This bank was not identified in this trench however it was visible in parts of the field. Secondary fill (304) was a dark grey peat, up to 0.2m deep, which was in turn covered by dark grey peaty clay silt (305) which was very similar to the topsoil and was 0.1m deep. The ditch was still visible in the field with a shallow bank on

its northern side. It appears to be visible on the 1<sup>st</sup> edition OS map of 1886 and it may be a small field boundary.

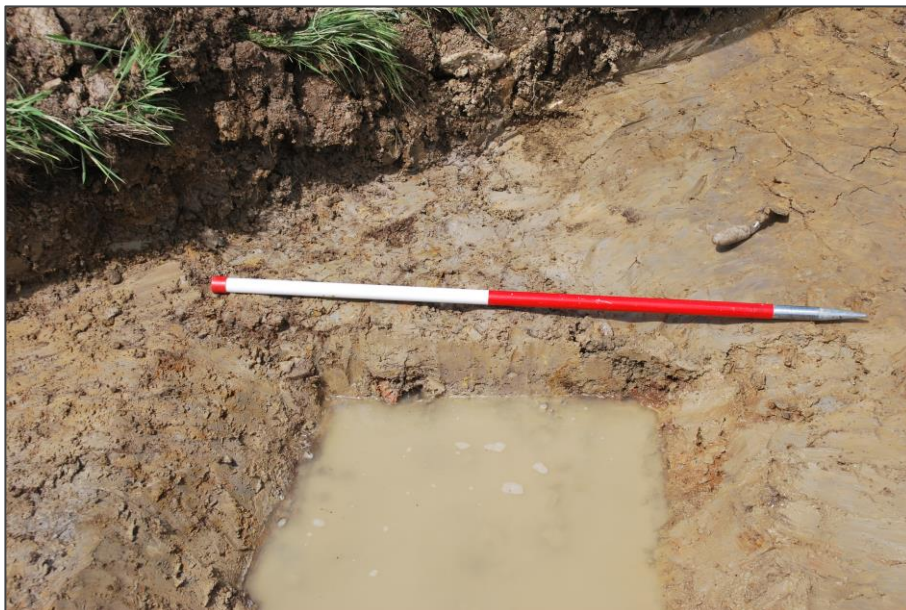
**Figure 6**  
**Trench 3 Ditch [306] looking north west**

Approximately 8.5m to the south of [302] a further parallel ditch/drain was recorded. This feature was 1.02m wide and over 0.25m deep. It was not fully excavated as it filled with water during excavation (Figure 6). It was filled by light yellow grey clay silt (307) which contained frequent large Victorian brick fragments.

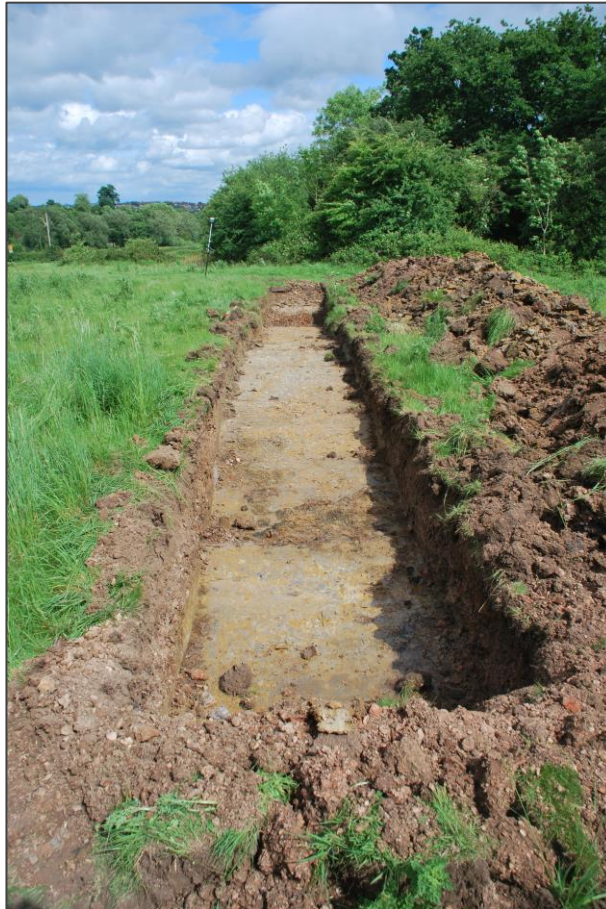
**Figure 7**  
**Trench 4 looking east**

Trench 4 was located approximately 45m south west of Trench 3 and was orientated roughly east west. Natural subsoil (403) was identified at between 62.56m and 62.87m AOD. This was covered by made ground comprising rubble and burnt material (402) up to 0.6m thick. Above this was imported dark brown peaty silt clay (400) topsoil (Figure 7).

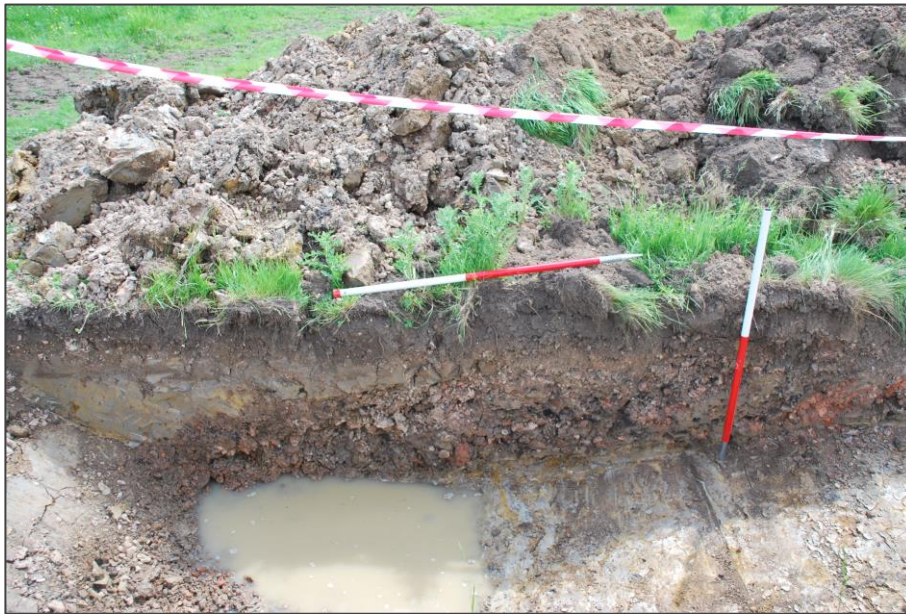
**Figure 8**  
**Trench 4 Ditch [404] looking south**

Deposit (402) also filled two large shallow cuts at either end of the trench ([404] at the east and [405] at the west). Feature [404] also contained reworked natural subsoil (401) (Figure 8). The extent of these features was not recorded as they continued on beyond the length of the trench. Both continued on for over 2m, [404] was up to 0.4m deep and [405] up to 0.36m deep. Both appear to date to the 19<sup>th</sup> century. These features, as well as ditch [703] in Trench 7, are thought to be responsible for a large circular geophysical anomaly which may relate to a crane base or some other industrial activity related to the construction of the railway line to the west. Such machines would have been necessary for the creation of the railway embankment and the railway line as well as the building of the bridge over Bath Road, 340m to the north which was finished in about 1840.

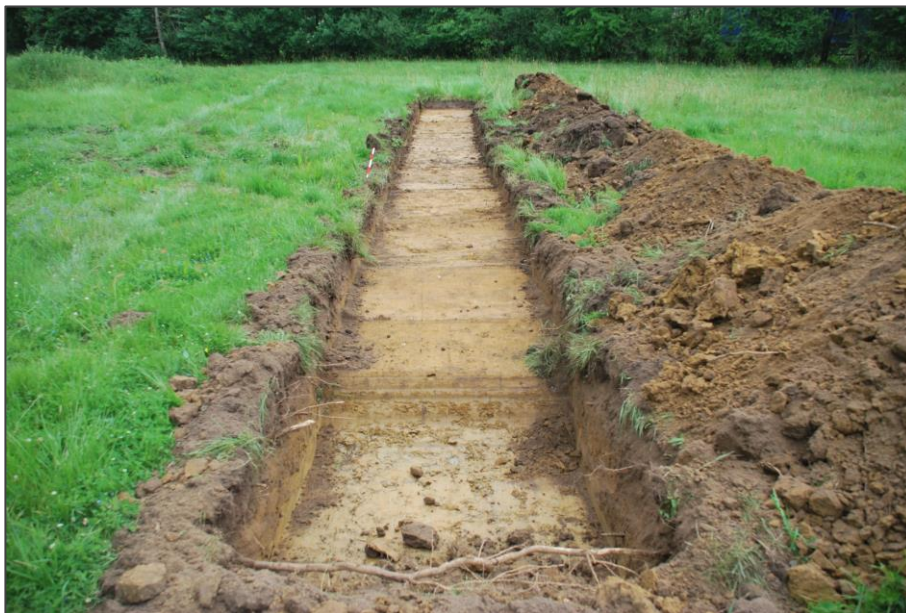
**Figure 9**  
**Trench 5 looking west**

Trench 5 was located approximately 65m south east of Trench 4 and was orientated roughly east –west (Figure 9). Natural subsoil (501), a yellow clay silt which was observed at between 60.45m and 61.67m AOD, was identified below up to 0.15m of mid brown grey clay silt topsoil (500).

No archaeological features were observed. The natural subsoil was siltier at the western end of the trench and this may account for the positive anomaly in the geophysical survey. No archaeological features were observed.

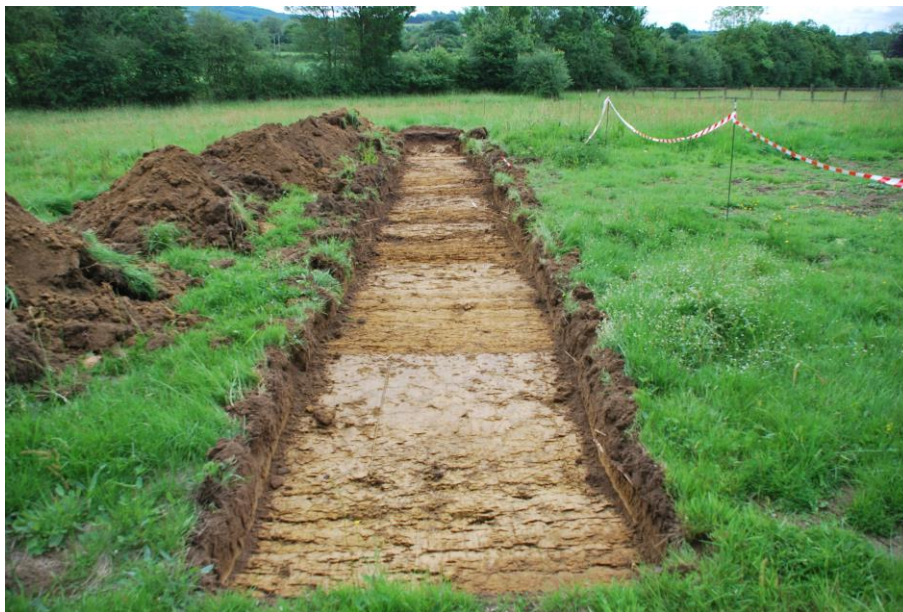
**Figure 10**  
**Trench 6 looking south east**

Trench 6 was located approximately 25m south west of Trench 5 at the southern end of the site and was orientated roughly north west –south east (Figure 10). Natural subsoil (601), a yellow clay silt was observed at between 61.47m and 62.46m AOD. It was covered by up to 0.2m of mid brown grey clay silt topsoil (600).

No archaeological features were observed. The natural subsoil was siltier towards the south of the trench and this may account for the anomaly in the geophysical survey. A single modern service trench was recorded running roughly east - west at the southern end of the trench. No archaeological features were observed.

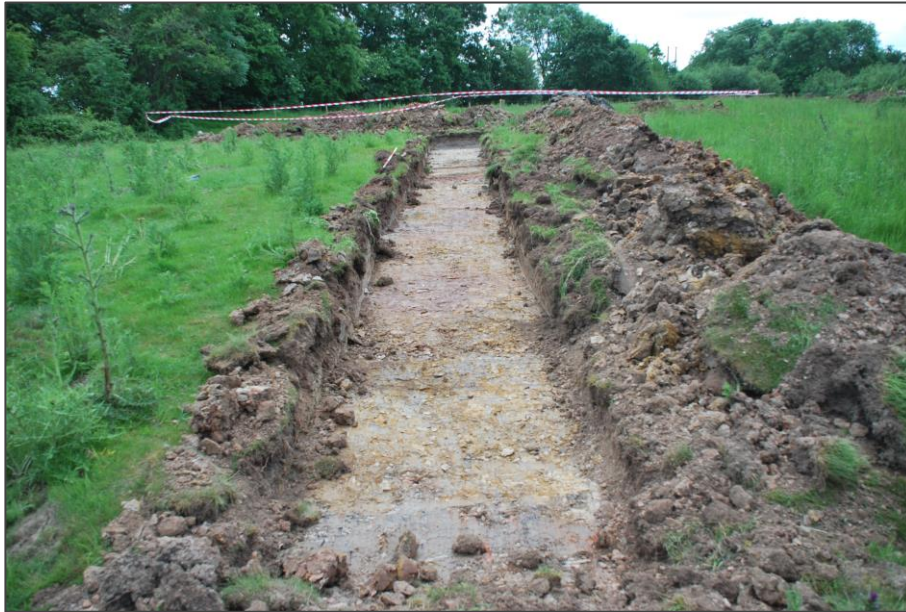
**Figure 11**  
**Trench 7 looking south**

Trench 7 created a 'T' shape with Trench 4 and was orientated roughly north – south (Figure 11). Yellow grey clay natural subsoil (702) was identified at between 62.14m and 62.76m AOD. It was covered by made ground (701) comprising rubble and burnt material which was up to 0.25m thick. This was covered by an imported grey peaty clay silt topsoil (700) up to 0.1m thick.

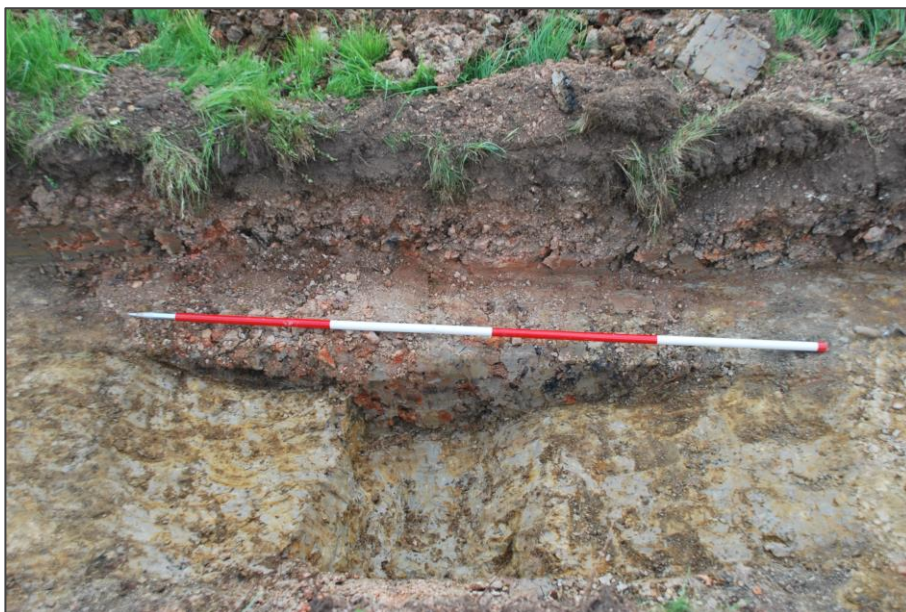
**Figure 12**  
**Trench 7 Ditch [703] looking east**

Ditch [703] was identified towards the southern end of the trench. It ran through the trench and was 1.9m wide and 0.39m deep. It was filled by (704) a grey clay containing rubble. The ditch had stepped sides at the north and south and had steep sides and a flat base in the middle (Figure 12). The purpose of the ditch is unclear. It appears to relate to part of a circular geophysical anomaly which relates to the construction of the Victorian railway to the west.

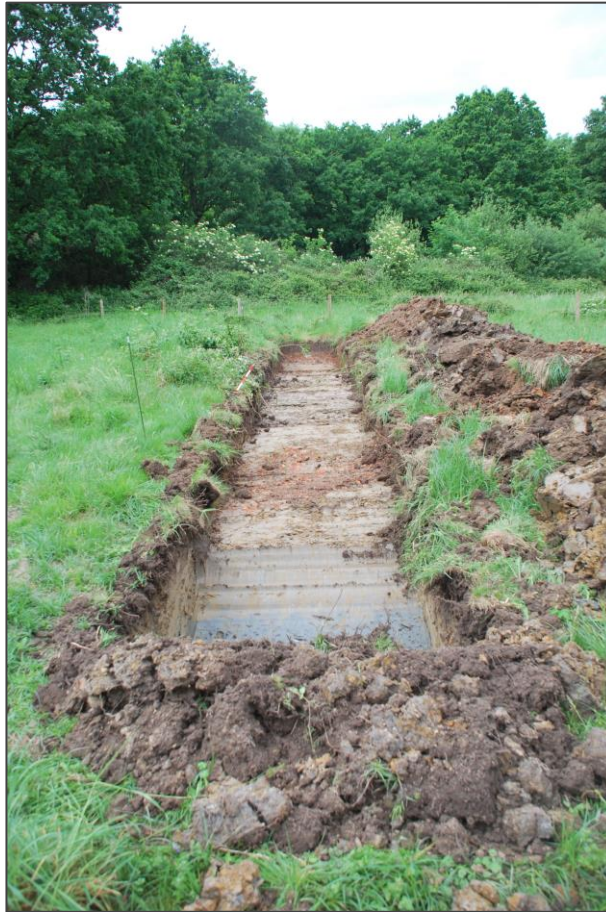
**Figure 13**  
**Trench 8 looking north west**

Trench 8 was located approximately 25m south west of Trench 4 at the west of the site. It was orientated north west – south east (Figure 13). The trench was excavated to the east of its intended position due to electric cables. Yellow grey natural clay (801) was overlain by up to 0.2m of mid grey clay silt (800) which contained occasional rubble inclusions. Natural subsoil was recorded at between 63.52m and 63.67m AOD.

Two features were identified cut into the base of the trench. Feature [802] was cut into the very northern end of the trench. It was over 5.6m long, running beyond the limit of the trench to the north and over 2m wide, continuing on beyond the trench to the east and west. It was up to 0.62m deep and had gradual sloping sides and a flat base. It was filled by rubble and burnt material (803). Ditch [804] was located approximately 8m to the south east. It ran through the extent of the trench and was 1.55m wide. It was not excavated by contained rubble/burnt material (805). These two ditches appear to relate to a circular anomaly identified by the geophysical survey which may be related with the construction of the 19<sup>th</sup> century railway line to the west.

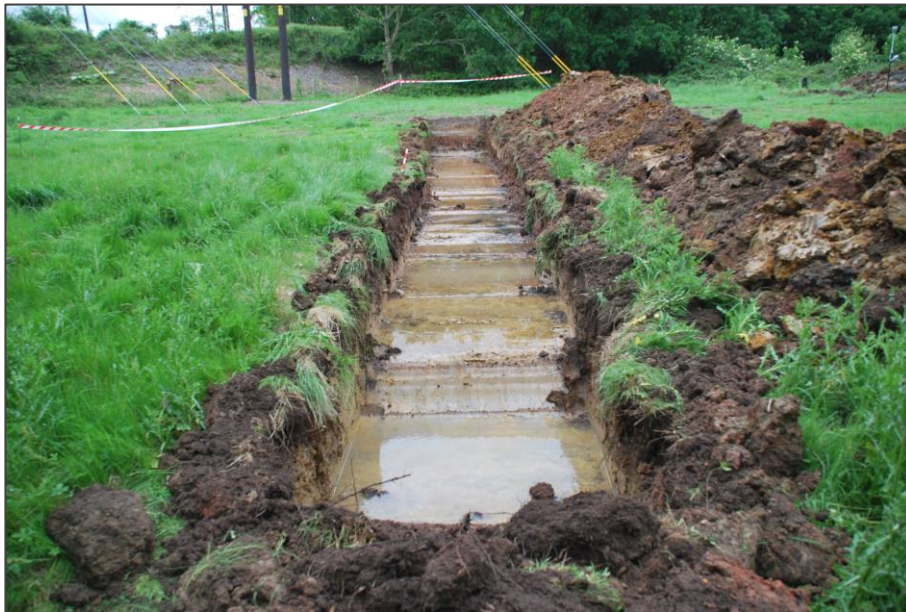
**Figure 14**  
**Trench 9 looking north west**

Trench 9 was located approximately 10m south of Trench 8 and was orientated north west – south east. Yellow grey natural clay (902) was observed at between 62.47m and 62.61m AOD (Figure 14). This was covered by up to 0.3m of made ground (901) comprising rubble and burnt material. This was then covered by imported mid brown grey clay silt topsoil (900) which was up to 0.45m thick (Figure 15).

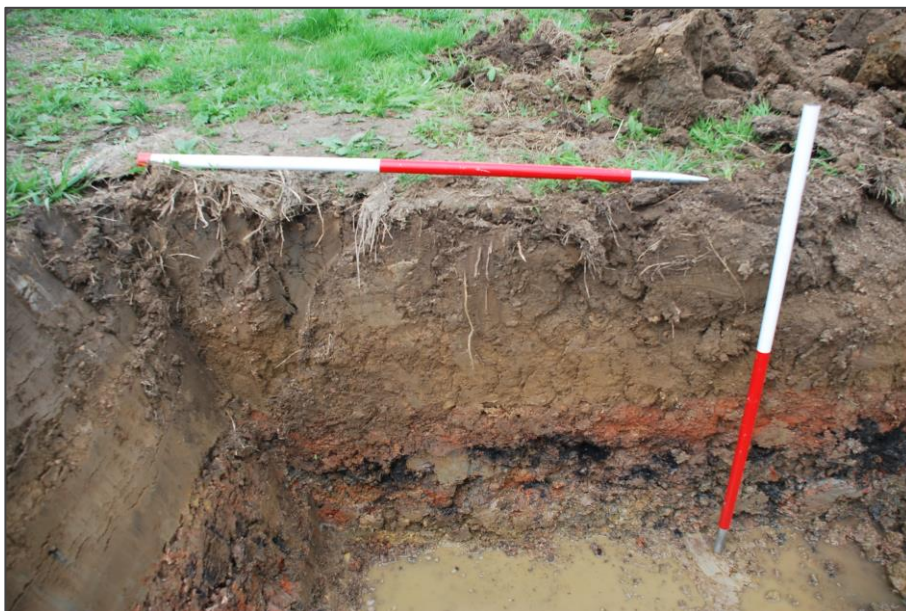
**Figure 15**  
**Trench 9 Section looking north east**

A gully approximately 0.4m wide and 7.2m long ran along the northern side of the trench orientated north west – south east. The bottom of the trench was covered with water before there it was possible to examine this feature. It was filled by rubble/burnt material (904) and may represent a drain.

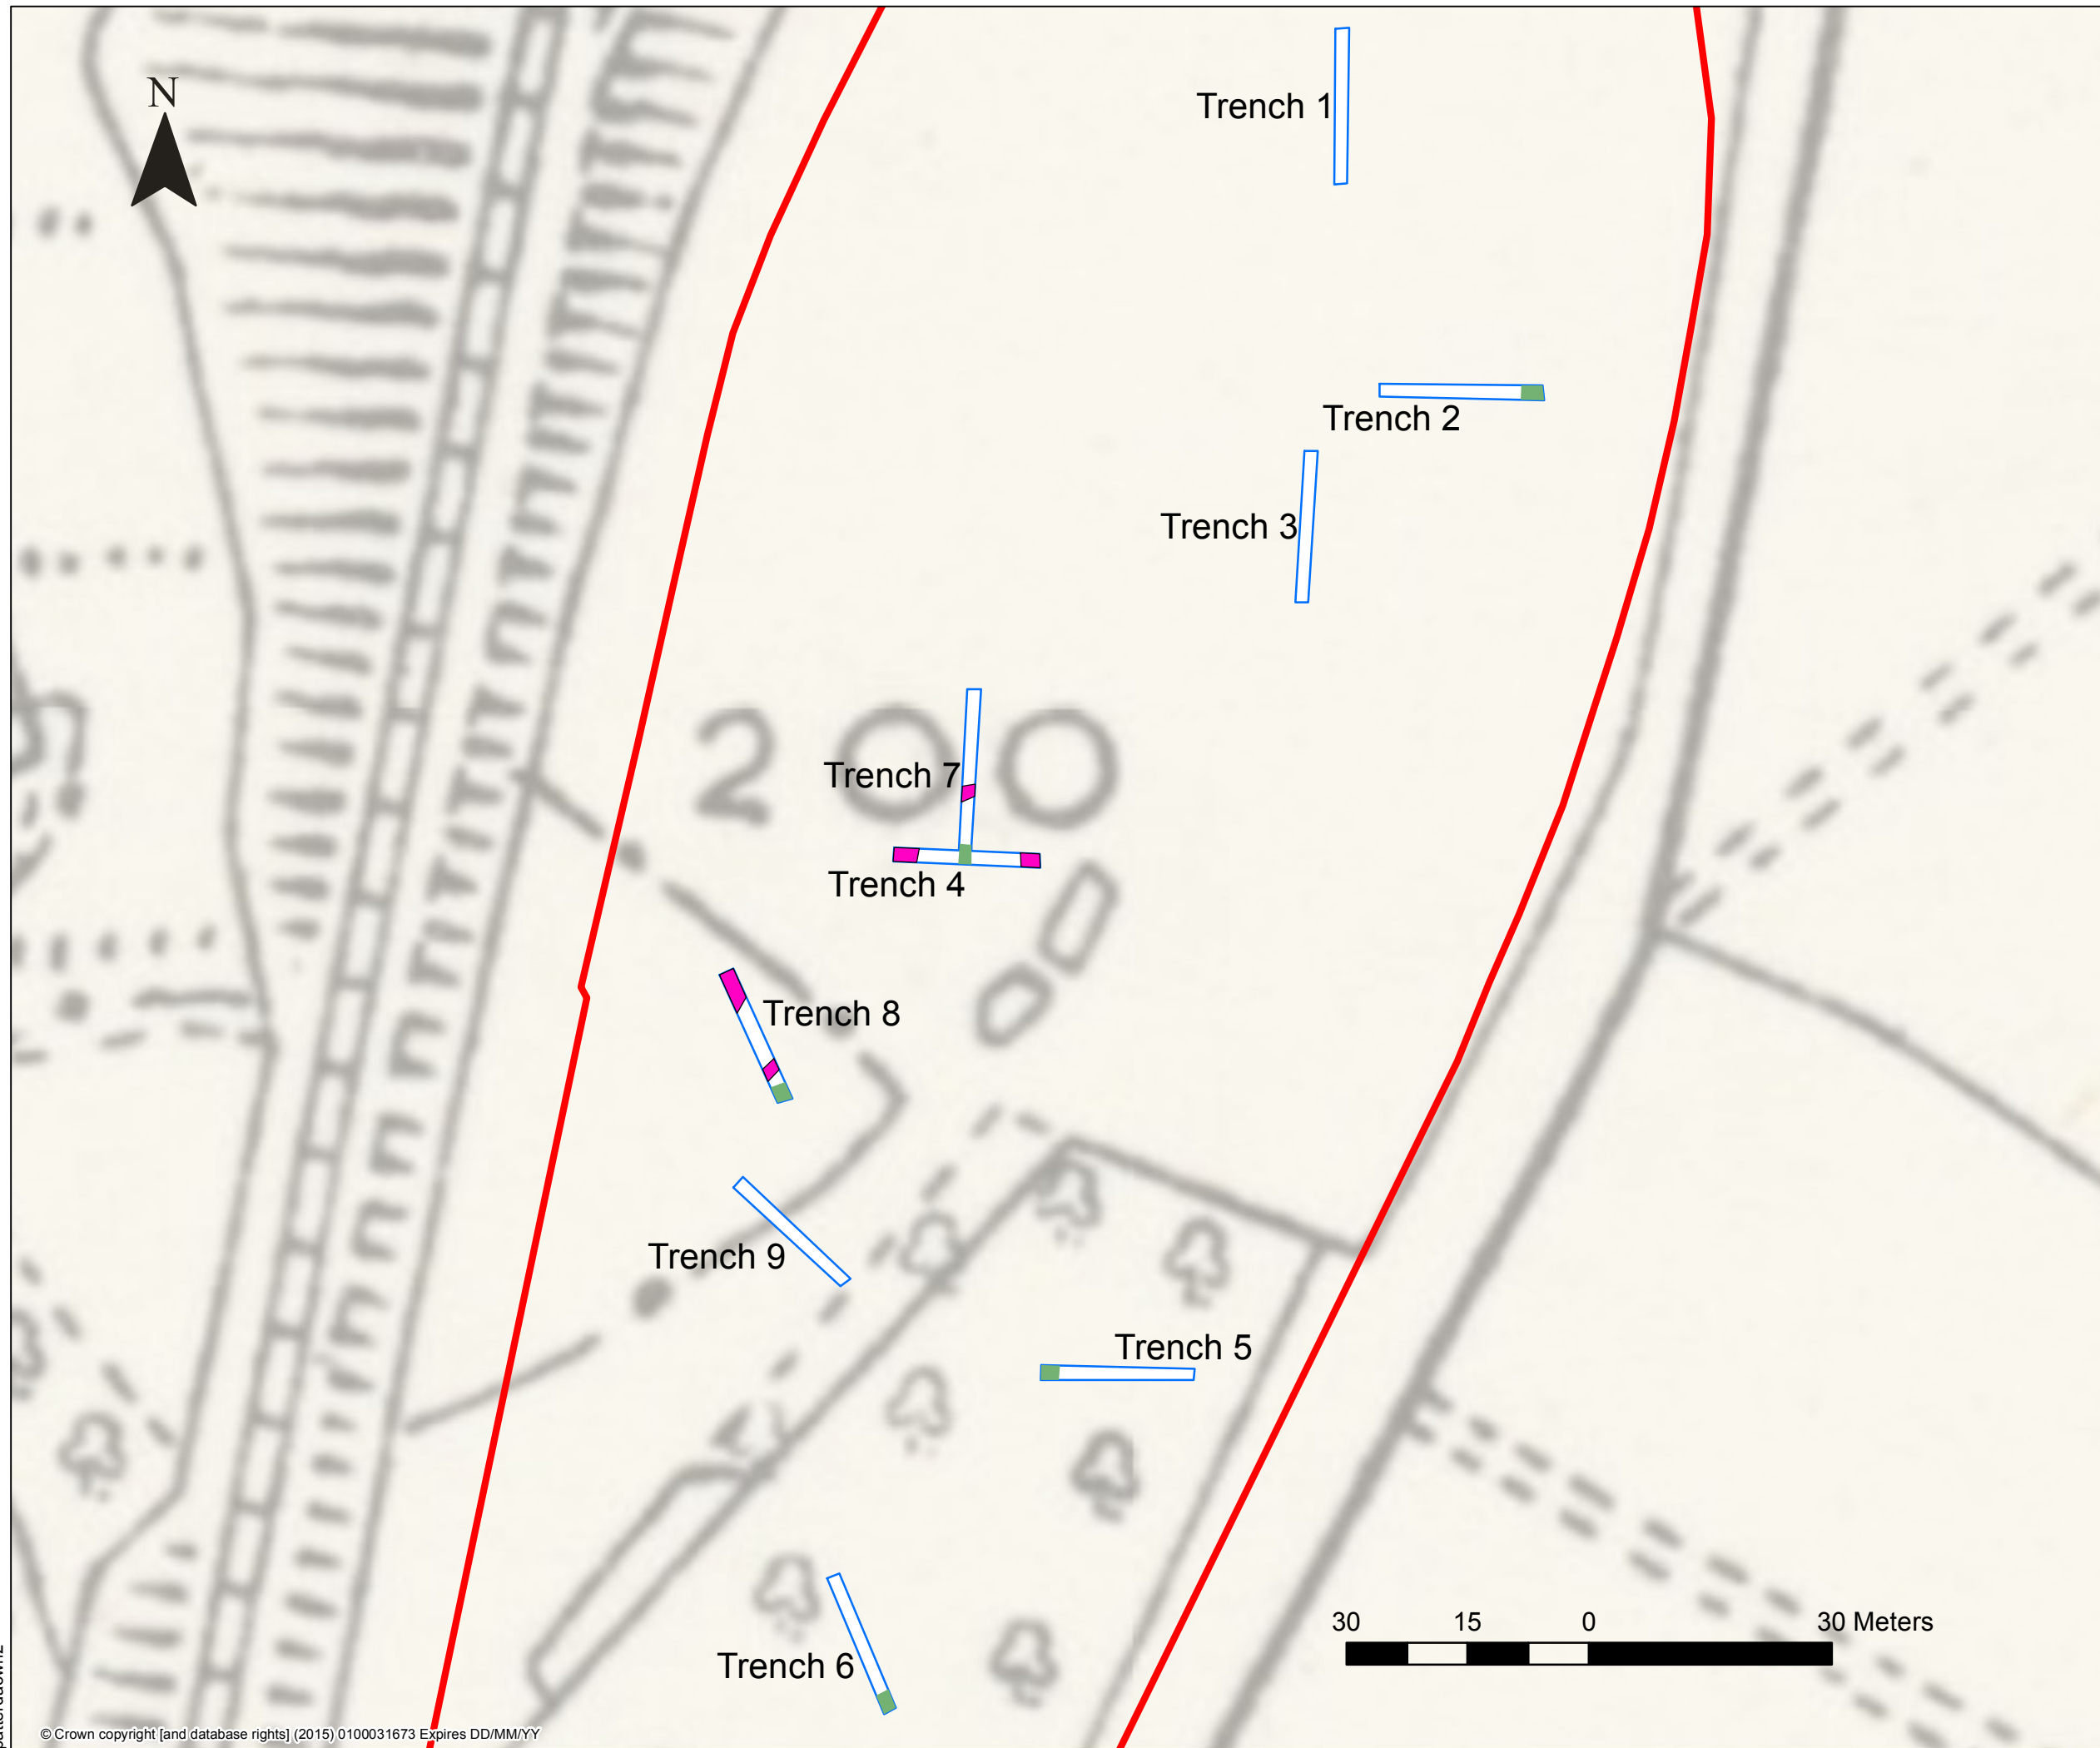
**4**

It was proposed to undertake the excavation of nine trenches 20m long x 1.8m wide to evaluate the site (Drawing 4). This represented a 2.5% sample of the available area and they were located based on the results of the geophysical survey undertaken by Sumo.

PATTERDOWN ROAD  
ARCHAEOLOGICAL INVESTIGATION  
**TRENCH PLAN**
