# WALNEY AIRFIELD, WALNEY ISLAND, CUMBRIA

## Report on an Archaeological Evaluation

Prepared for: BAE Systems

SLR Ref: 406.00155.00024  
Version No: Final  
October / 2017

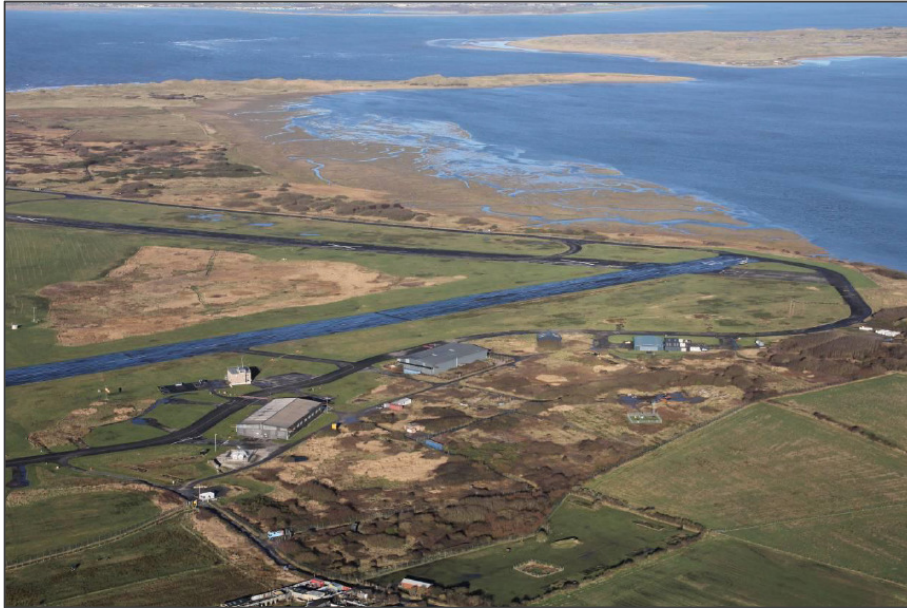
**Figure 2**  
**General view of eastern section of Walney Airfield (image taken by Lawrence Hill)**

In terms of topography, North Walney is divided into three clear zones: coastal foreshore, sand dunes system occupying the western fringes of the northern spit and lowland marsh and scrub (Figure 2). The site lies close to a landscape of dynamic sand dune systems, several areas of which rise to 35-40m AOD. The site, however, stands at a height of between 9m and 16m AOD.

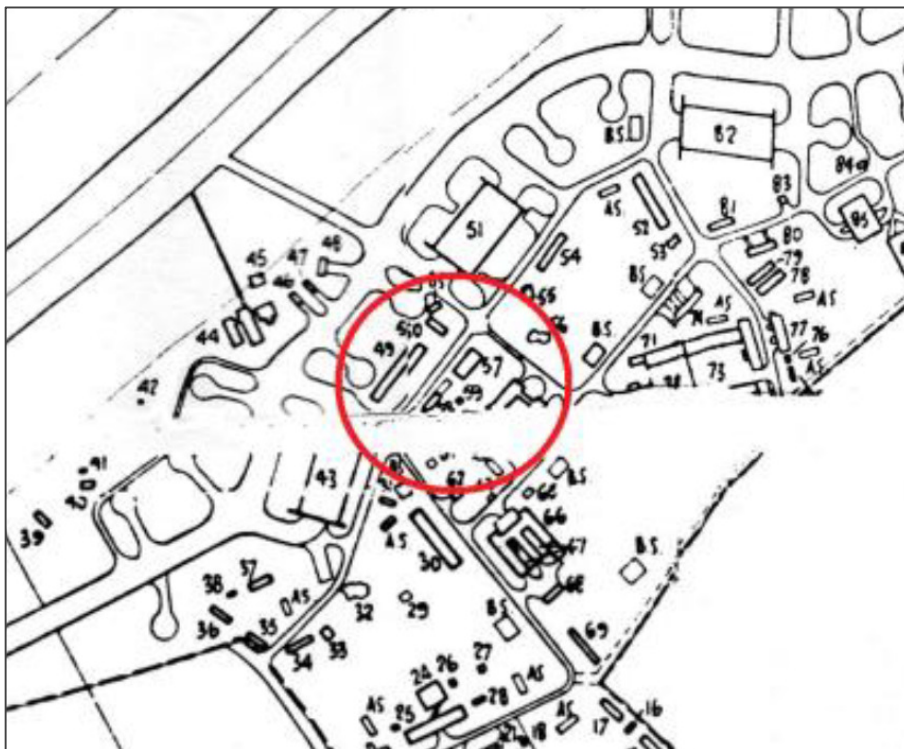
**Figure 3**  
**Extract from World War II or early Cold War inventory of airfield**

During the latter stages of World War II (or sometime soon after) a plan of the base and all its buildings was produced (Figure 3), along with a series of aerial photographs (e.g. Figure 4). At this time, the evaluation site housed at least six buildings/structures [marked within red in Figure 3] including an Armoury (Building 49), BAA

Store (Building 50), Towed Target Store (Building 57)<sup>6</sup>, WAAF Latrine (Building 59) and Fuel Compound (Building 85).<sup>7</sup> This area stood between two large hangars (Buildings 43 and 51) and south-east of the Control Tower (Building 44). Since the publication of this inventory, these buildings/structures have been demolished; however, subsurface remains of these buildings survive.

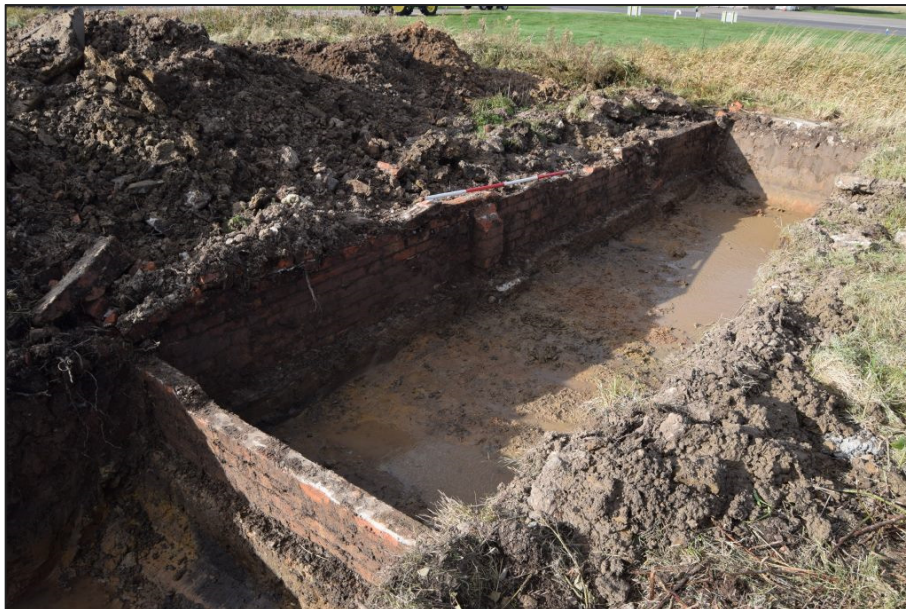
**Figure 5**  
**Trench 1 looking south west**

Trench 1 was the most westerly trench excavated at the site and was orientated roughly north west – south east (Drawing 1, Figure 5). It was advised by an on-site ecologist that this trench be moved approximately 2.5m to the south west of where it was originally to be dug due to a possible Natterjack toad habitat.

The natural subsoil in the area was a brown orange sandy clay (100) which was recorded at approximately 13.20m AOD across the trench. This was overlain by mid grey silt clay (101) which may have represented the original topsoil on the site. Cut through the topsoil and sitting on top of the natural subsoil were concrete foundations (104) on which were set brick wall base (105) (Drawing 1). The concrete was up to 0.25m thick and ran for 8.7m along the southern side of the trench before returning at its southern end to the north east. The brick wall base was made up of bricks measuring 235mm x 70mm x 110mm set in a stretcher bond one brick thick with low buttresses present at approximately 2.5m intervals along its length. It survived up to eight bricks high. No floor relating to the foundations was identified.

To the north of the north west – south east section of the foundation (101) was covered by 0.48m of light grey mottled yellow silt clay (102) and to the south by the same depth of orange grey brown silt clay (103). Both deposits represent made ground.

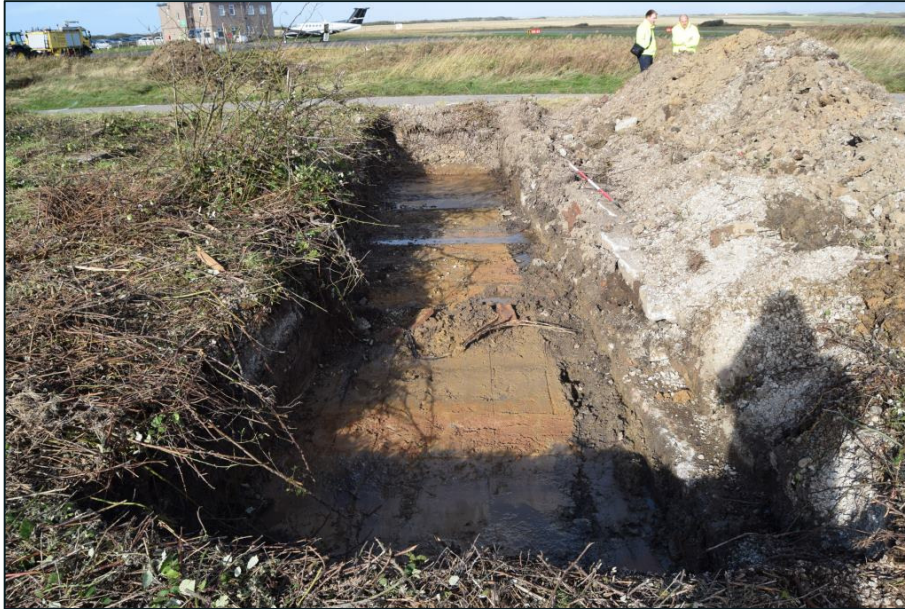
**Figure 6**  
**Trench 2 looking north west**

Trench 2 was located approximately 15m south east of Trench 1 and was orientated roughly north west – south east (Drawing 1). The natural subsoil in the area was a brown orange sandy clay (200) which was recorded at approximately 13.85m AOD across the trench (Figure 6). A concrete foundation (203) was recorded running along the northern side of the trench for approximately 8m (Drawing 1). It was 0.2m thick and 0.5m wide. The natural subsoil was covered by 0.4m of dark grey brown clay silt (201) which may represent the original topsoil.

The relationship between this context and the foundation was unclear. This was covered by 0.4m of crushed concrete and rubble (202). A service trench ran parallel with the foundation on its south western side while a dead electric cable crossed the trench 2m from its southern end.

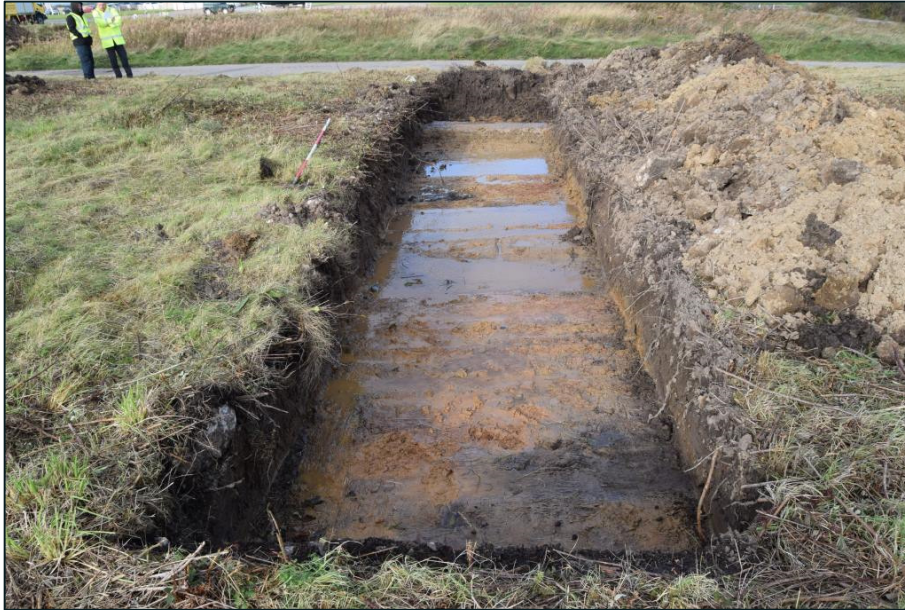
**Figure 7**  
**Trench 3 looking north west**

The natural subsoil was a brown orange sandy clay (300) which was recorded at between 13.76m at the southern end and 13.95m AOD at the northern end (Figure 7). This was covered by 0.4m of mid grey brown clay silt (302) which may represent buried topsoil. A concrete foundation (301) was recorded cutting through (302) running across the trench 2m from its northern end (Drawing 1). It was 'L' shaped, 0.12m thick and up to 0.8m wide. These contexts were all covered by 0.2m of dark brown clay silt (303).

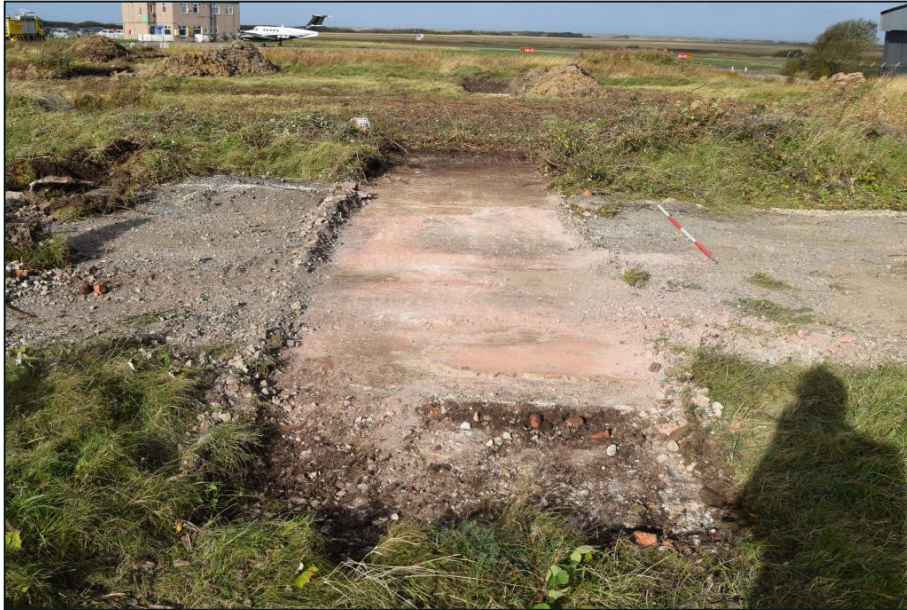
**Figure 8**  
**Trench 4 north west**

Trench 4 was located approximately 17m north east of Trench 3 and was orientated roughly north west – south east (Drawing 1, Figure 8). Natural brown orange sandy clay subsoil (500) was identified at 14.17m AOD at the south east of the trench.

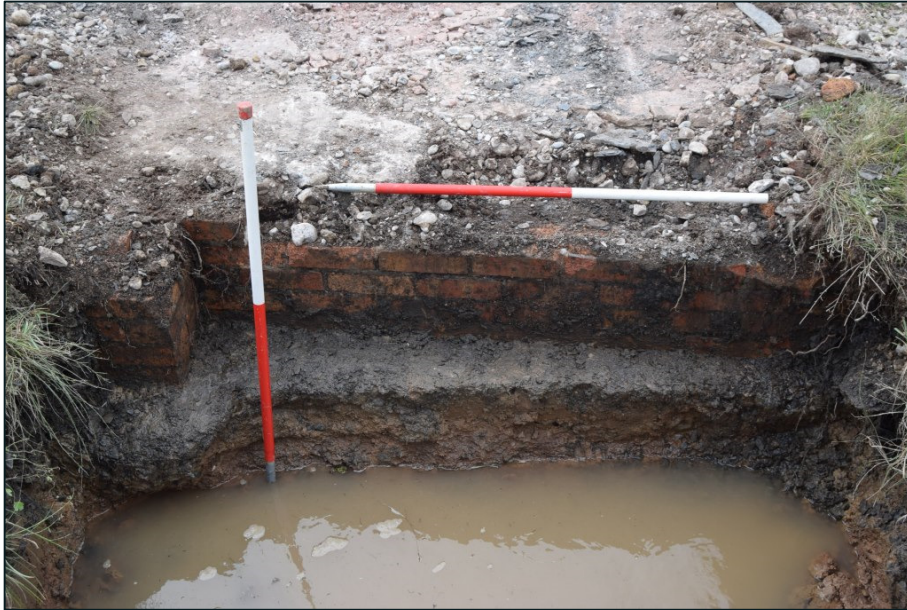
**Figure 9**  
**Trench 4 concrete foundation (404), wall (405) and floor (406) looking north west**

This was covered by mid brown grey silt clay (401) up to 0.3m thick which may represent buried topsoil. This was cut by a concrete foundation (404) and brick wall base (405) orientated roughly north east – south west. The concrete was approximately 0.3m thick. The wall base was made up of bricks the same size as those in Trench 1 and was again constructed using a stretcher bond (Figure 9). A buttress was recorded at the southern limit of the exposed wall base and it survived to up to 4 bricks high. To the north of the foundation was a concrete floor (406) at current ground level (14.97m AOD).

Context (401) was covered by up to 0.3m of slate in a dark grey silt (402) which was in turn covered by 0.1m of mid brown clay silt (403).

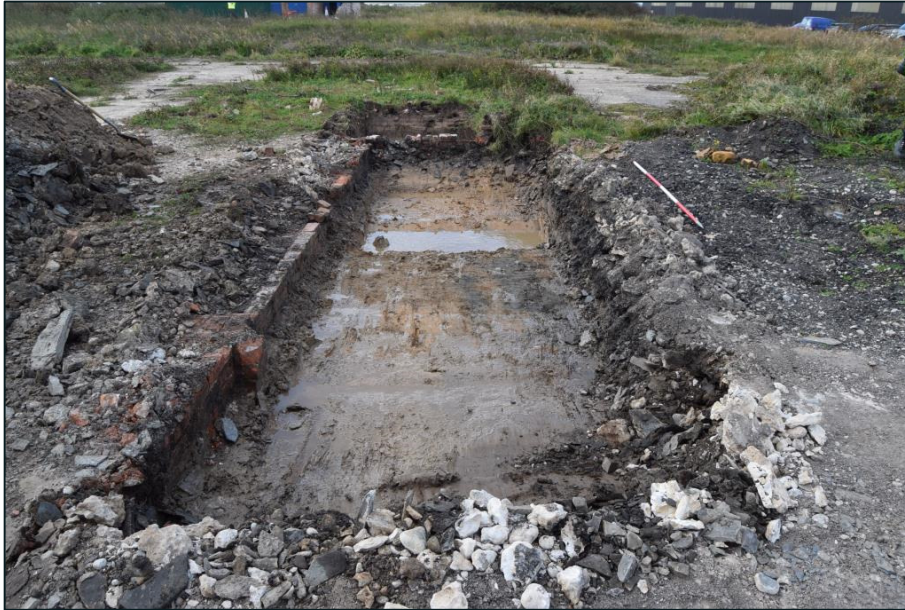
**Figure 10**  
**Trench 5 looking south west**

Trench 5 was located approximately 11.5m south of Trench 4 and was orientated roughly north east –south west (Drawing 1 and Figure 10). Natural brown orange sandy clay subsoil (500), which was observed at between 14.48m AOD at the east and 14.29m AOD at the west, was identified below up to 0.15m of mid grey brown grey clay silt (501) which may represent buried topsoil. This deposit appeared to be cut by concrete foundation (503) and brick wall base (504). These ran along the east side of the trench for 7.8m before turning to the north west at their southern end (Figure 11). The concrete foundation was 0.1m thick and over 0.2m wide. The wall base was made up of similar bricks to those recorded in Trenches 1 and 4. It was one brick thick and survived up to three bricks high. A single buttress was recorded along its length. Context (501) and the concrete foundation base were covered by up to 0.5m of slate in a dark grey silt (502), the same as (402), which lay against the side of the wall base. In places this was covered by broken concrete which appeared to have been part of the same floor as (406).

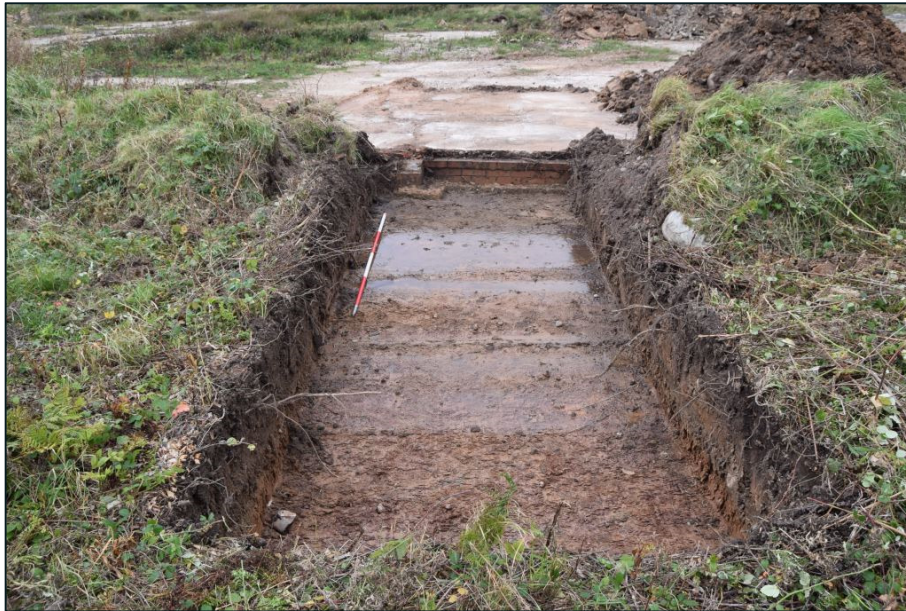
**Figure 12**  
**Trench 6 looking north west**

Trench 6 was the most easterly of the trenches excavated, approximately 13m south east of Trench 5 (Drawing 1). Natural subsoil (600), a brown orange sandy clay was observed at approximately 14.55m AOD at the eastern end of the trench (Figure 12). It was covered by up to 0.1m of light brown grey clay silt (601) which may represent a buried topsoil. This was in turn covered by 0.5m of dark brown grey clay silt (602). A concrete foundation (603) and wall (604) crossed the line of the trench approximately 4m from the western end (Figure 13). The concrete foundation was at least 0.2m wide and 0.1m thick. The wall base was made up of bricks the same size as those identified in the other trenches and was constructed in a stretcher bond. It was up to 3

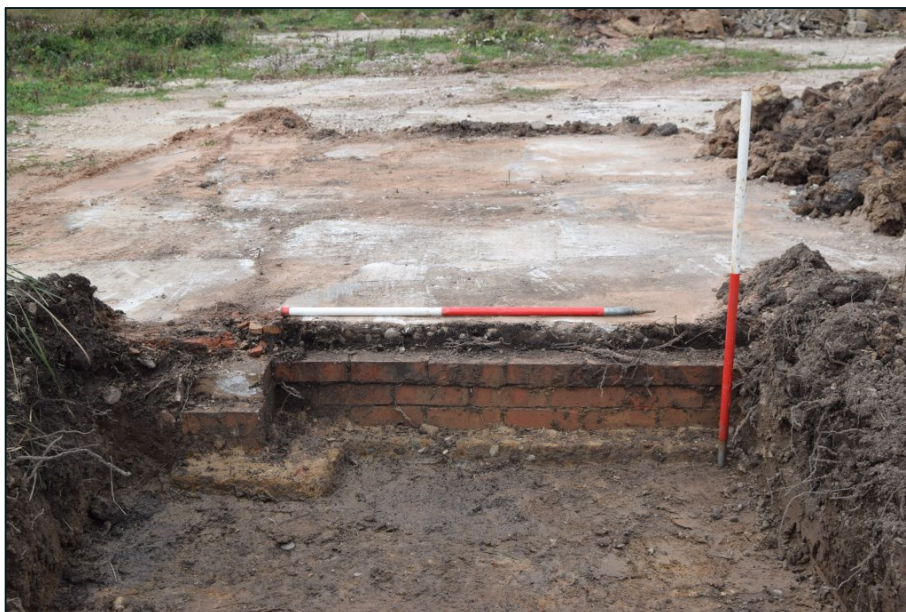
**Figure 13**  
**Trench 6 wall base (603)/(604) looking north west**

bricks high with a buttress at the southern end of the exposed length. A concrete floor (605) was recorded to the west of the foundation at 14.95m AOD.

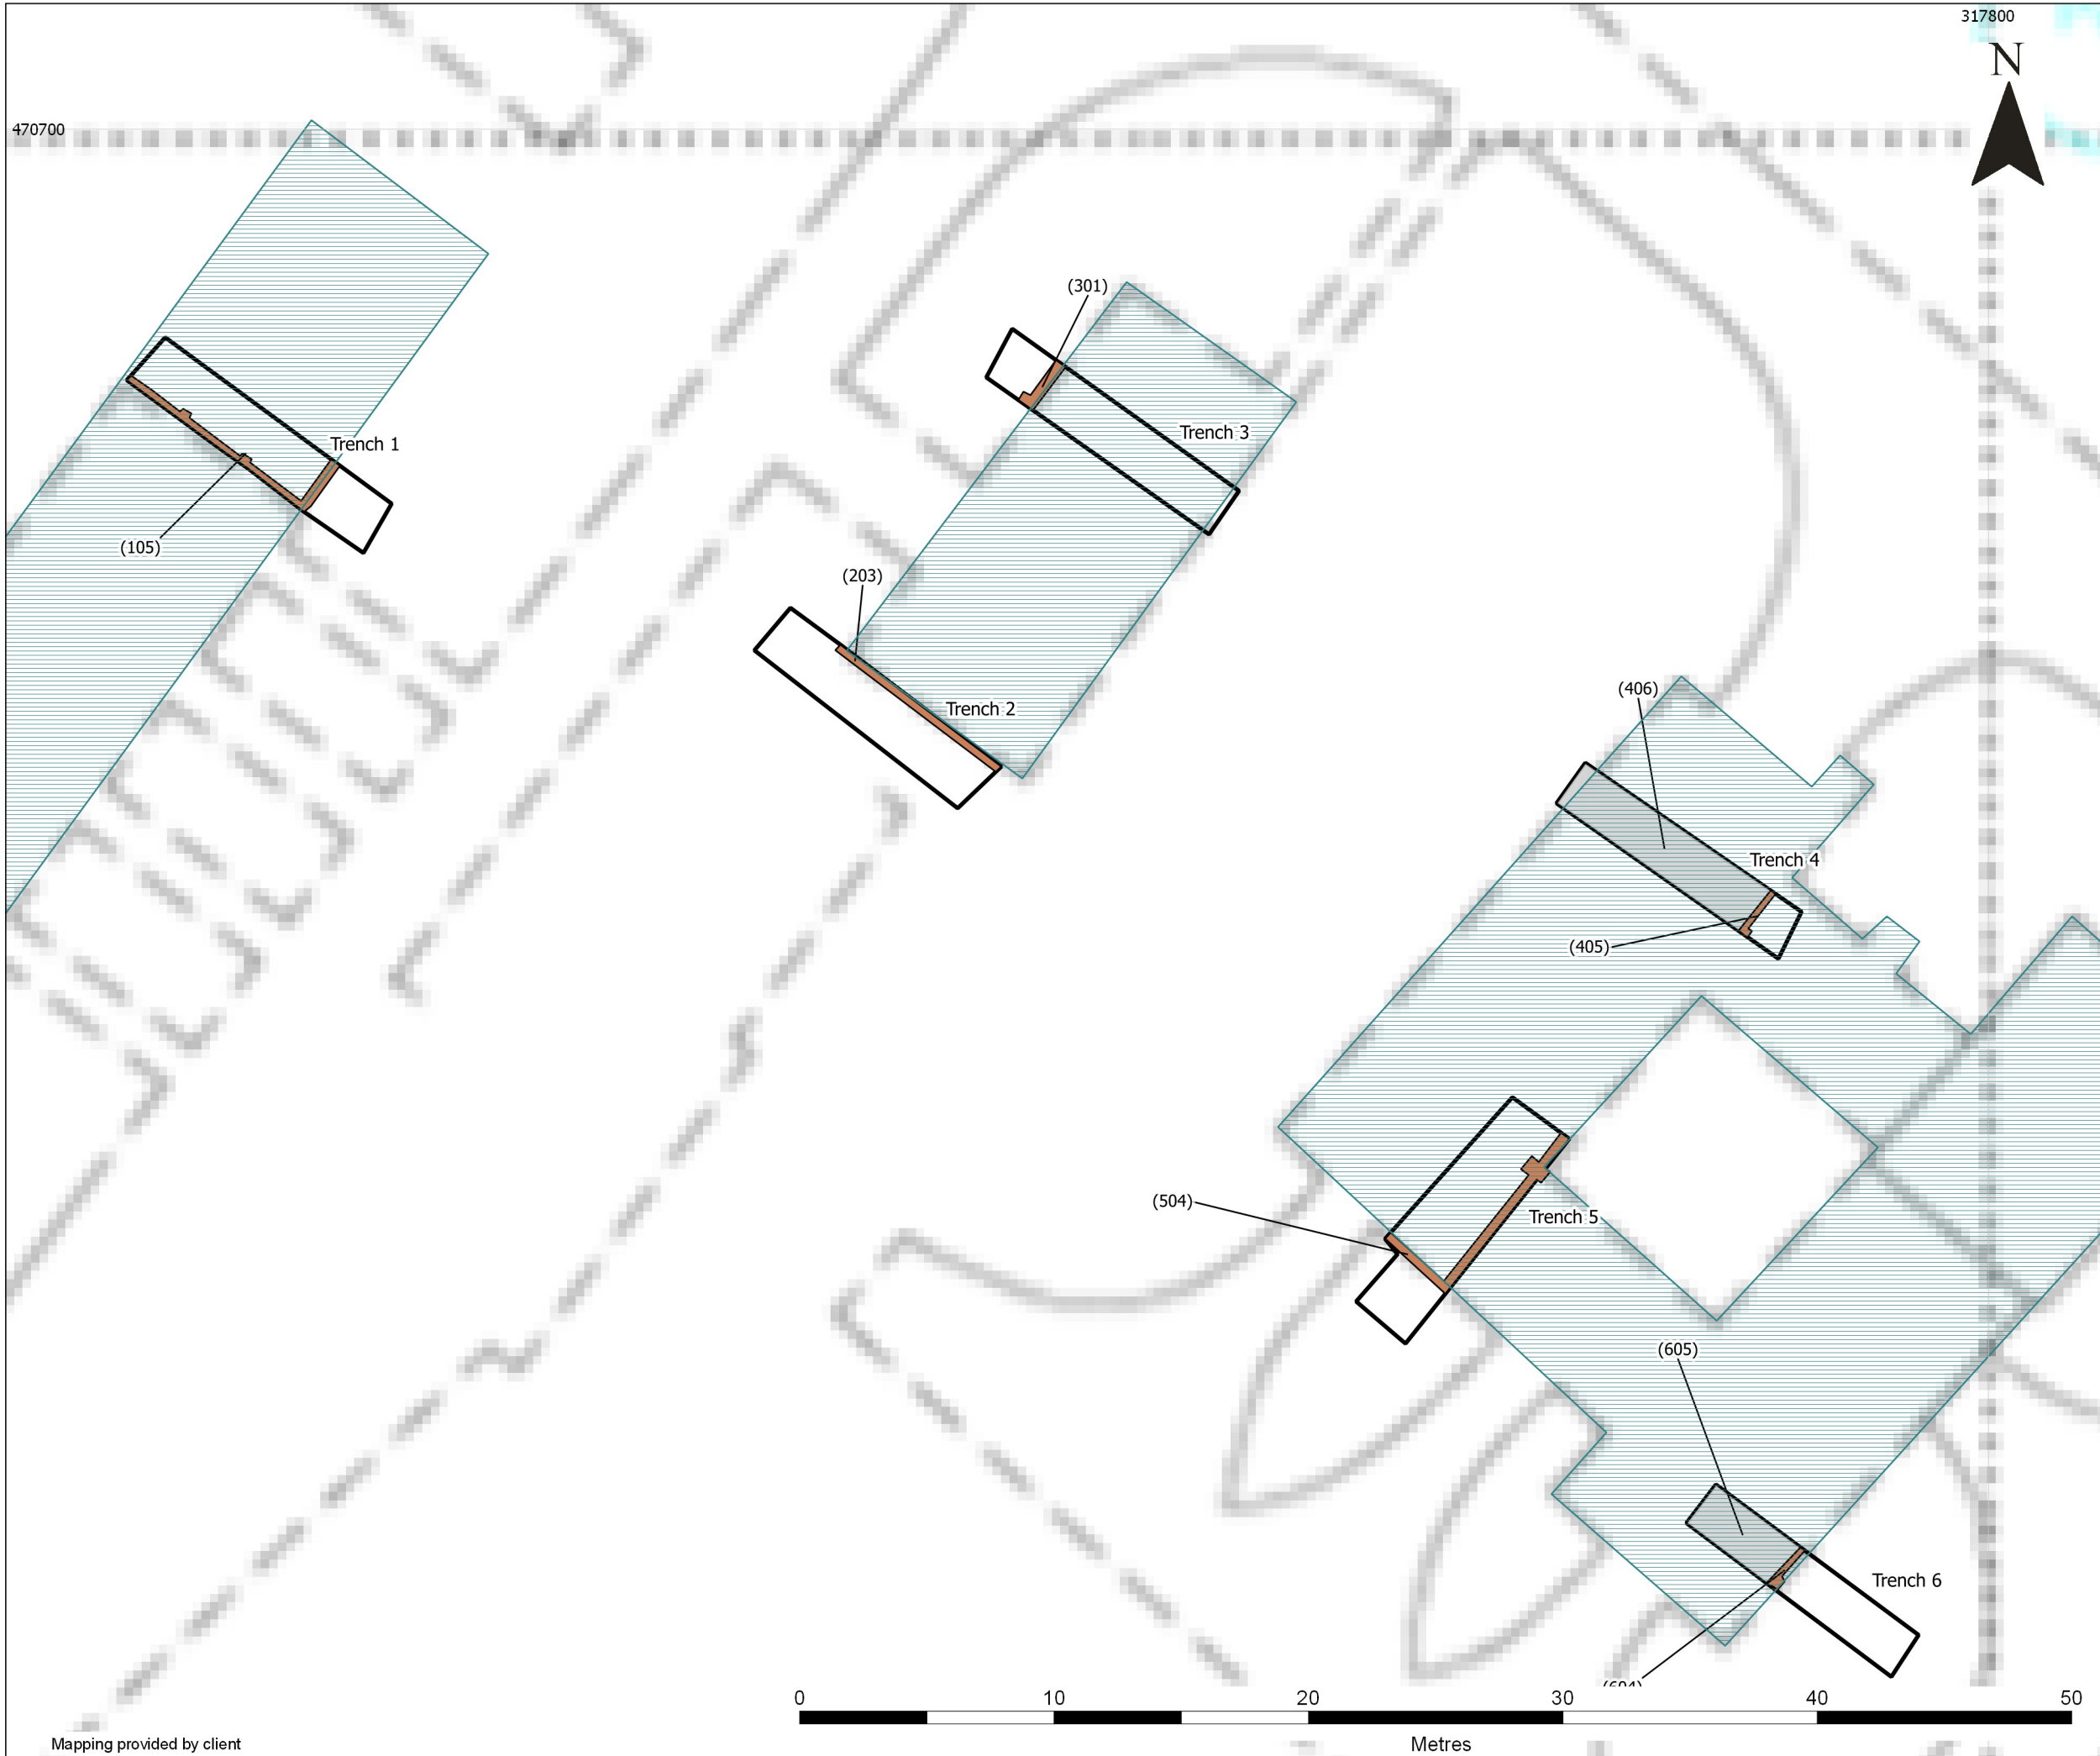
WALNEY AIRFIELD  
ARCHAEOLOGICAL EVALUATION  
FEATURES IDENTIFIED AND 1958 OS MAP  
BUILDINGS  
**DRAWING 1**

Six trenches were targeted on World War II period buildings across the site (Drawing 1). Trench 1 targeted the remains of an armoury building while Trenches 2 and 3 targeted a towed target store

Six trenches were excavated at Walney Airfield, all of which were targeted on the remains of World War II buildings (Drawing 1).

Remains were identified in each trench (Section 6 above). The buildings appear to have been constructed with footings cut through the existing topsoil and concrete poured in to create a foundation base. Single width brick wall bases were then constructed on top of these foundation bases using regular buttresses as support. The brick type appears to be consistent across the site (as standard in most World War II sites). Slate in a silt matrix was used as a sub-base for concrete floors. Made ground is present across the site, presumably introduced to raise the level of the site above the water table. All of the trenches flooded immediately after excavation.

The preservation of the building remains varied across the site with only concrete foundation bases present in Trenches 2 and 3. Elsewhere in Trenches 4, 5 and 6, foundations were well preserved and floors present.
