**SOUTHMEAD POLICE STATION,  
SOUTHMEAD ROAD, BRISTOL  
BS10 5DW**

**Report on Archaeological Fieldwork**  
Prepared for: Care UK

SLR Ref: 402.02498.00011.27  
Version No:1  
May 2018

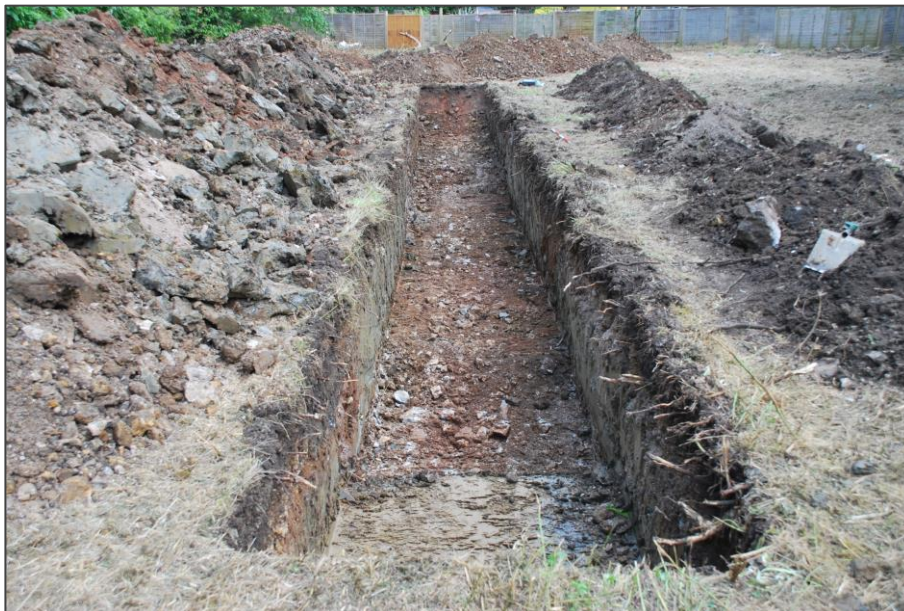
**Figure 3**  
**Trench 1 looking east**

Trench 1 was located at the south west of the site and was orientated roughly WNW – ESE (Figures 2 and 3).

At the surface of the trench dark brown silt clay topsoil (101) up to 0.2m thick was recorded overlying made ground comprising orange brown silt clay (102) up to 0.2m thick. This covered the natural orange brown silt clay subsoil (103) which contained frequent limestone cobbles. The natural subsoil was identified at about 53.74m AOD.

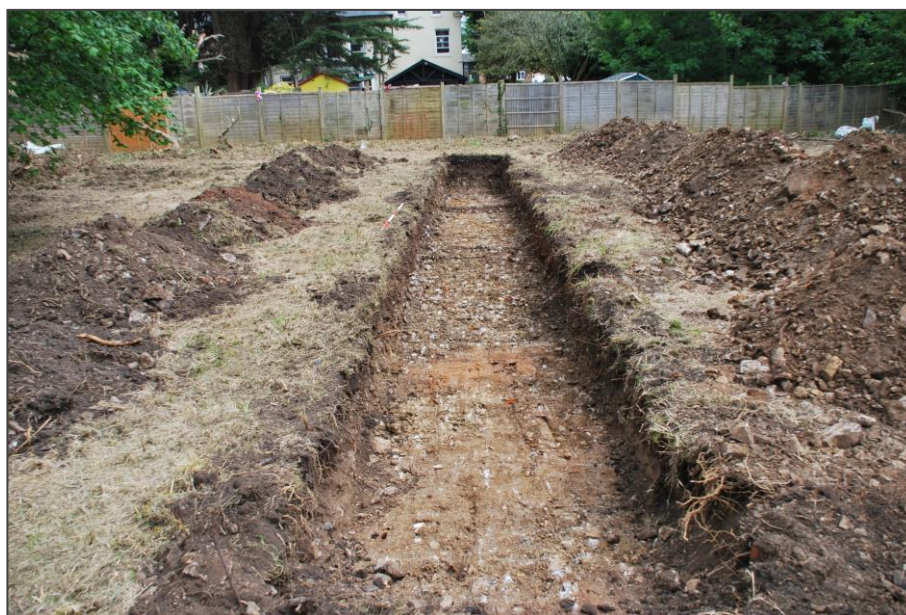
**Figure 6**  
**Trench 2 looking south east**

Trench 2 was located approximately four metres east of Trench 1 and was orientated roughly north west – south east (Figure 2).

Dark brown silt clay topsoil (200) overlay yellow grey clay silt made ground (201) which was above natural orange brown silt clay (202) which comprised 50% limestone pieces (Figure 6). This was observed at between 53.55 m and 53.73m AOD. No features of archaeological significance were observed.

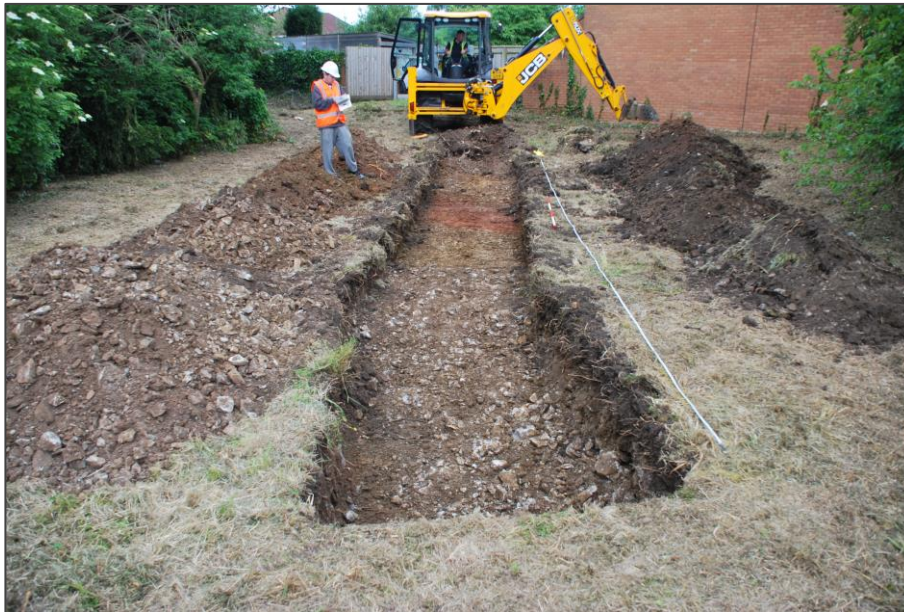
**Figure 7**  
**Trench 3 looking north**

Trench 3 was located to the north of Trenches 1 and 2. It was orientated roughly north – south (Figure 2).

Dark brown silt clay topsoil overlay yellow brown silt clay natural subsoil comprising 50% limestone at the south while at the north the natural subsoil was a yellow silt clay with no limestone (Figure 7). The yellow brown silt clay containing the limestone is thought to underly the yellow silt clay. An area of in situ burning was observed approximately 8m from the northern end of the trench. There was no evidence of fire debris observed in any of the contexts above it. The natural subsoil was at between 53.72m and 53.92m AOD.

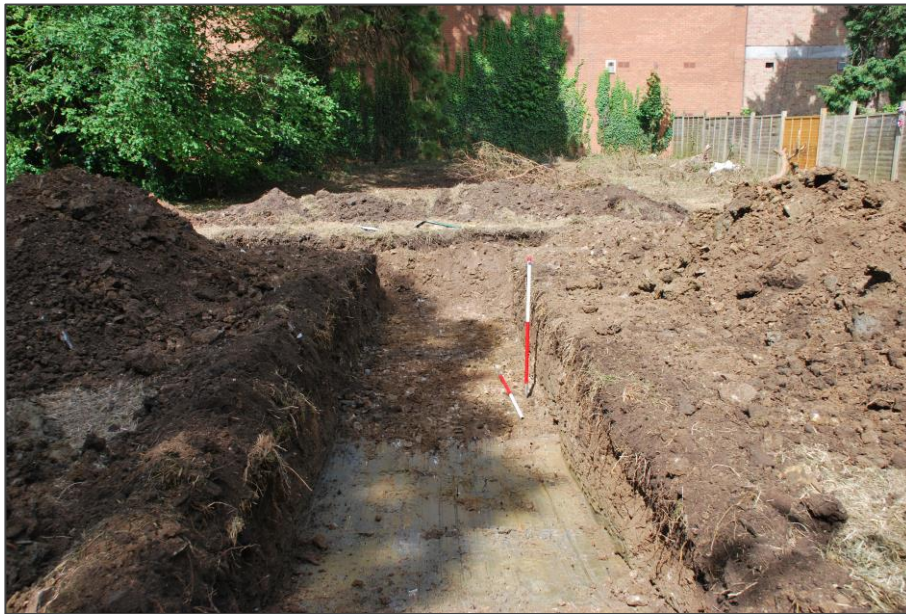
**Figure 8**  
**Trench 4 looking north east**

Trench 4 was excavated directly to the south of Trench 2 (Figure 2). It was 7m long and orientated roughly north east – south west. It was dug to try and identify the line of the wall/landscaped step previously identified in Trench 1. This was recorded approximately 2.8m from its southern end as [403] and was filled by blue grey clay (404) (Figure 8). The stratigraphy of the trench was otherwise identical to Trench 2. The natural subsoil was identified at 53.62m AOD.

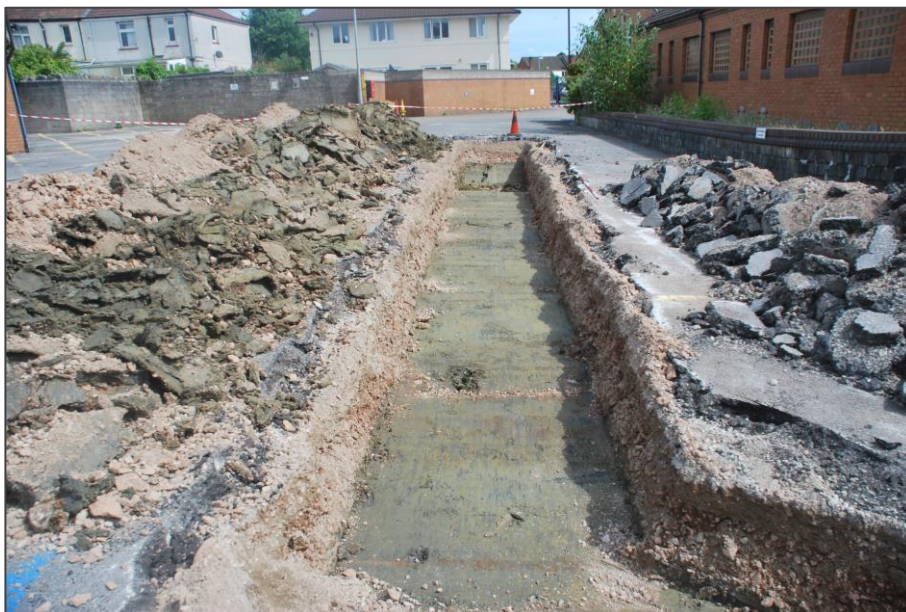
**Figure 9**  
**Trench 5 looking south east**

Trench 5 was located to the north of the police station and was the most north easterly trench on the site (Figure 2). It was orientated north west – south east. This area was evidently contaminated with diesel and several tanks are known within the site.

The tarmac of the car park (500) was up to 0.2m thick. It covered 0.3m of red grey hard-core (501) which in turn overlay 0.3m of coarser grey red hard-core (502). This was over the natural subsoil (503) which was a green grey clay and was recorded between 55.39m and 55.49m AOD (Figure 9). A test pit at the east end of the trench identified limestone bed rock at approximately 54.45m AOD. No features of archaeological significance were identified within the trench.

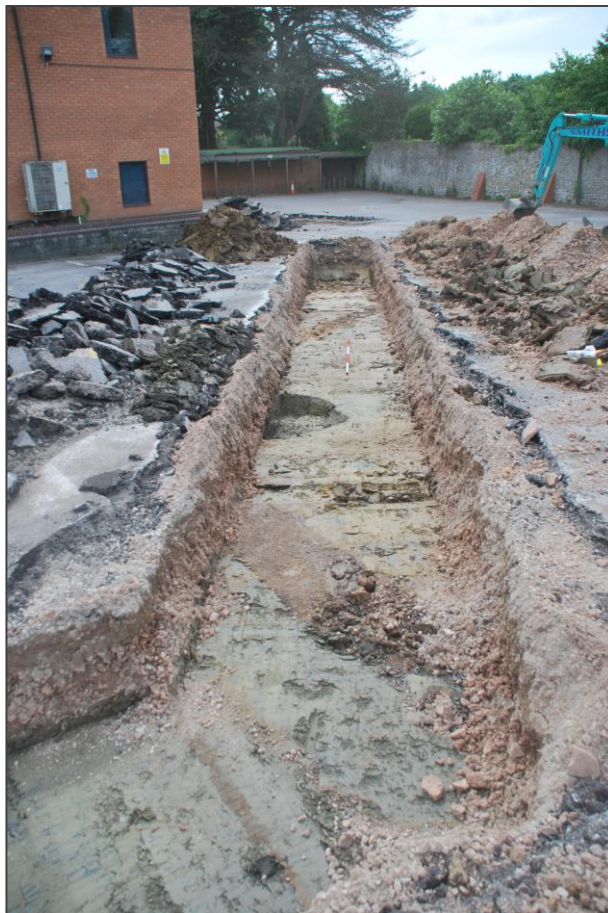
**Figure 10**  
**Trench 6 looking WSW**

Trench 6 was a continuation of Trench 5 to the west, orientated ENE-WSW (Figure 2). The general stratigraphy was the same as Trench 5 with 0.2m of tarmac (602) overlying two layers of hard-core (601 and 602) with a green grey clay natural subsoil which became more yellow to the west (Figure 10). The natural subsoil was recorded at between 54.5m and 55.49m AOD.

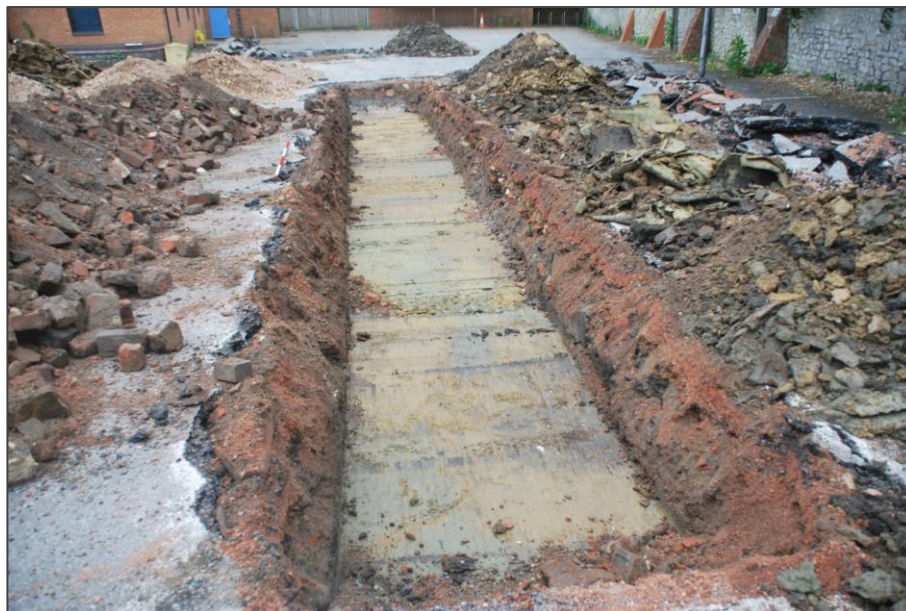
**Figure 13**  
**Trench 7A looking south west**

Trench 7 was the most north westerly trench (Figure 2). It was split into two lengths due to services, the northern part was 16m long (7A) and the southern 4m long (7B). It was orientated north east – south west.

In Trench 7A up to 0.1m of tarmac (700) overlay 0.32m of rubble (701) comprising brick, tiles and stone (Figure 13). This covered black clay silt (702) which was up to 0.15m thick and overlay the grey yellow clay subsoil (703). Context (702) may represent buried topsoil. The natural subsoil was recorded at between 54.45m and 55.4m AOD.

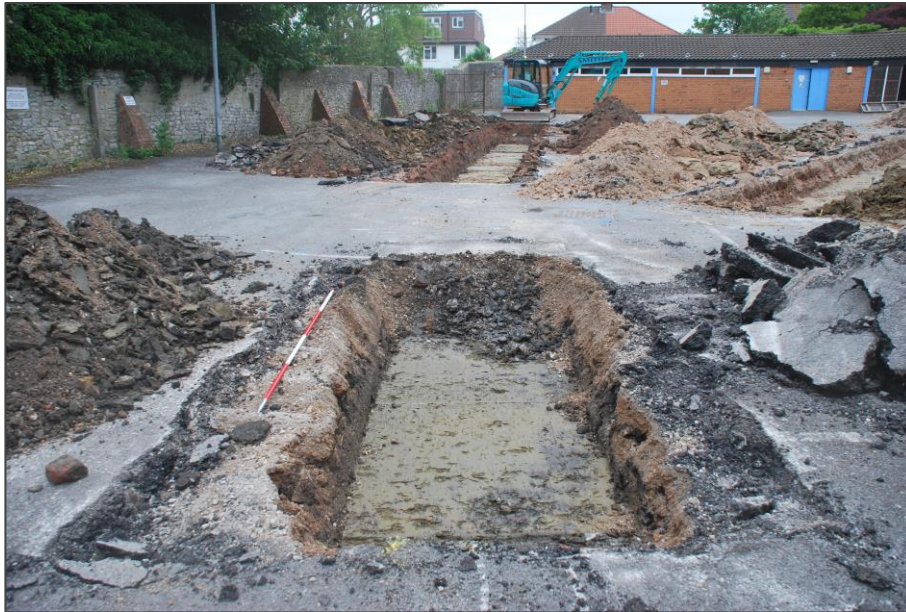
**Figure 14**  
**Trench 7B looking south west**

The stratigraphy in Trench 7B was the same as in 7A (Figure 14). The natural subsoil was recorded at 54.23m AOD.

No archaeological features were observed in either part of the trench.

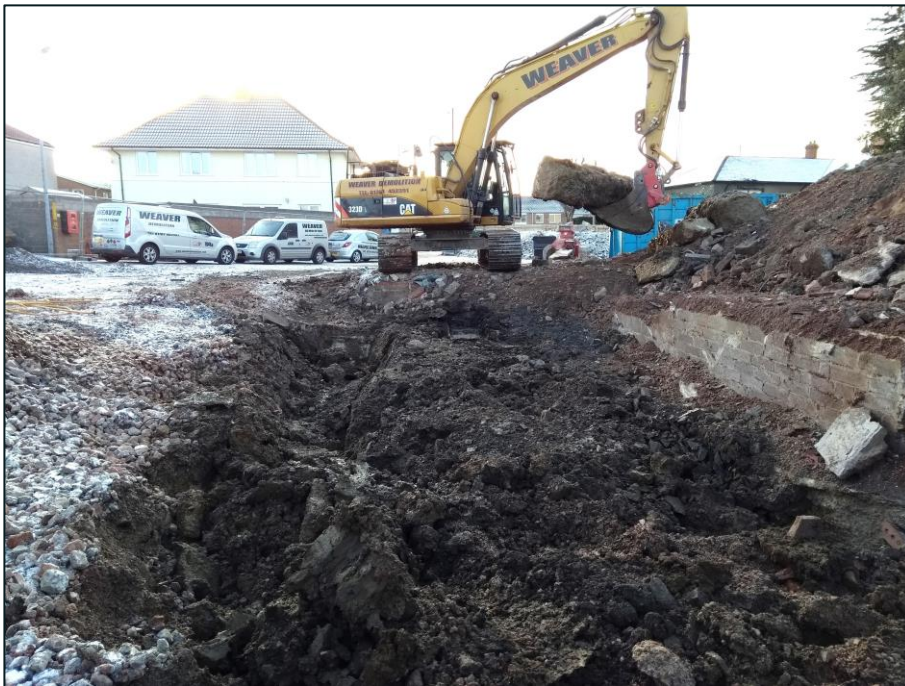
**Figure 15**  
**Removal of footings at north of former police station looking east**

A watching brief was carried out on the removal of the police station footings and the construction of an access road between 27<sup>th</sup> February and 14<sup>th</sup> March 2018 (Figures 2 and 15-17). The watching brief identified similar stratigraphy to that identified in the trenches in the car park area to the north with an average of 0.15m of tarmac (1000) in areas outside the police station overlaying between 0.3m and 0.5m of dark grey hard-core/stony made ground (1001). This also ran below where the police station had stood. It covered grey yellow clay natural subsoil (1002).

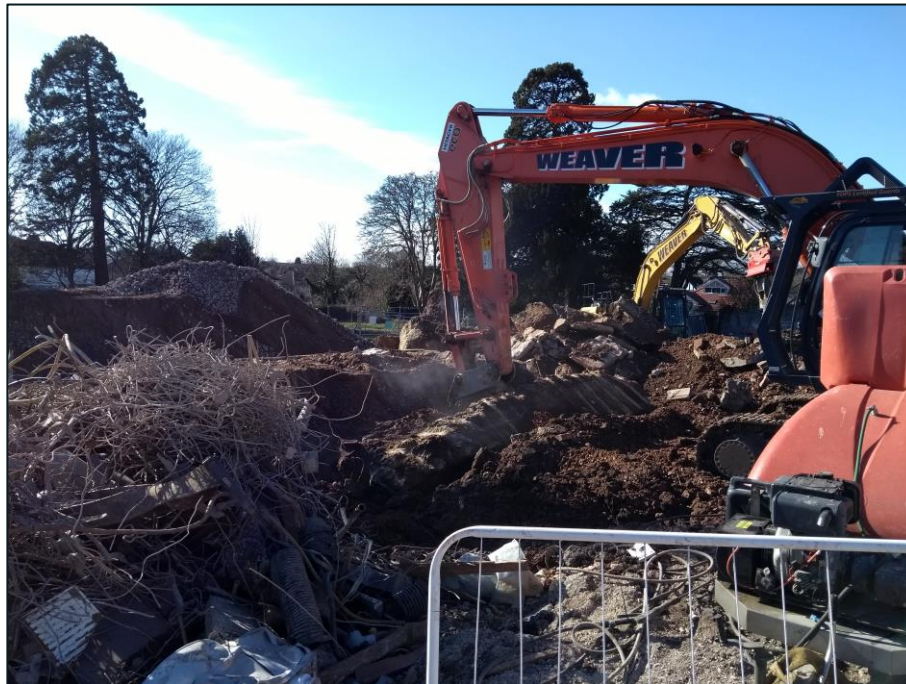
**Figure 16**  
**Removal of footings at south of former police station looking south west**

The former police station stood on poured concrete strip footings that were up to 1m wide and 1m deep. These were cut into the underlying natural subsoil. Below the police station any soil appeared to have been removed with up to 0.5m of rubble/stony deposit (1001) lying directly on top of the natural clay. A diesel tank and a number of services relating to the police station were identified cut into the natural subsoil.

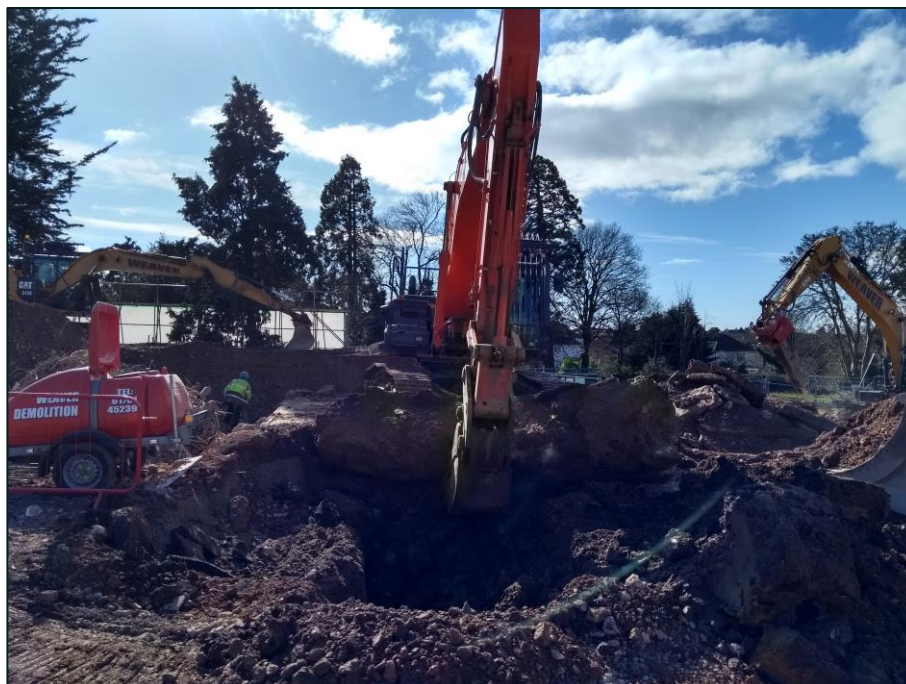
**Figure 17**  
**Removal of footings towards eastern end of former police station site looking south**

No remains relating to Southmead Manor were identified nor were any other features of archaeological significance. It is thought any features would have been removed during the construction of the police station.
