1 ST ALBANS ROAD, LEICESTER

Report on an Archaeological Evaluation

Prepared for: SASCO Properties Ltd

SLR Ref: 406.08871.00001
Version 2
October 2018

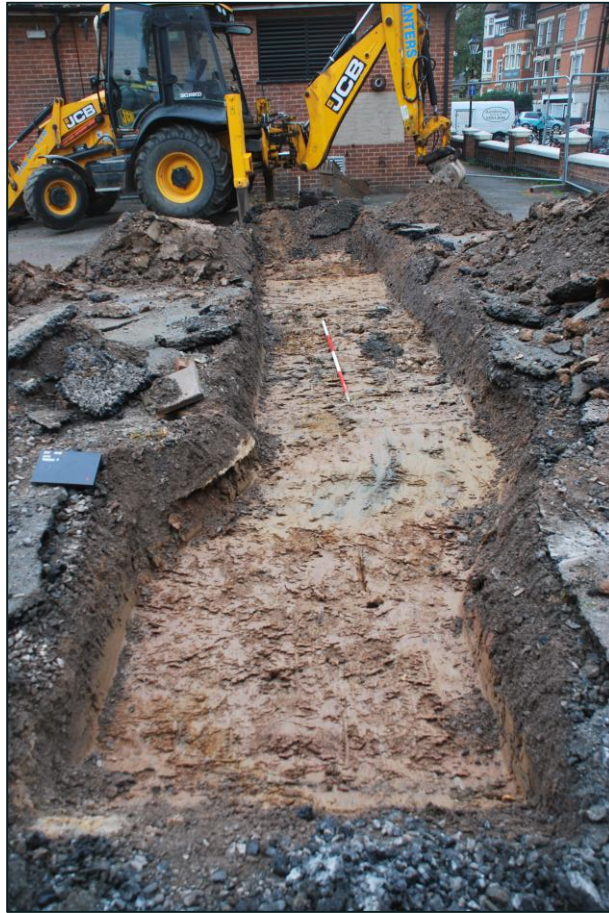
Figure 5-2
Trench 1 looking south west

Trench 1 was the most northerly trench on the site and was orientated north east – south west. The trench was excavated with a dog-leg due a large concrete obstruction under the tarmac. Light grey silt clay geology was observed at between 99.71m and 99.75m AOD across the trench (Figure 5-2). This was covered by 0.23m of dark grey hardcore which was in turn covered by 0.1m of tarmac (Figure 5-3).

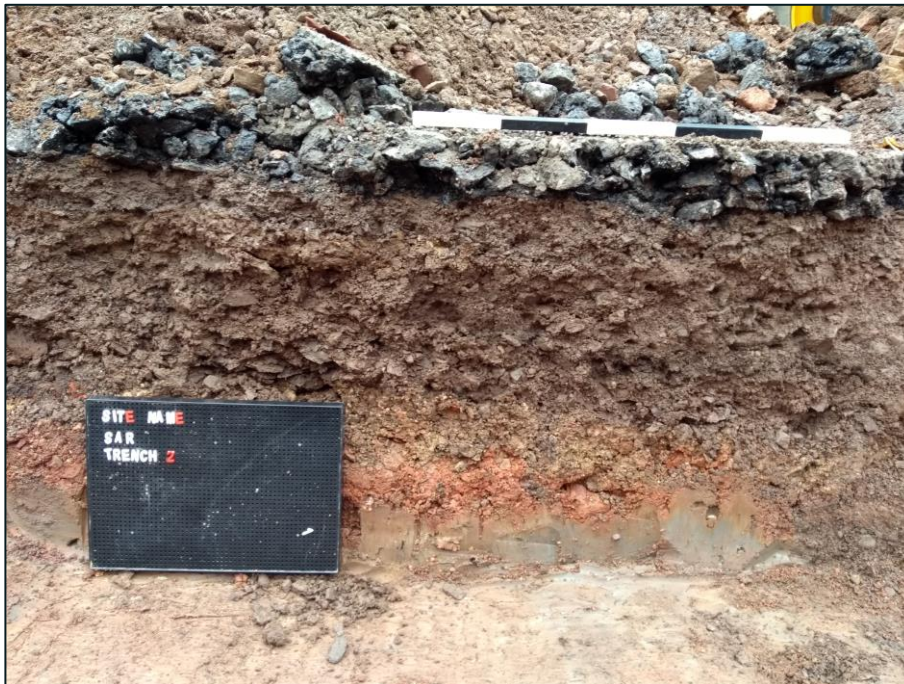
Figure 5-4
Trench 2 section looking south west

The stratigraphy within the trench (Figure 5-4) comprised natural grey brown silt clay geological deposits (204) recorded at between 99.42m and 99.46m AOD. This was overlain by a layer of crushed brick (203) up to 0.05m thick which was in turn covered by yellow grey hardcore (202) 0.05m thick, dark grey hardcore (201) up to 0.25m thick and 0.1m of tarmac (200).

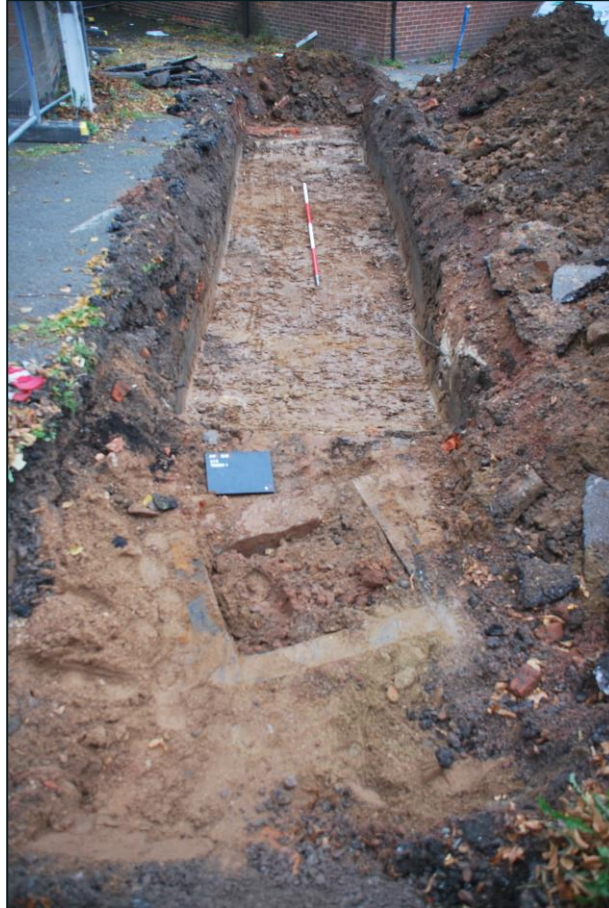
Figure 5-6
Trench 3 looking west

Natural light grey brown silt clay geology (303) was recorded at between 99.71m and 99.75m AOD across the trench (Figure 5-6). This was covered by up to 0.35m of dark grey brown silt clay which contained pieces of brick and charcoal (Figure 5-7). It appeared to be derivative of the underlying geology and may represent landscaping at the site. It was covered by rubble up to 0.2m thick that was covered by 0.1m of tarmac. At the very east of the trench a brick foundation was identified connected to a steel frame which was covered in concrete (304). The frame was set in yellow builder's sand. Its purpose is unclear. It may be part of an entrance feature at the gate of the car park. At the western end of the trench a concrete and curving modern brick foundation (305) was identified which may also have been part of an entrance feature.
