8 – 14 MANSFIELD ROAD, DERBY

Historic Building Record (Level II)

Prepared for: **Wheeldon Homes**

SLR Ref: 422.08473.00001
Version No: 1
June 2018 (revised July 2019)

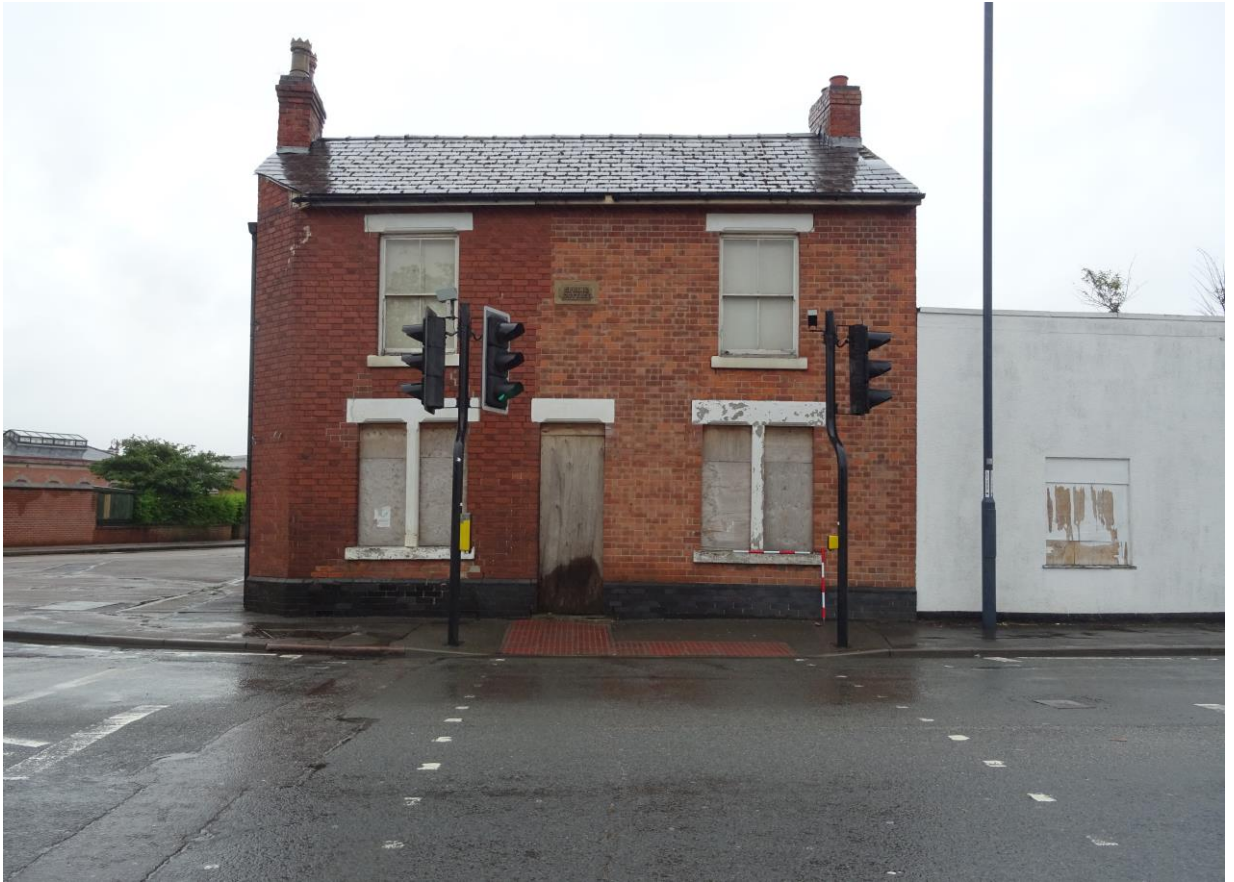
Plate 1: west facing elevation: 1m scale.

Located on the junction of Mansfield Road and Fox Street Spring Cottage is a late Victorian end of terrace type L-shaped house. Principally the building is of varying colours of red brick constructed with a mix of both English and stretcher bonds. The front elevation (**Plate 1**) has two upper four pane sash windows with stone sills and lintels and two lower four pane sash windows each with a central stone mullion with stone sills and lintels.

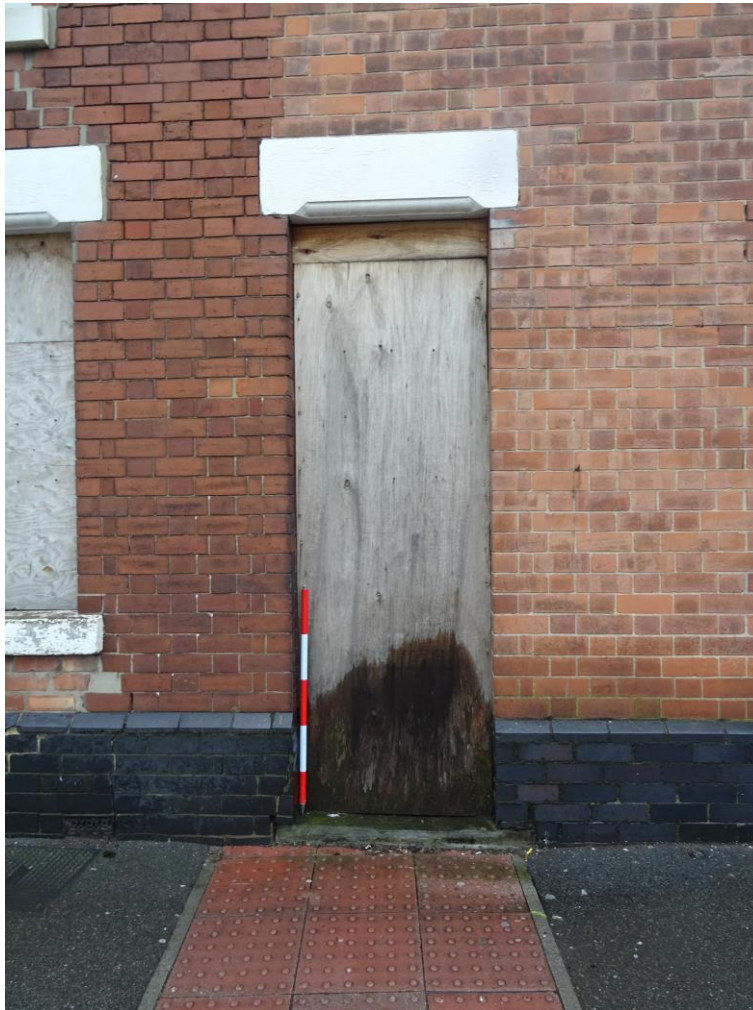
Plate 5: front entrance of Spring Cottage: 1m scale.

The building has a steep pitched slate roof with two plain chimney breasts and pots and one Elizabethan style breast and pots on the northern gable end. The front door has a modern wooden frame and door with a decorated glass panel above. (**Plate 5**).

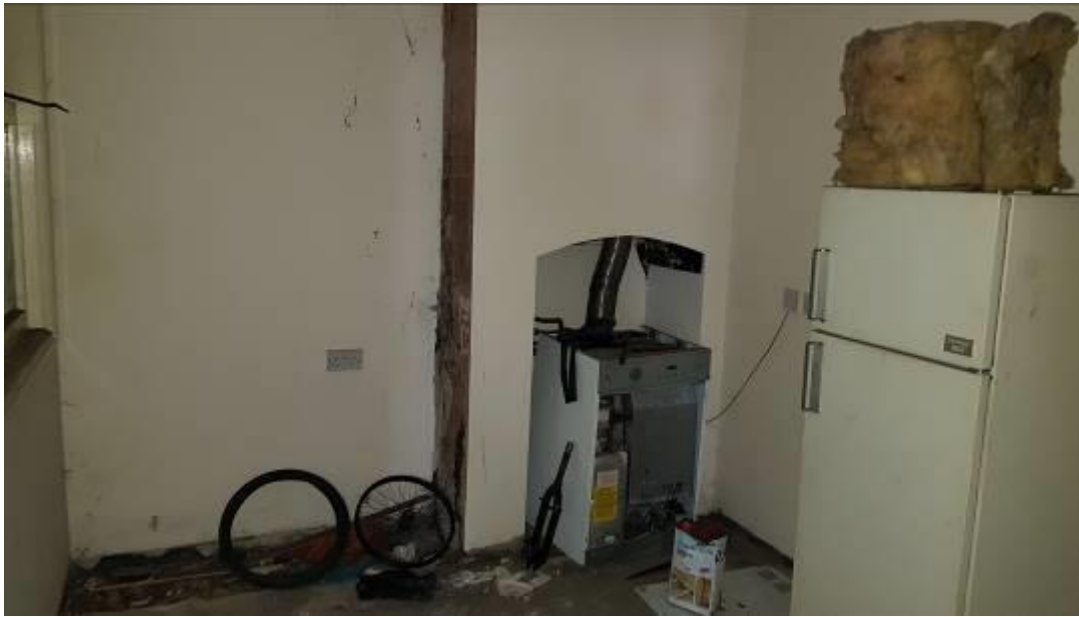
Plate 12: kitchen (lower floor). No scale.

Internally a steep wooden central staircase leads up to the second floor. The present kitchen is located on the southern lower floor room. The kitchen has been completely altered and modernised with no obvious original features present save for an arched alcove for a former fireplace now used to vent a tumble dryer (**Plate 12**).

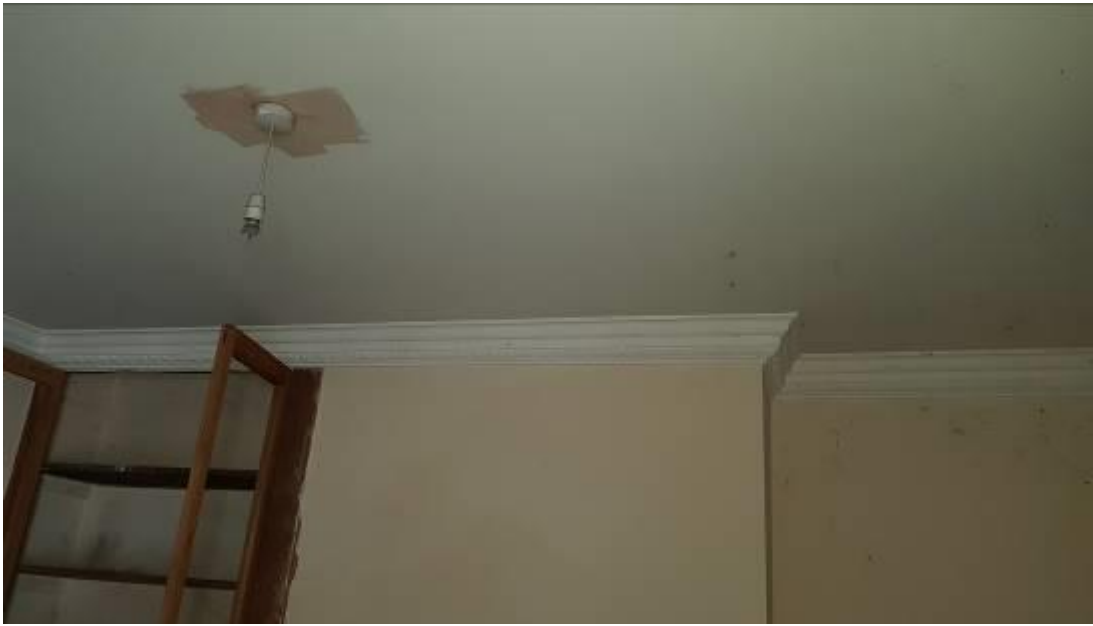
Plate 14: living room cupboard and cornice (lower floor). No scale.

Immediately opposite the kitchen is the living room. The living room contains a former fireplace, a decorative cornice and Victorian moulded skirting boards. No ceiling rose is present. The interior moulded window frame (**Plate 15**) appears original with one of the fireplace alcoves utilised as a cupboard/cabinet (**Plate 14**). As with the kitchen the floor is cement and no boards are present.

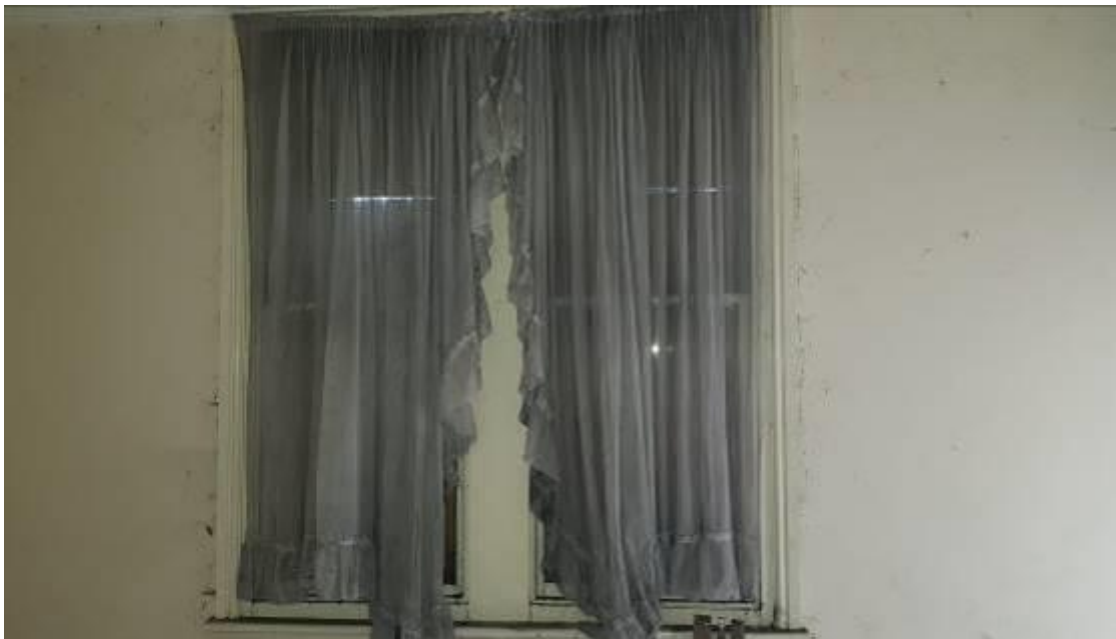
Plate 15: living room moulded window frame (lower floor). No scale.

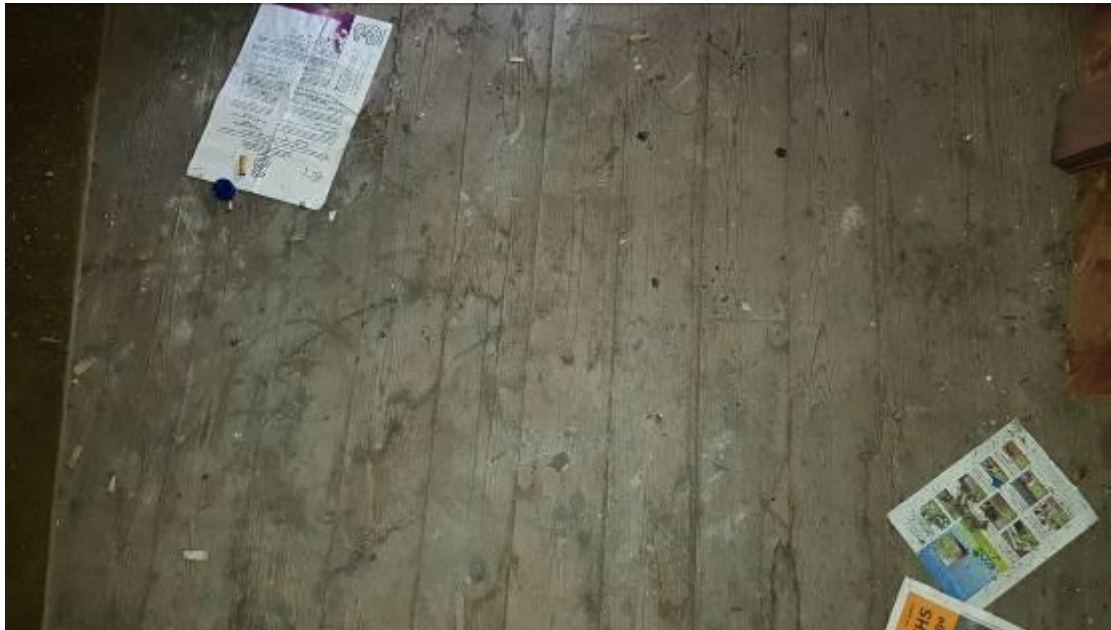
Plate 16: bedroom 1 (north). Floorboards. No scale.

At the top of the central stairway, on the second floor, to the left is the northern bedroom. This bedroom mirrors the living room in layout including identical cornice, moulded window frame and skirting boards. Narrow Victorian floorboards are present some (**Plate 16**) with head nails showing and a ceiling rose is also present (**Plate 17**). The room has a central 1950s style fireplace and grate (**Plate 18**).

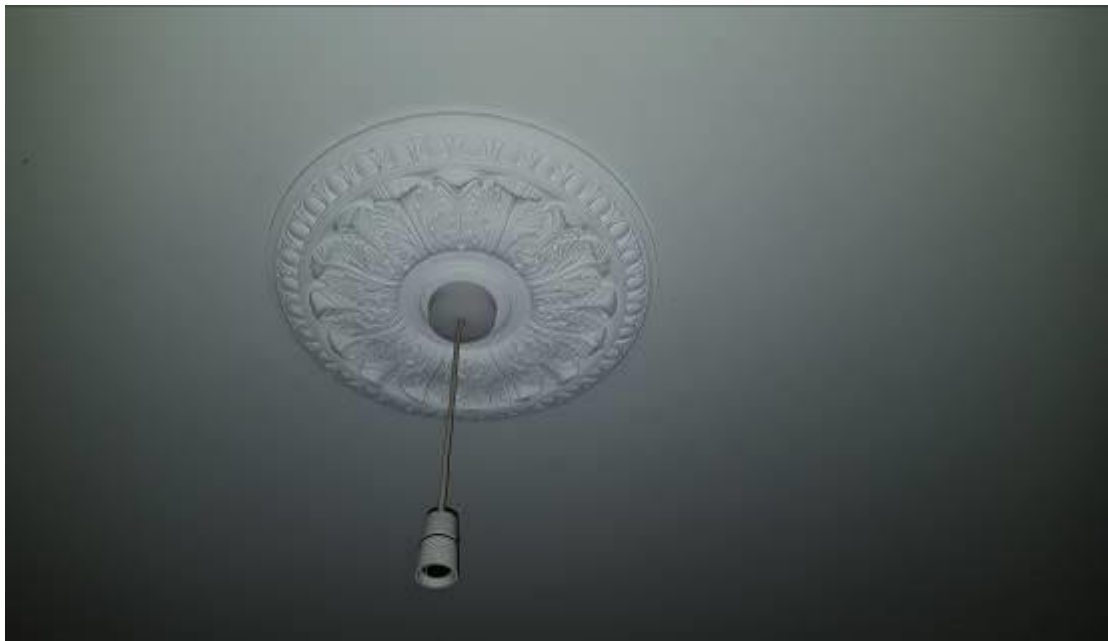
Plate 17: Bedroom 1 (north). Ceiling rose. No scale.

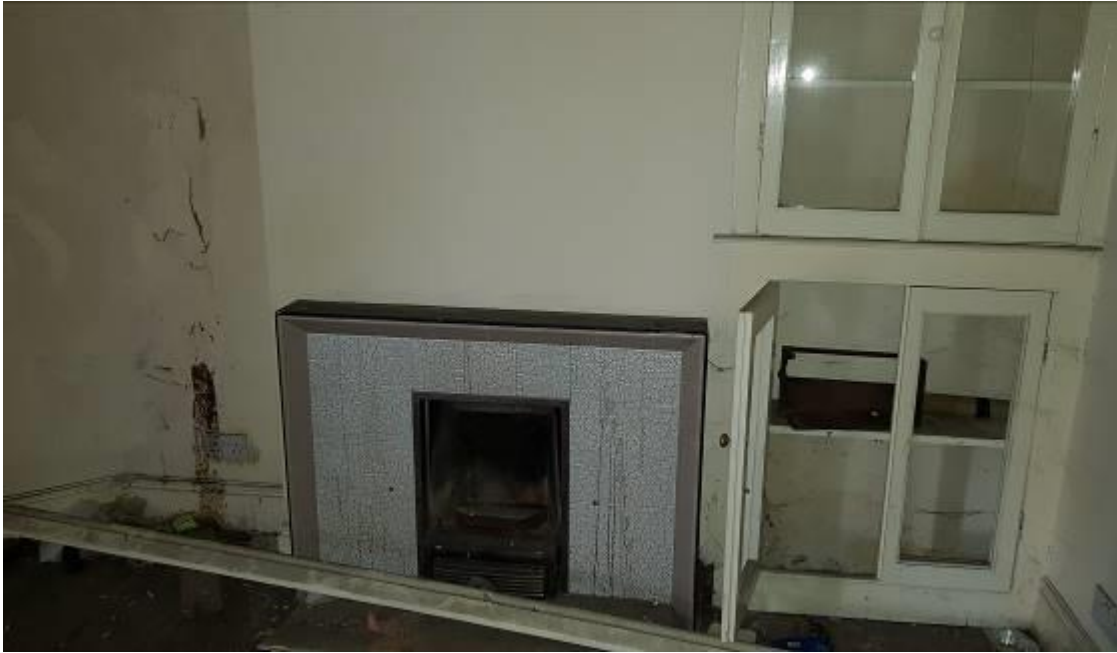
Plate 18: Bedroom 1 (north). Fireplace and surround. No scale.

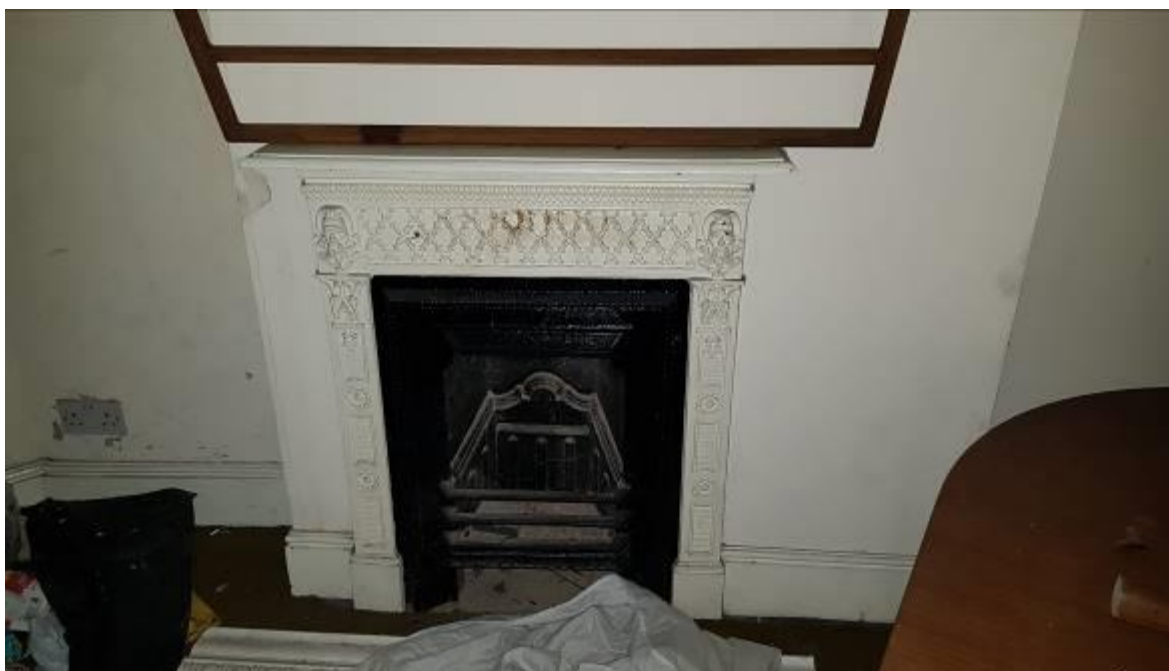
Plate 24: bedroom 2. Fireplace and surround. No scale.

Immediately across the landing (**Plate 20**) is bedroom 2 which has a similar layout to bedroom 1. However, this room has been altered and the cornice/coving removed. The room contains a late Victorian fireplace and grate (**Plate 24**). A further room is at the rear of the property and is accessed off the landing (**Plate 26**). This room forms the rear elevation of the building. The room is of a similar shape and style to bedrooms 1 and 2. The ceiling, however, falls away to the north reflecting the steep pitch to the roof at this part of the building. The room has similar floor and skirting boards to that of bedrooms 1 and 2 although this room was in a state of refurbishment as there was no window frame present and some of the skirting had been pulled away from the wall. No cornice/coving was present (**Plate 27**). An original fireplace and surround were present in this room (**Plate 28**).

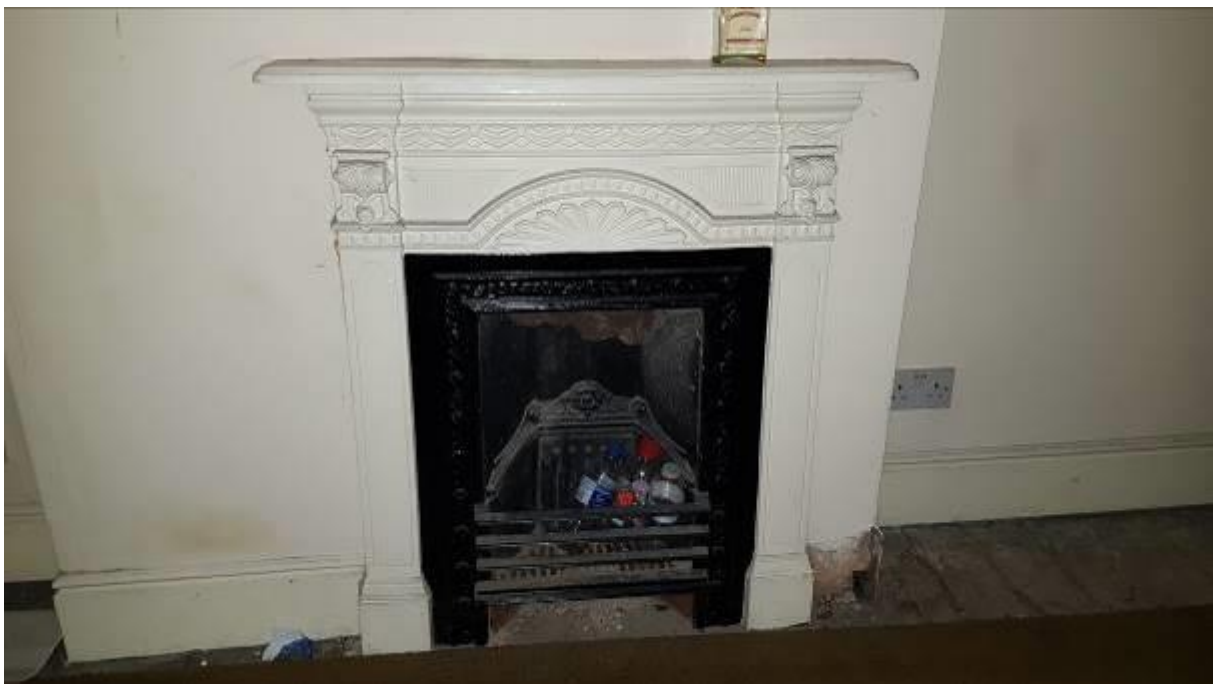
Plate 28: bedroom 3. Fireplace, grate and surround. No scale.

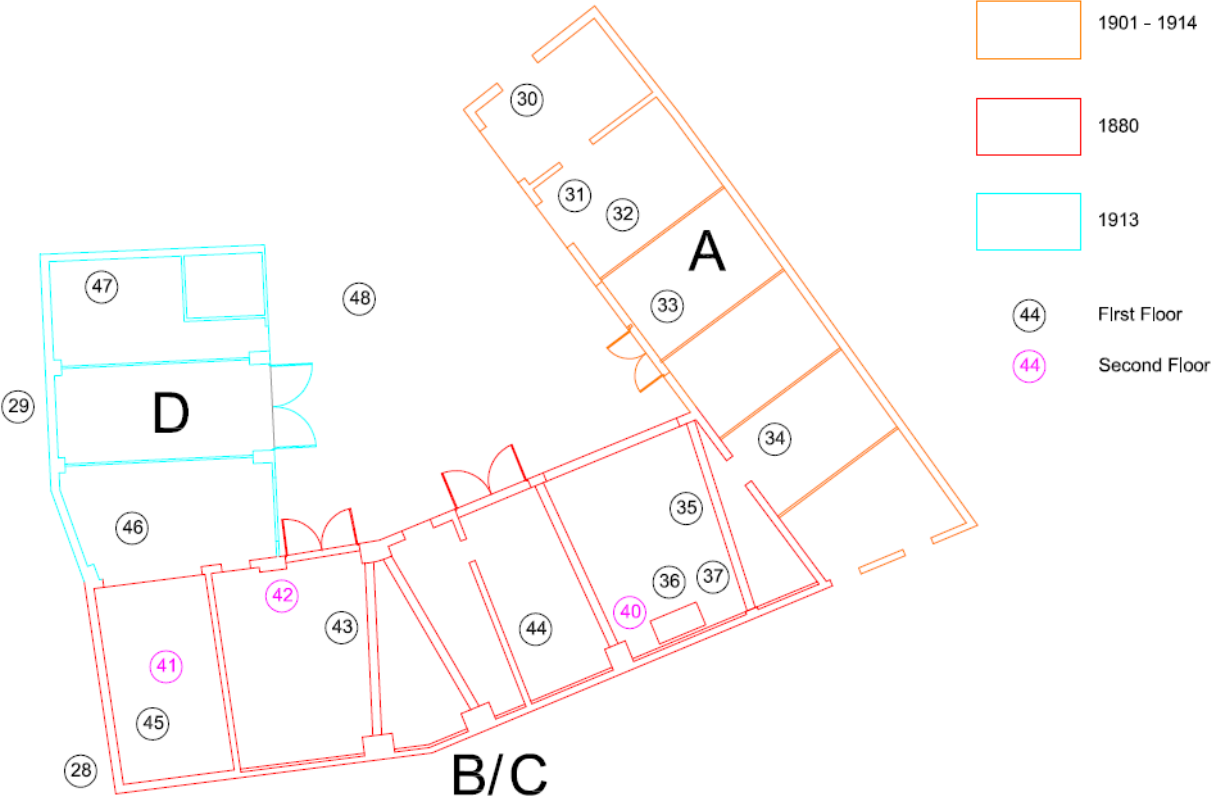
Dwg 2: Photographic Locations and Phasing

The building is made up of four sections A, B, C and D which reflect the historic phasing of the workshop (see Dwg.2).

The buildings development began with the section that runs west to east (Section B, Dwg 2) which forms the southernmost part of the site. From cartographic evidence this section was present by 1880 with section A (Dwg, 2) being added after 1901. **Plate 31** shows the view west along section A. The building has a gabled end to the north and south and has principally stretcher bond brick fabric. Traditional King post roof trusses support the open gable roof which has been panelled internally on to which corrugated asbestos sheeting has been laid with regularly placed sun lights running the width of section A. With regard to original features there are some remnant 20th century electric power points and shut offs located across Section A but nothing of particular provenance to the early 20th century.

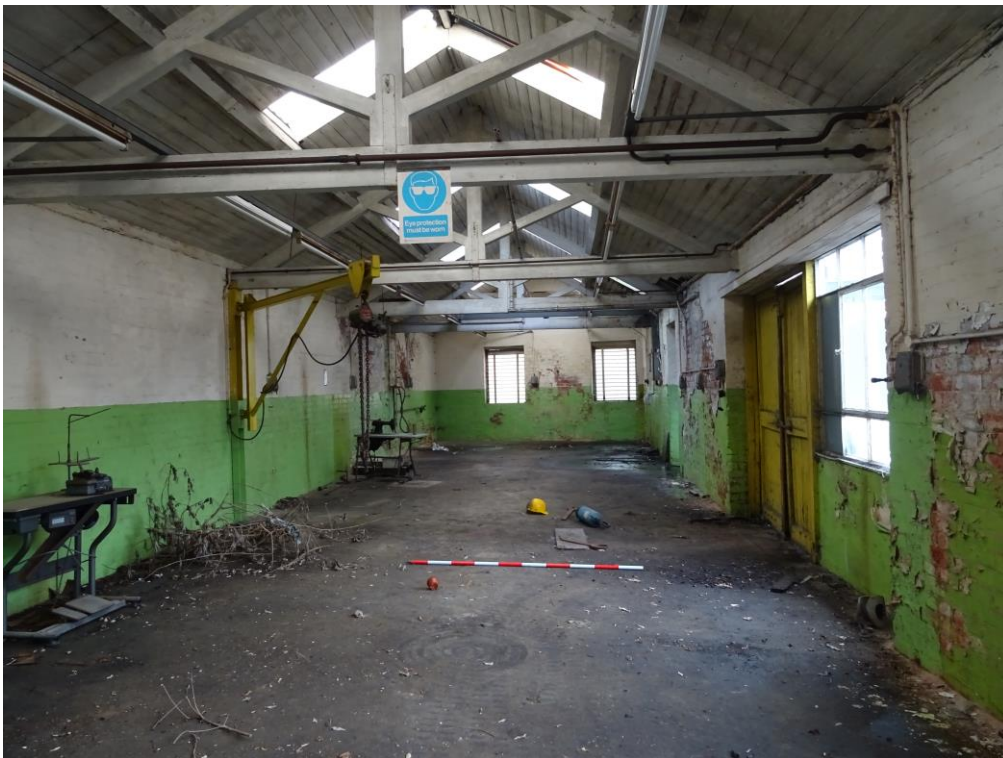
Plate 31: view west along section A. 2m scale.

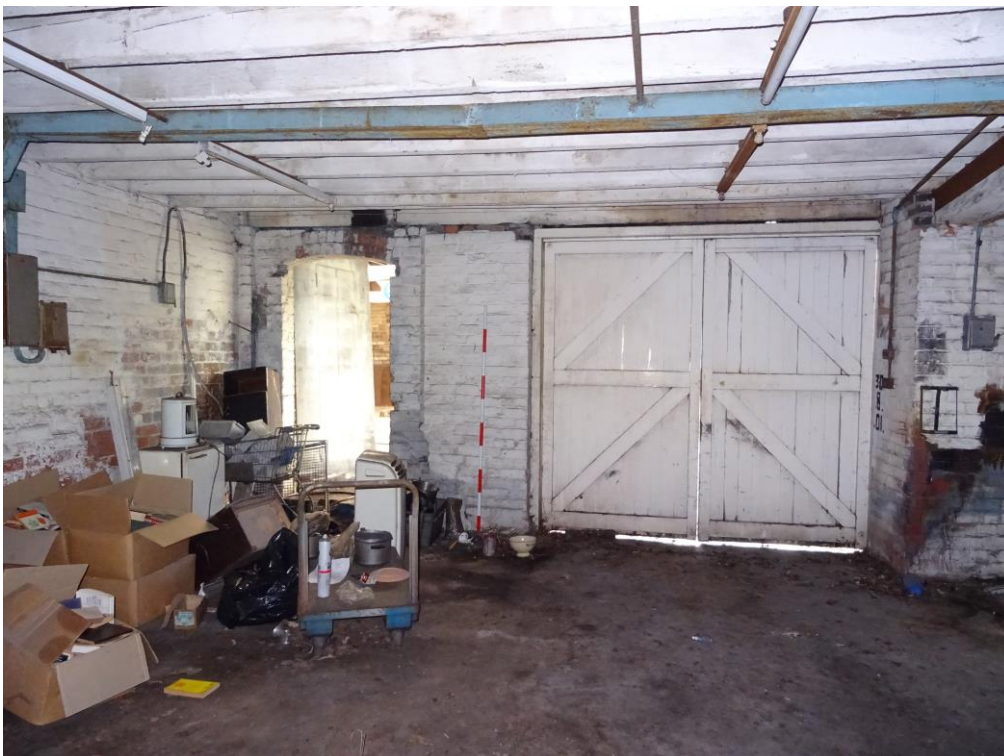
Plate 35. Exit to courtyard from section A. 2m scale.

Plate 35 notes the exit to the courtyard from section A, Section B (Dwg 2). The buildings internal structure is again of stretcher bond with some English bond (**Plate 37**). Above are hanging floor joists (**Plate 35 and 39**) with supporting beams which support the upper floor, Section C. Section B has no significant remaining furniture indicating original use and has had modern doorways fitted haphazardly into the existing structure.

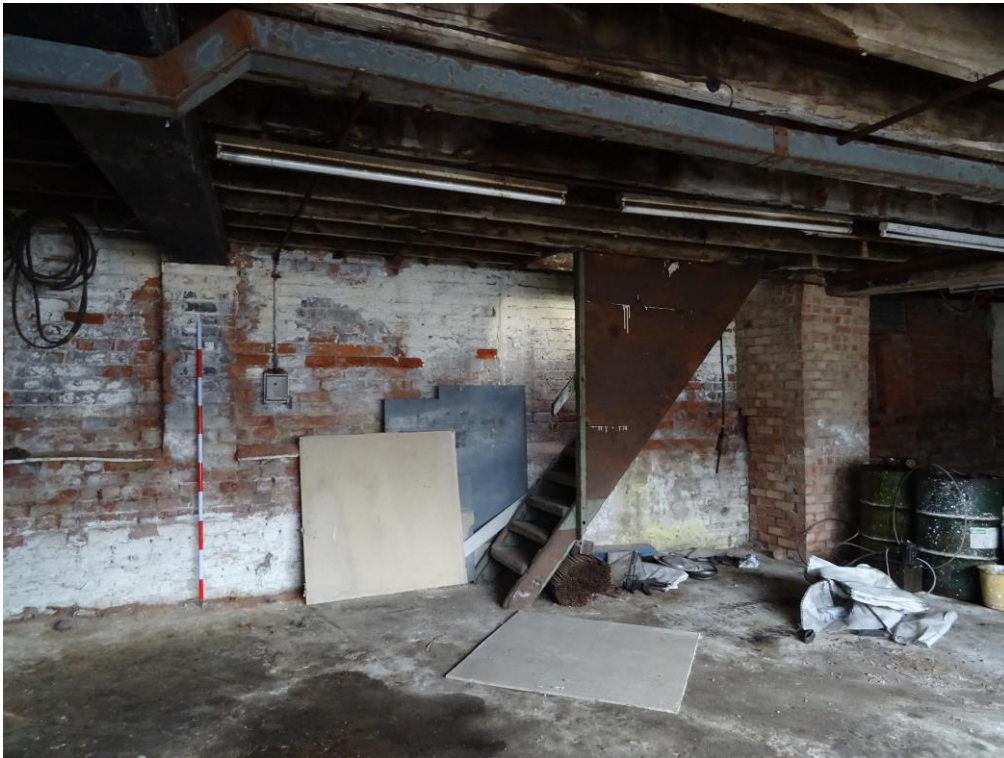
Plate 36. Southern elevation of section B with staircase to upper floor C. 2m scale.

Section C is accessed via a wooden staircase (**Plate 36**) and is of the same construction fabric as B. However, the northern aspect (**Plate 40**) has been altered in recent years to include modern window panels and panes. The same King post roof trusses are present onto which corrugated sheeting is added as in section A. Modern brickwork piers are noted supporting the trusses suggesting some attempt to reinforce the upper floors of B and C. It is probable that the corrugated sheeting is not the original roof material and Section C has seen significant alteration in roof style and architecture.

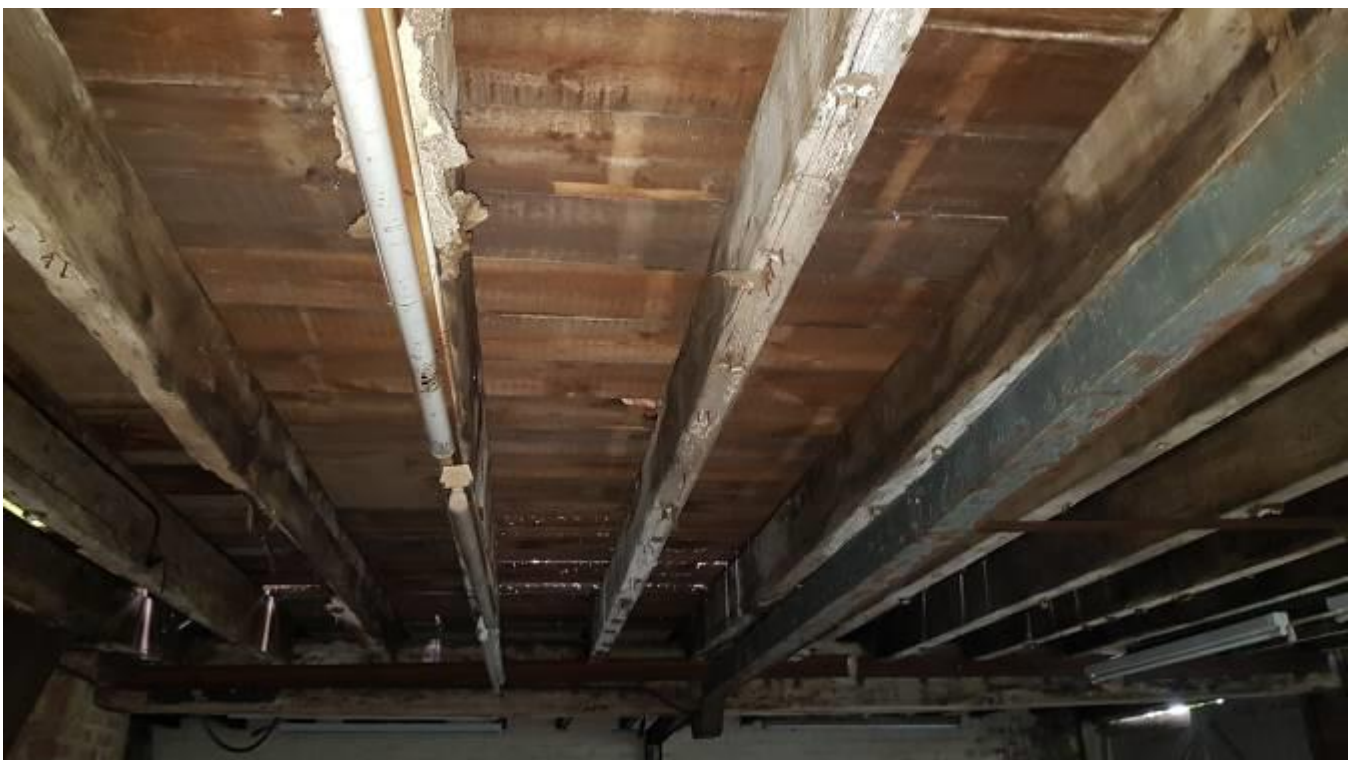
Plate 39: East – west hanging floor joists Section B. No scale.

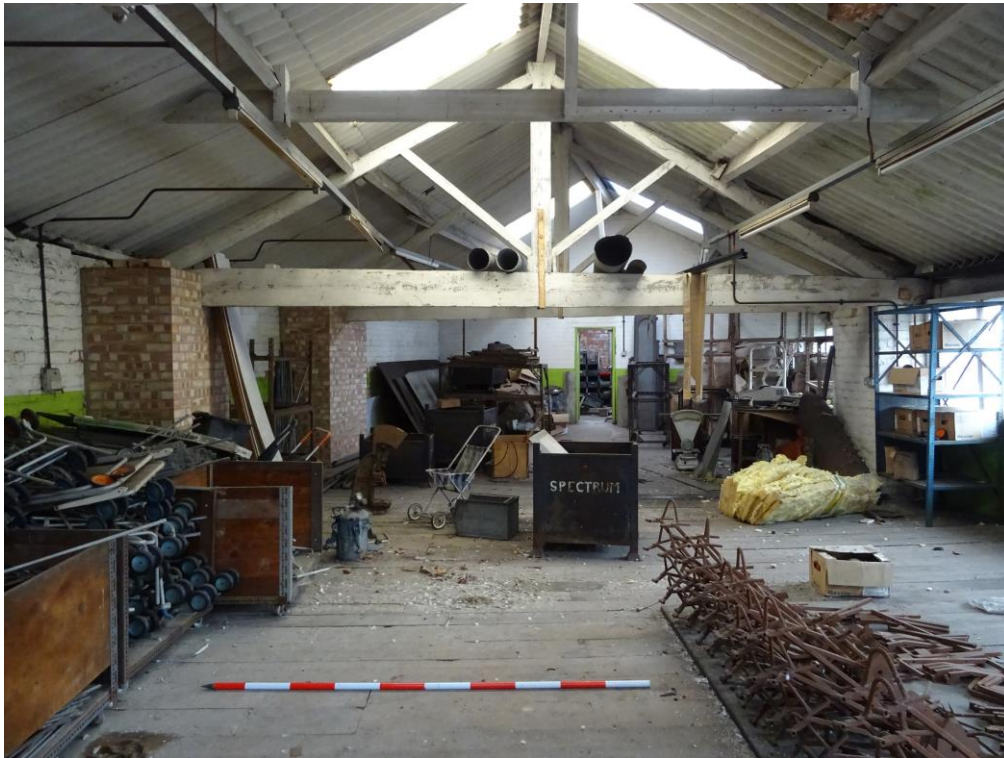
Plate 40: east – west upper floor Section B. 2m scale.

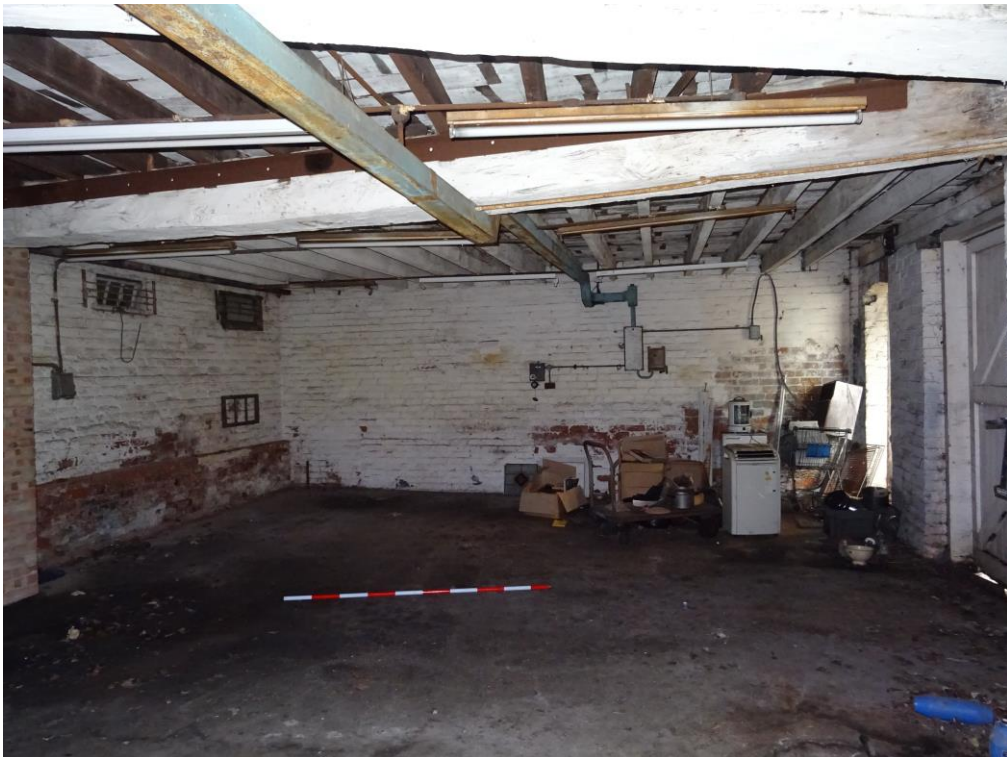
Plate 45: Section B western elevation. 2m scale.

Section B joins section D on at its western end (**Plate 45**). Section D is a stretcher bonded lean-to structure with a corrugated sheet roof as B and C supported by mono pitch type wooden roof trusses. This section of the workshop has seen considerable alteration in recent years.
