YORK PLACE, MANSFIELD ROAD, NOTTINGHAM

STUDENT ACCOMMODATION

Report on Archaeological Field Evaluation

Prepared for: Hydrogen York Street Limited

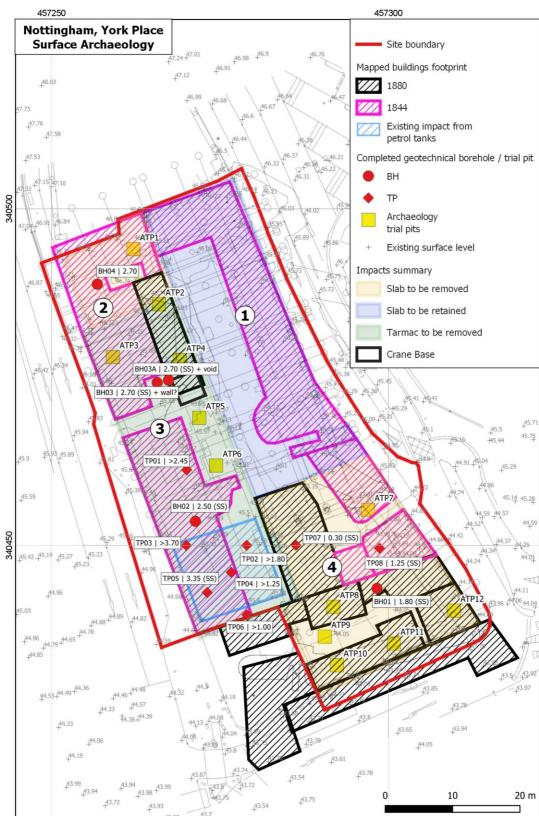
Figure 1-2
Historic Building Footprints, Investigations and Future Impacts

Building footprints, potentially dated pre-1844 and certainly pre-1880 by reference to historic mapping, are shown in Figure 1-2.

In order to preserve the sub-surface archaeological remains the building is to re-use the existing piling and floor slab from York House. Outside the area where the existing slab will be retained (1 in Figure 1-2), groundworks for the new building had the potential to damage or destroy potential surface archaeological remains.

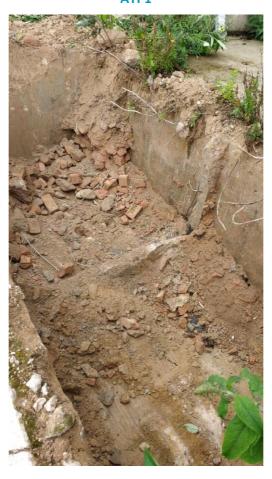
Figure 4-1

| Trial Pit | Description | Figure |
|---|--|---|
| ATP1 | concrete and brick rubble to 1.3m bgl ⁴ then a substantial slab | 4-1 |

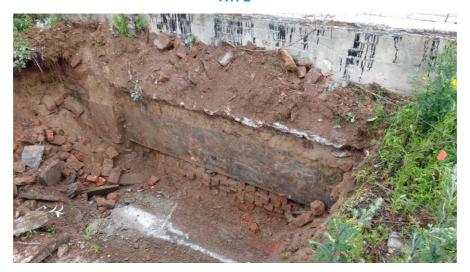
Figure 4-2 ATP2

| Trial Pit | Description | Figure |
|---|--|---|
| ATP2 | flagstones and brick rubble down to 1.55m bgl then concrete slab and pile cap with ground beam in one corner. | 4-2 |

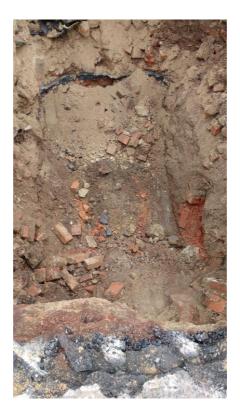
Figure 4-4 ATP4

| Trial Pit | Description | Figure |
|---|--|---|
| ATP4 | sand and brick to 2.35m bgl then slab | 4-4 |

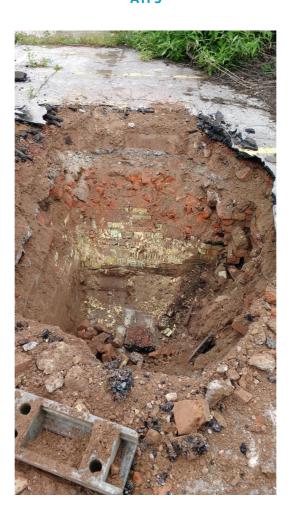
Figure 4-5 ATP5

| Trial Pit | Description | Figure |
|---|--|---|
| ATP5 | rubble-filled cellar lined with walls of red brick over yellow brick with holes to 2m bgl then slab | 4-5 |

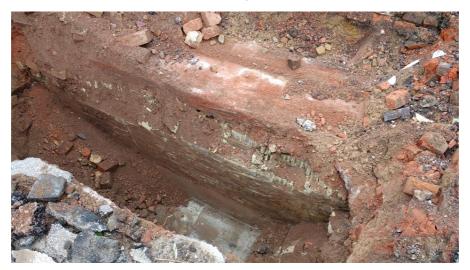
Figure 4-6 ATP6

| Trial Pit | Description | Figure |
|---|--|---|
| ATP6 | rubble-filled cellar on east side of pit with wall of red brick over yellow brick down centre of pit; east side excavated to 1.7m bgl to slab | 4-6 |

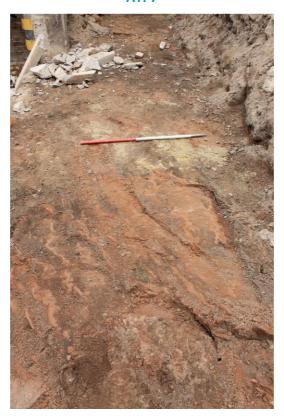
Figure 4-7 ATP7

| Trial Pit | Description | Figure |
|---|--|---|
| ATP7 | Exposed bedrock at surface | 4-7 |

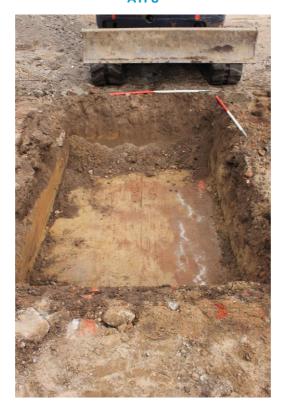
Figure 4-8 ATP8

| Trial Pit | Description | Figure |
|---|--|---|
| ATP8 | Loose grey to yellow sand and building rubble to 0.3m bgl then a concrete slab | 4-8 |

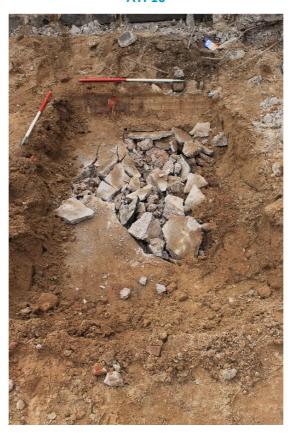
Figure 4-9 ATP10

| Trial Pit | Description | Figure |
|---|--|---|
| ATP10 | Loose grey to yellow sand and building rubble to 0.3m bgl then a concrete and bitumen slab. Beneath the slab was a 0.25m thickness of broken concrete and building rubble then black friable sandy clay over loose yellow sand and brick rubble (base not reached) | 4-10 |

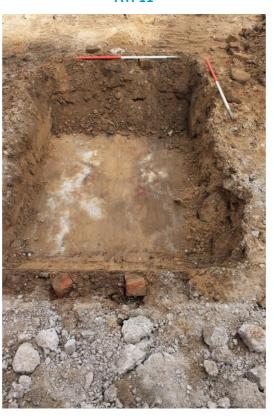
Figure 4-11 ATP11

| Trial Pit | Description | Figure |
|---|--|---|
| ATP11 | Loose grey to yellow sand and building rubble to 0.35m bgl then a concrete slab | 4-11 |

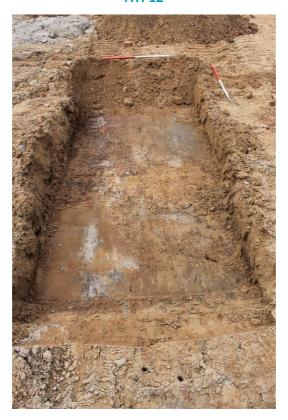
Figure 4-12 ATP12

| Trial Pit | Description | Figure |
|---|--|---|
| ATP12 | Loose grey to yellow sand and building rubble to 0.25m then a concrete slab | 4-12 |

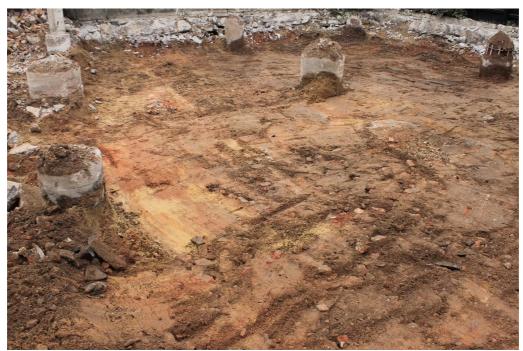
Figure 4-15
Area Around ATP7-ATP12 Stripped to Formation Level

Sandstone with no archaeological features showing was exposed north of the excavated area, west of ATP7. Elsewhere in this area the stripping of the Site down to formation level of 43m AOD, roughly 400mm below the top of the lower slab, revealed a layer of made ground and building rubble with no surface archaeological features or deposits visible except some two disturbed wall-lines described below (Figure 4-15).

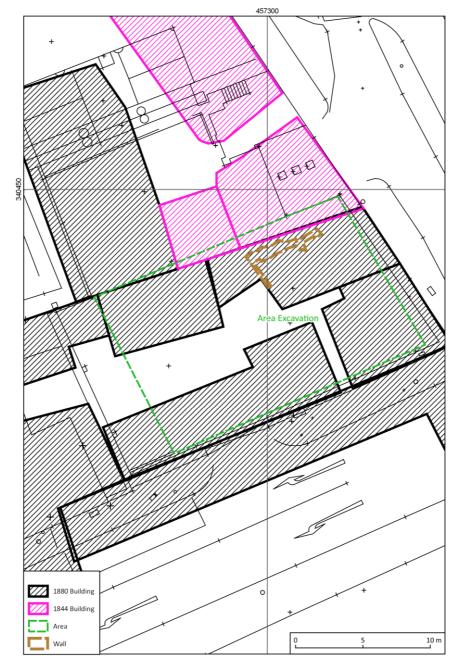
Figure 4-16
Area Excavation

The walls were laid out in an L-shape with at least three courses of brickwork present. The bricks were of Victorian to early 20th century dimensions (roughly three inches thick) and the wall varied in width from nearly 1m in the north to 200mm in the south-west. Its alignment included a distinctive angle and corresponded closely with buildings of 19th century date mapped shown on the 1880 Ordnance Survey Town Plan (Figure 4-16 to 4-18). The map shows that the thicker wall was a property boundary while the thinner western wall was an internal feature.

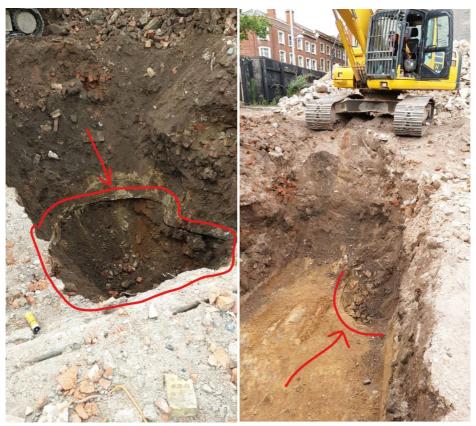
Figure 4-19
Brick wall facing Northwest

Two surface pits were excavated by contractors to test the ground conditions in within the area required for the crane base construction (Figure 4-19; pictures supplied by Fed3 project managers). These show the roof of the 'destroyed caves' partly breached.

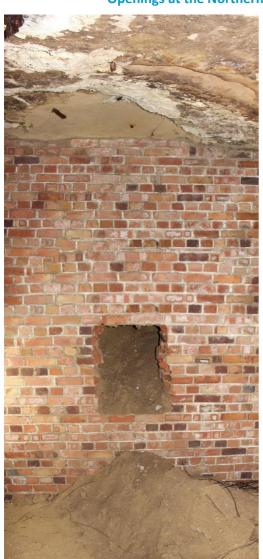
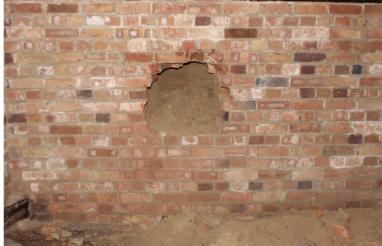
Figure 4-20
Openings at the Northern (left) and Southern Ends of the 'Destroyed Caves'

Two small openings were made in the brick blocking at either end of the 'destroyed caves'. They confirmed that the caves are fully filled with debris; at the north end the cave roof continues a short distance into the filled area before visibility is blocked by fill, on the southern opening only fill is visible.
