PAULS MOSS, WHITCHURCH, SHROPSHIRE

Archaeological Evaluation
Prepared for: Strata Housing Ltd

SLR Ref: 406.06406.00002
Version No: 1
February 2020

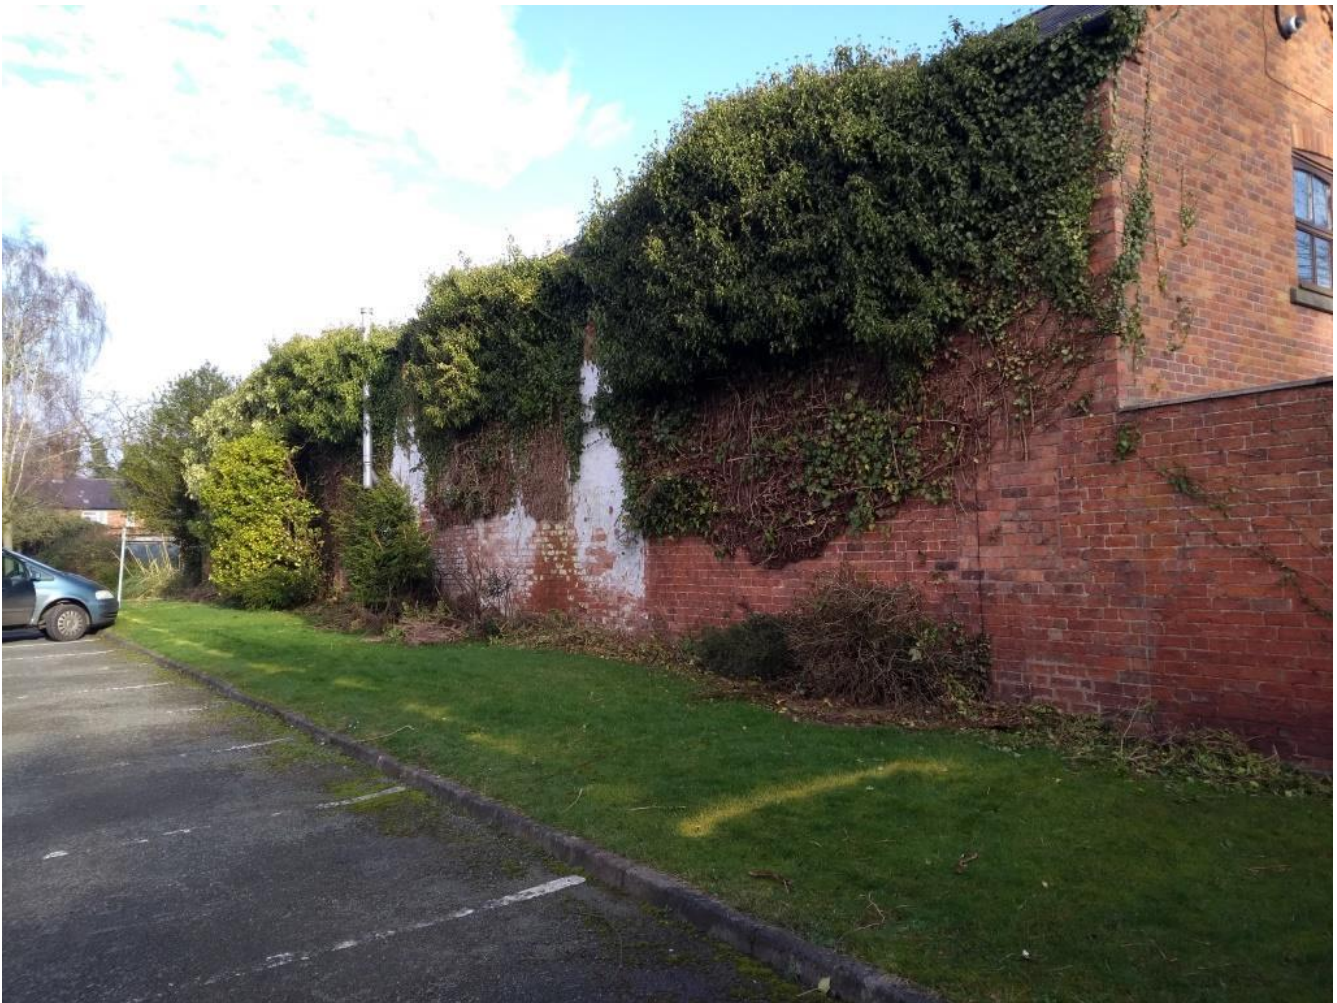
Figure 3
Trench 1 location looking NW (note white-washed wall)

Trench 1 was 19m long with a ramp out of its southern end, and was oriented north-west – south-east. It was positioned at the edge of a grassed area lying between a building wall and a car park (Figure 3). Due to the constraints surrounding the trench it was not possible to step the sides. Machine excavation was therefore conducted to a depth of 1.2m through dark-brown sandy silt made ground, where in the north-western half of the trench geological natural was not identified. Instead, brick rubble and surviving wall courses were present to around 1.1m BGL and below was a clay sand containing post-medieval brick and other material. In the south-eastern part, natural was identified apart from a square-cut linear feature [1005] of a depth greater than 1.9m BGL which had been cut from immediately below topsoil and terminated c.3m into the trench (Figures 4 & 5).

The northern part of the trench lies within the original footprint of the adjacent building which is shown on historic mapping around 1900 as extending to the limit of the current car park (Figure 6). It is still present on 1937-61 mapping, so the building was likely reduced to its current extent with the construction of the current Pauls Moss buildings and car parking area. Cement and whitewash are still present on the surviving wall face.

Evidence for building demolition was provided by the large amounts of brick found in the soil, especially in Trench 1, where a white-washed area of the wall of the standing building on its eastern side suggested that a structure had been located against this wall at some time in the past (Figure 3). Historic mapping shows that the footprint of the building indeed extended over the area of Trench 1 during the early 20th century (Figure 6). The southern end of a small cobbled area was just clipped at the northern edge of Trench 1 which might have formed a courtyard for this structure, and it seems likely that the standing building and its demolished extension were possibly stables and a related coach house.

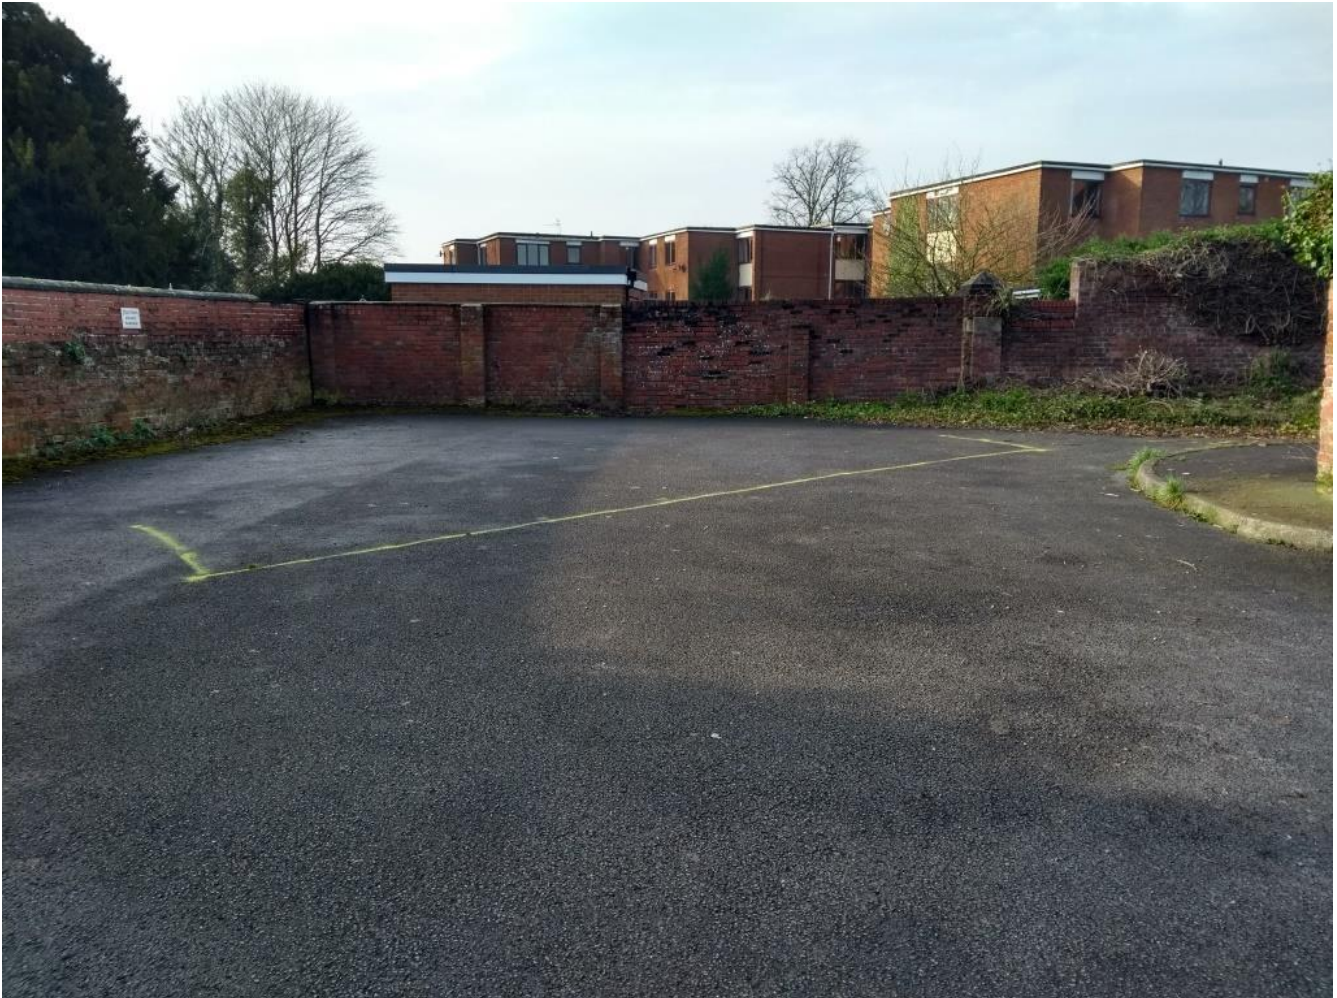
Figure 7
Trench 2 looking WSW with redundant housing block in background

Trench 2 was situated outside of the main development site in a tarmaced area adjacent to a residential property. It was on the highest ground in the area and was the closest trench to the Roman road which lies c.20m to the east. The trench was 9m long with a ramped end and oriented WNW-ESE (Figures 7 - 9).

No archaeological features were identified, though half of a square pit loosely filled with modern rubble was present mid-way along the trench. The deposit sequence below tarmac was 300m of roadstone overlying another 300mm of dark, compacted made ground. Natural was identified at c.800mm BGL. A potential linear feature/gully was investigated at the northern end of the trench, but this had no artefactual inclusions and was retrospectively interpreted as a slightly deeper zone of the general deposit of made ground.

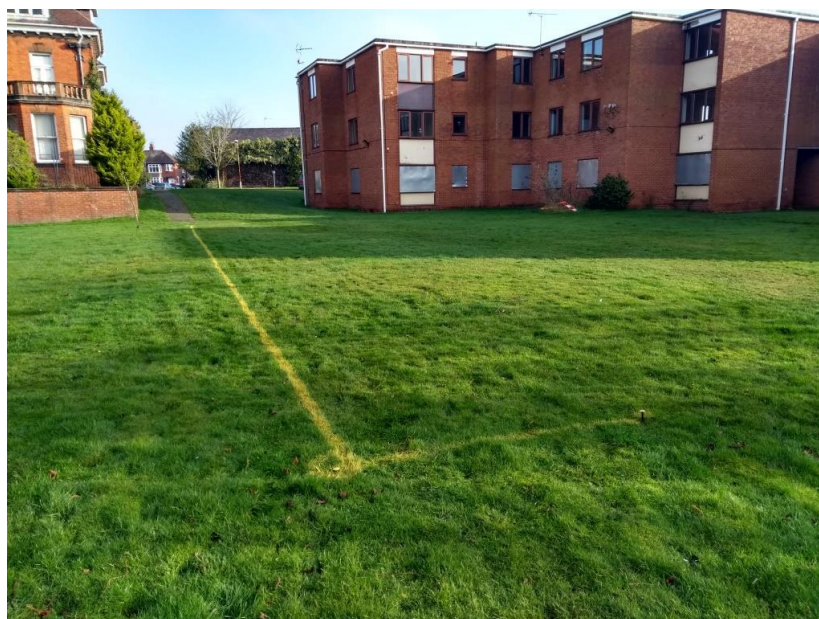
Figure 13
Trench 4 looking E

Trench 4 was 17m long with a 3m ramp at its eastern end, and oriented northeast-southwest (Figure 13). The deposit sequence revealed a depth of between 1.2 and 1.45m to natural undisturbed geology, with the deepest zone at the southwest (Figures 14 and 16). Below topsoil, a layer of hard core and early modern made ground overlaid a buried soil containing post-medieval pottery, animal bone, clay-pipe stems, as well as bottle and window glass. The north-eastern end of the trench was curved slightly (Figure 15) to avoid striking a gas main which was not identified by the cable avoidance tool as it was plastic.

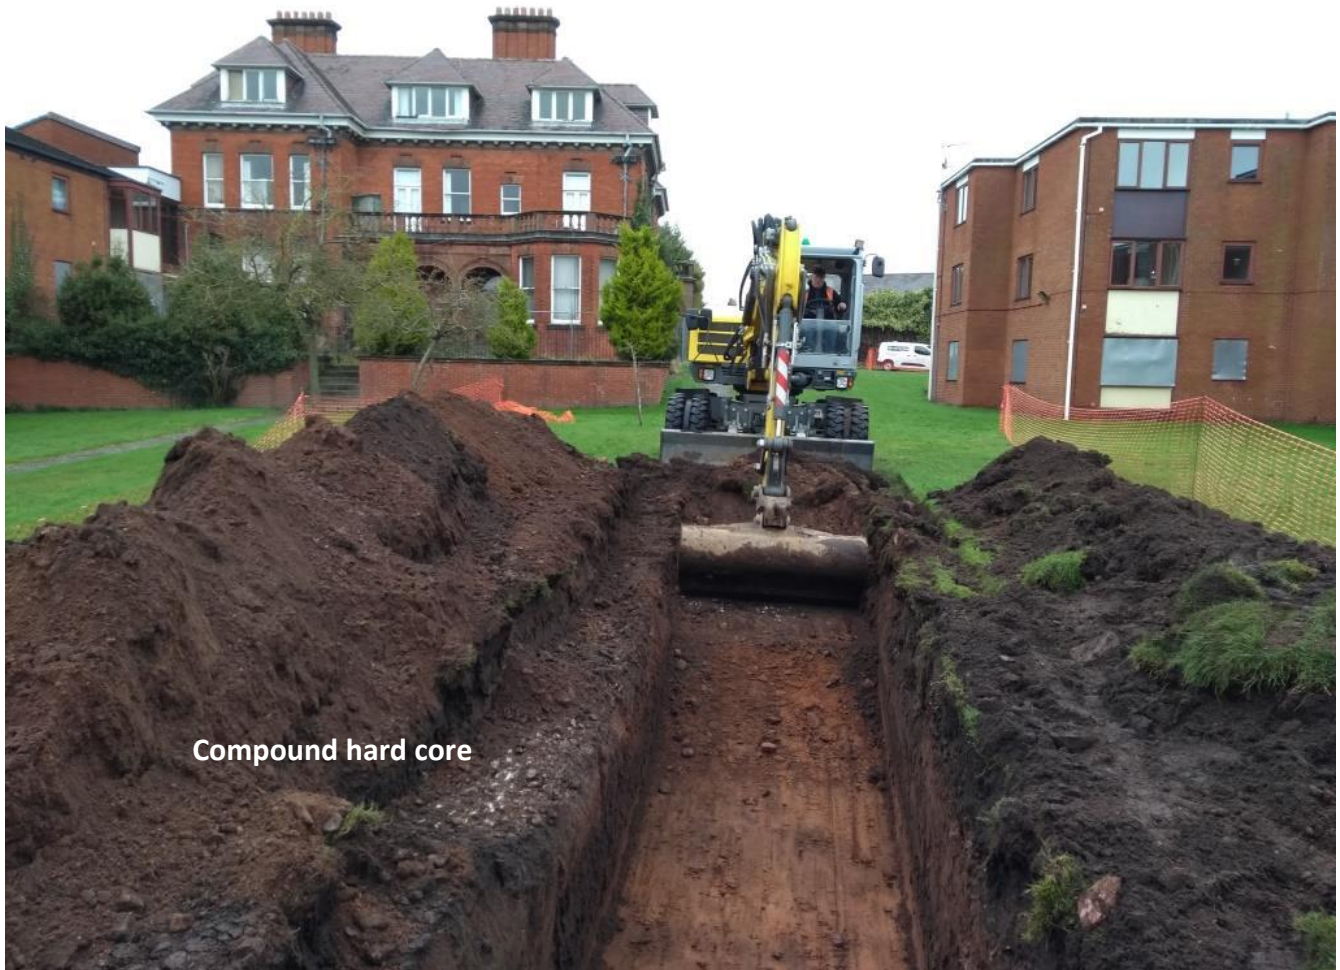
Figure 14
Trench 4 looking NE towards Pauls Moss House and redundant housing block

It has been assumed that the stony layer was part of the compound area laid out when the existing 1970s buildings were constructed. The depth of made ground beneath this layer suggests a major landscaping phase when the Victorian house and gardens were constructed, perhaps part of a design to terrace this part of the garden and raise it up from the natural fall towards Pauls Moss to the west.

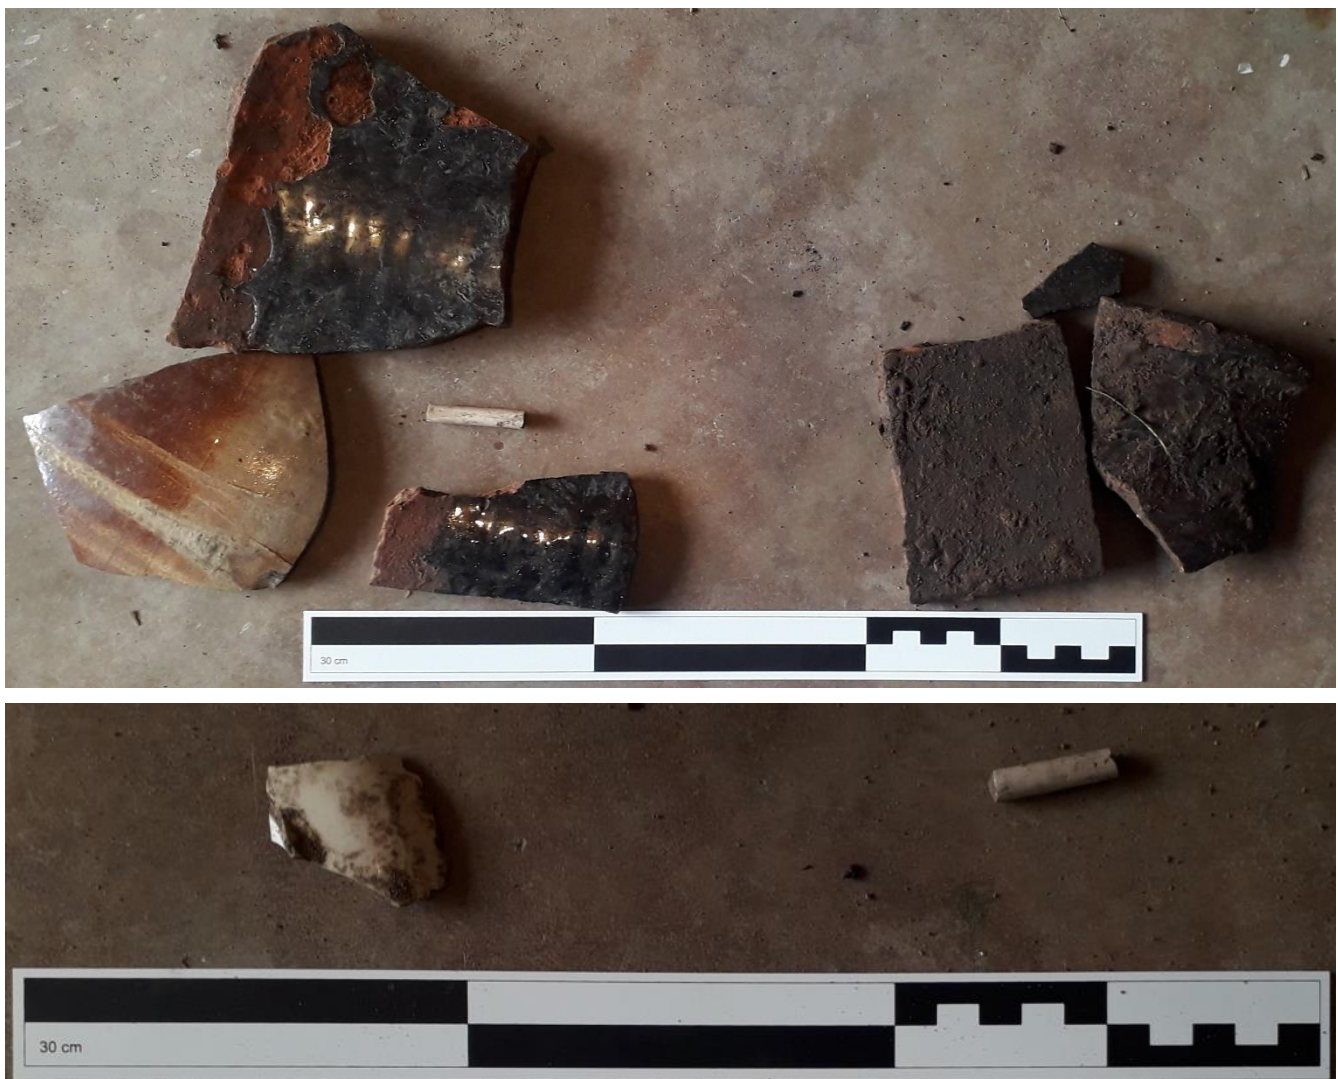
The trial trenching at Pauls Moss revealed deep deposits for Trenches 1, 3 and 4, but a relatively shallow sequence for Trench 2. The latter was outside of the garden area for the main house, but the other three trenches show a post-medieval horticultural soil with bricks, tiles, clay-pipe stems, bottle glass, some animal bone and ceramics (Figure 17) with a depth that varied between 0.8 – 1.45m below current ground level. The post-medieval pottery and clay-pipe fragments probably reflect the horticultural use of the land prior to construction of the Victorian house and gardens, and some of the bricks appear unfrosted and relatively large, so of an earlier date than the house construction. A deep feature [1005] at the southern end of Trench had been cut from high in the deposit sequence (Figure 5), showing that this steep-sided ditch or pit was of relatively modern origin, and it had been back-filled with horticultural soil.

Figure 17
Top: Unstratified post-medieval glazed pottery and clay pipe stem
and pot sherds from fill (1004) within feature [1005]
Below Victorian glazed ceramic from (3001) and clay pipe stem from (4004)
