Hulands Quarry, Bowes, County Durham

Phase 2: Archaeological Watching Brief
for Aggregate Industries

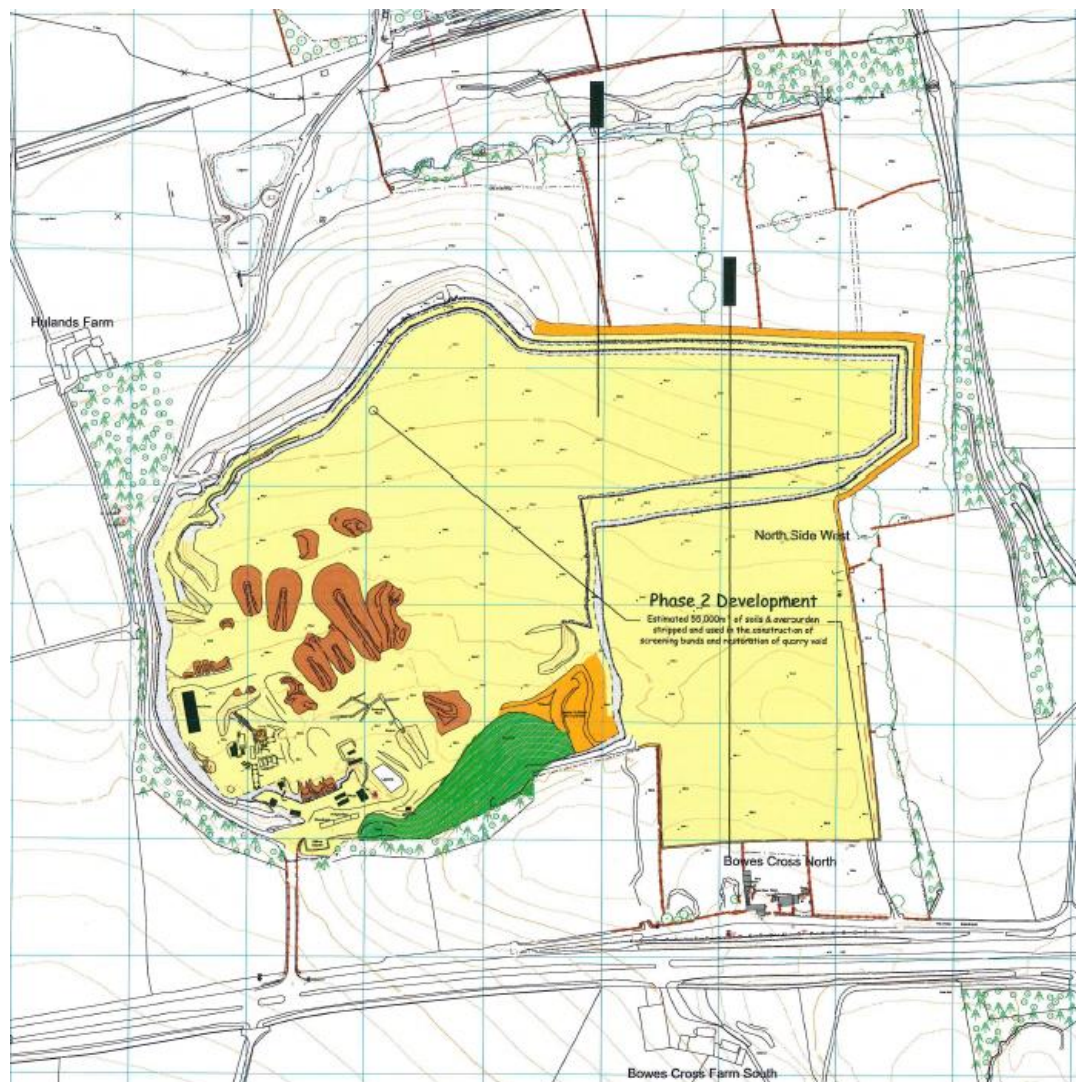
Figure 1: Phase 2 area monitored in June of 2015

The development site is approximately 12ha in area and is located on the north side of the A66, which follows the line of a Roman road, and south of a disused railway line. It is 2.5km east of the settlement of Bowes, and 1km west of Boldron, in County Durham (Drawing 1; NGR NZ 019139). The general topography of the area is mostly falling northwards, into the valley of Thorsgill Beck. The Phase 2 area lies in the south eastern corner of the quarry (Figure 1), and measures 55,000m²

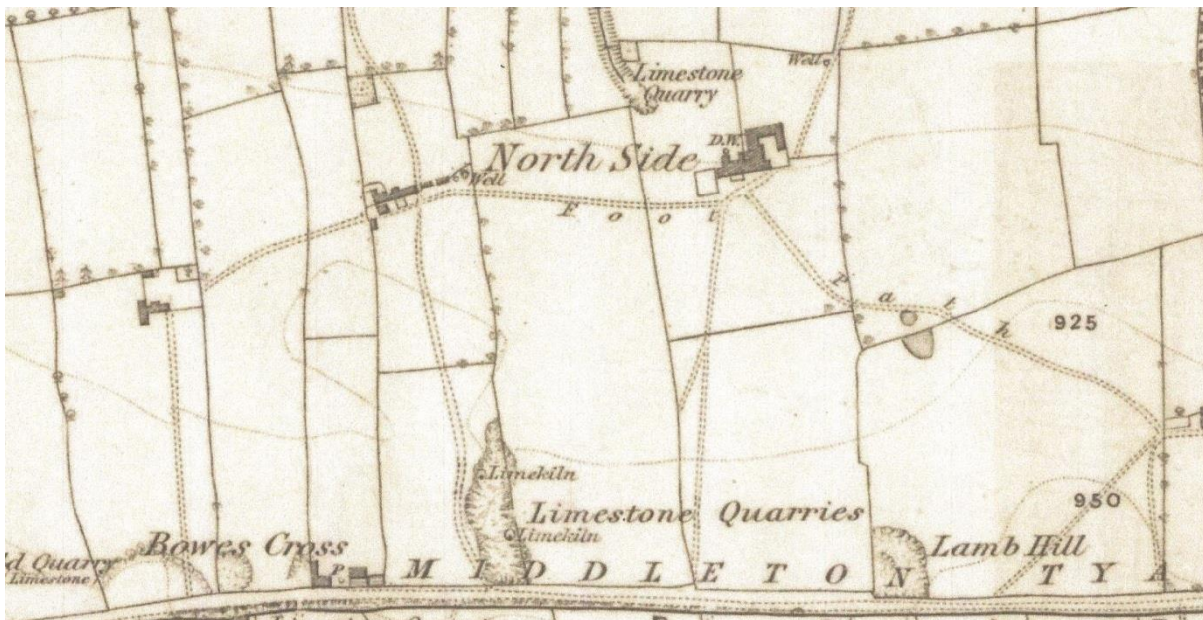
Detail of Phase 2 area and North Side West farm

Figure 3: Extract of 1895 1:10,560 Ordnance Survey map with the area of watching brief in red, reproduced with permission of the National Library of Scotland

Foundation 109 comprised a line of roughly hewn limestone blocks. It was of drystone construction, built on an east - west orientation. It aligns with an east - west boundary wall depicted upon the 1857 OS map of the area, to the south of North Side West farmstead (Figure 3; Plate 6).

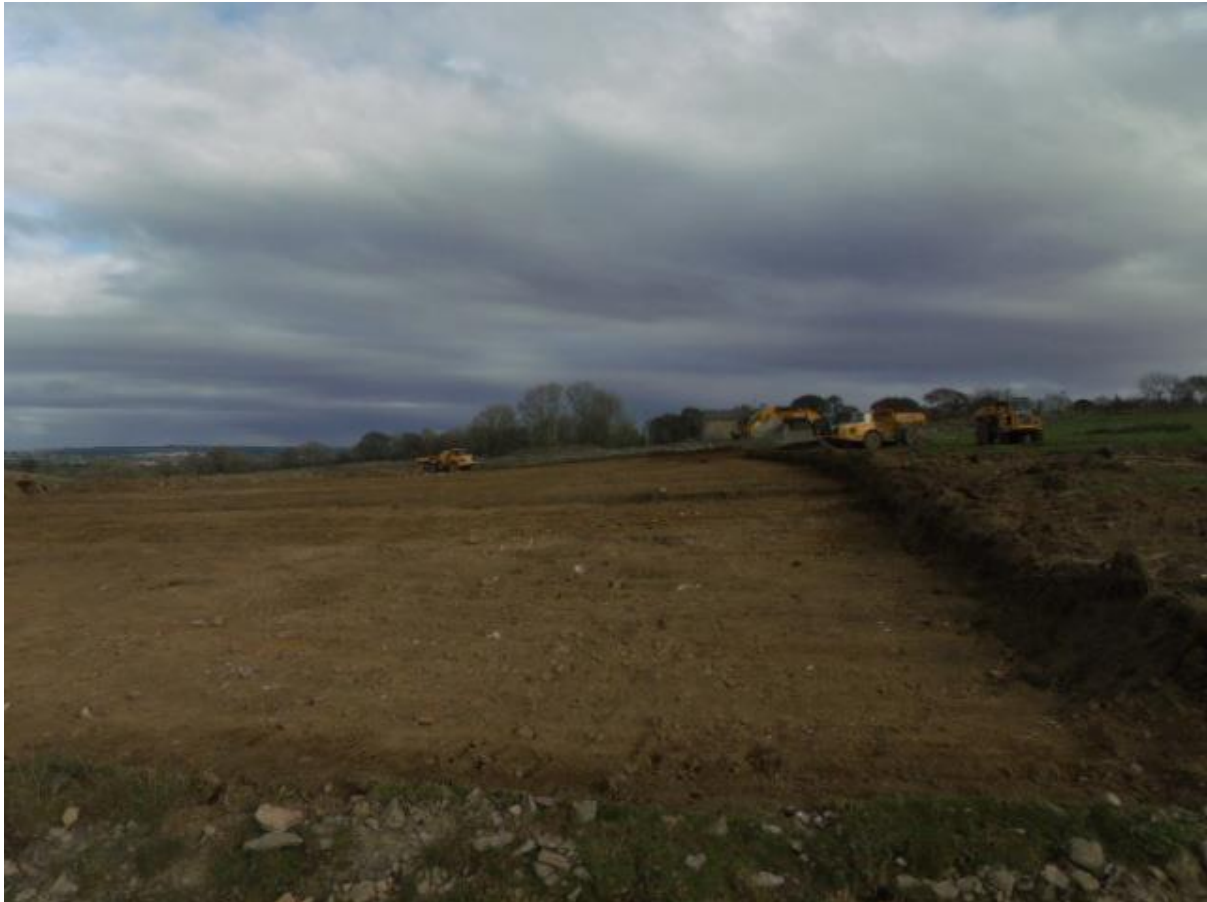
Figure 4
Completion of 4th strip 24/10/15 looking east toward North Side West farm

The work was undertaken in October and December of 2014, and June and September of 2015. The programme of works removed approximately 0.10 – 0.5m of soil (context 101) which lay above a subsoil (context 100) of blue boulder clay and orange-brown colluvial silts which were 0.1m deep on the higher (southern) part of the site, and up to 3m deep on the downslope side of the site to the north, to reveal the underlying carboniferous limestone. The operation was generally conducted as a series of strips across the Phase 2 area from north – south (Drawings 2 and 2a). The general appearance of the site during the soil stripping operation is shown in Figure 4, and an example of subsoil deposits are shown in Figure 5.

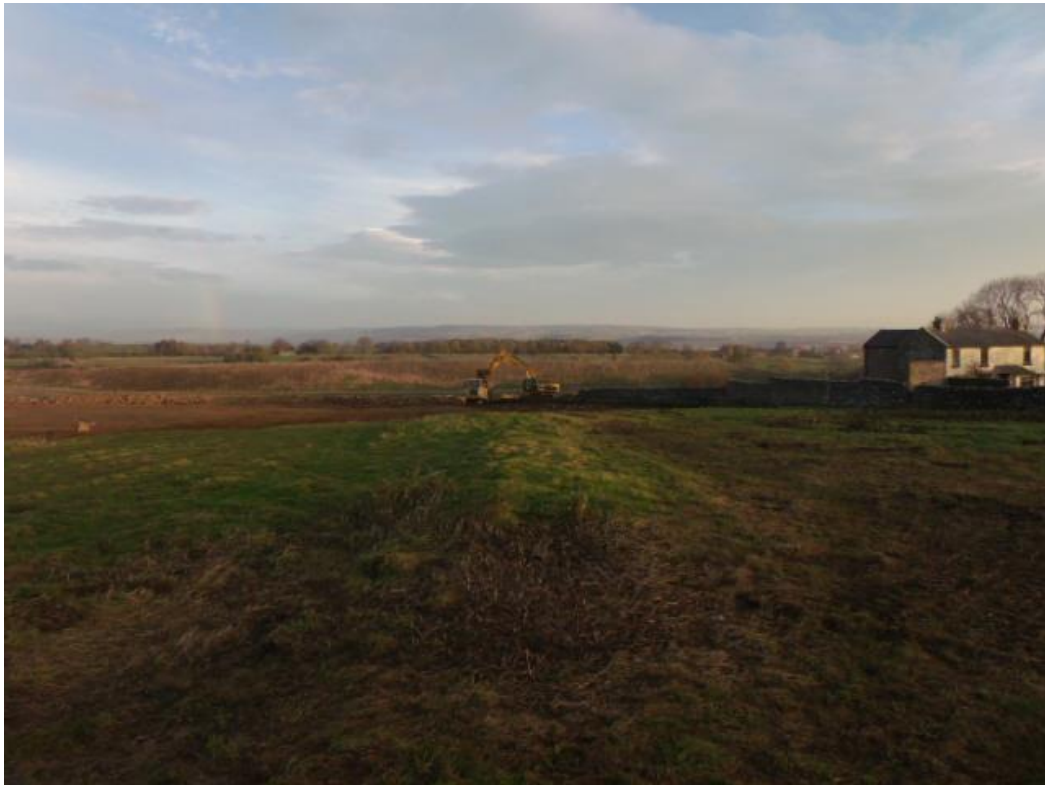
Figure 6
View of earthwork mound before stripping, looking north-east

No remains of archaeological interest were found within the first stages of soil stripping in October 2014, but during the 5th strip along the eastern boundary and in the general proximity of North Side West farmstead, a possible buried structure was investigated. The conclusion reached on excavation was that this was a dump of stone, rather than anything with a more definite form (Figures 6 and 7). During the final stage of stripping along the eastern boundary, however, archaeological deposits were found associated with North Side West farmstead and a former boundary wall. At the time of the watching brief the farmstead was largely still extant in its final configuration, but was scheduled for demolition. Detailed context descriptions are provided in Appendix 1 of this report. The stripping of this eastern part of Phase 2 was conducted during 2015, and was complicated by the existence of power lines running through the area (Figure 8).

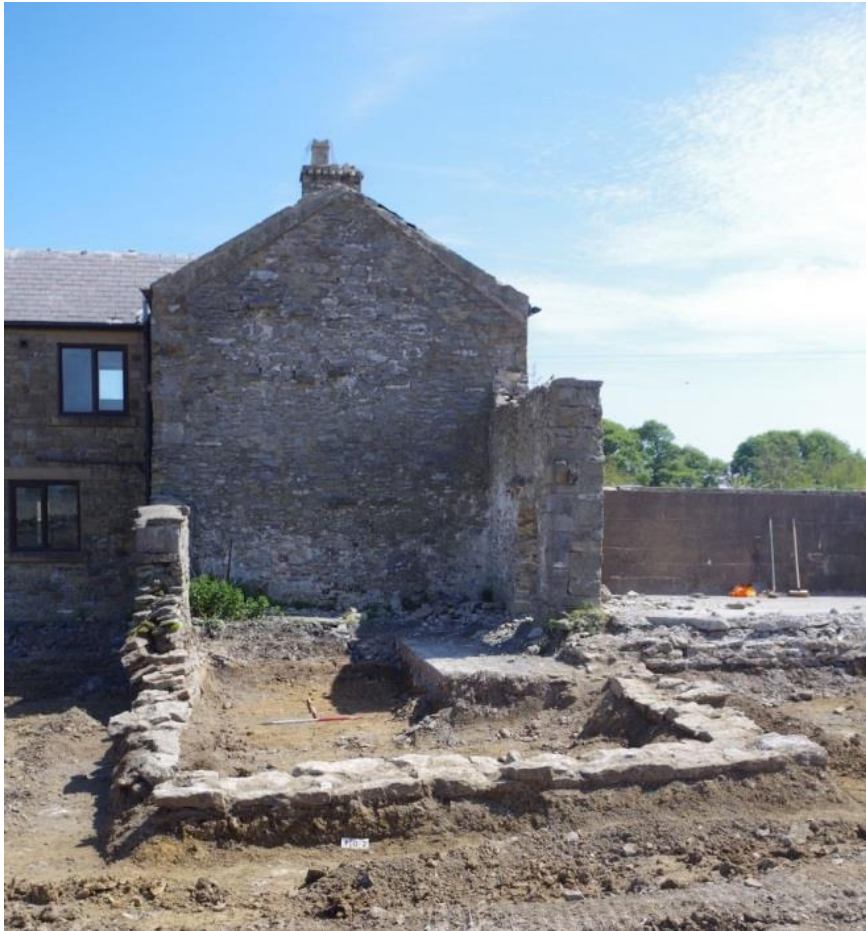
Plate 1: North Side farmstead with exposed archaeological walls, looking east

The former western buildings of North Side farmstead were located by the watching brief (Drawings 2 and 3). Part of the structure was still extant, albeit much dilapidated, adjoining the western gable end of the existing building (Figure 6 and Plate 1). The watching brief exposed the extent of a northern and southern sides of single room, walls 103 and 104, and the western end of the building, wall 102 (Drawings 4 and 5).

The room exposed measured 11m in length, as measured from the gable end of the existing building, and aligns roughly with the indicative position of the western end of the building depicted in the 1895 OS map (Drawing 4). It is quite feasible that this is also the limit of a building depicted upon the earlier OS map (Figure 2), with the difference in size due to the nature of the symbols of the historic mapping as opposed to true difference in the building dimensions.

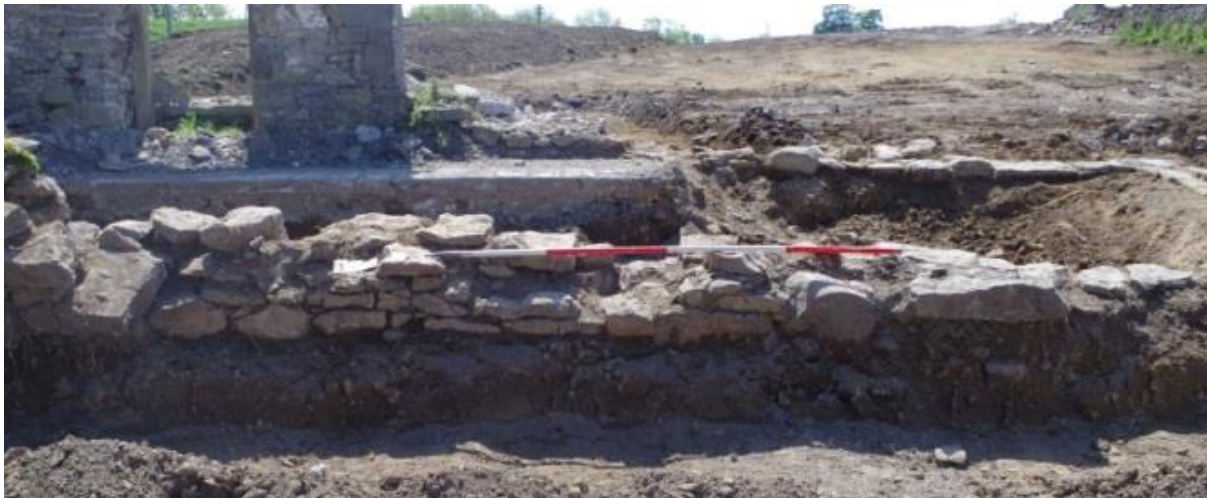
Plate 2: Wall 103, looking south

The walls measured 0.6m to 0.75m wide, one to four courses in height. Lime mortar bonding was only observed at the eastern end of wall 103, where the remains were four courses high (Plate 2). They comprised a randomly coursed construction of roughly squared and irregular limestone blocks, a maximum of 0.30m by 0.20m by 0.30m in size. The walls appear to have been built upon a clay platform, used to level the area, although this was not fully exposed. No construction cut was observed and the buildings appear to have been constructed directly upon this surface. Part of a modern interior concrete floor was located in largely the eastern half of the structure (Drawing 5).

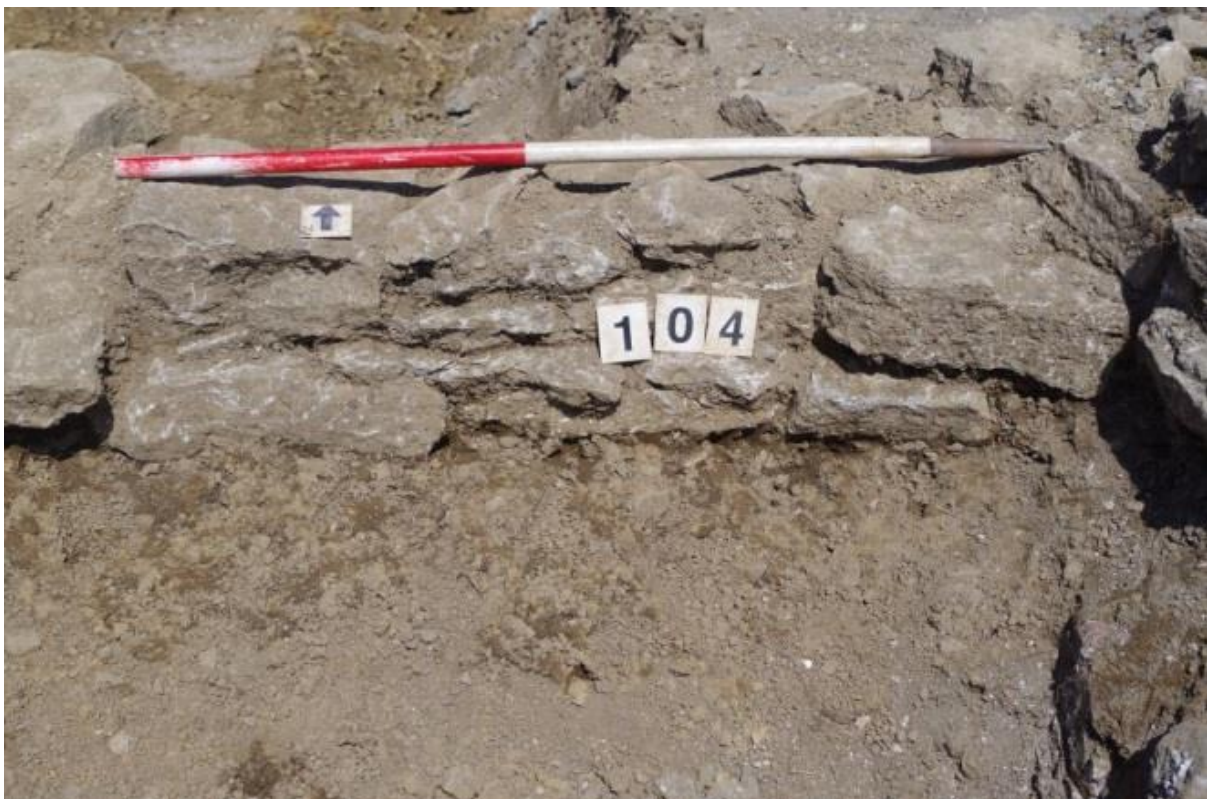
Plate 3: Blocked threshold within wall 104, looking north

Wall 111 and 110 (Drawing 5) were built upon 103 and 104 respectively, but a misalignment of wall 111 with that of the masonry of 103 was observed suggesting two phases to the building. In addition, the masonry of wall 104 narrowed to 0.4m in a location adjacent to wall 105 (Drawing 5; Plate 3). It is highly likely that this is a former threshold of the earlier phase of the building, subsequently blocked up when the doorway in wall 110 was utilised.

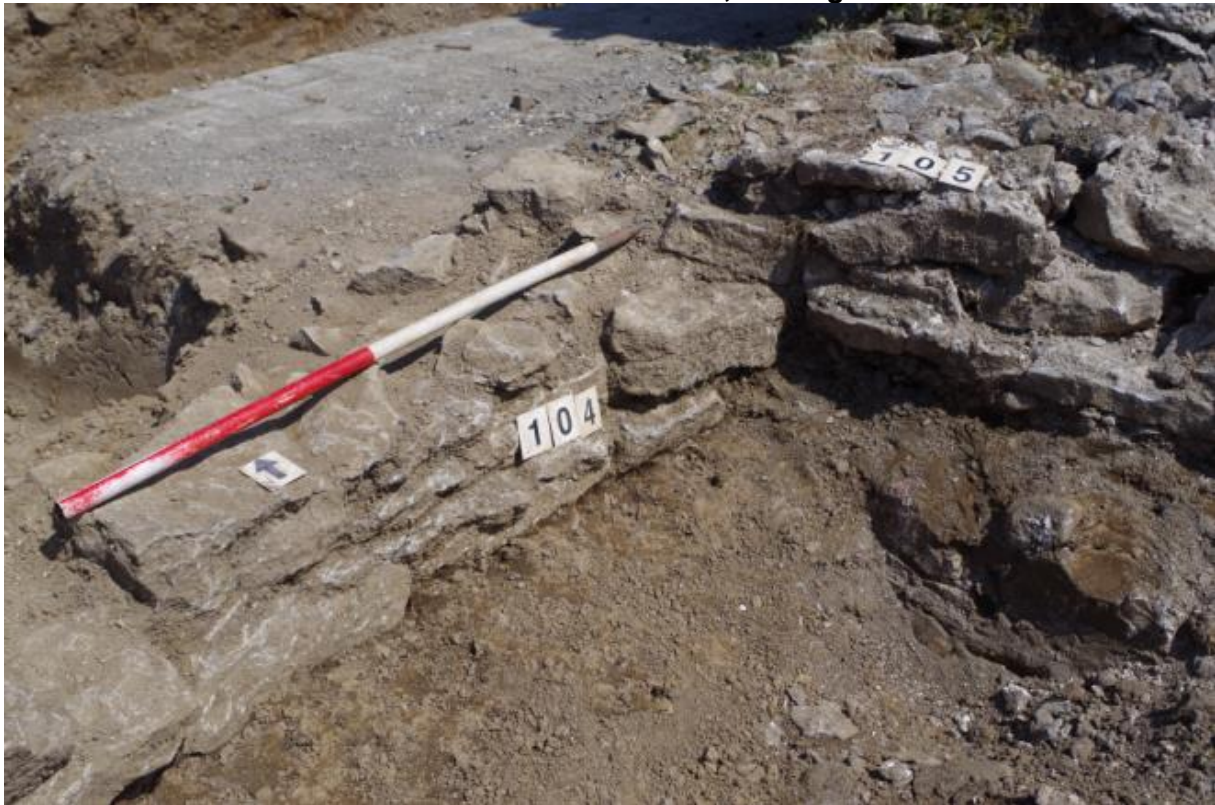
Plate 4: Junction of walls 104 and 105, looking north - east

Wall 105 butted against 104, and also comprised roughly hewn limestone and was of a drystone construction (Plate 4). As with wall 104, no construction cut was recorded. The wall aligns with a western boundary of a squared enclosed area to the south of the property, depicted upon the 1857 OS map of the area (Figure 9).
