HIGHFIELD FARM, PALTERTON, DERBYSHIRE

Archaeological Evaluation
Prepared for: **DJ Atkinson Construction Ltd**

SLR Ref: 403.07728.00002
Version No: 1
October 2020

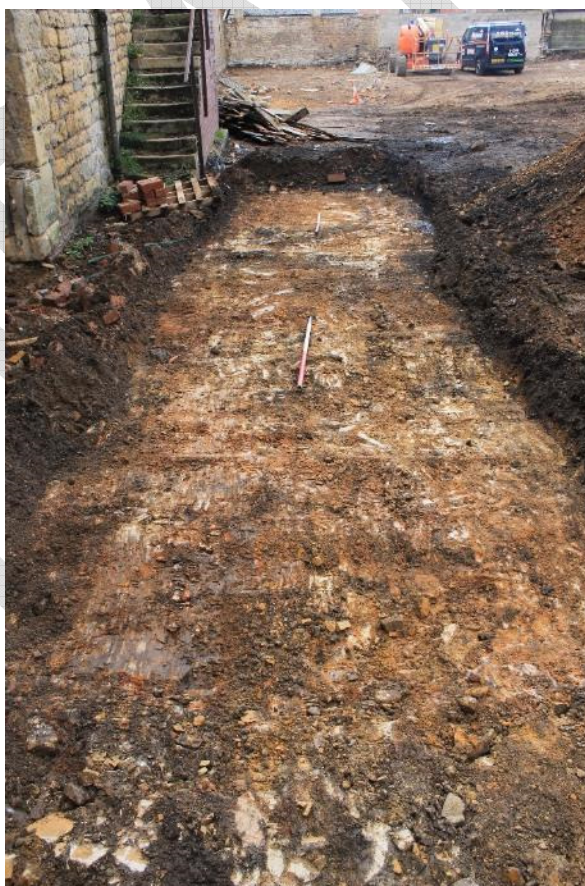
Figure 3
Dolostone in Trench 02

Figure 3 shows the high level of the dolostone at the highest part of site (<0.2m BGL).

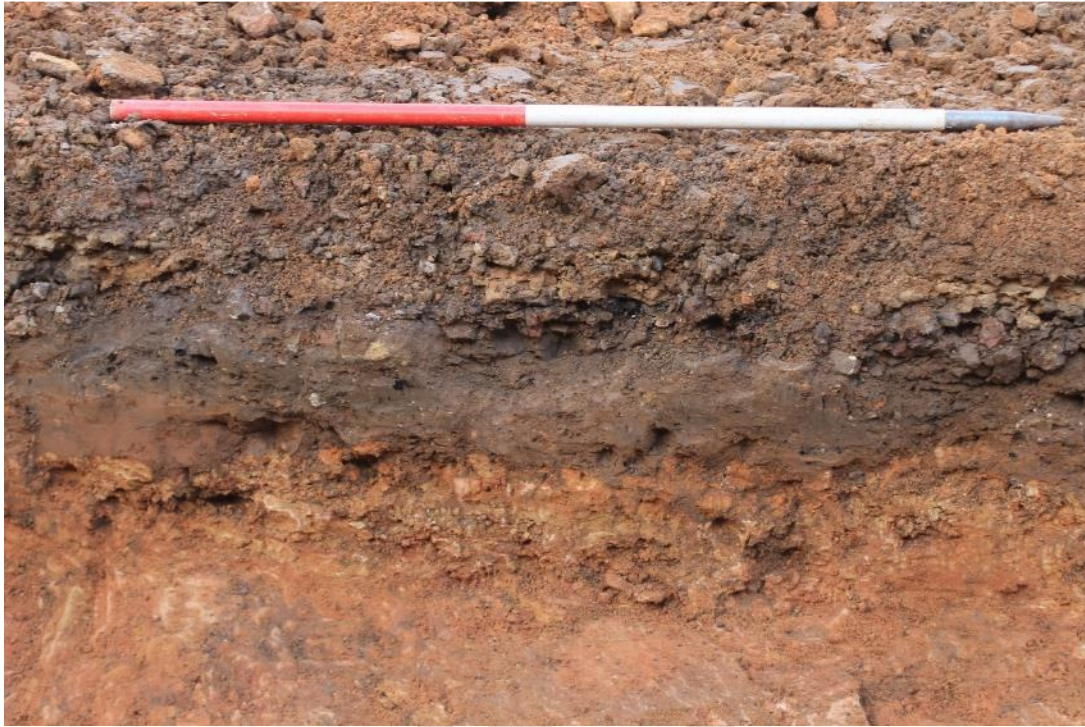
Figure 6
Deposit Sequence in Trench 06

Figure 6 shows the modern made ground above weathered limestone, with the tabular limestone forming the trench floor.

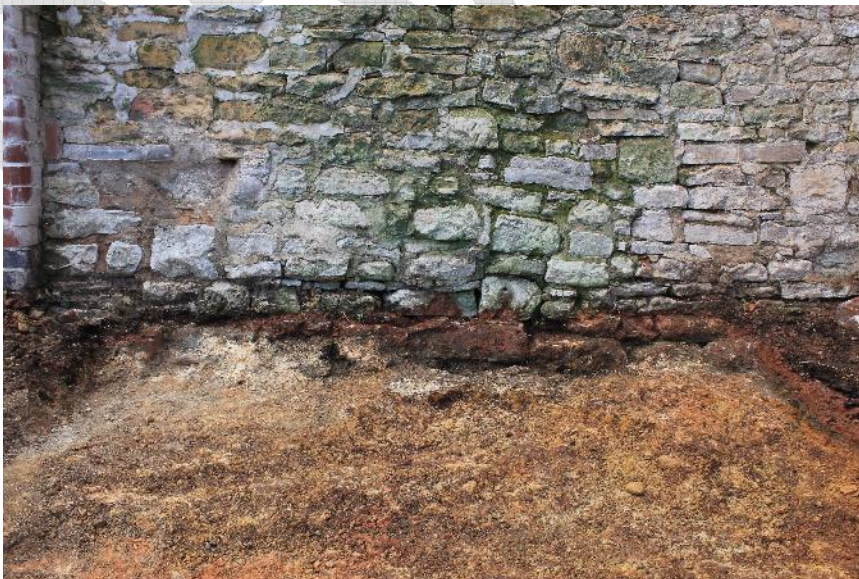
Figure 11
Wall in Tr 01

The wall to the west of Trench 01 was investigated to determine whether it was cut into the limestone. As shown in Figure 11, it was built up on top of the tabular limestone, which proved to be very shallow at that point.

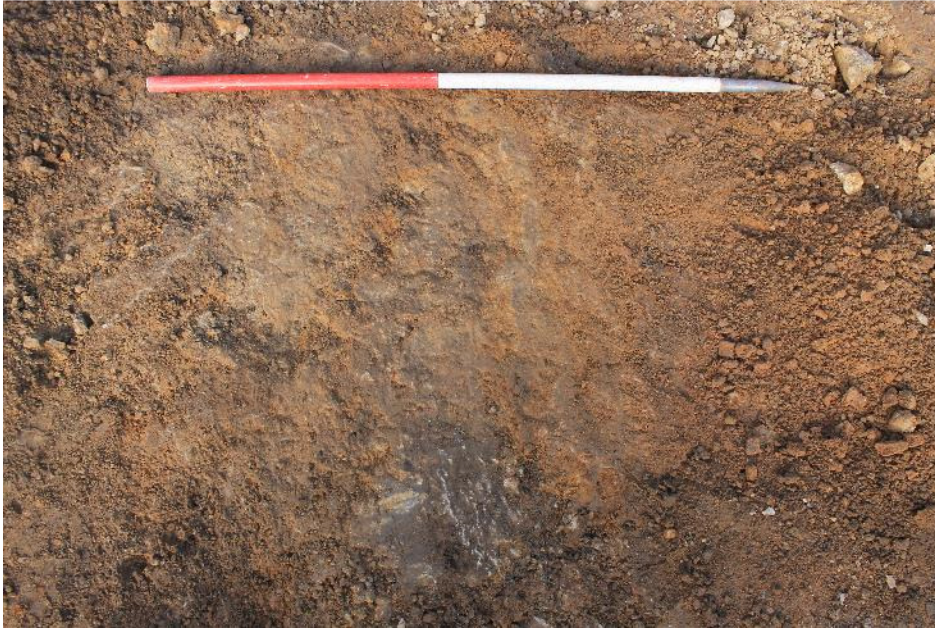
Figure 12
Investigated Area Trench 05

A possible feature was investigated in Trench 05, though cleaning revealed it to be a thin spread of darker silt (possibly a small area of surviving soil) above the bedrock, and not an archaeological feature.

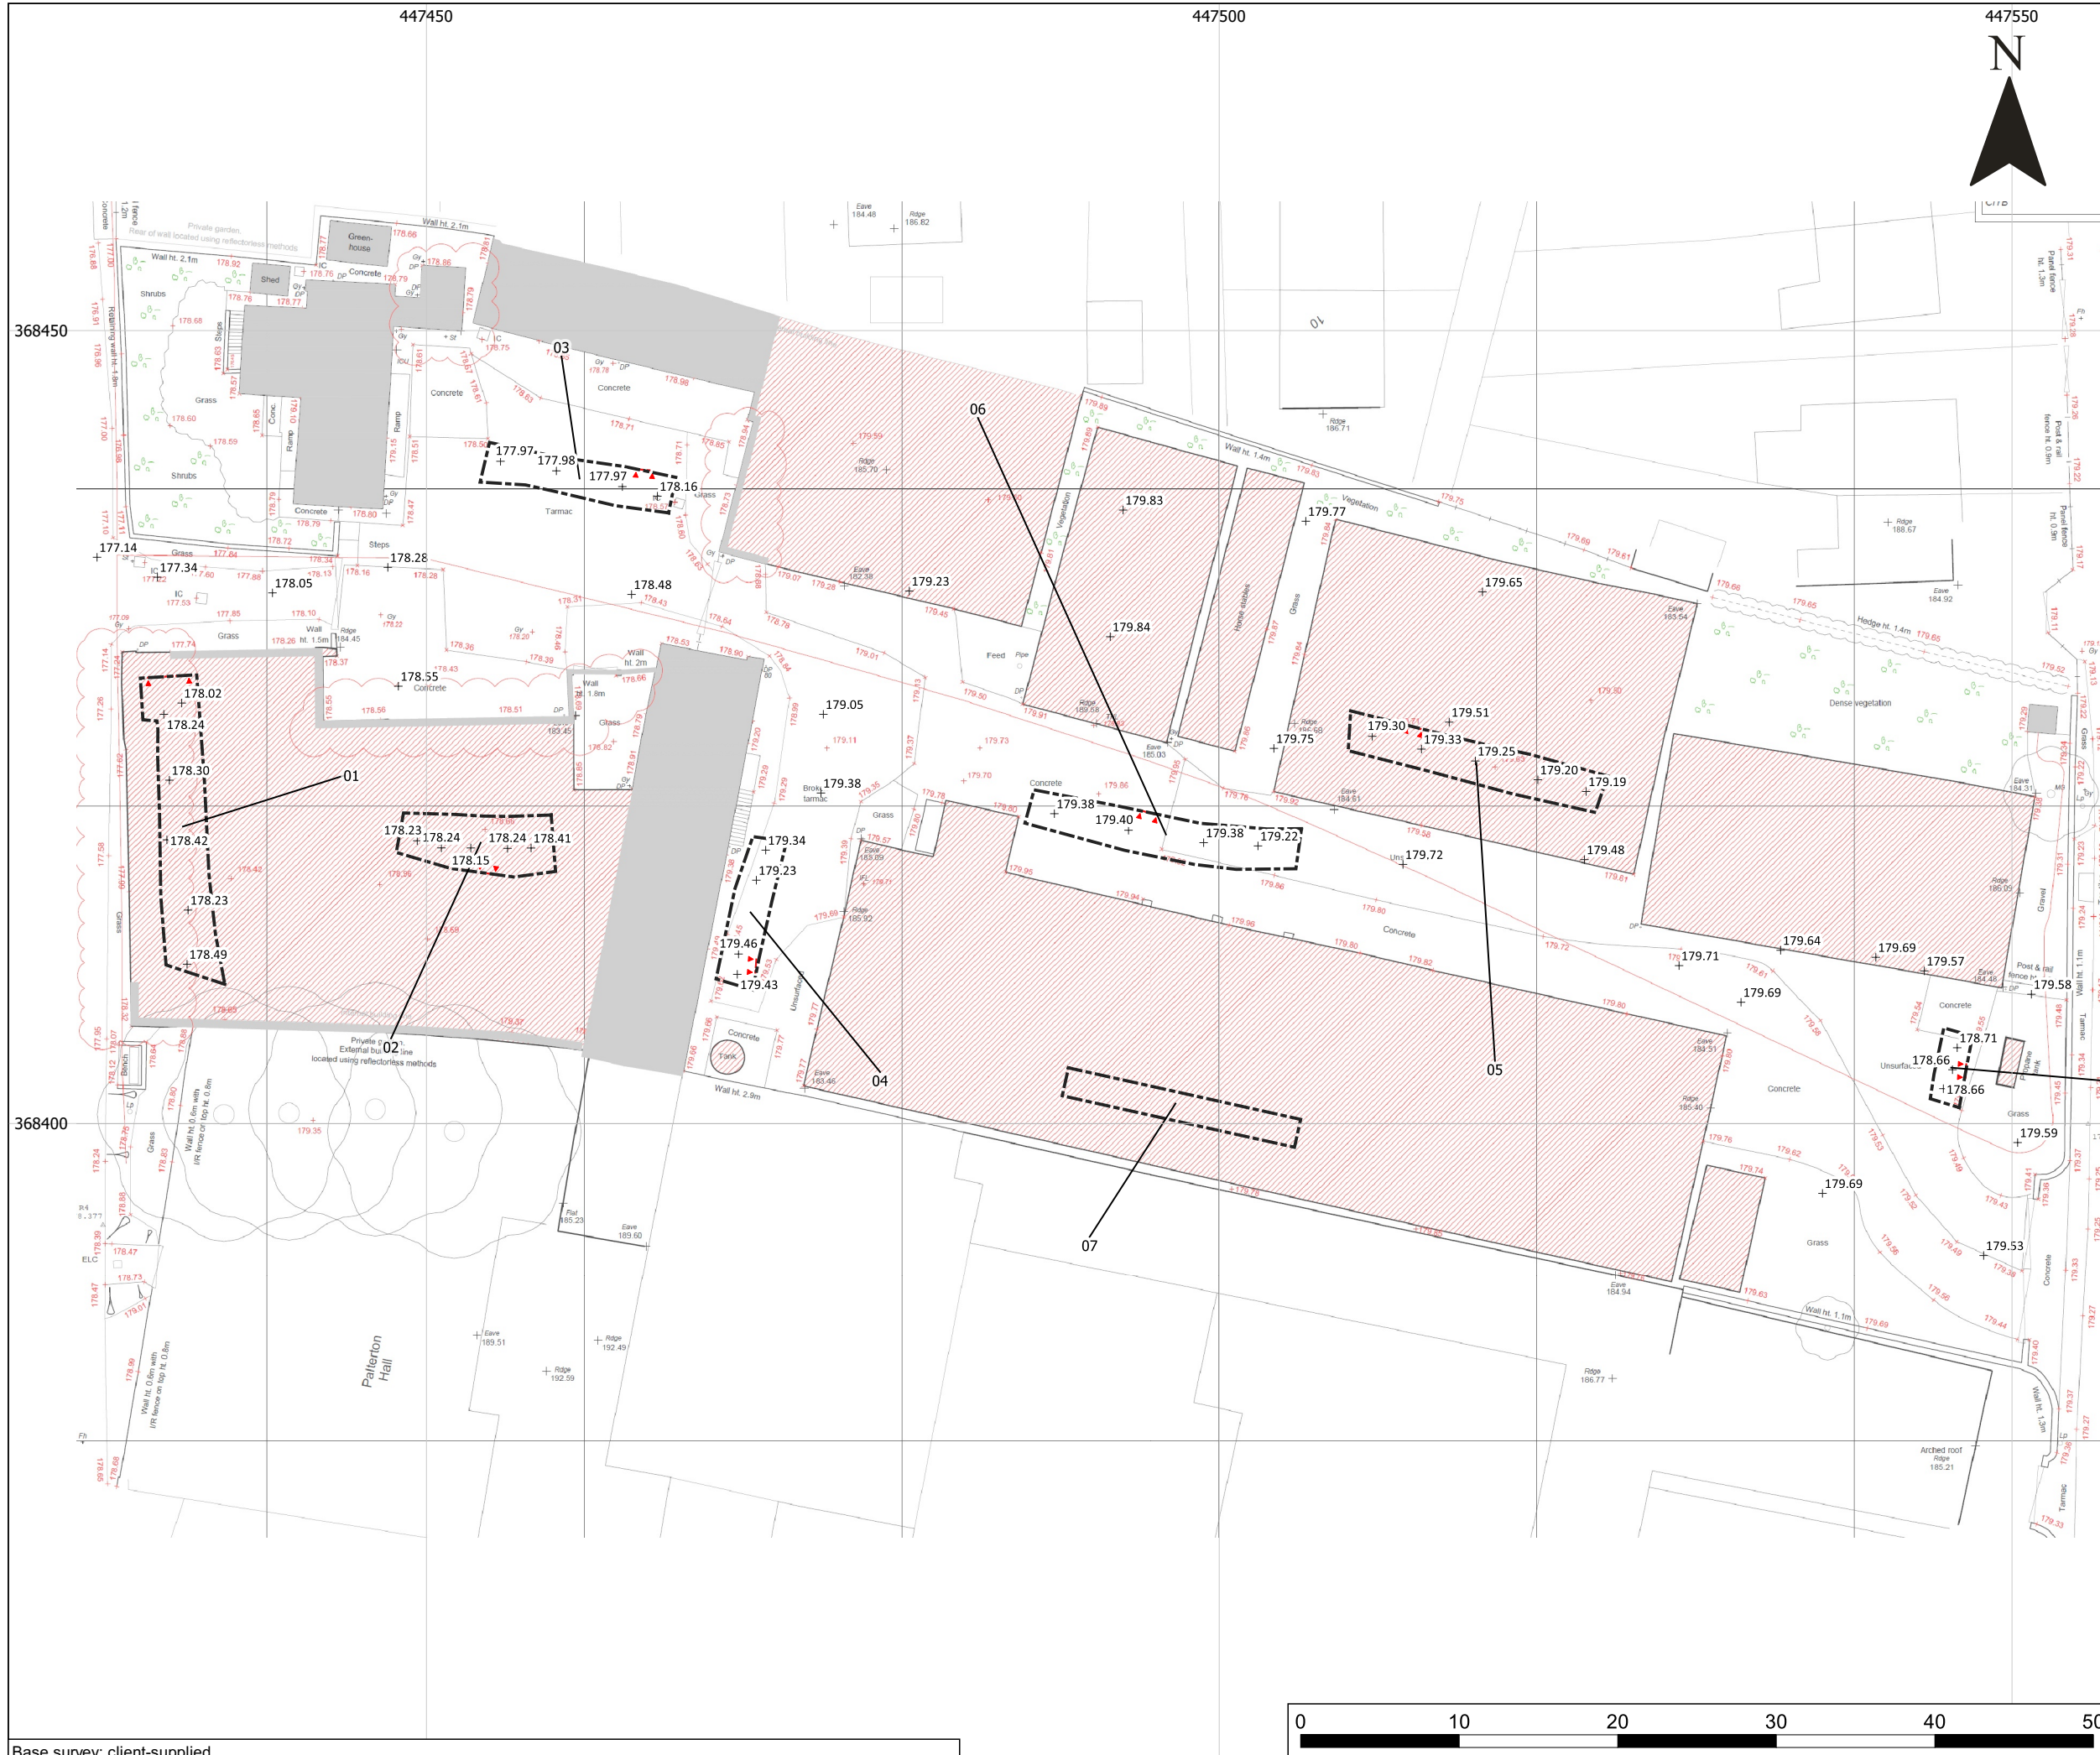
PALTERTON, DERBYSHIRE
ARCHAEOLOGICAL FIELD EVALUATION
TRIAL TRENCH LAYOUT
DRAWING 01

Following modification of the original layout set out in the WSI due to site constraints, eight trial trenches were identified for excavation as shown in Drawing 1. In the event Trench 07 was omitted due to the lack of finds in the other trenches.
