NORTHLIGHT HERITAGE
REPORT: 73
PROJECT ID: 4363161
DATA STRUCTURE REPORT

**Blairforkie Drive, Bridge of Allan
Stirlingshire**

Archaeological Evaluation

Data Structure Report

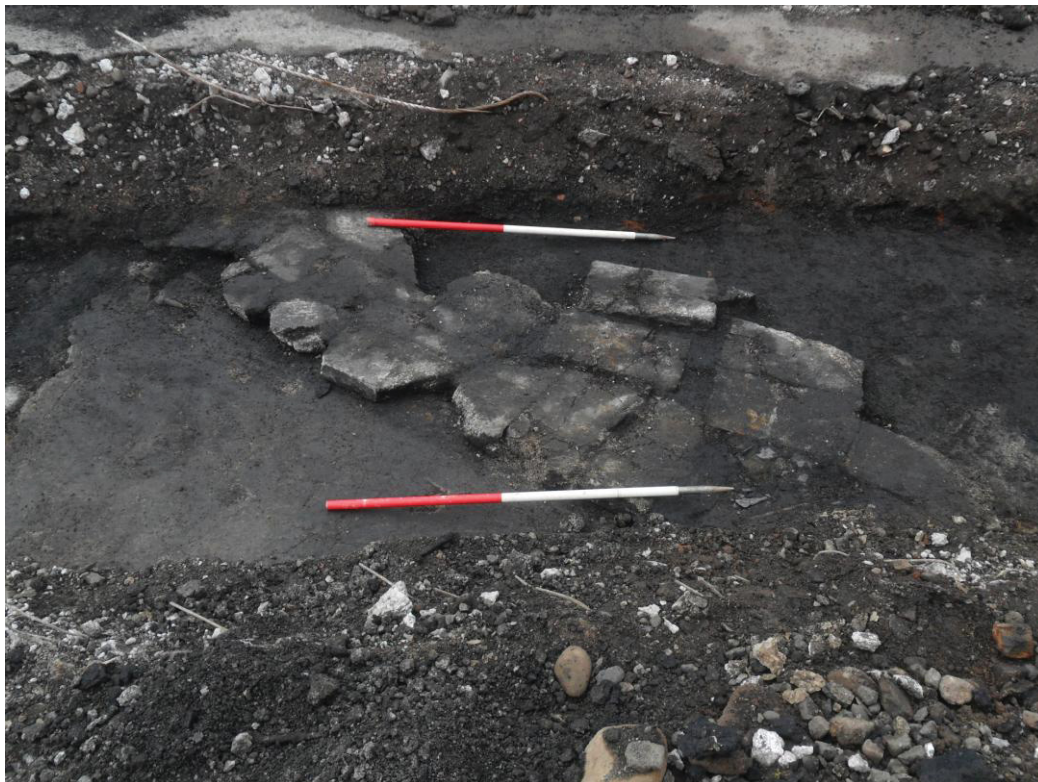
Trench 1 was excavated at the western corner of the existing warehouse. In the centre of the trench, beneath a concrete surface (008), which measured 0.16 m in depth, and a layer of gravel and brick rubble preparation/levelling material (009) , were the remains of a short section (approx 1 m in length) of a NE–SW running wall comprised of concrete blocks (011), measuring 0.08m in height. To the south eastern side and running beneath this wall was a concrete floor surface (012), and to the north west was a thin, 0.10m deep, layer of tar (010).

Beneath these deposits, and continuing throughout the rest of the trench, were a series of made-ground layers. Immediately below the tar (010) and concrete surface (012), was a layer of mottled yellow/white ash (013) which appears to have been used as a levelling deposit for the tar surface (010). Immediately below this ash layer (013) was a deposit of reddish brown clay, ranging in depth from approx 0.50–1.00 m, with frequent large boulder inclusions. Subsequently below this deposit was a light reddish brown sand layer with frequent stone inclusions (015) thought to be natural subsoil.

Plate 1: Wall [011] and surfaces (010) & (012) in trench 1

There are scant remains of a previous structure, as seen in trench 1, which may relate to fragmentary preservation of elements of 19th or 20th century structures. The wall may relate to the existing warehouse structure, as it runs almost perfectly in line with the upstanding western wall.

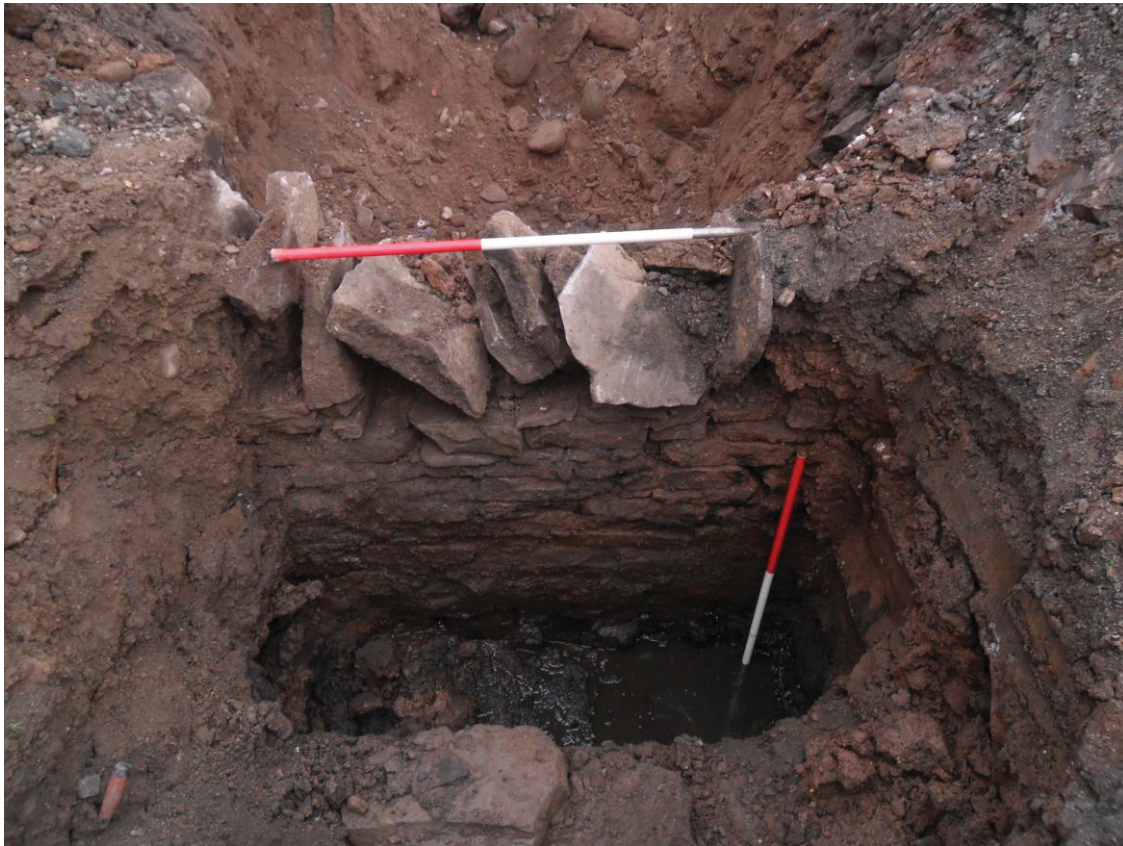
Trenches 5 and 6 revealed a series of made-ground layers and levelling materials, detailed in appendix 1. These trenches also contained the remains of a dry stone wall [034] & [045] that ran east to west forming the southern edge of a lade. The wall itself was located at approximately 0.50 m below the gravel surface (028) & (036) and was at least 1.50 m in depth, however due to waterlogged conditions it was impossible to ascertain the exact depth. The northern face of the wall was constructed of squared off dry stone blocks with thin flat dry stone sitting on edge as the top course, whereas the southern face was a series of rounded stones, <0.35m diameter, simply piled up against the back of the wall acting as a support. The northern boundary wall of the lade was not identified within the evaluation trenches. On the southern side of this boundary wall were deposits of reddish brown sand (031) & (042), natural alluvial deposits into which the lade was dug. To the north of the wall was a deposit of rubble and silt which has been used to backfill the lade after it went out of use.

Plate 2: Northern face of lade wall [034] in trench 5.

The walls discovered within trenches 5 and 6 are believed to be the southern boundary wall of a lade which ran east to west through the site. This lade can be seen on Stobies' 1783 map as well as later OS mapping and has remained in a well preserved state beneath this demolition material which was deposited around and on top of the wall. Only the southern boundary of the lade was identified within the trenches and no trace of the northern boundary was found. In trench 6 this was likely due to numerous utilities and services (drains and water pipes) identified at the northern end of the trench. In trench 5 the southern wall was located at the northern end of the trench and the northern wall may still survive outside the trench.
