<b>NORTHLIGHT HERITAGE</b>	<b>New Lanark World Heritage Site</b>
REPORT: 188	<b>Lanark</b>
PROJECT ID: 1045	
DATA STRUCTURE REPORT	<b>South Lanarkshire</b>

New Lanark World Heritage Site

Data Structure Report

*New Lanark Trust*

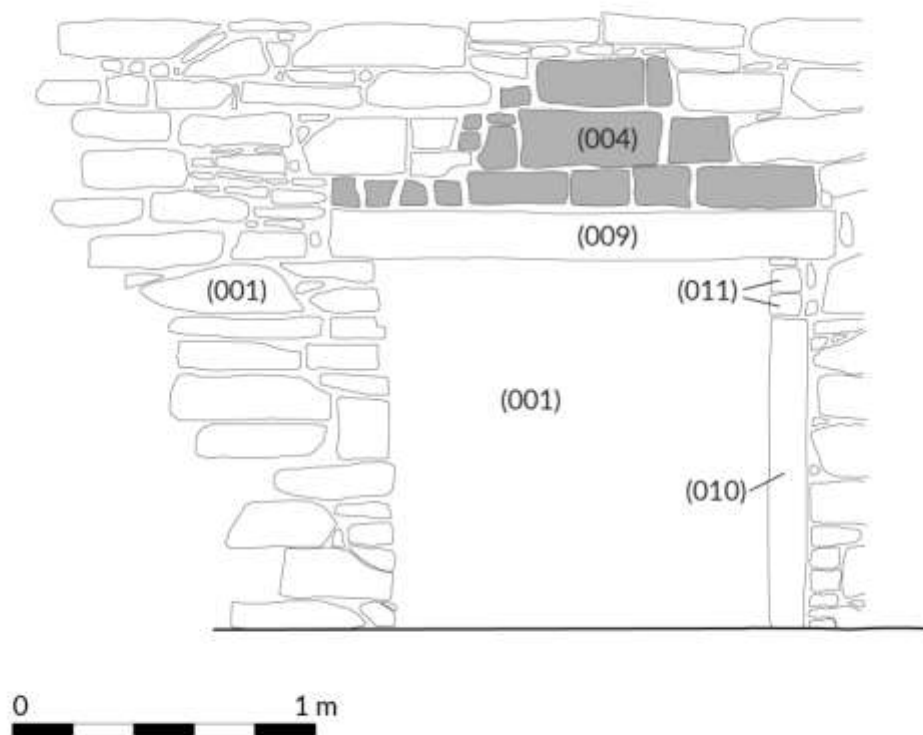
Figure 2: Elevation of fireplace

Directly above the fireplace lintel [009] is a repair/alteration to the fireplace and is evident by a 'stepped' shape of lighter coloured stone blocks [004]. As with the remainder of wall [001], these later blocks are bonded with lime mortar. The area of repair [004], as seen in plate 1, measures 1.60 m in length at its maximum extent (the base) and 0.45 m at its minimum (at the top). The stones used in the repair are very similar to those used throughout wall [001] other than, as previously mentioned, are slightly lighter in colour. The stones at the western side all appear to be far smaller in size than the remainder of the patched area, ranging in size from approximately 0.10 m x 0.10 m up to 0.45 m x 0.17 m.

The internal southeast facing wall [001] (plate 1) was subject to archaeological recording. The wall measures 6.60 m in length and is comprised of angular stone blocks varying in size from approximately 0.10 m x 0.10 m up to 0.60 m x 0.15 m and is bonded with a lime mortar. 3 m from the north-western corner and 2.4 m from the north-eastern corner is a concave fireplace [018]. This fireplace, which is 1.20 m in width x 1.20 m in height x 0.60 m in depth is comprised of two large stone slabs [003] and [010] at either side both of which measure approximately 1 m in height x 0.40 m deep x 0.12 m thick. The north-eastern sidewall [003] has collapsed and now lies within the fireplace whereas the opposite side [010] still remains *in-situ*. Lying on top of the *in-situ* sidewall [010] are two relatively modern bricks [011]. The bricks, which were presumably mirrored on the opposing side, no longer remain. Above these bricks [011] sits the fireplace lintel [009] which measures 0.16 m in height x 1.68 m in length and 0.10 m in depth.

The large area of stonework above the fireplace is an indication that the fireplace has been altered at some point, perhaps in relation to the possible range/boiler. Interestingly the fireplace is no longer in alignment with its surroundings and appears offset when compared to the slate slabs/brickwork surrounding it. Again this is perhaps a further indication that the internal layout has been significantly changed for different phases of use.

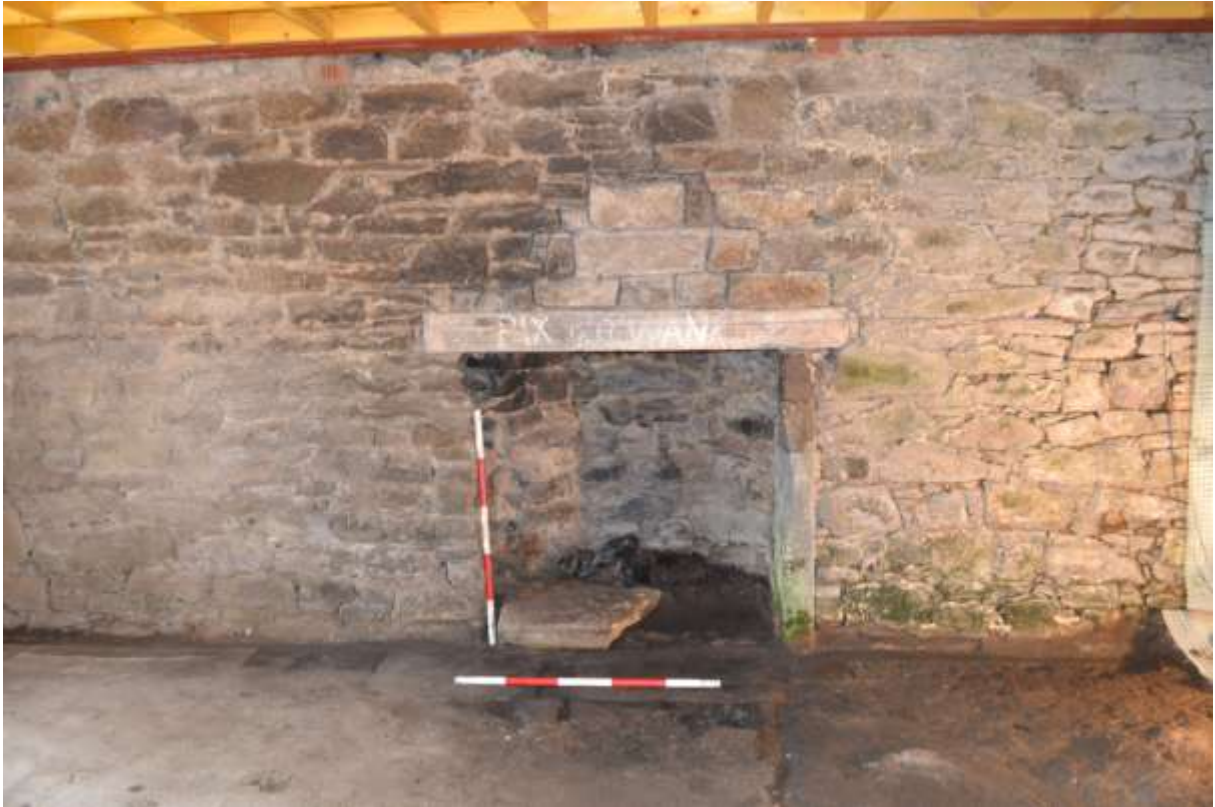
Plate1: Internal southeast facing wall, fireplace and repair and low lying arch.

To the right hand side of the fireplace there is the possibility of a very low lying arch [035], approximately 0.50 m in height by 2.40 m in length which has been blocked up at some point with stone [036] very much in keeping with the rest of the wall [001] making it very difficult to distinguish. This possible arch was not spotted during the excavation process but post excavation through the photographic images taken of the wall. It appears that the internal semi circular opening would have measured approximately 2 m in length at its maximum extent and approximately 0.40 m in height, the depth is unknown. The arch [035] comprises stone varying in size from 0.10 m x 0.10 m up to approximately 0.40 m x 0.15 m and as with the entire wall [001] has a lime mortar bonding. The base of this arch has a cement footing [037] which consists of approximately 0.10 m in height of cement angling down from at approximately 45° and overlying a course of dark coloured, almost slate like in appearance, bricks [017] which are part of the overall fireplace surround/hearth.

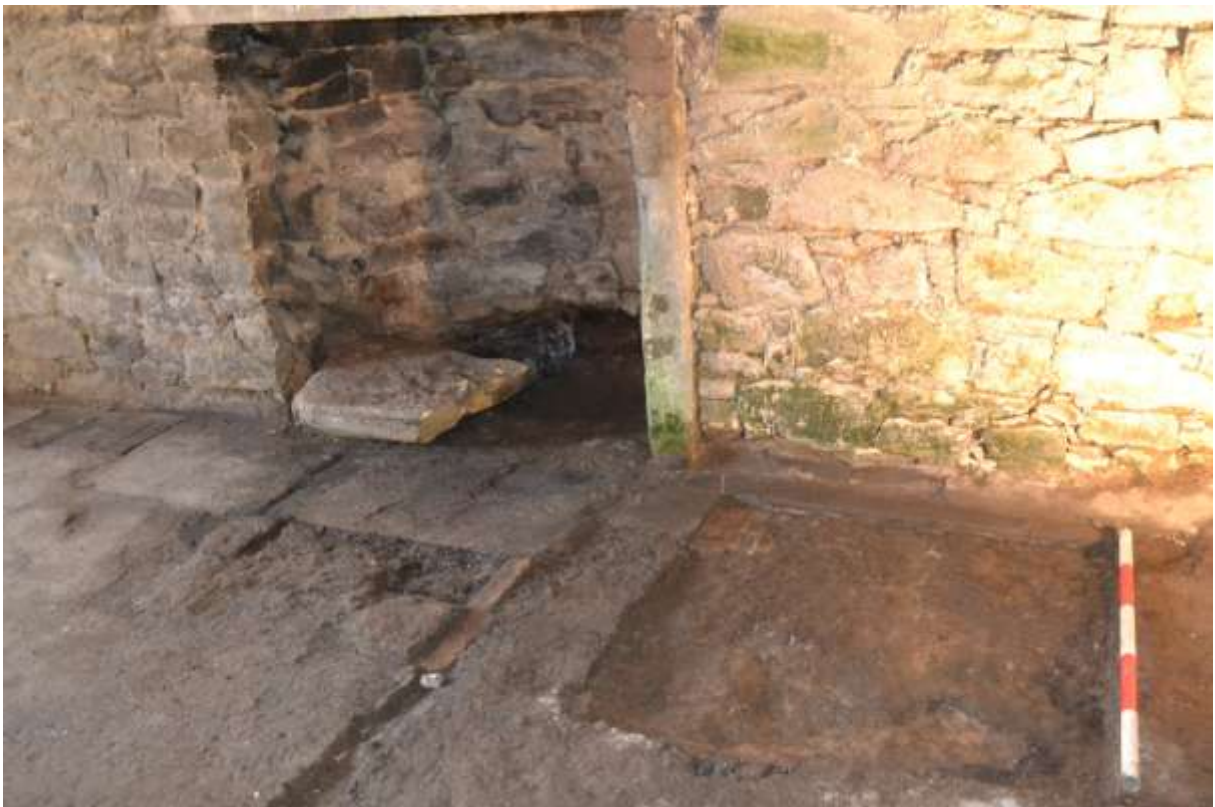
Plate 2: Fireplace with row of bricks on right hand side, fire surround slabs, mortar footprint of missing slab and possible setting for range or similar.

The fireplace surround/hearth comprises of a single row of bricks, running along the full length of the wall [001] into either corner of the room. The single row of bricks to the left hand side of the fireplace [015] appears to be smaller in size than those to the right hand side of the fireplace [017]. Those on the left [015] range in dimensions from 0.23 m x 0.06 m to 0.07 m x 0.06 m whereas the corresponding row of bricks to the right hand side of the fireplace all appear fairly regular in size measuring 0.22 m x 0.13 m. Protruding in towards the room at the extent of the bricks [015] and [017] closest to the fireplace, are two small stone slabs [024] and [025] measuring 0.23 m<sup>2</sup> and a smaller, half slab at 0.23 m x 0.10 m. As with the rows of bricks [015] and [017], these stone slabs [024] and [025] have a very dark slate like appearance. One of these larger slabs to the right hand side of the fireplace [025] is missing; however a mortar footprint (022) of this missing slab was noted within trench 4 indicating that at one time both sides of the fireplace were symmetrical.

Within concrete floor surface [005] immediately in front of fireplace slabs [016] is a small area which has clearly been disturbed, see plate 2. Two bricks [038], measuring approximately 0.20 m in length x 0.08 m in width line the eastern side of the disturbed area and the concrete appears to be missing in patches and re-laid in others. It is possible that this is an indication that a range or boiler may have been present here at one point in time.

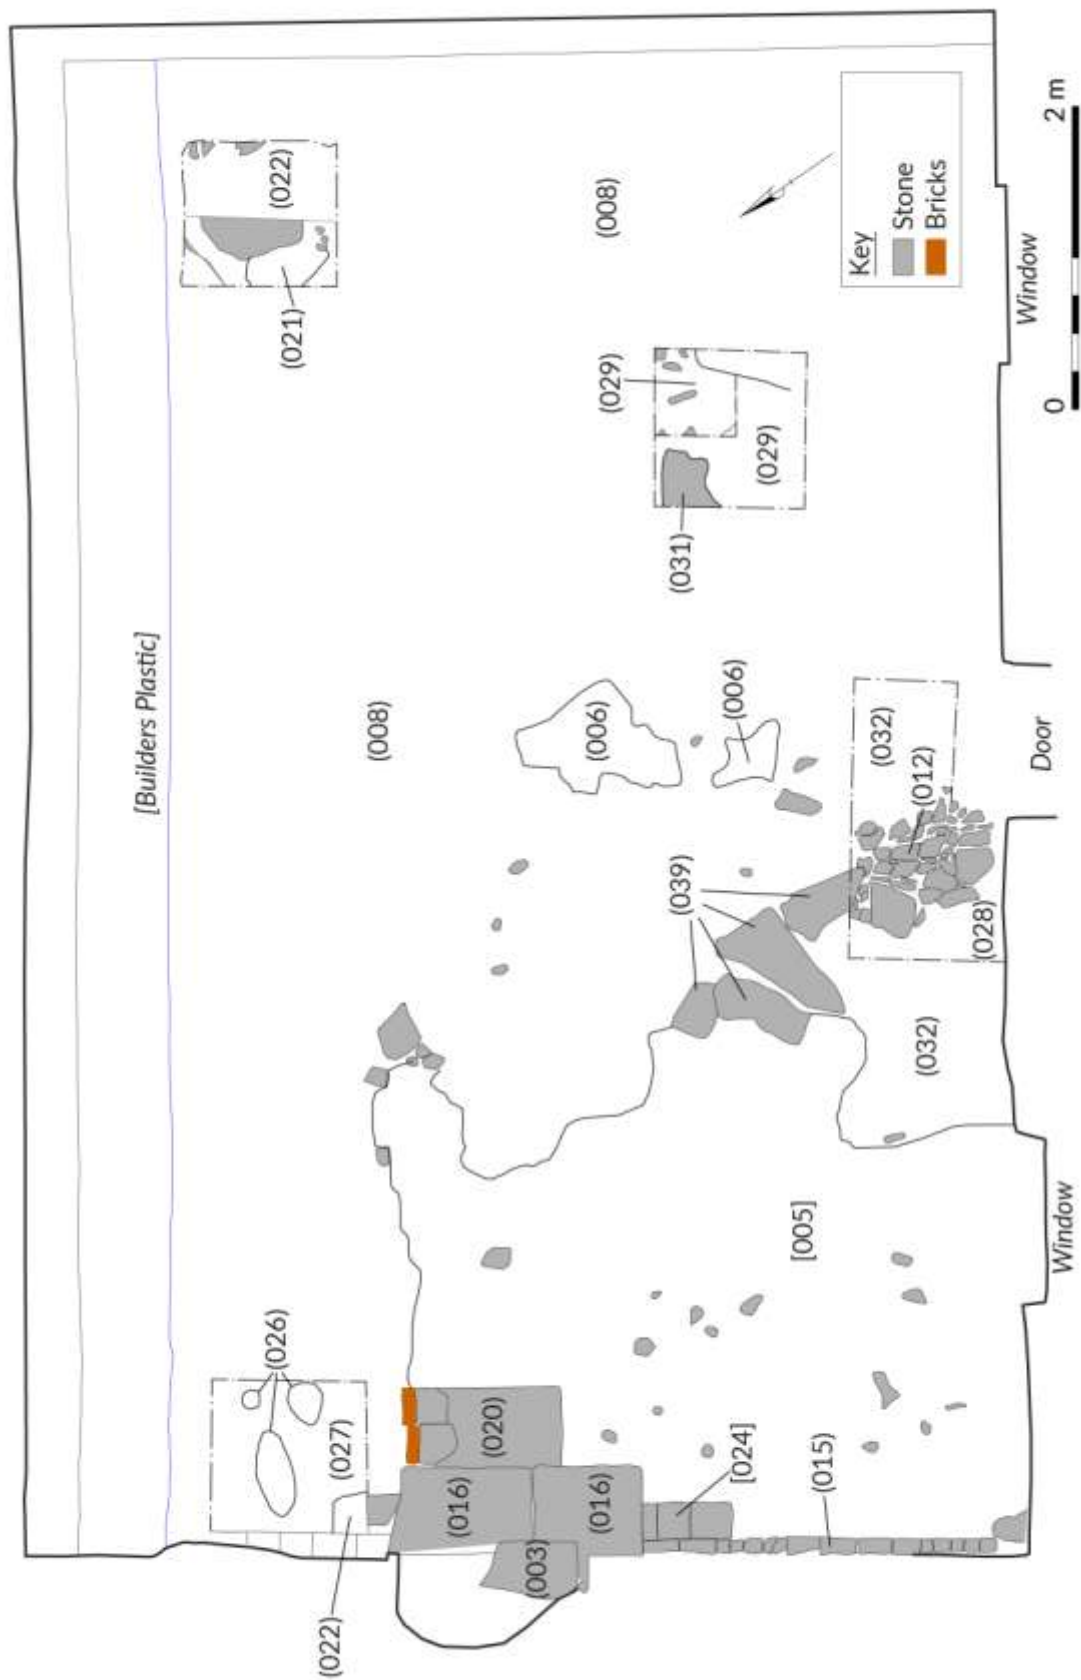
Figure 3: Post excavation plan of basement floor

Directly in front of the fireplace are two larger stone slabs [016] of which one measures 0.88 m x 0.60 m and the other 0.74 m x 0.60 m. These slabs are abutting bricks [015] and [017] as well as slabs [024] and [025] to the left and right. It appears that these larger stone slabs, as well as all of the other brickwork making up the fire surround are almost symmetrical with these large stone slabs in the centre of the room. However the fireplace itself appears to be offset slightly as can be clearly seen in figure 3.

Laid up against the fireplace surround [015], [016] and [024] on the north-western side of the basement floor is a large irregular shaped concrete floor surface [005]. The concrete covers the entire north-western corner of the room and has a near straight edge running parallel with the eastern edge of the fireplace. The southern edge of this concrete floor surface is much more irregular in shape as can be seen in the post excavation plan (Figure 3). The southern and eastern sides of the concrete surface abuts deposit (008) which comprises moderately compacted mid brown/grey sand and gravel deposit, ranging from 0.02 m – 0.05 m in depth and covers the majority of the basement floor. The surface of the concrete has a stippled finish in order to give it some degree of grip.

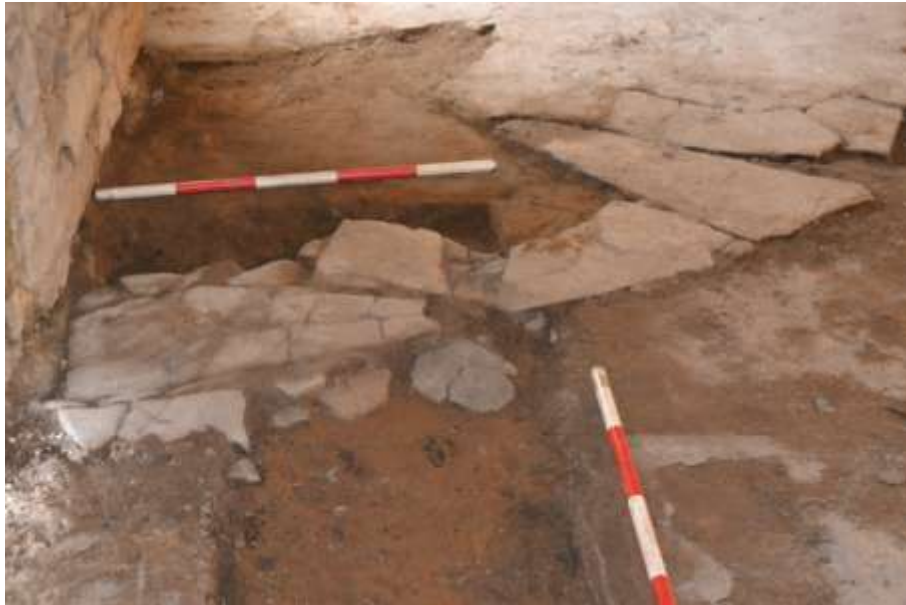
Plate 3: Arc of cobble and flagstones and possible lower cobbled surface.

Immediately to the left hand side of the basement entrance is an area of cobbles [012] measuring 1 m north – south by 0.60 m east to west and flagstones [039] measuring 1.60 m north – south by 0.80 m (at maximum extent) east to west. The area of cobbling is generally comprised of small irregular shaped relatively flat cobbles of varying sizes; however there are two rows of cobbles laid on their edge forming some sort of pattern (see plate 3 below). The flagstones [039] are abutting the cobbles [012] and together are forming an arc of stonework measuring 2.60 m north to south by 0.80 m east to west. The concrete floor surface [005] (see chapter 6.7) has been laid against the flagstones [039]. There are possible indications of a lower cobbled surface [014] evident below cobbles [012] in the form of a few cobbles at a lower depth to the east of [012]. Both the cobbles [012] and flagstones [039] appear to have been set at the same level as deposit (008) indicating that it is likely these were all laid before deposit (008) was laid as there is no indication that the area of cobbling or flagstones had been cut into this deposit and is highly unlikely that they would have been left proud of the ground level if it was the case (008) was accumulated at a later date. The cobbled surface [012] has been laid atop a very firmly compacted dark brown gravely sand deposit (033) which appears to be a foundation deposit below the cobbles. It is unclear as to the full extent of this deposit or as to whether this is also beneath flagstones [039] due to the limited extent of the excavation. Immediately north-west of the area of cobbling was an irregular shaped patch of sterile orange sand (032), again due to the time constraints with the excavation it was not possible to determine the full extent or nature of this deposit.

Trench 4 was opened up just inside the basement entrance, to the left hand side of the door and measured 1.55 sq. metres. This trench exposed the possible lower cobbled surface [014] (see section 6.9) which may indicate either the possibility of an earlier phase of occupation or the possibility of repairs having taken place to the cobbled surface. Beneath this cobbled surface lay a foundation deposit (028). This deposit would have been used in order to give the cobbles a solid and level base on which to be laid. In the eastern half of the trench, below deposit (008), was a very firmly compacted gravel deposit (033), approximately 0.05 m in depth. A very small 'patch' of a similar gravel deposit (013) was exposed within trench 1, the fact that this appears not to be a uniform deposit used over the entirety of the basement floor and only appears to appear sporadically may indicate it has been used to reinforce some of the softer/wetter areas of the basement floor. Below this gravel deposit (033) was very firmly compacted mottled orange sand natural (032).

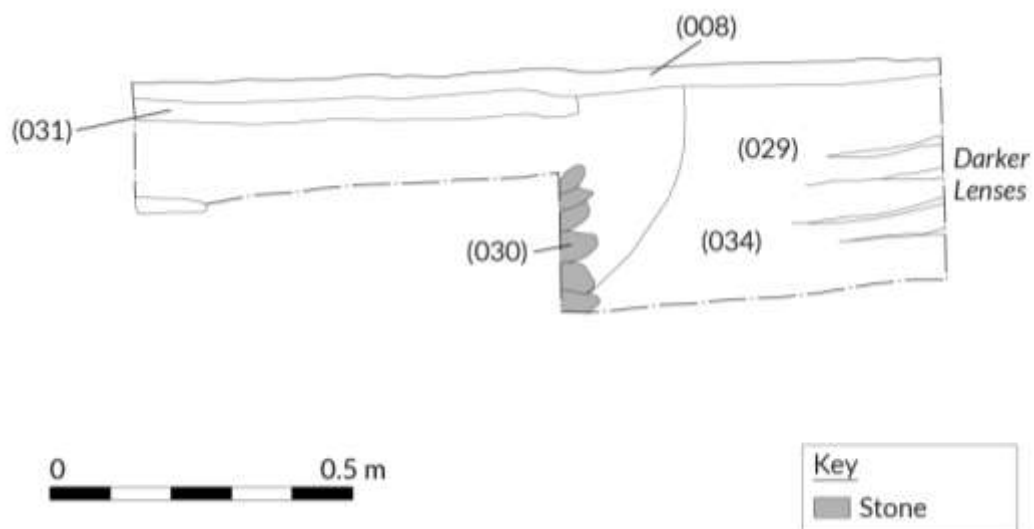
Figure 4: South-west facing section of trench 1

Trench 1, which measured 1m<sup>2</sup>, was opened up in the south-east corner of the basement. Below the initial deposit of (008), which covered the entire basement floor, was a small patch of tarmacadam (031), measuring 0.40 m x 0.20 m x 0.05 m deep, in the north-western corner of the trench. Directly beneath this deposit (031) was a deposit of moderately compacted dark brown sandy silt with abundant angular stone inclusions which appears to be the fill of a cut [034]. The cut [034], which was only visible in the south-west facing section, cut through natural sand deposit (029) and, although the base was not visible due to the limit of excavation, appears to be roughly concave in shape. It is likely that this relates to a foundation deposit below the tarmacadam (031), perhaps if there was a particular wet or soft patch which required reinforcement. Similarly, on the south-western corner, immediately below deposit (008), was a small patch of gravel (013), approximately 0.02 – 0.05 m thick. This is likely to have been used to reinforce the ground of a wet or soft patch, much like the function of the tarmacadam (031).
