<b>NORTHLIGHT HERITAGE</b>	<b>Govan Graving Docks Ground Investigation</b>
REPORT: 171	<b>Archaeological Watching Brief</b>
PROJECT ID: 607	
DATA STRUCTURE REPORT	Govan Graving Docks, Clydebrae Street, Glasgow

Govan Graving Docks

Data Structure Report

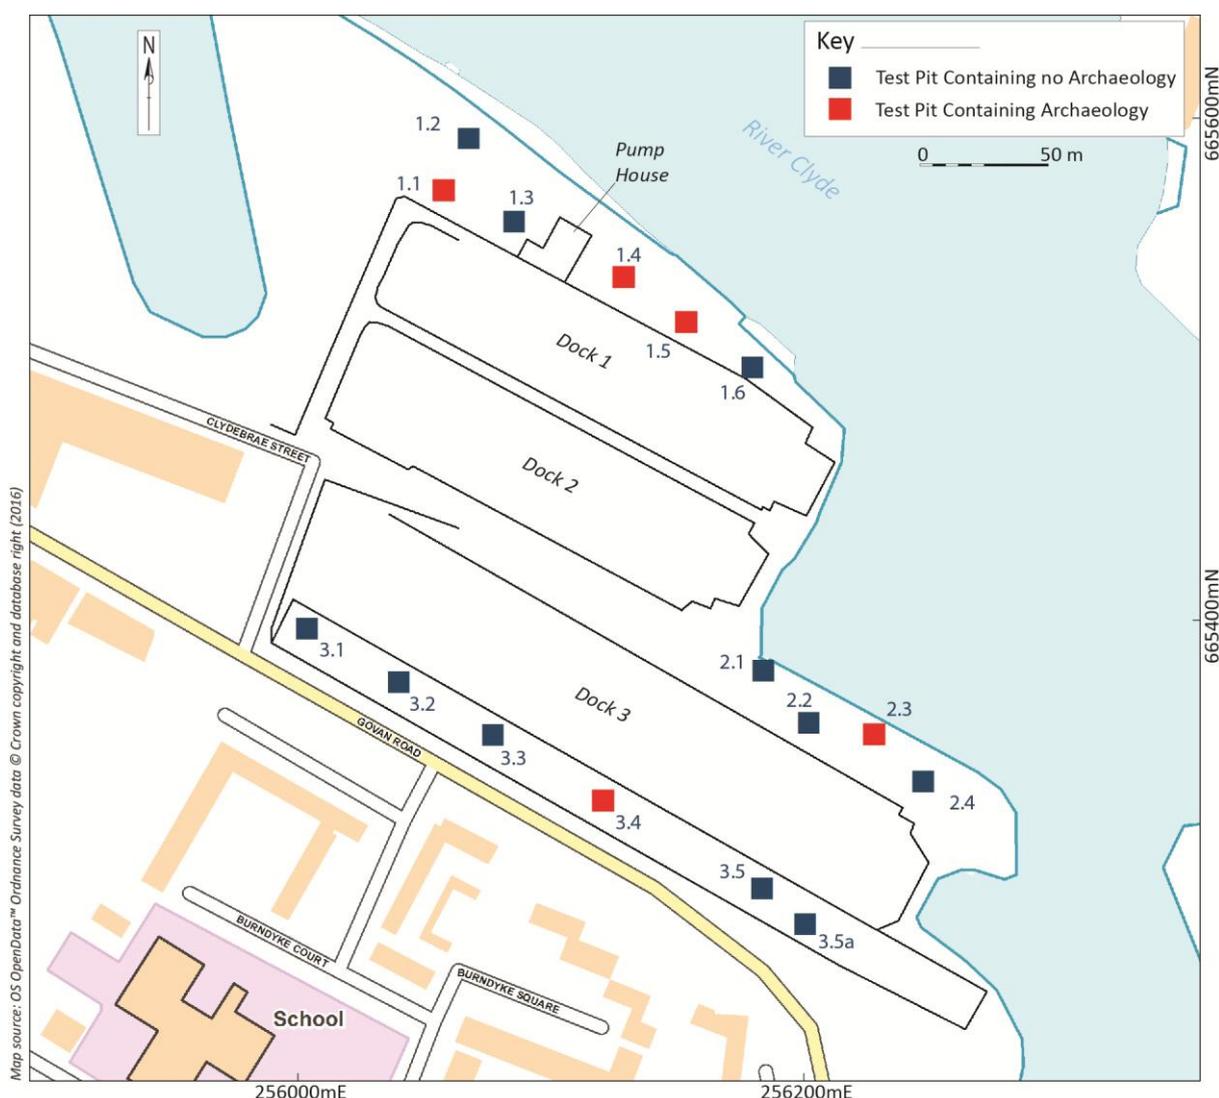
Figure 2: Test Pit Location

A total of 16 test pits were excavated in the graving dock area (Figure 2). Details of all 16 test pits are provided in Appendix 1, Tables 1 & 2 while the 5 test pits containing structural archaeological remains (Test Pits 1.1, 1.4, 1.5, 2.3 & 3.4) are described further in the following paragraphs.

Of the 11 test pits that contained no structural archaeology (Figure 2) the deposits comprised sterile sands and clays that extended the full depth of the test pits, the exception being the uppermost layers that had been disturbed by Graving Dock activity. These disturbed layers generally consisted of an upper layer of cobbles with associated concrete beneath.

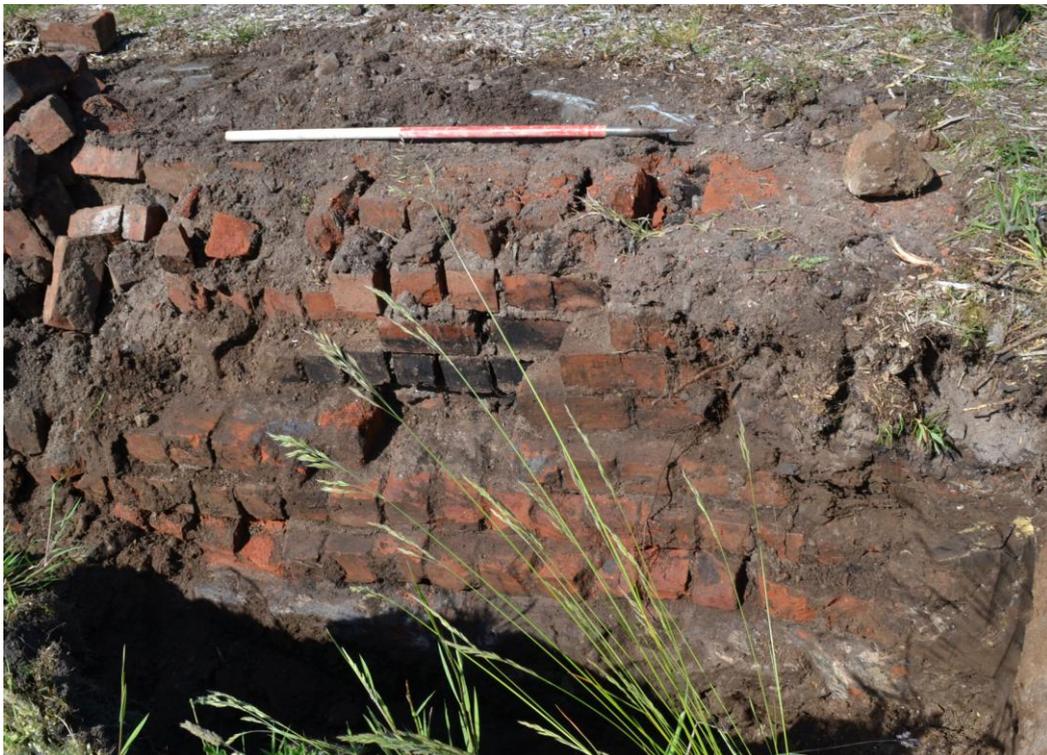
Plate 1: Foundation wall [021] in test pit 1.5

Test Pit 1.5 was located to the south-east of Test Pit 1.4 (Figure 2). The surface deposit here comprised a grey/brown silty sand topsoil (020) 0.10 m in depth. Beneath this and running along the full north-eastern side of the trench, a red brick foundation wall [021] was present (Plate 1). This foundation wall was 0.82 m in depth which corresponded to eight courses of brick, with each course stepping out slightly from the top down (Plate

1). Each of the non-frogged bricks measured approximately 0.2 m in length by 0.1 m in width and were 0.07 m in depth. They were bonded by a likely concrete based mortar. Directly beneath the topsoil and abutting against the north-eastern edge of the brick wall [021] were two courses of cobbles (026), each of which were approximately 0.15 m wide by 0.25 m in length and were 0.25 m in depth. The cobbles were not exposed enough to fully ascertain their relationship with the brick wall but it is possible they form some kind of edge to the wall.

The red brick wall foundation [021] sat directly on top of a 0.35 m deep concrete layer (022). Beneath this concrete was a deposit of mid-brown clay with frequent charcoal fleck inclusions (023). It measured approximately 0.2 m in depth and sat on top of a mid-brown clay (024) which extended beyond the base of the 3 m deep test pit.

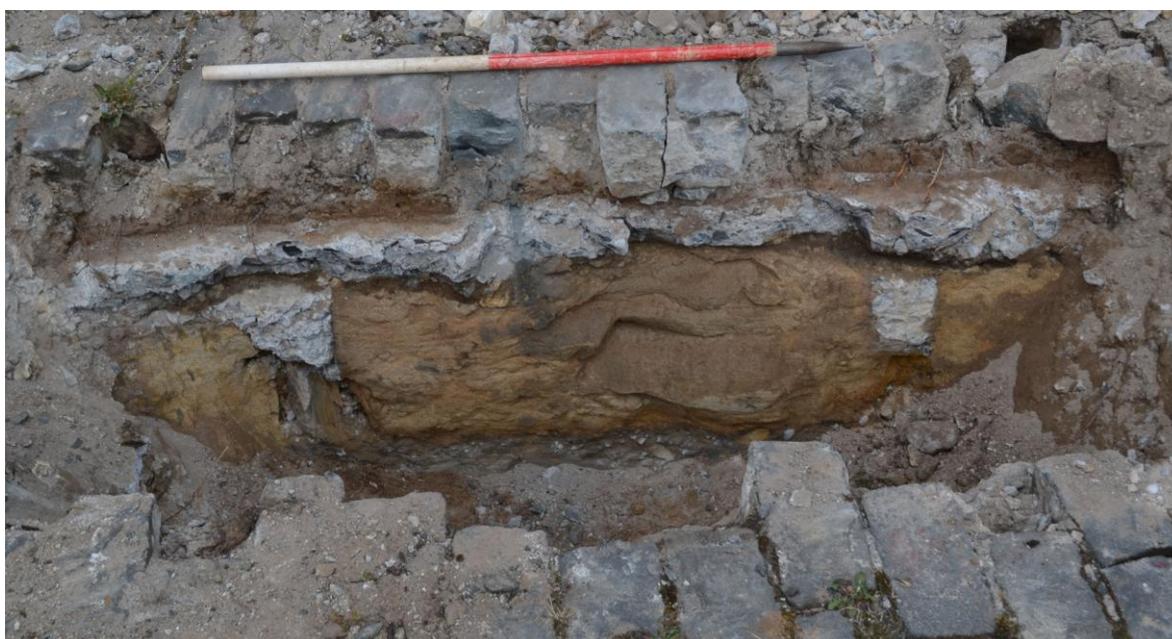
Plate 2: Sandstone block [049] in test pit 2.3

Beneath the thin dark sand deposit (044) was a very large sandstone block [049] measuring at least 1.80 m in length by 0.40 m in height (Plate 2). In section this sandstone block [049] appeared to have had two vertical features cut through it that were located at either end of the test pit (Plate 2). The cut on the north-western side [048] measured 0.17 m in width by 0.4 m in depth while that on the south-eastern side [051] was narrower measuring 0.12 m in width by 0.40 m in depth. The primary fills of each cut comprised sandstone fragments (047 & 052 respectively) which appear to have been used to fill the base of the cuts while the secondary deposit comprised concrete (046 & 050 respectively).

The large sandstone block [049] and associated cuts [048 & 051] sat directly on top of a further layer of concrete (053), the dimensions of which were not ascertained due to test pit excavation not proceeding beyond this point.

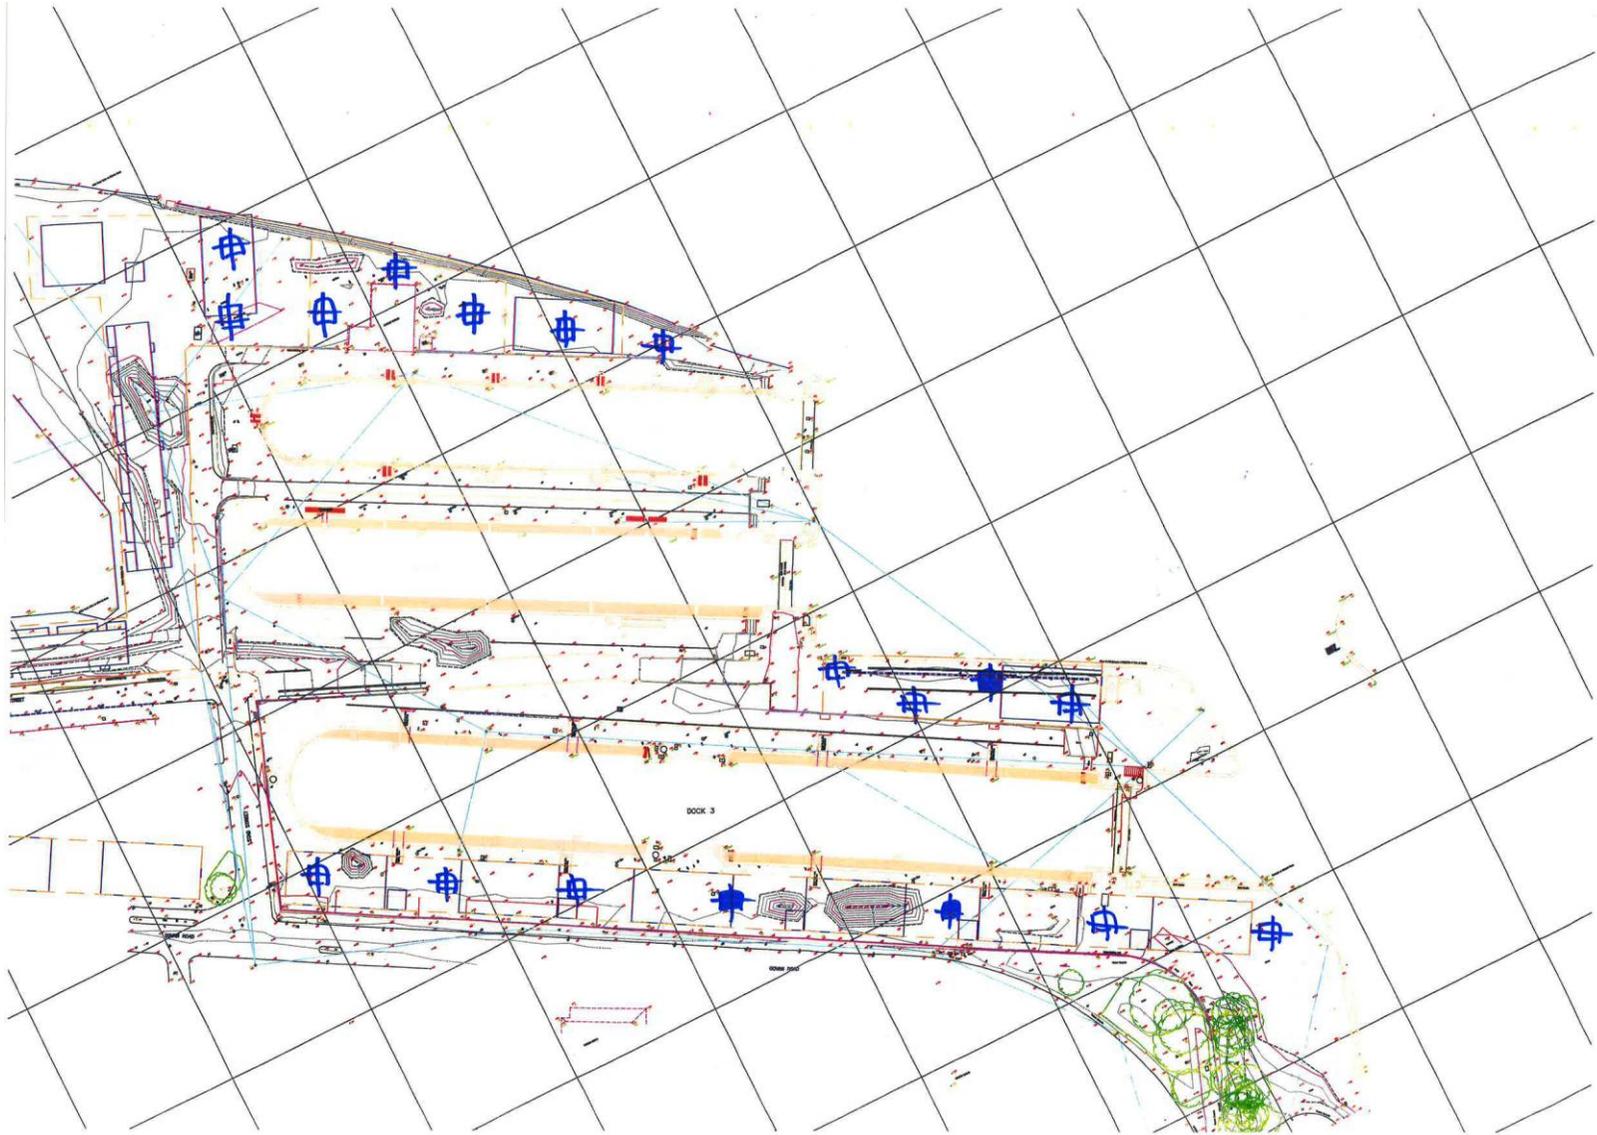
10.0 Trial Pit Location Plan

The main stages of ground disturbance relating to the ground investigation works will be monitored by a suitably qualified archaeologist. The proposed trial pit locations within the listed eastern part of the Graving Docks site are attached.
