**Archaeological Evaluation & Standing Building Survey**

DATA STRUCTURE REPORT | Benderloch, Argyll & Bute

The Old Smithy, Craigneuk, Benderloch,  
Argyll & Bute, PA37 1RT  
NGR: NM 90455, 37696

Data Structure Report

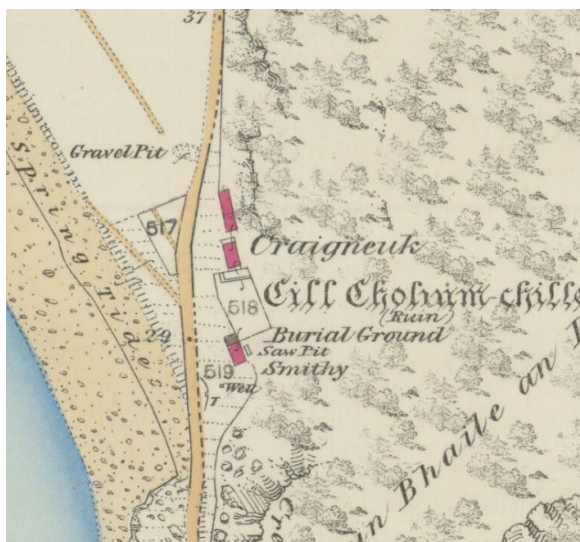
A cluster of buildings annotated as 'Craigneuk' is shown on Roy's Military Survey of 1747 to 1752 while more detail is seen on the OS first edition 25 inch to the mile map, surveyed in 1871 and published in 1875 (Figure 2). On the OS map of 1871 two buildings are annotated 'Craigneuk' at the northern end of the complex while, immediately to the south, the current graveyard and remains of Cill Choluim-Chille are shown. Off the south-western corner of the graveyard the smithy building is depicted while a well is shown to the south-west and a saw pit immediately to the east.

Figure 2: Extract of OS first edition 25 inch to the mile map, surveyed 1871, published 1875

The entire trench consisted of 0.7 m of topsoil which lay on top of a sterile brown sand, gravel and pebble deposit also seen at the north-eastern end of Trench 5 (011). This was interpreted as the natural subsoil. No trace of the saw pit located here on the first edition OS 25 inch to the mile map surveyed in 1871 (Figure 2) was located.

The presence of a well just to the east of the wall location on the aforementioned early OS maps (Figures 2 & 3) could also explain the water ingress experienced within Trench 1, particularly given the natural water table might not be expected to be so high here. A local visitor suggested that the position marked as a well on the early OS maps corresponded to where they remember a spring being present.

The standing building survey of the Smithy building itself showed it to be in relatively good condition although no architectural detail was noted that would suggest the current building dated from before the nineteenth century, as noted on the early OS maps (Figure 2 & 3). However, the lack of evidence for earlier smithing activity during this work does not remove the possibility that the site was in use prior to the nineteenth century.

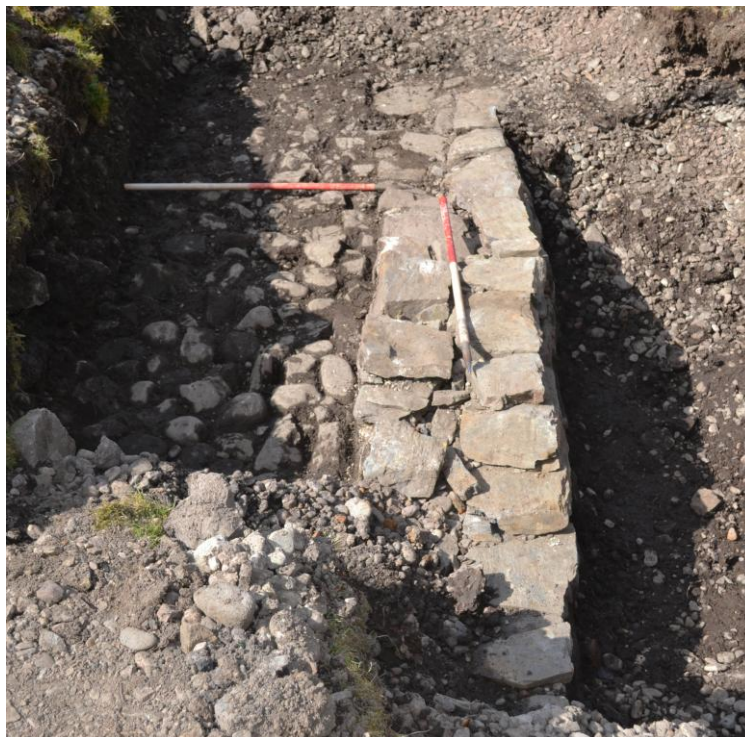
Plate 1: Wall [003] and cobbled surface (004) from the south-east

were the lower courses and foundations of a stone built wall [003]. The wall [003], which extended outwith the north-western extent of the trench, was exposed over 4.10 m of its length, to approximately 0.60 m in depth and existed up to five courses in height (Plates 1 & 2).

Where revealed it was constructed of large relatively flat stones up to 0.4 m in size. It appeared as a double skin with a core of smaller angular and fragmented stones. Traces of lime mortar was present on the western side although only in very small patches. No evidence of a foundation cut for the wall was uncovered although this could, at least partially, be due to the unstable nature of the surrounding gravel and pebble deposits.

Abutting the western side of the wall [003] was a cobbled surface (004) which appeared to continue outwith the extent of Trench 1 to the north-west, south-west and south-east (Plate 1 & 2). It comprised a single layer of sub-angular and sub-rounded cobbles within a very dark brown/black silty sand matrix (004). Two fragments of glazed ceramic were recovered from within the matrix of the cobbled surface (004).

The only archaeological remains which were discovered during the evaluation were the dry stone wall and associated cobbled surface located at the northern end of Trench 1. Given two fragments of post-Medieval pottery were recovered from the matrix of the cobbled surface it would suggest that they are post-Medieval in date and likely from the eighteenth or nineteenth centuries. Given its broad orientation it is feasible that they could relate to a boundary wall, shown extending west from the Smithy before turning south, at this approximate location on the 2nd edition OS 25 inch to the mile map revised in 1897 (Figure 3) while it could also relate to the arcing feature annotated 'T' on the first edition OS 25 inch to the mile map surveyed 1871 (Figure 2). Despite the origins of the wall and cobbled area remaining unclear what is more certain is that the ground level has been raised significantly since the time the wall was in use, possibly relating to the event which led to the formation of mixed deposit (008).

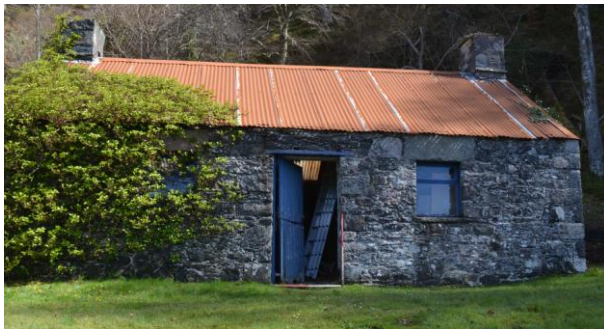
Plate 3: Western (front) Elevation

In general at the time of survey the remains of the Old Smithy building were in relatively good condition with all the walls being intact and upstanding. Externally the single storey building measured approximately 9.5 m north to south by 6 m east to west and stood up to 5.5 m in height from ground level at the southern gable end to the top of the chimney. The ground level around the building was not consistent, this being most obvious at the rear (east) of the building where an accumulation of material had built up against the wall (Plate 4, see section 6.25 & 6.26).

The western side of the building had two windows each measuring 0.92 m by 0.77 m in size. The doorway sat between these two windows (Plate 3), in the centre of the western wall, and measured 2 m by 1 m in size (Plate

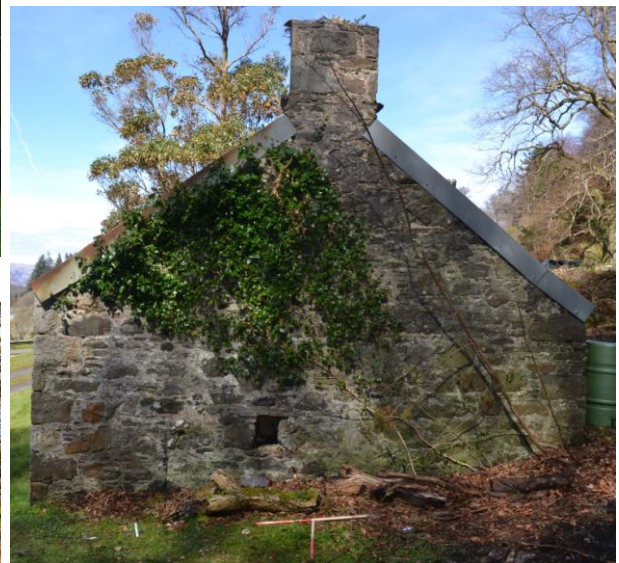
Plate 5: Southern Gable End

On both the northern and southern gable walls a roughly rectangular hole (Plates 5 & 9), with sides varying between 0.4 m and 0.5 m in length, extended through both the internal and external stone walls creating an open hole through the building, although both had subsequently been blocked by wooden logs. On both gables these holes were located below small recesses (Plate 9) more similar to those on the eastern internal wall but which appeared to form a raised inlet to the chimney.

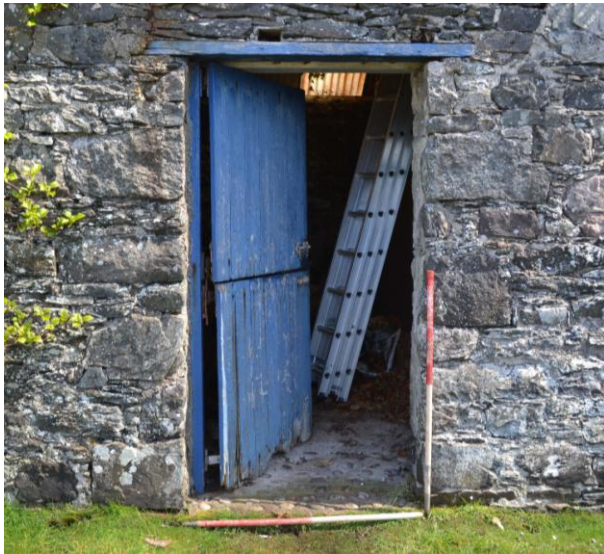
Plate 6: Doorway to Smithy

6). The lintel around the windows appeared to be constructed of wood on the inside with stone blocks on the outer face. The sills around the windows were of stone construction. The wooden lintel above the doorway appeared to have undergone some previous repair work with the stone and brick work above the door having been replaced with some modern bricks (Plate 7).

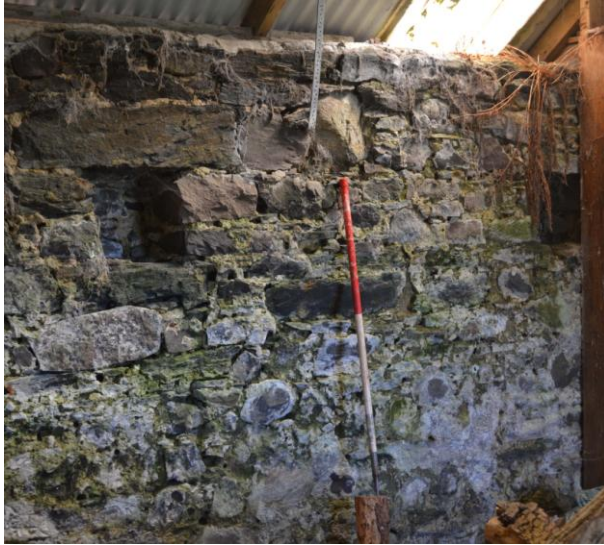
Plate 8: Two recesses on internal face of eastern wall

On the internal face of the eastern wall four small recesses were constructed approximately 1.45 m above floor level. The recesses had an opening that measured approximately 0.3 m by 0.3 m (Plate 8) while they varied in depth. Their construction was confined to the inner stone wall of the building and no corresponding recesses were present on the western interior wall.
