NORTHLIGHT HERITAGE	Woodyett Farm
REPORT: 177	Archaeological Watching Brief
PROJECT ID: 0425	
DATA STRUCTURE REPORT	Woodyett, South Lanarkshire

Woodyett Farm, South Lanarkshire

Data Structure Report

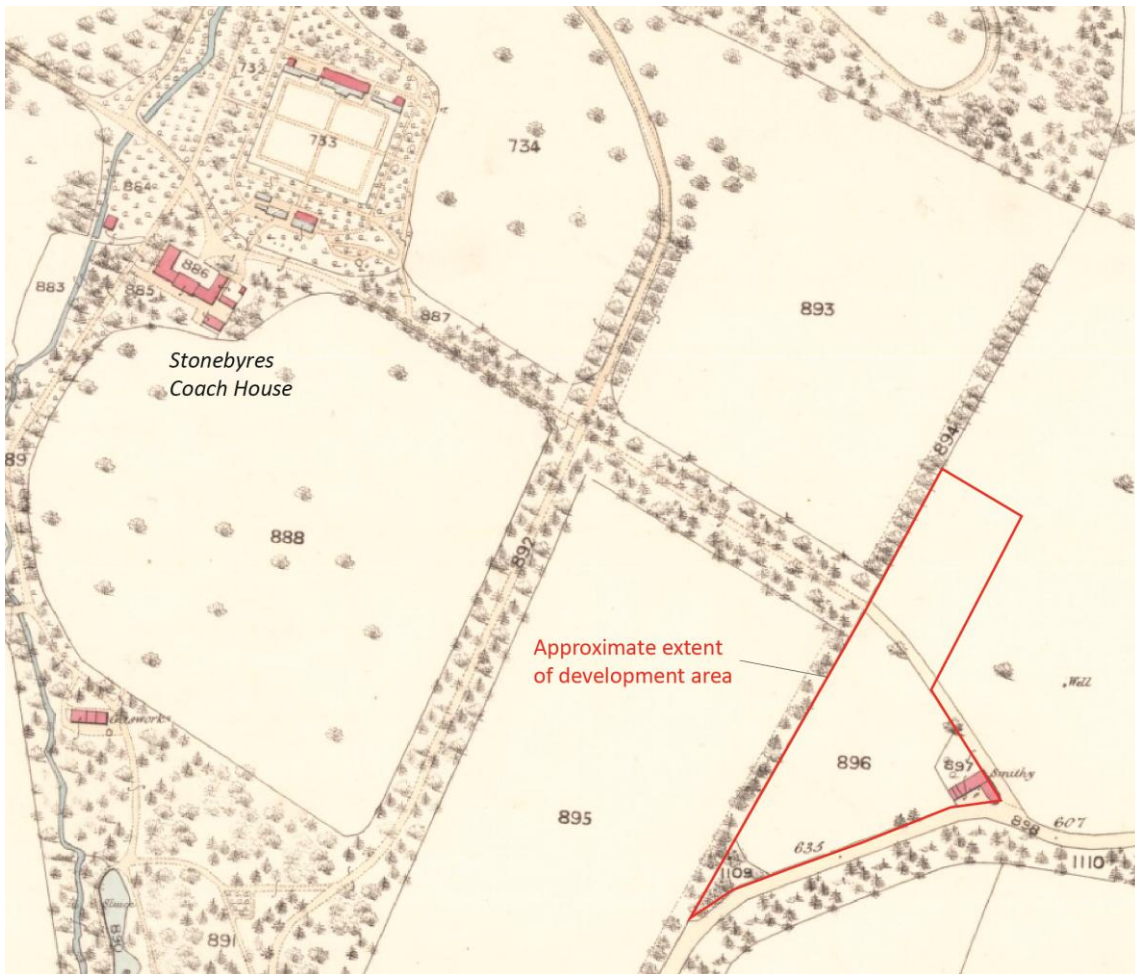
In the south-eastern corner of the development area the same first edition OS map depicts a smithy next to the road (Figure 2). This is not annotated as a smithy on subsequent OS maps of the same series (surveyed in 1896, 1910 & 1941) but buildings are shown to be here until at least the 1941 edition.

Figure 2: First edition OS 25 inch to the mile map, surveyed 1858, published 1864 (courtesy of the NLS)

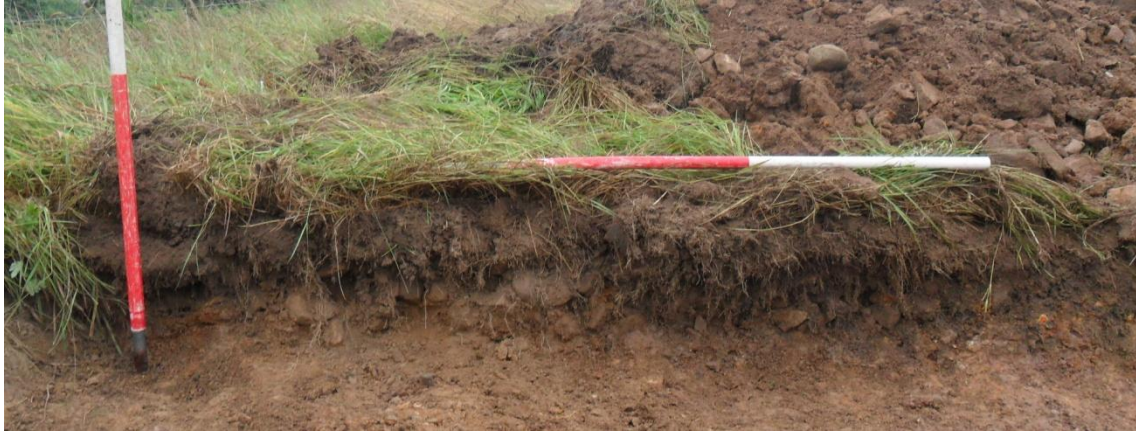
Directly below the turf of the 3 m wide terrace was a layer of rough small cobbled stones (016), each between 0.01 m and 0.10 m in size, which sat directly on top of the natural subsoil (002). This rough surface, likely relating to a former rough track, existed to 0.20 m in depth and 2 m in width (Plate 1) although was not well defined.

Plate 1: North-west facing section through possible rough track surface (016)

The ephemeral remains of a roughly cobbled track surface were uncovered where it was truncated by a geothermal heating system at the north-eastern extent of the watching brief area. This previously recorded routeway that ran past the Smithy towards/from Stonebyres existed to 0.2 m in depth and 2 m in width.

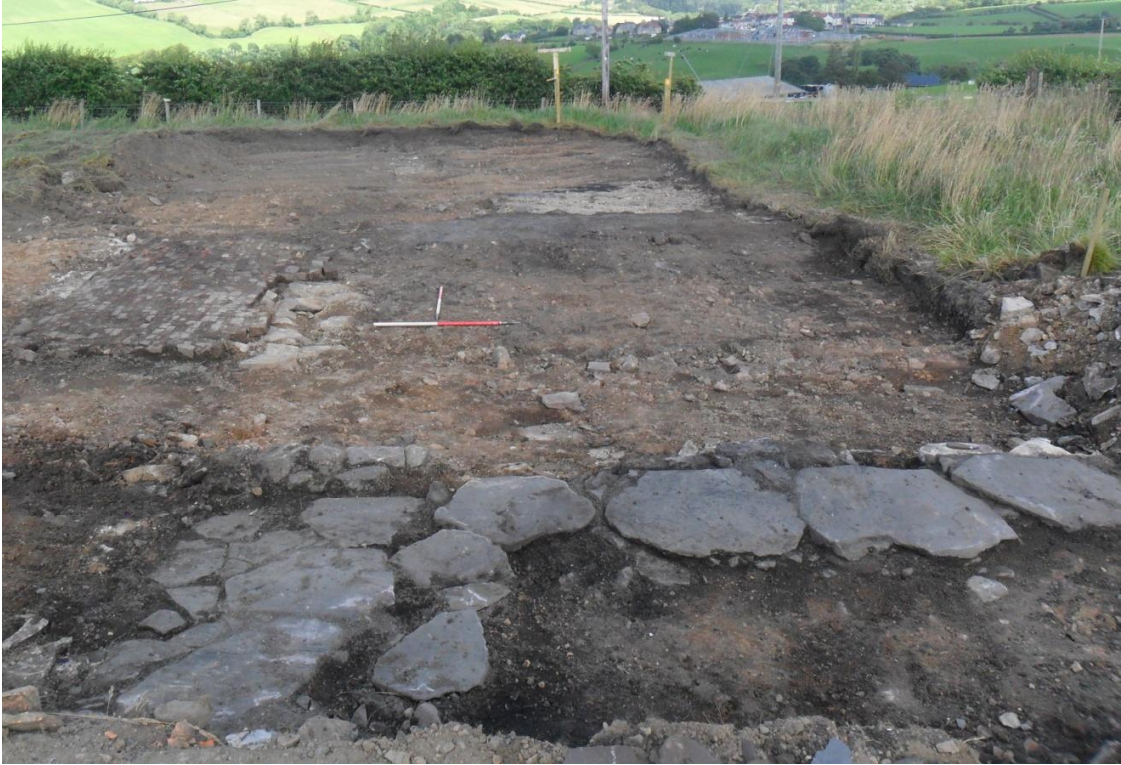
To the north-west of (015 & 009) was a rectangular area, measuring 3.6 m by 2.1 m, of tightly packed red, yellow and grey bricks forming a flat surface (008). This brick surface only existed to one course in depth and, in the majority, lay directly on top of the natural subsoil (002). The exception to this was along its south-eastern edge where it overlay a row of larger rectangular roughly dressed stones (007) one course in depth, 0.20 m to 0.30 m in size and set within a light yellow sand matrix (012). Although possibly representing a stone footing the dressed stones (007) did not sit in any obvious cut.

Plate 2: Brick (008) and stone paved (005) surfaces in the former Smithy area

A second structure was suggested by the brick surface (008) although this clearly post dated the insertion of a ceramic field drain uncovered beneath the structure.

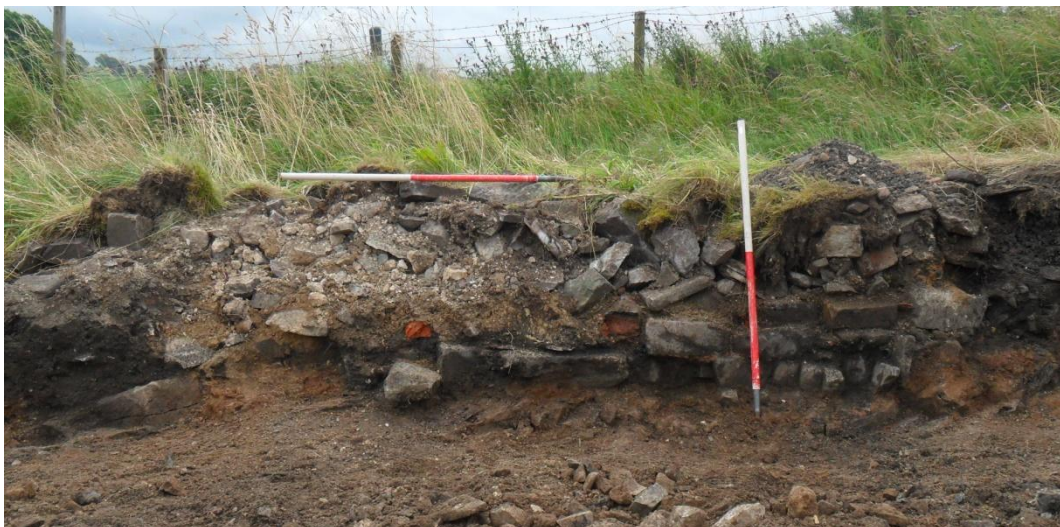
Rubble (003) consisted of fragments and larger pieces of angular stone between 0.10 m and 0.5 m in size. Occasional rectangular dressed stone pieces between 0.30 m and 0.50 m in size were also present along with red, yellow and grey brick all within a mixed matrix of mid-yellow sand and dark grey sandy silt. This deposit appeared to represent the remains of a demolished stone, brick and mortar structure while, although not clearly visible in plan, the north-west facing trench section through this area revealed a possible surface of rectangular dressed stones (014), between 0.20 m to 0.50 m in size, at the base of the rubble (Plate 3).

Plate 3: North-west facing section at trench edge showing rubble layer (003) and possible surface (014)
