DATA STRUCTURE REPORT

Temporary Installation of Artwork

Archaeological Watching Brief

Aird's Lane, Glasgow

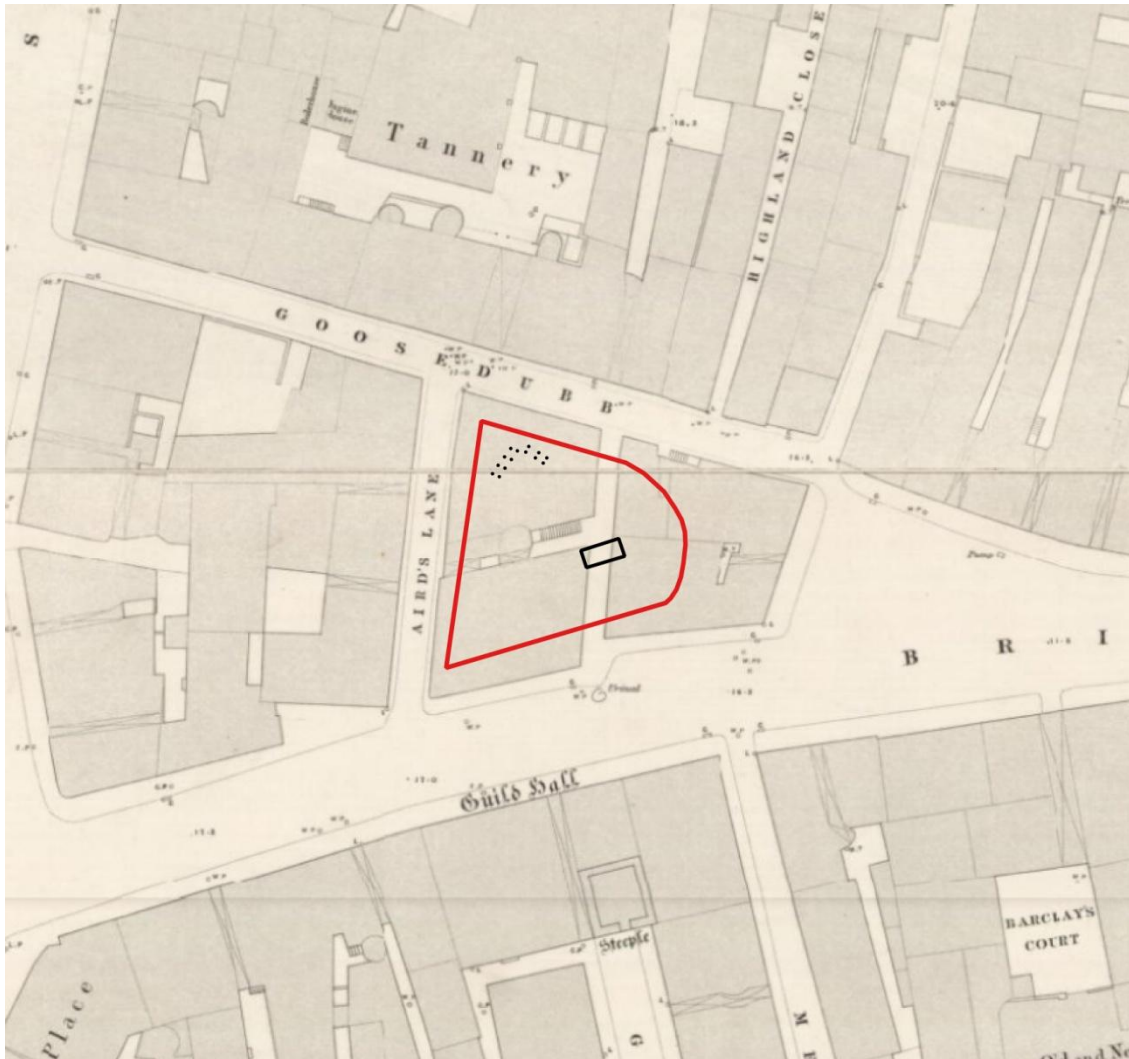
Figure 2: First edition OS Town Plan surveyed in 1857-1858. The red line corresponds to the approximate location of the project area and the black to the watching brief trenches (as seen on Figure 1).

The nineteenth century buildings which occupied the Aird's Lane area are clearly seen in the first edition Ordnance Survey (OS) Town Plan of the area surveyed in 1857-1858 (Figure 2). A Tannery is noted to the north of Goosedubb but none of the buildings adjacent to Aird's Lane are annotated.

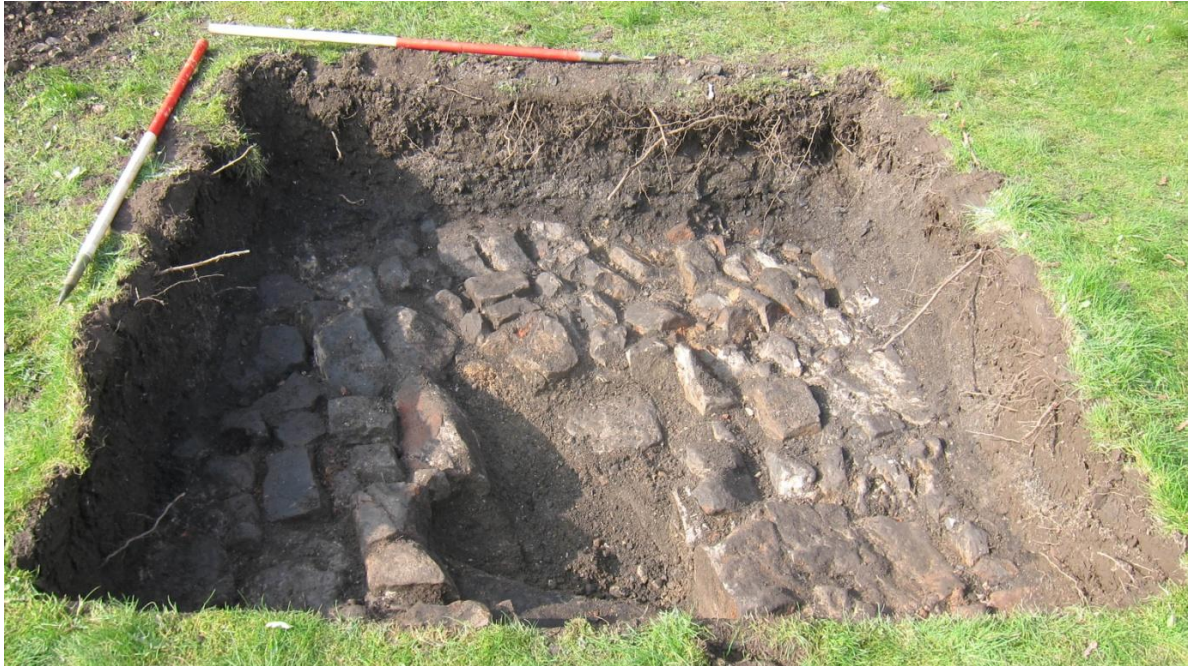
Beneath approximately 0.30 m of mid-brown silty sand topsoil (001) a distinct tarmac surface (002) was present. This tarmac surface (002), present across all the trench, existed to 0.13 m in depth and lay on top of a relatively level surface of small irregular sandstone blocks (003, Plate 1).

Plate 1: Sandstone rubble/surface beneath topsoil in eastern part of artwork foundation trench.

The layer of sandstone rubble (003), lying beneath the topsoil of the main artwork foundation trench, appeared as a possible surface, albeit uneven. It is possible this relates to a former surface that existed prior to the tarmac and/or grassing over of the site, however, it is also probable that the surface has formed from a thin layer of compacted sandstone demolition/infill rubble used to level the site prior to the placing down of the tarmac layer (002).

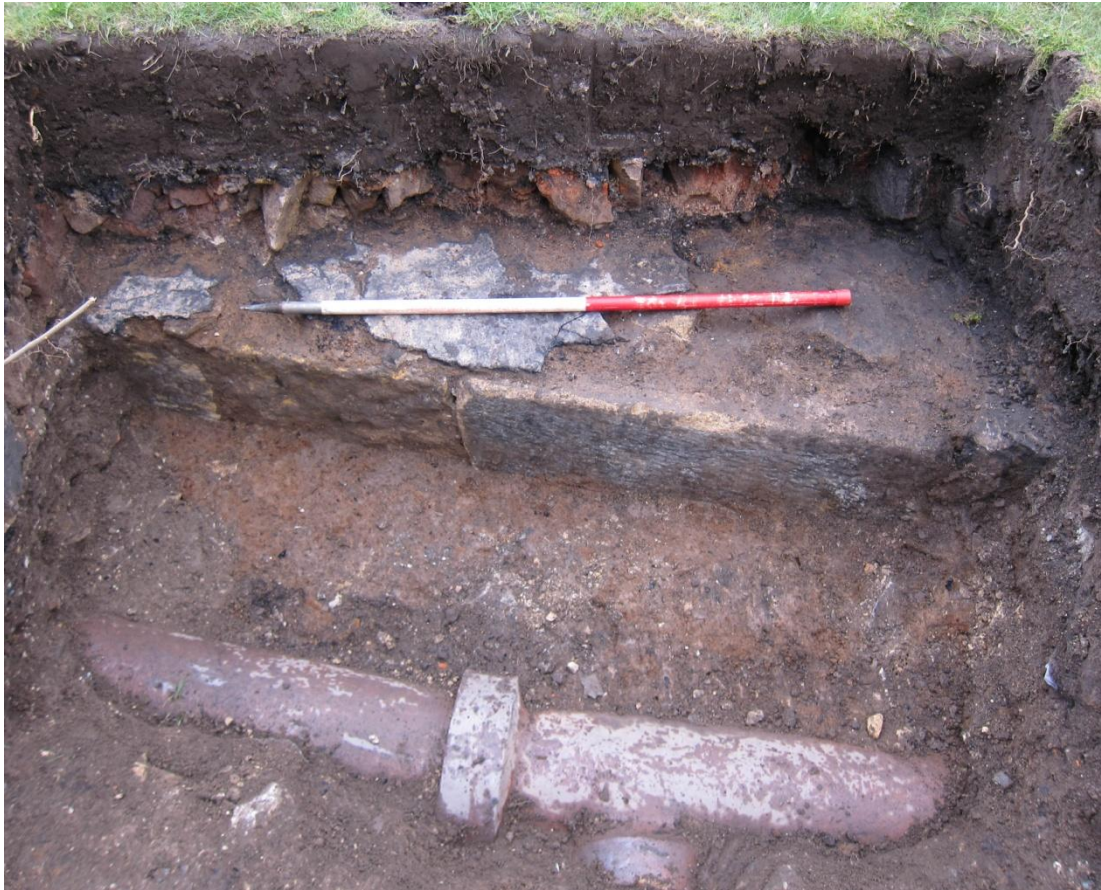
At the far eastern end of the trench, immediately beneath the sand stone blocks (003), was a thin, approximately 0.08 m thick, layer of a bitumen type substance (006) which, in turn, overlay a large sandstone wall [005] the top of which was 0.5 m in depth from the current ground surface. The wall ran in a north by east direction and continued out with the trench to the north, south and east (Plate 2). The wall [005] was revealed to 0.3 m in depth and continued beyond the base of the trench into a deposit of orange clay containing frequent charcoal flecks (008). This deposit appeared to abut the wall.

To the west of the sandstone wall [005] one side of a service trench [007] had been cut into the orange clay (008) and contained a ceramic waste pipe (Plate 2). The service trench cut [007] and associated pipe ran in an almost north to south direction and were, therefore, on a slightly different orientation to the substantial sandstone wall [005]. At the far northern end of the service trench the cut changed orientation by approximately 45 degrees towards the sandstone wall.

Plate 2: Sandstone Wall [005] and historic services at eastern end of artwork foundation trench.

From its form and location it is clear that the substantial sandstone wall uncovered at the eastern end of the trench related to the outside western wall of the building noted here on the OS Town Plan of 1857, that which became the Bridgegate Free Church in 1860 (Figures 1 & 2). It is likely that the wall uncovered in the trench formed the foundation for the main wall, a likelihood which was further suggested by the presence of the bitumen material (006) on top of the wall, a substance commonly used as a dry course. Due to the limited depth and extent of the trench further interpretation of the wall and related deposits was not possible.

Given the archaeological remains uncovered during the watching brief were of relatively recent date, and that the wall of the Bridgegate Free Church was preserved *in-situ*, it is recommended that no further archaeological works are required in relation to the installation of the temporary artwork and related seating.

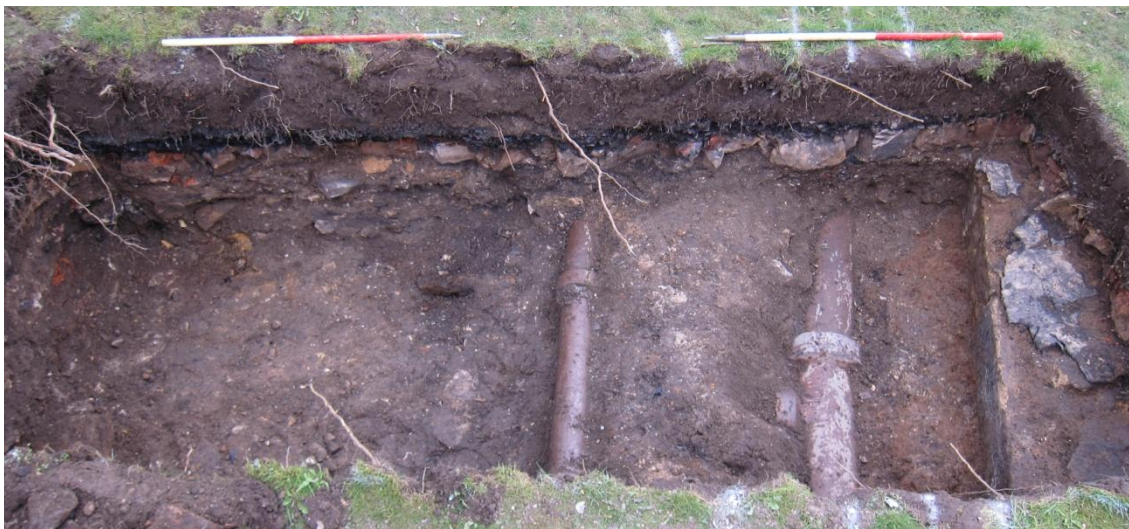
The cut [007] was only visible to the east of the pipe while, to the west and across the remainder of the trench, lay a mixed deposit of orange/grey clay, sand and gravel with frequent sandstone fragments (004). A further ceramic waste pipe (Plate 3) was located within this deposit 0.8 m to the west of, and on the same orientation as, the pipe initially uncovered adjacent to the wall [005]. The top of both these pipes were approximately 0.6 m below the current ground surface.

Plate 3: Sandstone Wall [005] and ceramic waste pipes to the west.

The deposits and features to the west of the wall, and the orange clay which abutted it, comprised one very mixed and deep layer (004), most likely an infill deposit, containing two ceramic waste pipes. The location and orientation of the pipes correspond to the lane which ran north to south immediately west of the former Bridgegate Free Church (Figures 2 & 3) where the pipes would have sat below street level. No makers stamps were visible on the pipes, therefore, it was not possible to ascertain a precise date for these. However, given the deposit in which they lie appears to cut a clay deposit which abuts the wall at the eastern end of the trench, it is likely they post date the wall and are of early twentieth century date.
