NORTHLIGHT HERITAGE	Houston & Killellan Kirk
REPORT: 108	Kirk Road, Houston
PROJECT ID: 4350161	Renfrewshire
DATA STRUCTURE REPORT

Houston & Killellan Kirk, Renfrewshire

Data Structure Report

Houston & Killellan Kirk

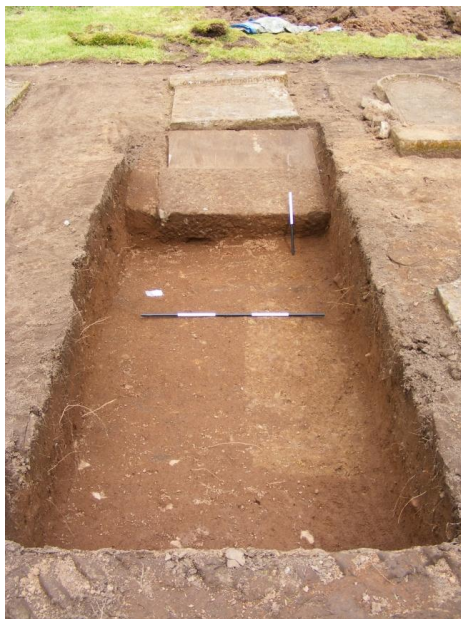
Plate 2 Trench 2 from the west

Trench 2 measured 1.3m by 3.6m and revealed a homogenous deposit of red-brown sandy silt (008). The trench was initially dug to a depth of 0.30m with no visible features apart from a large slab at the east end, which sloped down from the east end towards the west. The trench was then dug to a depth of 0.5m to reveal the whole of the slab. At this depth a fragment of tooth was found within the sandy silt (renumbered as 010) and a grave cut (007) with a fill of mottled light yellow/ brown sandy silt (009) was identified. The inclined slab proved to be the lower part of Gravestone 120. This trench showed that the burial associated with Gravestone 120 lay between 1.30m to 2.90m to the west of the current location of Gravestone 120. Two coffin nails were the only other finds from this trench.

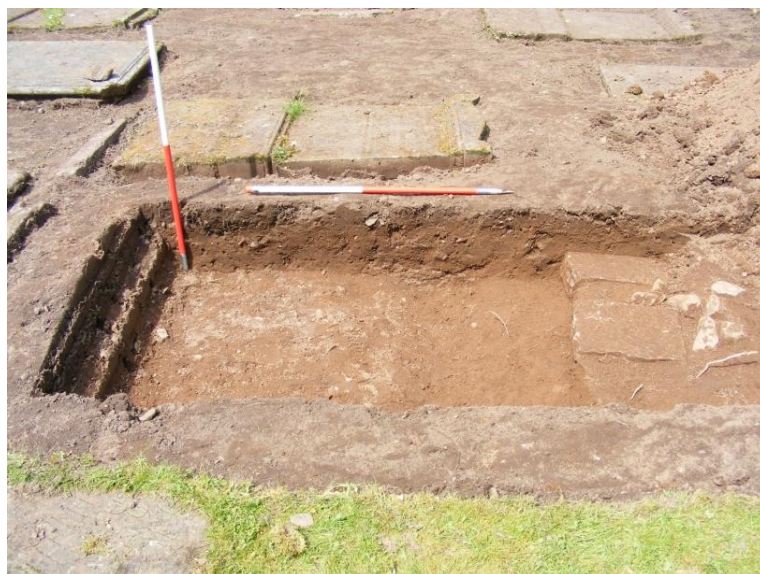
Plate 5 Trench 5

Trench 5 measured 2.5m by 1.3m and revealed homogenous stony red brown sandy silt (=002) to a depth of 0.35m. At the east end of the trench two small rectangular shaped stones were seen at a depth of 0.25m below the surface. Both stones were roughly dressed on their upper surfaces and may have been broken. A small number of rough cobble stones were piled up to the east of the square stones. This group of rectangular-shaped and rounded cobble stones may be foundation stones for a gravestone which has been moved in the past. No bones were seen and no finds were retrieved.

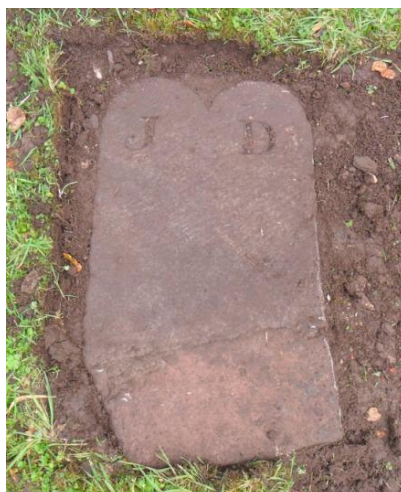
Only one new stone was uncovered during this operation and this was in the grassed area to the east of the building plot. It was small, lay flat and bore the inscription 'JD' (see Plate 6). One broken stone was found beneath gravestone 102 was dated 1706 (see Plate 7). Several broken fragments of an inscription were also found beneath Gravestone 78 (see Plate 8).

Plate 6 New stone inscribed JD, found to the east of the building footprint

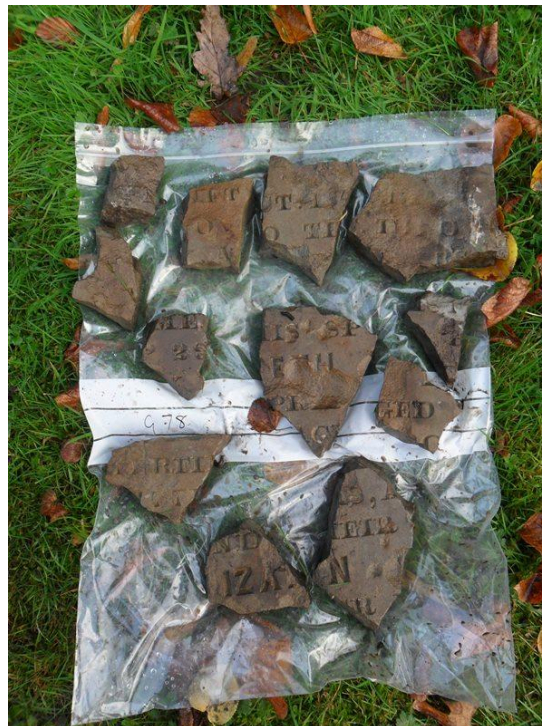
Plate 8 Broken inscription from beneath Gravestone 78

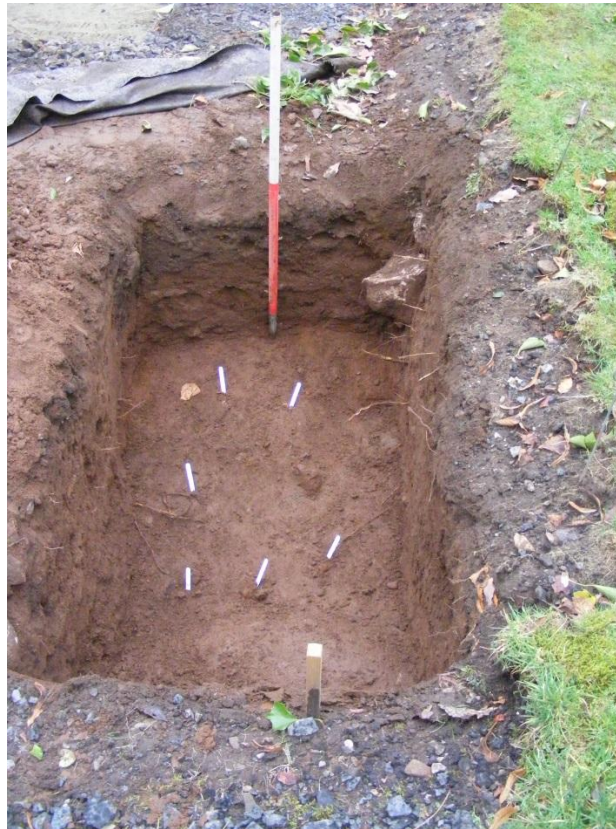
A trench in the north-east corner (where Gravestone 122 had been located) measured 1.60m long, 0.8m wide and was dug to a depth of 0.6m deep by machine. The trench was filled with loose red-brown sandy silt (=002) as seen elsewhere in the graveyard. The sides and base of the trench were cleaned by hand and a more compact deposit was seen in the north-west and south-west corners. Further cleaning revealed a small number of coffin nails and a very small patch of extremely degraded bone (See Plate 9). The bone was soft to the touch (jelly-like) and it would not have been possible to lift. It was not possible to identify the bone, but it was probably human. The bone and nails were seen at a depth of 0.75m from the current surface. The deposits in the north-west and south-west corners of the trench remained more compact. In order to see whether more robust bones survived to the west of the visible bone the trench was further excavated by hand to a depth of 1.20m, leaving the visible bones *in situ*.

Plate 9: Grave 122 White tags show the location of coffin nails and fragmentary bone.

The presence of the bones and the coffin nails at a depth of 0.75m suggests that there may originally have been a coffin burial here, but none of the coffin and very little of the bones have survived, probably because of the nature of the soil and the wet conditions. The bone was unidentifiable, although it is thought likely to have been human. The bone was left *in-situ* as it was not going to be disturbed further by the piling. The lack of an intact burial beneath Gravestone 122 meant that no licence to disinter was required before piling commenced.

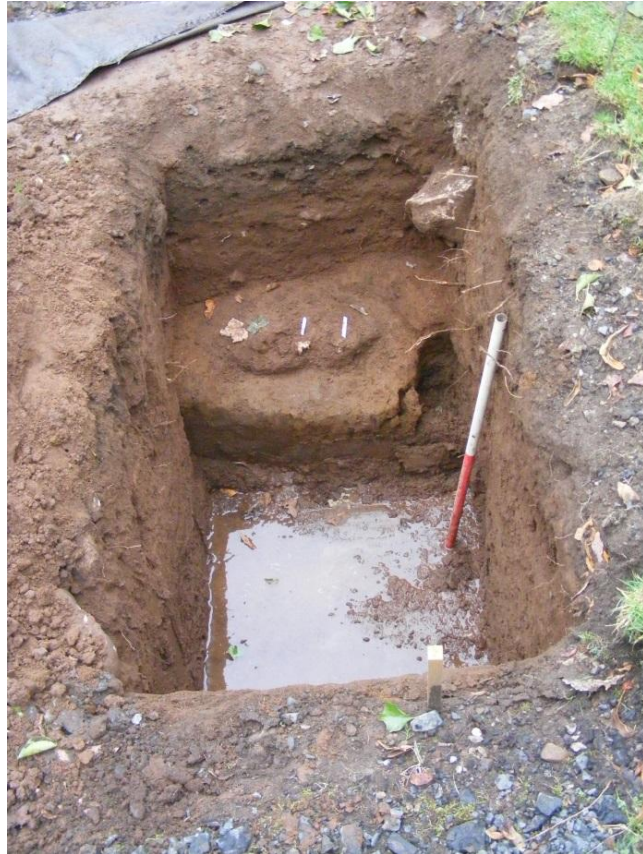
*Plate 10: Base of trench over Grave 122
Possible human bones still in-situ. From the west.*

At a depth of 1.2m a straight edge to the compact deposit was visible and so the trench was dug deeper by machine to see if this was a cut edge for another deeper burial. The compact deposit turned out to be a ledge of soft bedrock. The deposit immediately above the bedrock was red/brown sandy clay very similar in colour to the deposits above, but with a greater clay content. No bone was noted within this deposit. At a depth of 1.3m the soft sandstone was found across the whole trench and the base of the trench became infilled with water. It is probable that the surface of the bedrock is not uniform and has formed natural terraces.

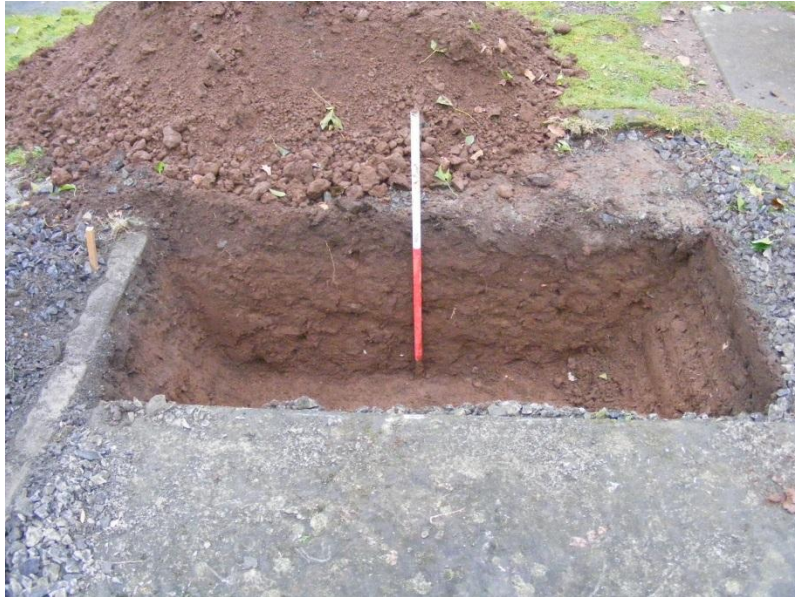
A trench measuring 1.8m long and 0.8m wide was excavated by machine over the location of pile 'c' to a depth of 0.7m (see Figure 2). A uniform deposit of loose red-brown sandy silt (=002) filled the trench and there was no evidence of any burial cuts or gravestones. A single disarticulated fragment of longbone was retrieved. This bone was in poor condition, very soft and abraded. There was therefore no archaeological issue with the location of Pile 'c'.

Plate 11 Trench in the vicinity of Pile 'c' and kerbing (003). From the north.

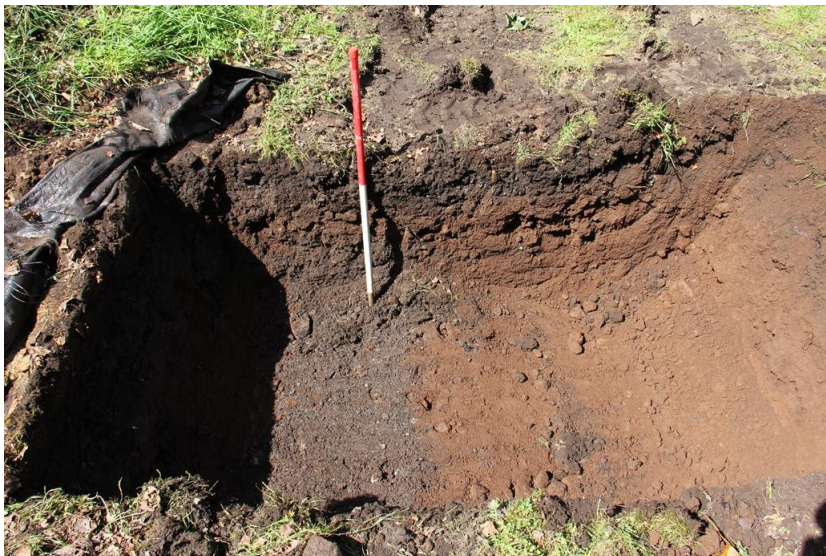
Plate 12 Linear feature 023 in Test Trench A

A linear feature (context 023) aligned east-west was seen at a depth of 0.5m from the surface of Test Trench A (see Figure 11). The linear feature was 0.6m wide and 0.3m deep with a broad U-shaped profile and was filled with black ash and blaes. The finds retrieved from the fill included a fragment of modern stained glass, a fragment of lead came and a circular metal object. This feature was interpreted as a modern informal ash drain with some objects which may have derived from the construction of the 19th century church. Fragments of bone were seen at a depth of 0.9m and so machining stopped. Further excavation by hand revealed five partial skeletons that were aligned east-west (see Figure 11 and Plate 12). Fragments of two shroud pins and several coffin nails with fragments of wood attached were found at this horizon. These burials were cleaned and recorded by Ruth Whyte (see Table 3). The partial skeletons consisted of five individuals with a wide range of ages from neonate to adult. The sex of the skeletons could not be ascertained.

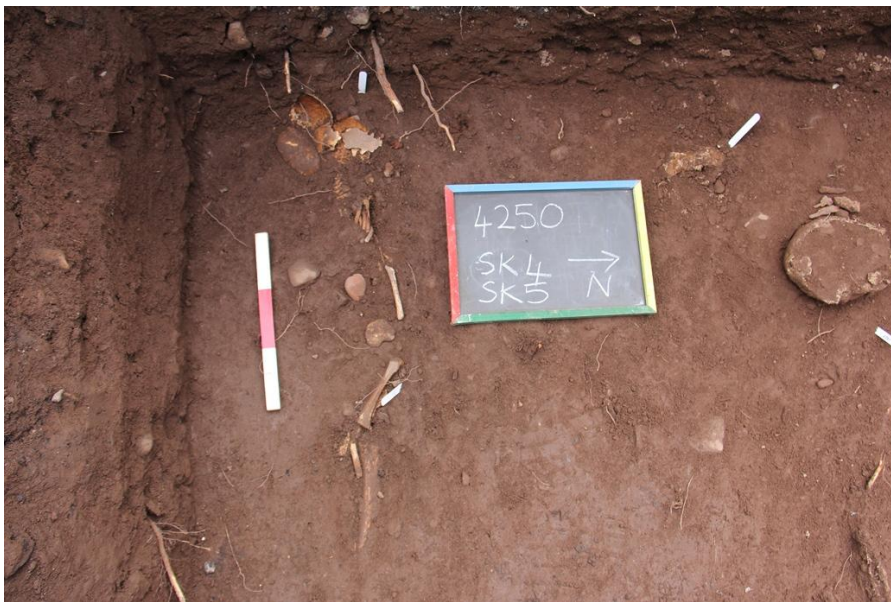
Plate 13 Skeletons 4 and 5 with skulls of Skeletons 3 and 2 to the right.

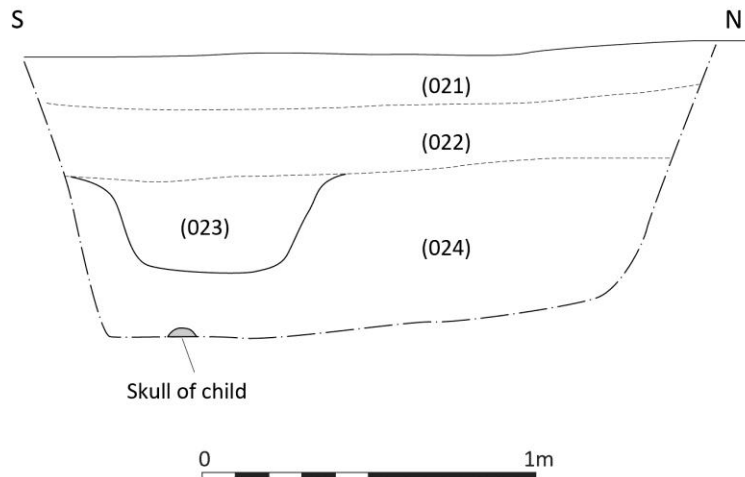
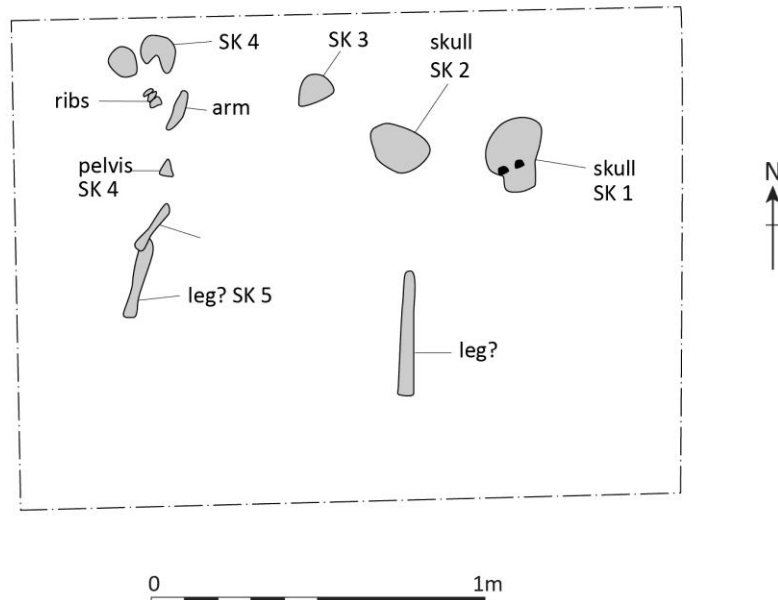
Figure 11 Plan and section of Test Trench A

East facing section of Test Trench A

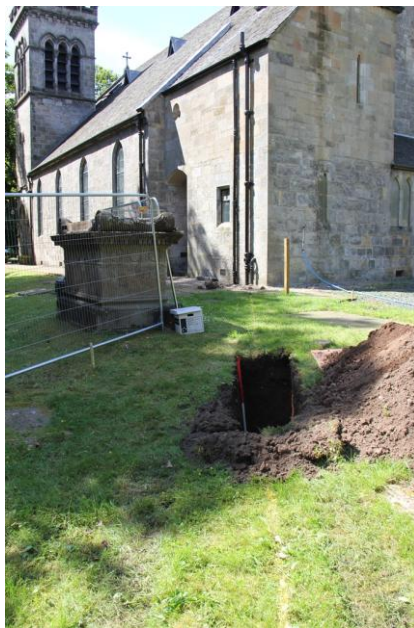
Plate 14 Test Trench B

This trench was dug to a depth of 0.9m. The layers consisted of a dark brown topsoil (=021), a mid brown clay loam with occasional stones (=022) and an orange brown clay loam (=024). At the base of the trench there were fragments of decayed wood which were interpreted as the probable remains of a coffin. No bones or other finds were seen. The depth of this potential coffin was deeper than the intended drain here so the conclusion from this trench was that there were no significant archaeological remains which would be affected by the drainage trench.

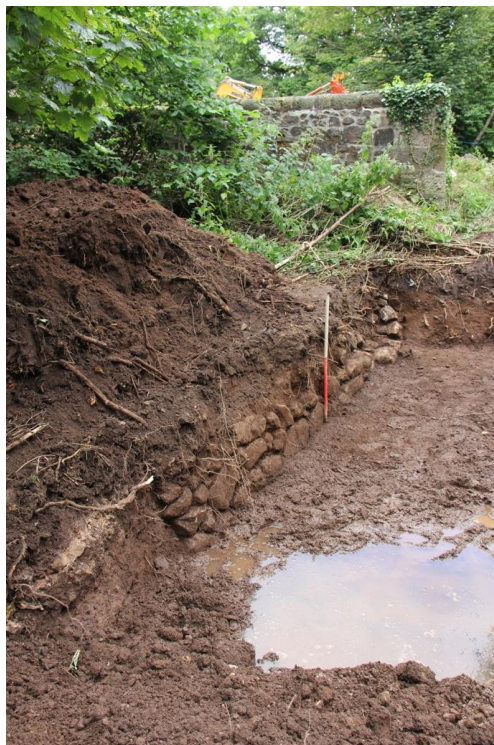
This walling corresponded to a line marked on the 1st edition OS map of Houston dated 1843-93 which extended from the south-east corner of the graveyard towards the edge of an extensive mill pond.

The revetment wall was considered a significant archaeological feature as it corresponded with a feature shown on the 1st edition OS map linking the graveyard wall with the, now infilled and no longer visible, mill dam. The trench was made wide enough to take the septic tank without disturbing the revetment wall which was left *in-situ*.

Plate 15 Test Trench C, from the south-east

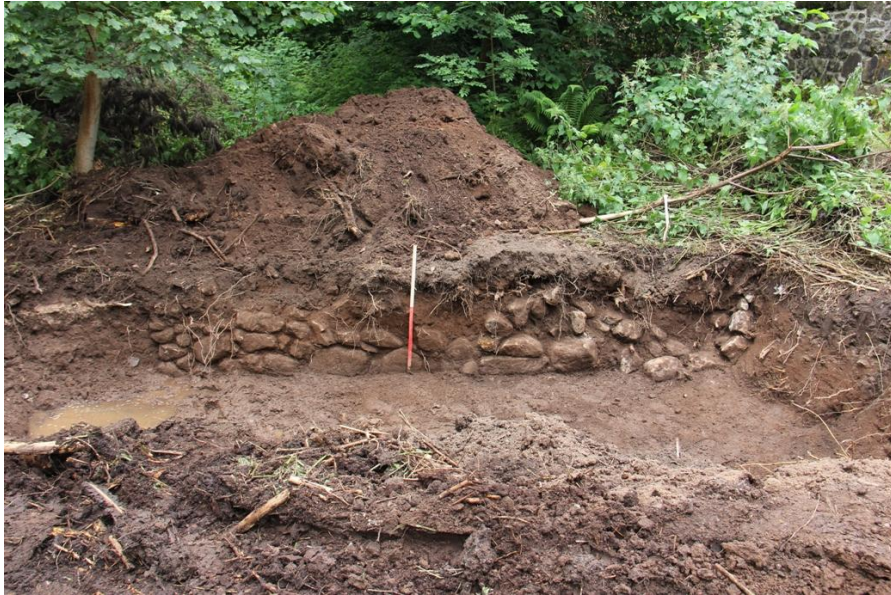
Plate 16 Test Trench C, from the east

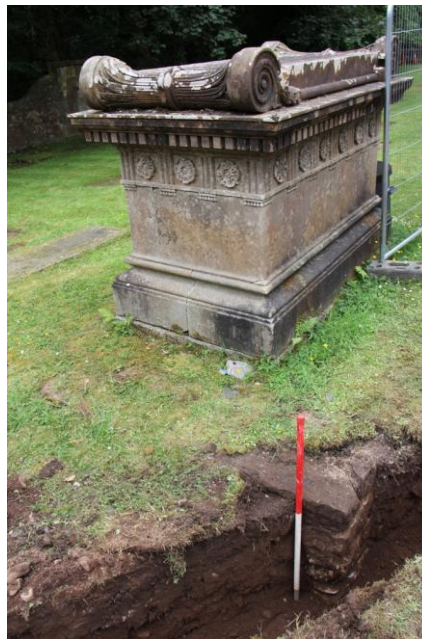
A substantial stone foundation base for the George Cuninghame Monteath memorial (d 1828) was exposed in the drainage trench. The foundation base measured 2.74m (9 ft) by 3.81m (12 ft 6 inches) and was at least 0.65m (2ft) deep. The width of the drainage trench allowed for the insertion of the pipe without damage to the memorial base.

Plate 17 Substantial foundation for George Cuninghame Monteath memorial
