NORTHLIGHT HERITAGE  
REPORT: 121  
PROJECT ID: 4405161  
DATA STRUCTURE REPORT

**Tarbet Isle**

**Loch Lomond**

Data Structure Report

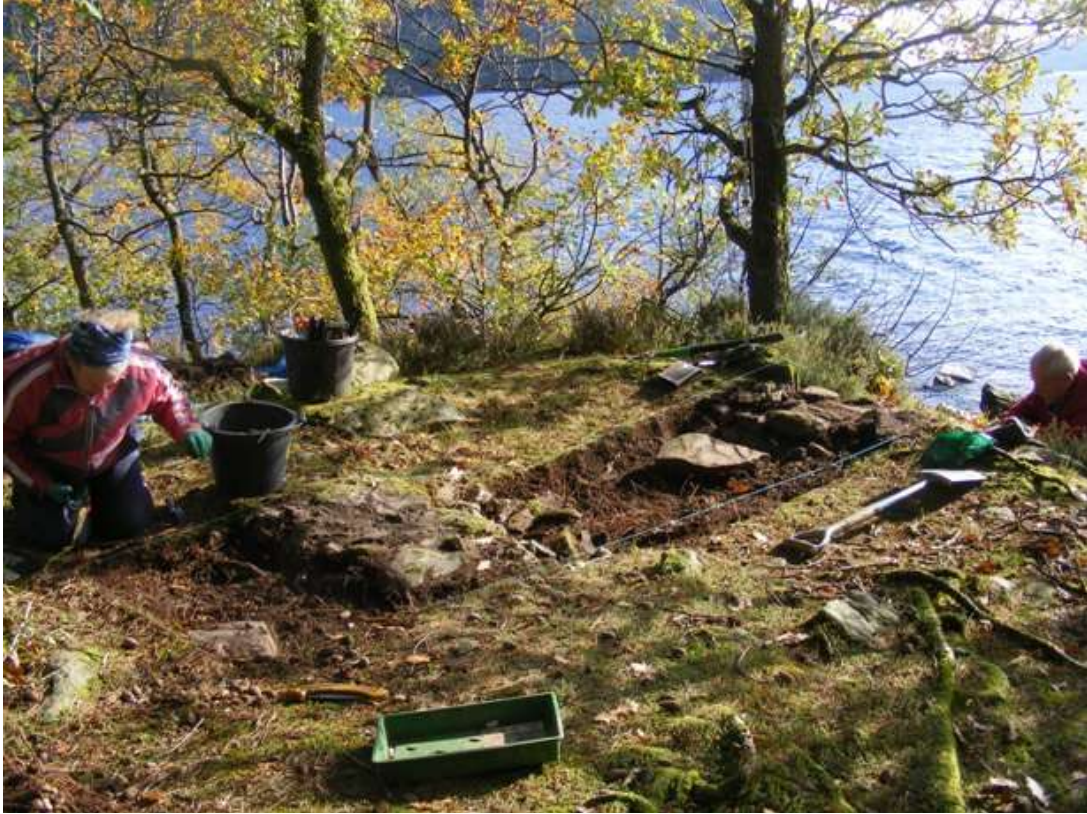
Cover Plate: Trench 2 across the southern end of the structure.

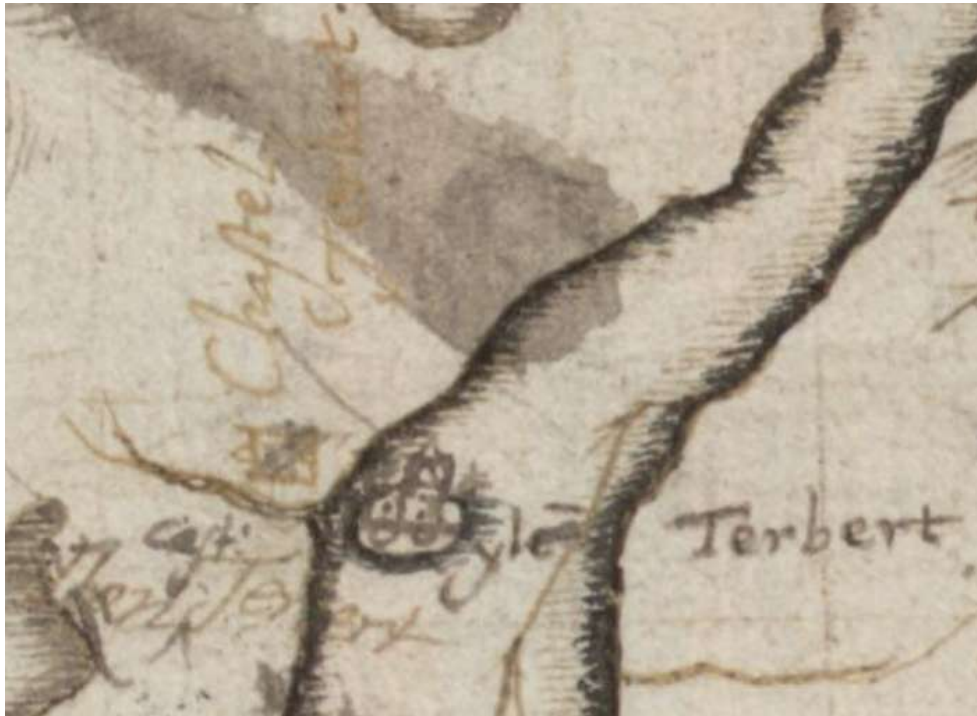
Figure 2: Loch Lomond by Pont (17) depicting a structure on 'yle Terbert' (NLS).

castles and houses of the period, as well as the names of some of the islands in Loch Lomond. Pont's map (No 17, Loch Lomond) depicts 'yle Terbert' occupied by a two storied structure with a high, gabled roof and a low annex to one side (see Figure 2). Pont's accompanying text to No 17 describes Tarbet very briefly as 'a pair of lenth with wood' (see Figure 3). This refers to the term 'bowshot of length', which is a measure of distance. The text mentions a wood but, surprisingly, no structure (see National Library of Scotland transcripts). On the mainland nearby, Pont depicts a structure called 'Castel Tarbart', which is thought to refer to a house belonging to the Macfarlanes at Clattochmore (NN30SW 1; see also James 2014). On another of Pont's maps (No 16 Gare Loch, Loch Long and Holy Loch) a single structure called 'Cast: Terbart' is depicted very close to the western shore, if not actually on the shore.

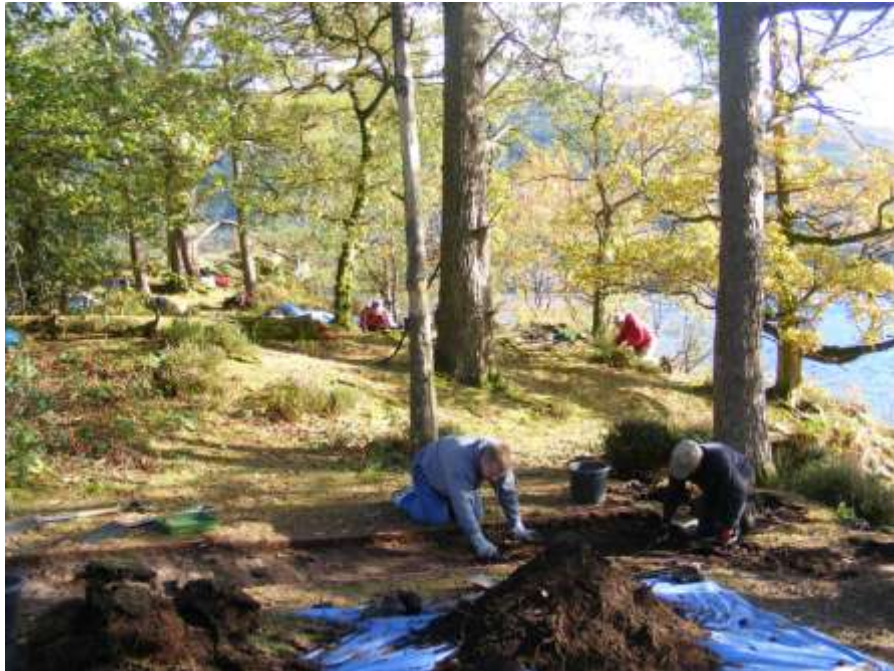
Plate 3: General view of the excavation from the west.

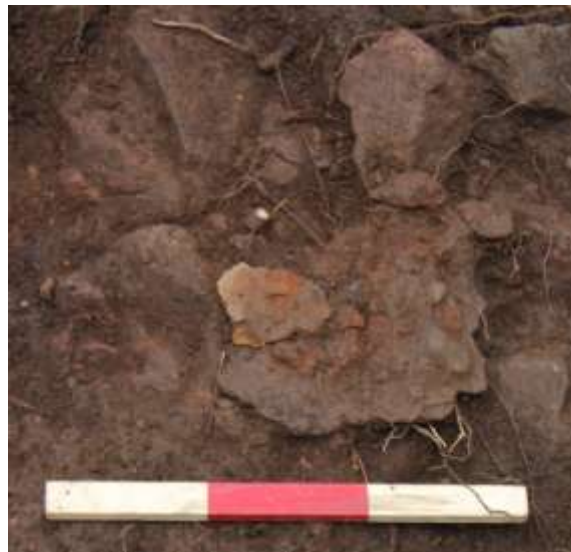
Plate 7: Iron object, possible spade or shovel, SF9.

A flat spade- or shovel-like iron object (SF9) was found on the surface of layer (043) (see Plate 7). Layer (043) also produced two pieces of flint (SF10 was a probable gun flint and one unnumbered, undiagnostic piece), a clay pipe stem fragment and a tiny fragment of medieval pottery (possibly from a jug with a lead glaze) from the sample. Two sherds of 17<sup>th</sup>-century pottery (SF6) were found within the tumble outside the west wall (046). The uppermost layer (040) contained a sherd of green bottle glass and a quartz flake.

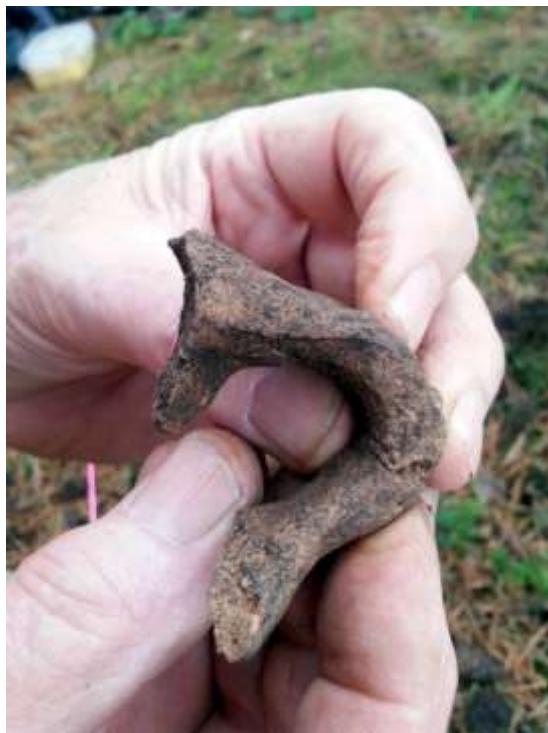
*Plate 12: Trench 2: a 13<sup>th</sup>- or 14<sup>th</sup>-century pottery handle (SF12 from context (001)).*

The uppermost layer (001) contained sherds of a medieval pottery handle (SF12, see Plate 12), a 19<sup>th</sup>-century clay pipe bowl (SF1, see Plate 13), two sherds of modern white ceramic, three sherds of clear vessel glass, a sherd of green bottle glass (which joined with the glass sherd from layer (006) and a fragment of a butchered rib bone. Apart from the pottery handle, all these finds are 19<sup>th</sup>-21<sup>st</sup> century in date. The handle formed rim neck and strap handle from a small thinly potted jug in a buff coloured sandy fabric. A 13<sup>th</sup> or 14<sup>th</sup>-century date

has been suggested for the handle although it is very worn and could perhaps be later (pers comm. G Haggarty).

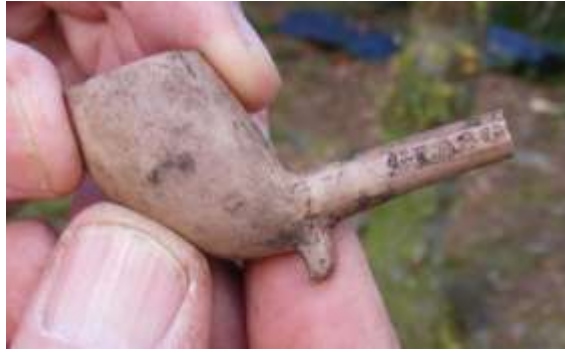
Plate 13: Trench 2: a 19<sup>th</sup>-century clay pipe made in Glasgow (SF1).

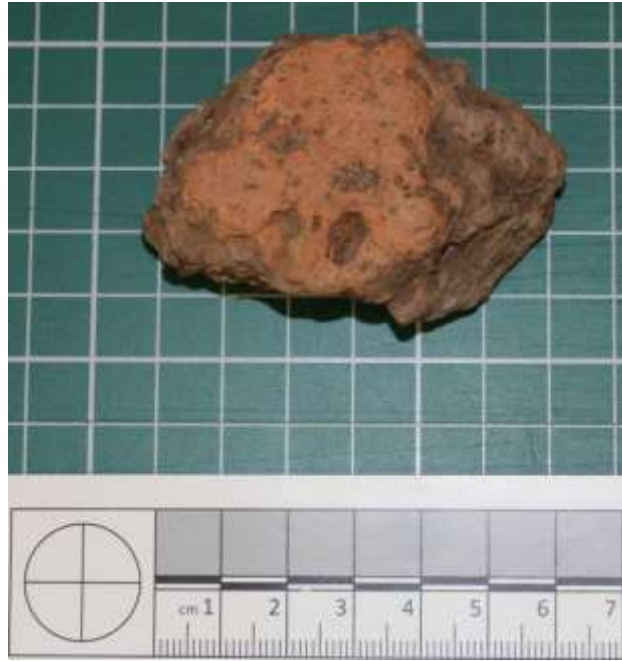
*Plate 17 Pottery sherd from a prehistoric bucket urn (SF 008, context (062))*

A large thick pottery sherd recovered from Trench 3 has been identified as a fragment of a large, flat-rimmed bucket urn, possibly used to bury a cremation. It dates to about 1500 to 1000 BC (pers comm Alison Sheridan). The sherd is most likely to have been disturbed from a cremation burial on the island and it is possible that the unusual amount of stone in this area could have once formed a burial cairn, which was robbed for the construction of the building. The disturbance of a cremation burial may also explain the single fragment of calcined bone found beneath the stone tumble (063). The single pottery sherd and bone adds to the very sparse evidence for prehistoric activity around the Loch Lomond area. The known sites include two Neolithic or Bronze Age lithic scatters in Arrochar (see Bjarke Ballin 2005; James 2014) These are likely to be traces of what was probably more extensive activity which took place beside water courses and near cultivable ground. The Loch Lomond area has been attractive for settlement throughout the prehistoric period, as attested by a Mesolithic and Bronze Age site at Midross (pers comms Dene Wright & Ally Becket) and the presence of several crannogs or artificial islands, which generally date to the later prehistoric and medieval periods.
