<b>NORTHLIGHT HERITAGE</b>	<b>Torness Cable Undergrounding</b>
REPORT: 184	<b>Archaeological Watching Brief</b>
PROJECT ID: 54	
DATA STRUCTURE REPORT	Torness Power Station, East Lothian

Torness Power Station

East Lothian

Data Structure Report

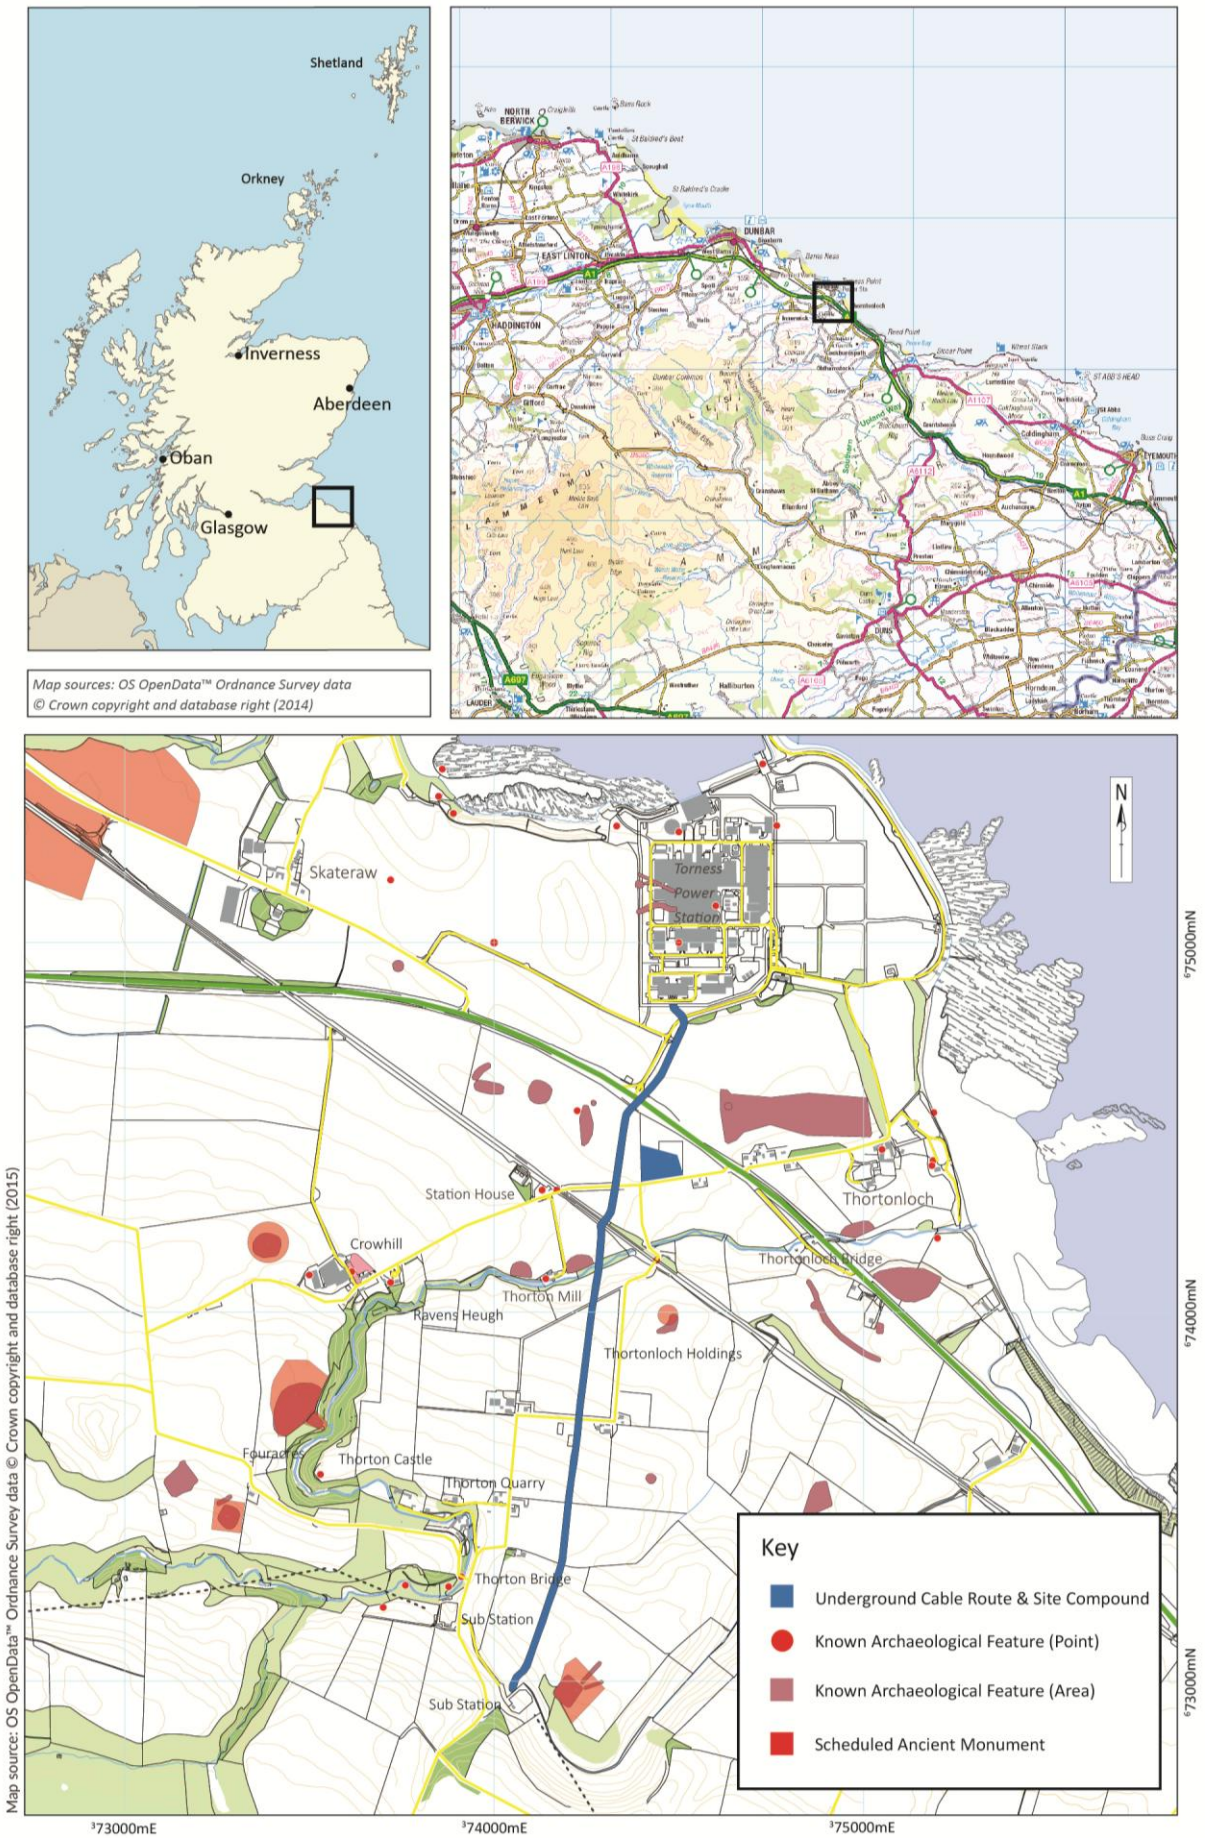
Figure 1: Site Location

The underground cable route extended some 2 km (Figure 1-4) between Torness Power Station in the north (NT 74485, 74827) to an existing substation in the south (NT 74052, 72976). The corridor ran through a landscape of gently undulating fields whilst also crossing the A1 road, a railway line and the Thornton Burn. The site compound was located just south of the A1 to the east of the underground cable corridor (Figure 1 & 2).

No previously recorded archaeology was noted directly within the working areas of the underground cable route or site compound, however, a series of potentially significant archaeological remains existed in close proximity to the undergrounding corridor (Figure 1).

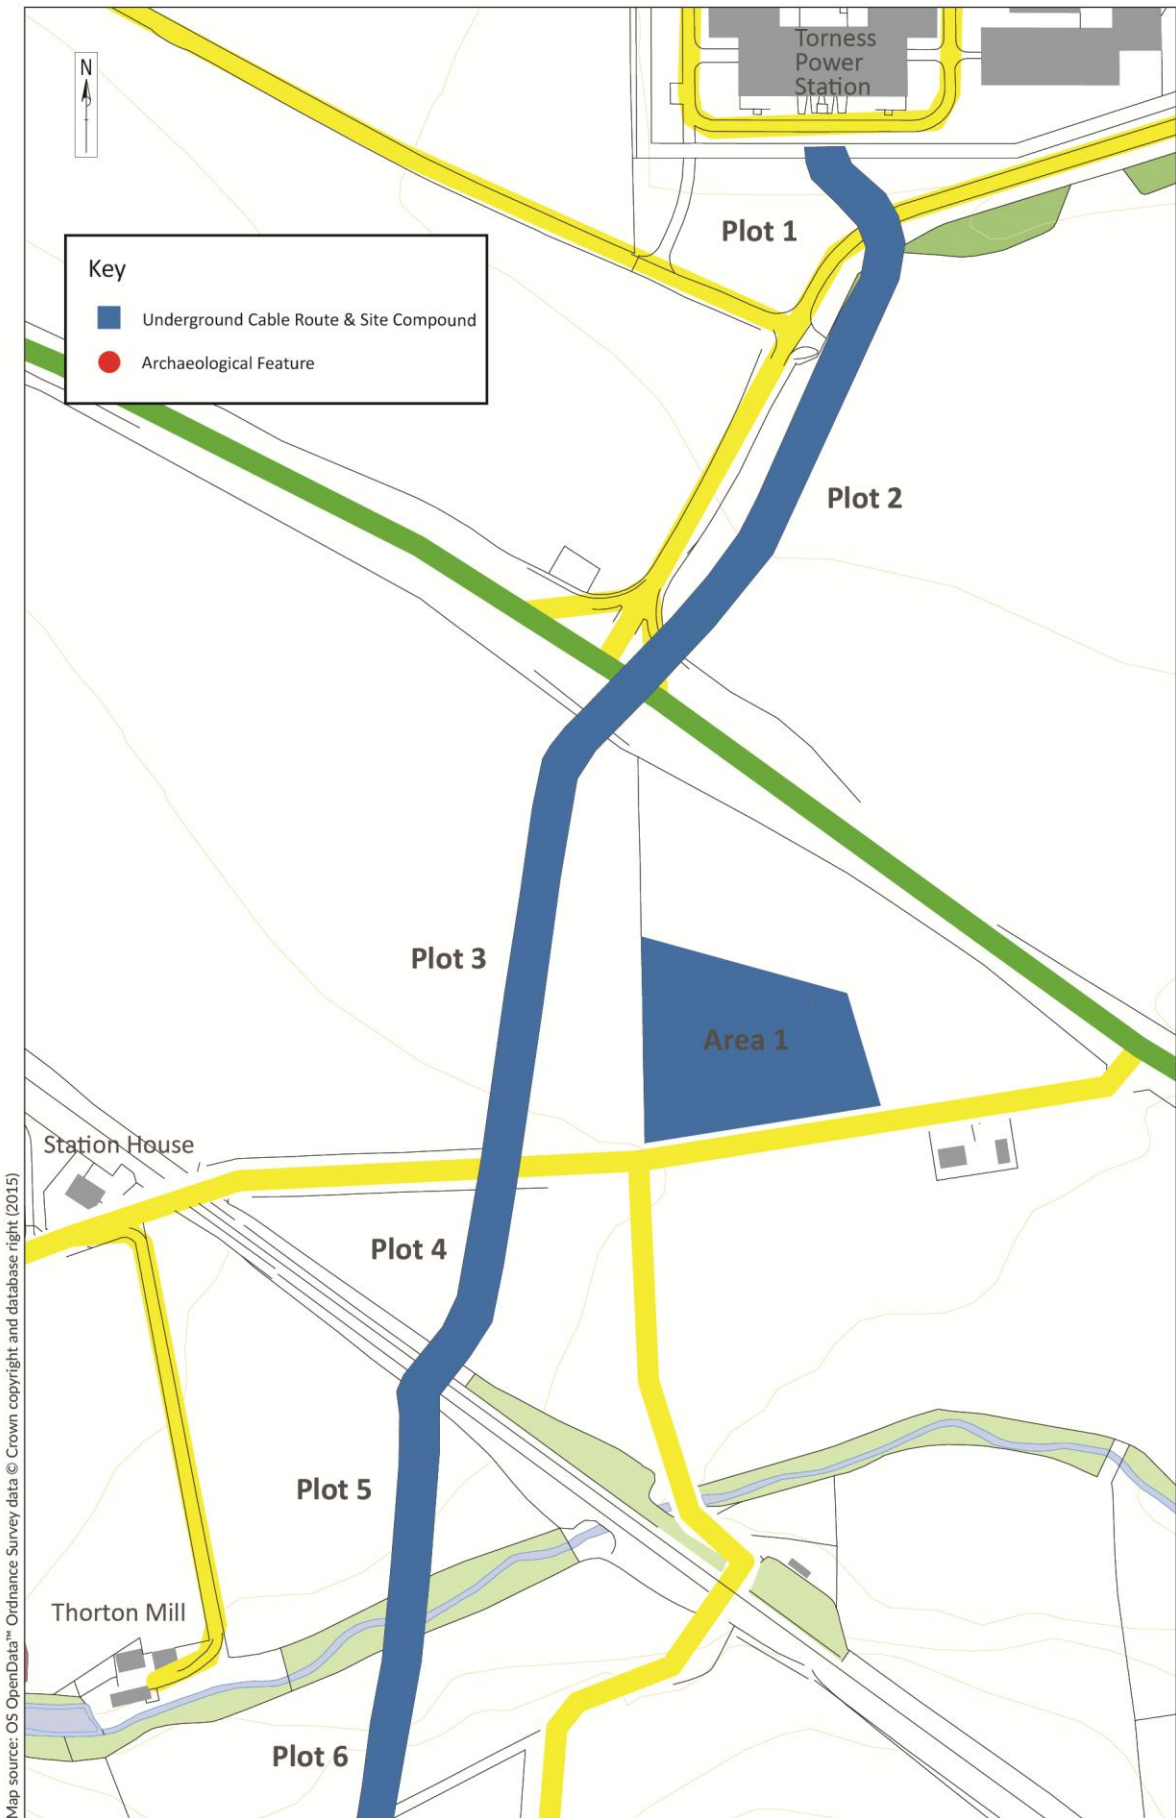
Figure 2: Northern section of cable corridor

Within Plot 3 (Figure 2) the topsoil comprised a red/brown clay sand (003) which covered all of the plot. The area had been extensively ploughed over a long period of time creating deep score marks in a red/brown clay/sand subsoil containing an occasional amount of rounded pebble and gravel inclusions (004). Several possible archaeological features (003-017) were uncovered during the watching brief here, however, all were natural in origin relating to the burnt out or decayed remains of trees and/or bushes. Patches of a shallow plough soil (015), present beneath the topsoil, was also noted across Plot 3.
