<b>NORTHLIGHT HERITAGE</b>	<b>Wee Dig Too: Provan Hall</b>
REPORT: 147	
PROJECT ID: 267	<b>Courtyard Test Trench</b>
DATA STRUCTURE REPORT	Auchinlea Park, Glasgow

**Provan Hall**

Data Structure Report

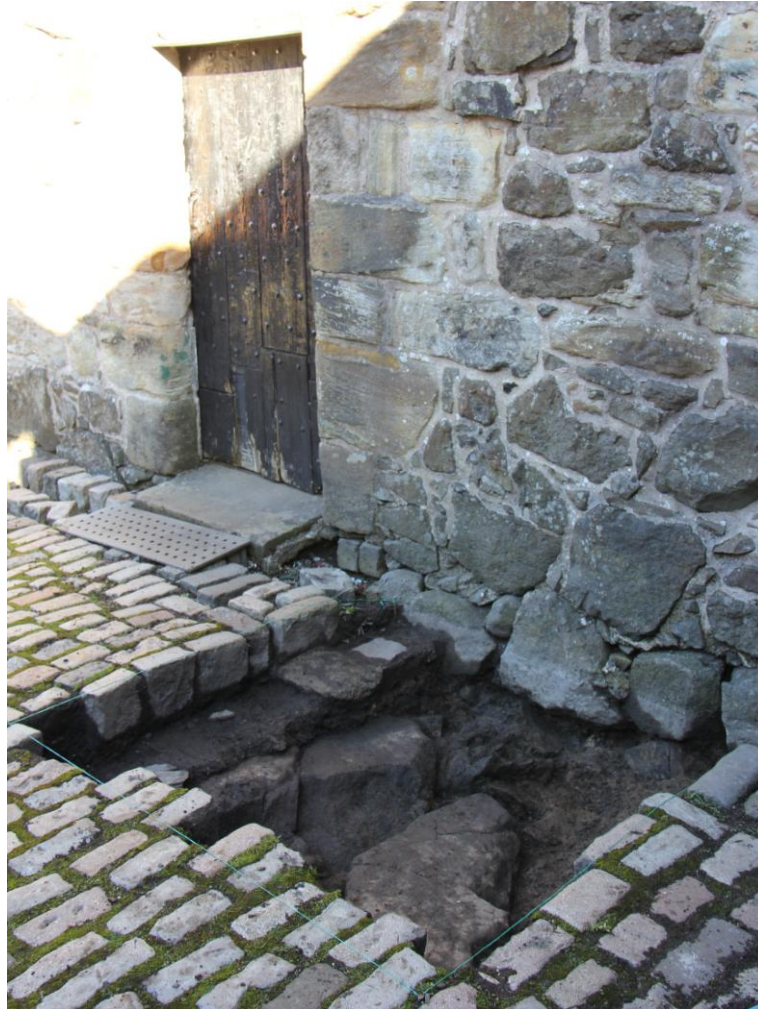
Cover Plate: Foundations of North Building sitting on bedrock and natural clay

The North building was constructed over bedrock (017) and subsoil (018) which were seen a depth of about 0.20m - 0.35 m below the surface (see Figure 2). The bedrock was deeply fissured and its surface was smooth and flat in some areas and very irregular as if truncated in others. The foundations of the North building consisted of a single course of angular stones and boulders (003) which were about 0.35m high and were stepped out from the face of the main wall (002) by about 0.10m.

The foundations for the North building were shallow (0.30m) and consisted of a single course of large stones stepped out from the main wall by about 0.10m. The bedrock within this trench is fissured and very uneven with a suggestion that part of it had been truncated perhaps to facilitate the construction of the house. As a result, the foundations were built either on bedrock as well as the clay subsoil.

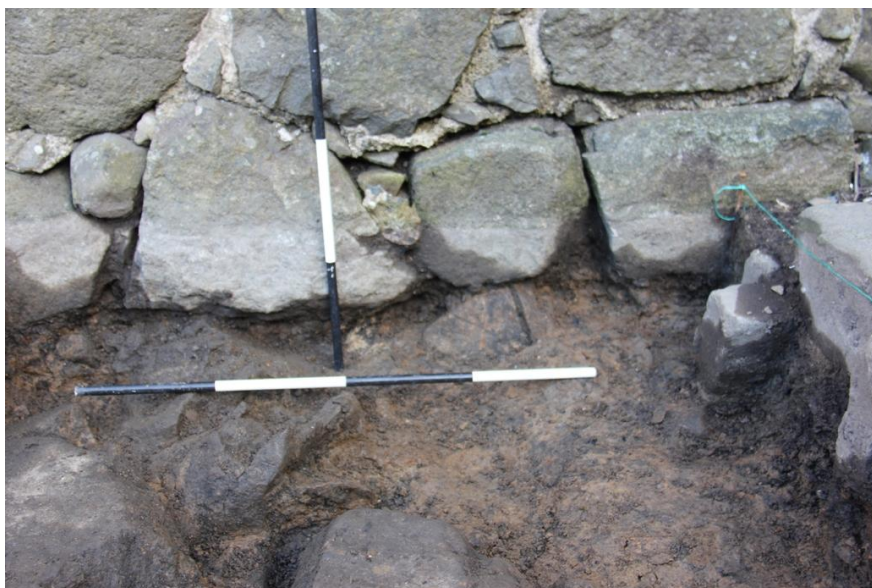
*Plate 1 The shallow foundations (003) of the North building sitting on bedrock (017) and clay subsoil (018).*

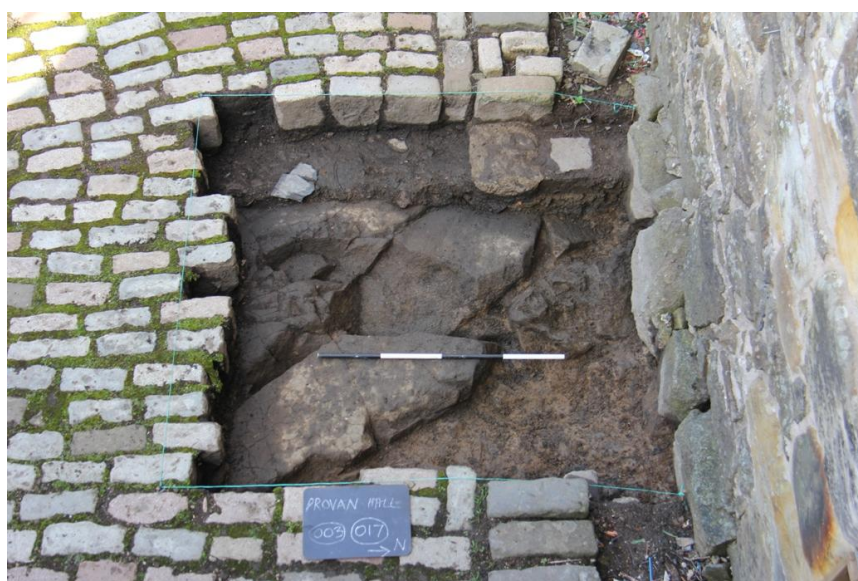
*Plate 2 Bedrock and natural subsoil sealed by layer (009) and mortar (008)*

These layers were sealed by a layer of compact mid-brown stone, clay and gravel (009) which contained a few sherds of late-medieval pottery and also very small fragments of 19<sup>th</sup>/20<sup>th</sup> century pottery and glass. The layers (016), (014), (015) and (009) together formed a deposit 0.18m deep which infilled and concealed the bedrock.

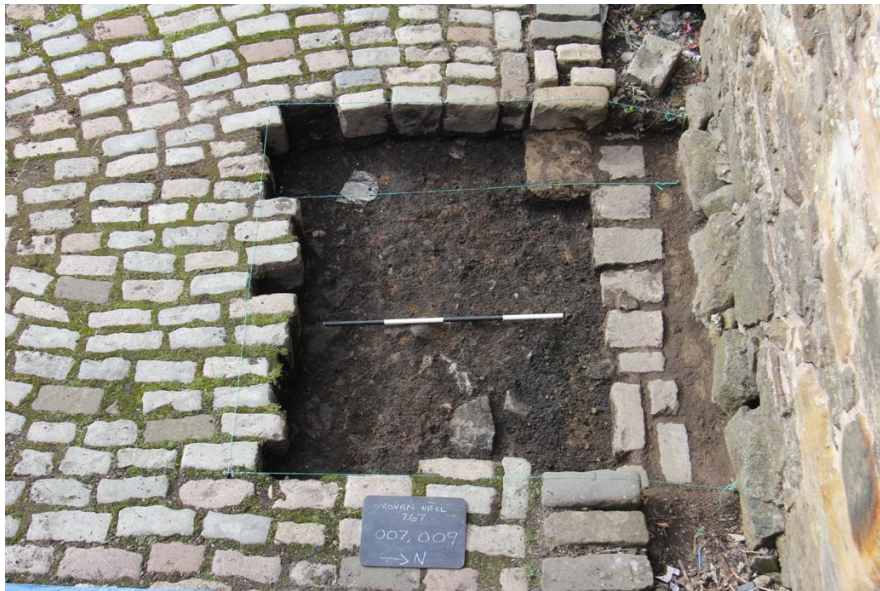
*Plate 3 The surface of the deposit (009) and drain (007)*

A shallow trench (010) about 0.15m deep had been cut through these three layers up against the wall (003/002), (see Figure 2). Within the base of this trench a layer of compacted mortar (013) was laid and two lines of stone sets (007) were placed on this surface to form a drain. The sets (007) were packed with sand (011) and (012). A single clay pipe tem was found at the bottom of layer (013).

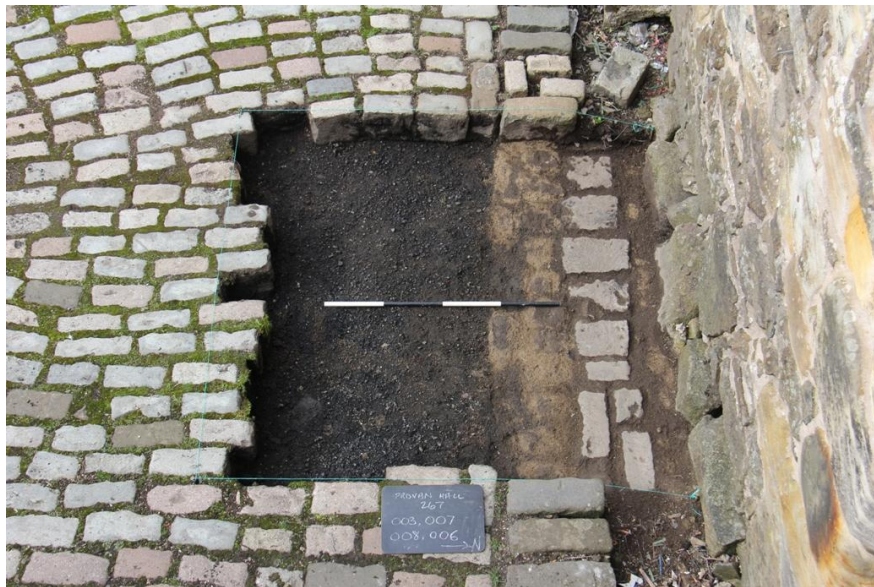
*Plate 4 The drain (007), mortar (008), and coal layer (006) underneath the stone sets (001) and sand (005)*

The surface of the courtyard was raised slightly with the deposition of a layer of coal fragments and industrial waste (006). Above this a thin layer of mortar (008) provided a foundation for the edge of the layer of stone sets within the courtyard (001) (see Plate 4). The rest of the stone sets were set into sand (005). An accumulation of modern debris and earth sealed the drain (004) up against the wall (003/002).

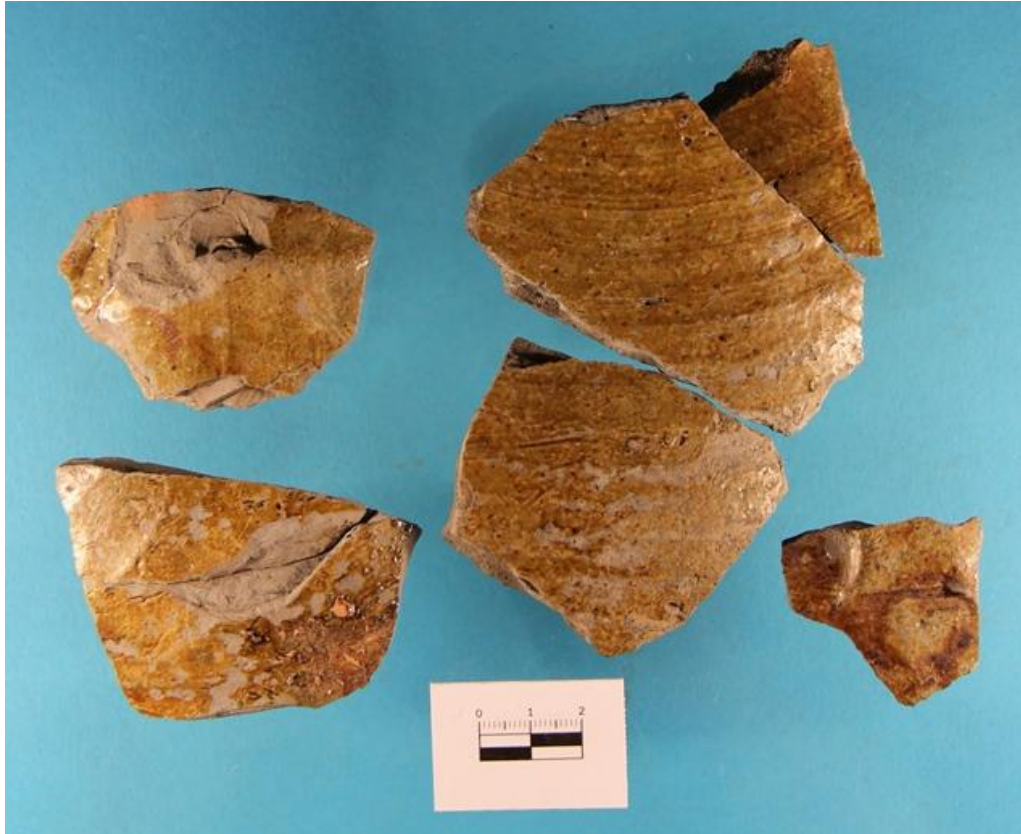
*Plate 5 Late-Medieval pottery*

The green-glazed pottery is the most useful dating evidence from this trench and is likely to be late medieval perhaps 15<sup>th</sup> -17<sup>th</sup> century. This pottery should be shown to a specialist for more detailed analysis. A few sherds of similar pottery were found during the excavations in 2014 and this could be analysed at the same time. The clay pipe is likely to be 19<sup>th</sup> century. These finds could be stored for now and be analysed at a later date along with material retrieved from the future programme of excavations.
