NORTHLIGHT HERITAGE	Inverkeithing Friary
REPORT: 221	Archaeological Excavation
PROJECT ID: 1679	Inverkeithing, Fife
DATA STRUCTURE REPORT

Inverkeithing Friary, Fife
NGR: NT 1296 8274

Data Structure Report
on behalf of
Fife Coast and Countryside Trust

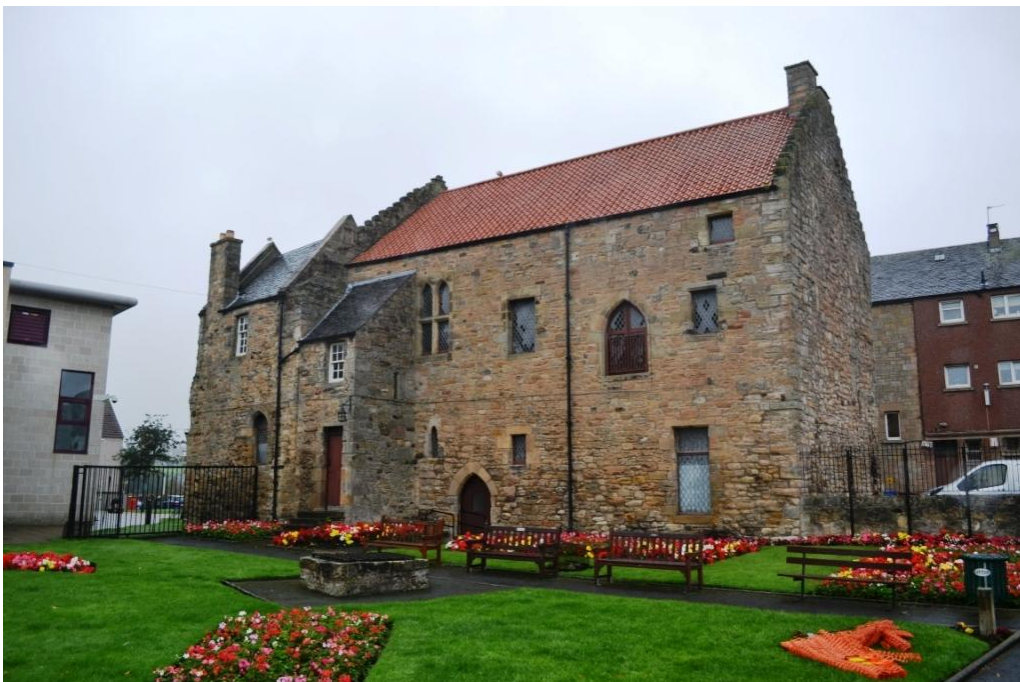
Plate 1: View of the Hospitium from the East

The East Range still stands and although much altered, the historic building that fronts on to the street is essentially a 14th century building. It was the Friary's Hospitium (Plate 1) (i.e. its accommodation block for visitors), its size possibly reflecting something of the large number of pilgrims that entered Fife via the ferry town of Inverkeithing.

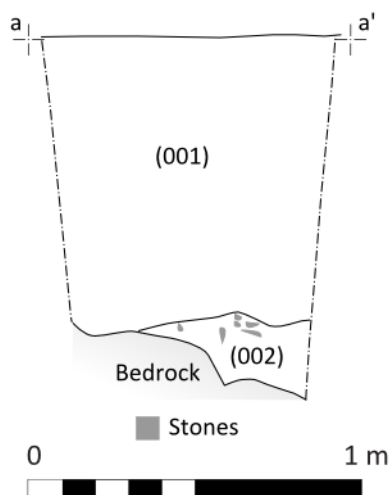
Figure 3: SE-facing section T1 S1

S1 (Fig 3) measured approximately 1.25m by 1.25 m and was up to 1 m deep. Topsoil (001) was removed to reveal a deposit (002) which contained rubble, some with mortar attached, as well as fragments of Medieval pottery (Plate 7). This deposit lay directly on top of the bedrock.

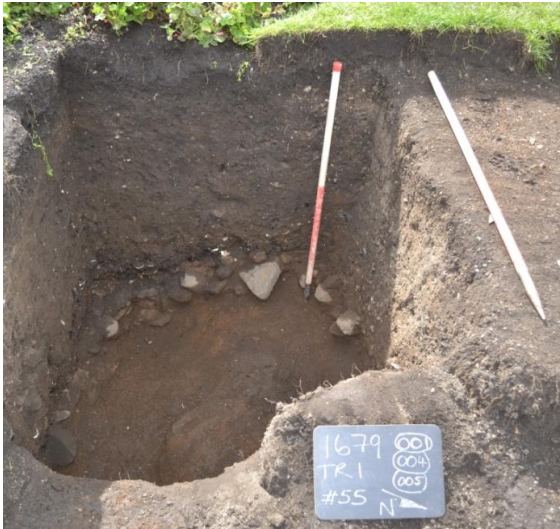
Plate 8: NE-facing section, T1 S2

S2, located to the SW of S1, contained similar deposits (Plate 8), although the material (005) found directly on top of the bedrock was composed primarily of cobbles, as opposed to what appeared to be wall-rubble in (002). This cobble material may correspond to deposits seen within T2, such as (010), and contained Medieval pottery, including a base sherd with finger-impressed decoration (Plate 9).

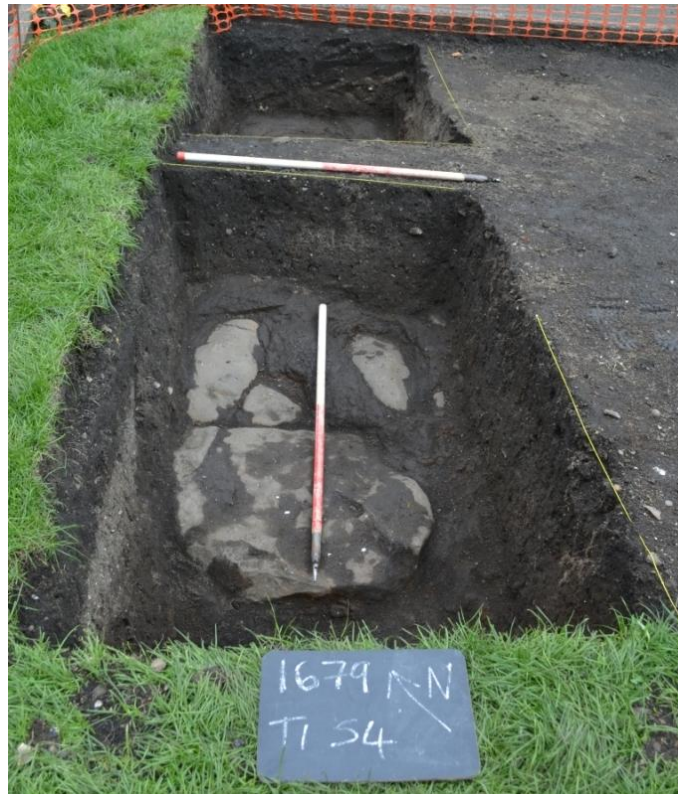
Plate 10: Bedrock within S4, S5 in background

These sondages were located on the NW edge of T1, closest to the Hospitium. Both contained topsoil/overburden, less than 0.5 m deep, lying directly on top of bedrock (Plate 10), demonstrating that the bedrock lies much closer to the surface at this end of the site, reflecting the natural slope down towards the Forth.

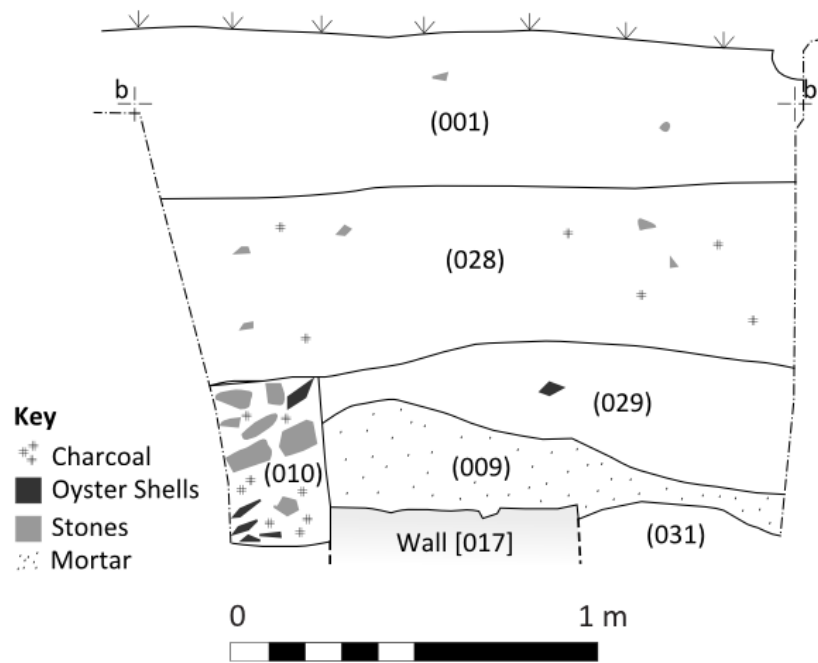
Figure 4: SE-facing section of S6

These sondages were located at the northern corner of T2 and contained deposits of topsoil-landscaping overburden (001 & 028) to a depth of approximately one metre. Below this a sequence of deposits and structural elements were identified which related to the construction and demolition of a wall (Fig 4, Plate 11). The demolition deposits included a deposit of sandy loam with oyster shells and some stones (029) on top of a thick layer of yellow-grey mortar (009).

Below the layer of mortar were deposits and a wall which almost certainly formed part of the north range of the friary. Deposit (010) was comprised of cobbles and stones within a dark loamy matrix. It contained frequent oyster shells and also fragments of green-glazed pottery and butchered animal bone. In places it appeared to form a surface (Plate 11), perhaps relating to the cloister walk, although only a small area of this deposit was revealed. Although not directly over-lying the wall (017), deposit (010) had originally been placed up against the wall.

A stratigraphical sequence was observed within T2 (Fig. 4) which showed the following sequence of events:

1. Construction of the friary wall (017) [14th C?]
2. Deposition of deposits (030 & 031), levelling material [14th C?]
3. Creation of the Cloister Walk (010) [14th C?]
4. Robbing out of the wall (017) [Probably post-Reformation]
5. Landscaping of the site (001 etc.) [1930's]

Evidence for the demolition of the structure was provided by mortar deposit (009), which overlaid the wall and a deposit within the structure (031). The illustrated section (Fig 4) demonstrated that the robbing out of (at least) the lower portion of the wall was undertaken from the interior of the structure, as no mortar was found on the southern side of the wall line. The mortar deposit (009) itself most likely represent the cleaning of stones as they were removed from the wall to make them ready for transport and re-use elsewhere.

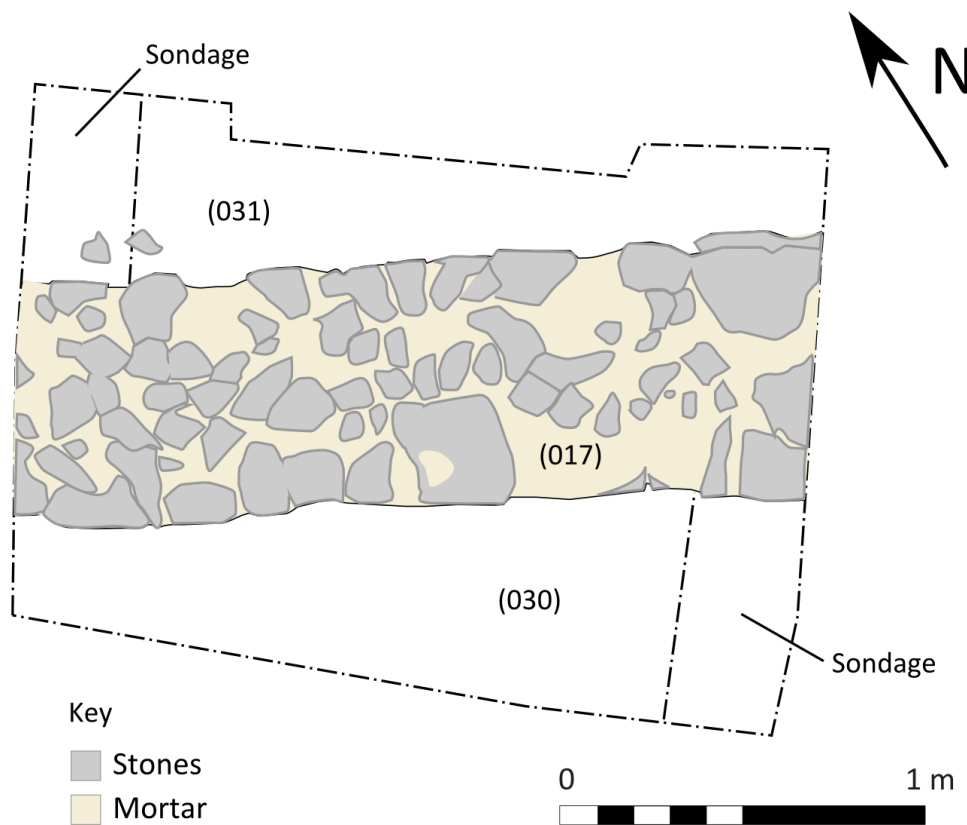
Figure 5: Plan of wall within Sondage 6/7

The wall itself (017) was approximately 0.7 m wide and had been built from yellow sandstone blocks, with rougher infill of natural bedrock cobbles, and bonded with a yellowish lime-mortar (Fig 5, Plates 11 ,12 & 13). Two small sondage slots were excavated in an attempt to reveal the surviving height of the wall (Fig 5), both of which revealed 3 rough courses of stonework (to c. 0.3 m height) on top of stone infill, likely of a foundation trench, although this material could not be excavated due to the depth of the trench and lack of available space. The two slots did provide some insight into the material on either side of the wall. On the northern side was a deposit of yellowish sandy loam (031) whilst on the southern side was a darker deposit of loam which contained a fragment of distinctively orange-glazed pottery (SF 1), of which further specialist analysis may prove useful.

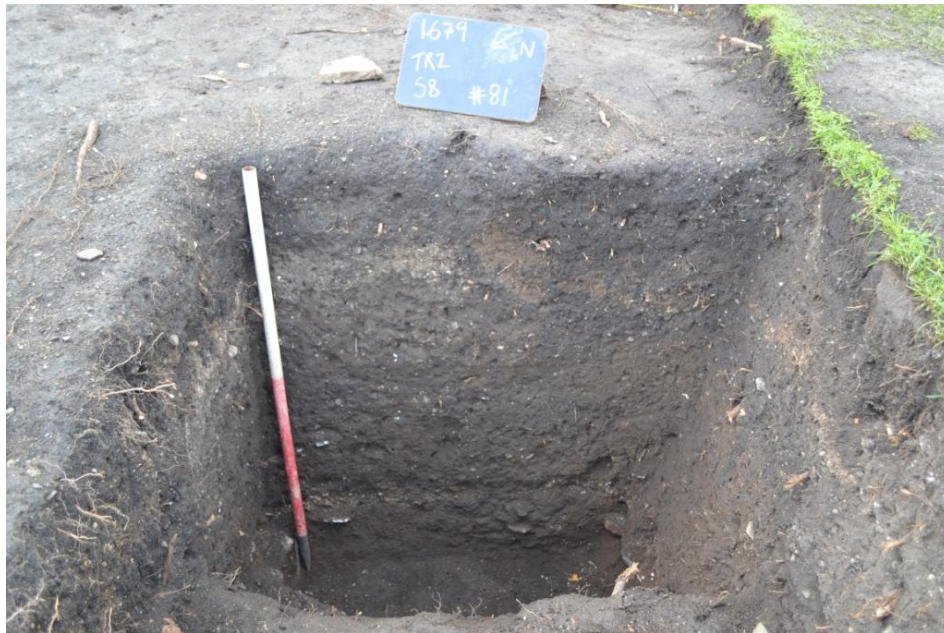
Plate 14: NW-facing section of S8

S8 (Plate 14) was excavated to the south of S6/7, within the estimated area of the cloisters. The upper deposits (001, 018 & 019) were 1930's landscaping deposits, and sealed a thin layer of sand and gravel (020) which may relate to the cloisters or perhaps the demolition of the friary. This deposit sealed a deposit of firm reddish-brown sandy loam (021) which contained sherds of medieval pottery, animal bone and charcoal flecks. A very similar deposit was also seen within S9 (024).

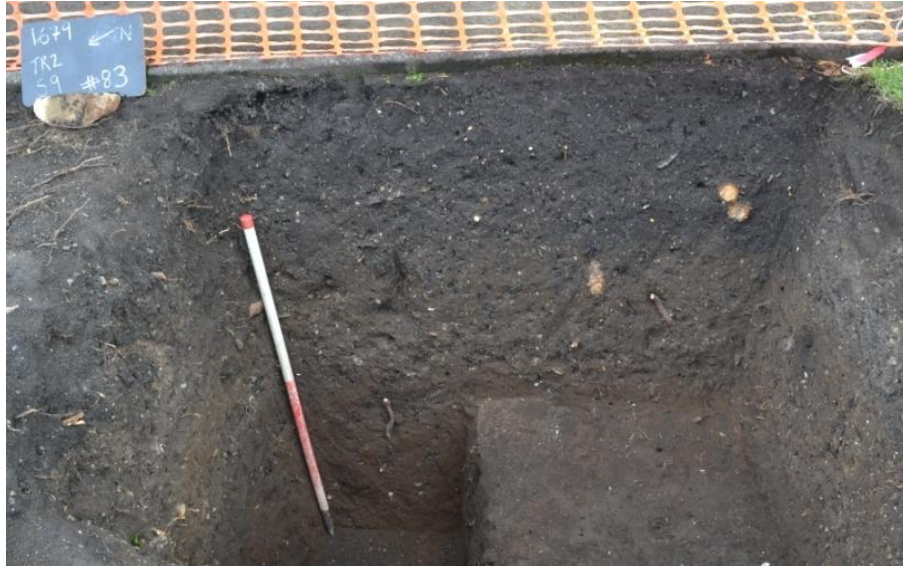
Plate 15: NW-facing section of S9

S9 (Plate 15) was located in the southern corner of T2 and contained a very similar sequence of deposits as seen in S8 (these were 001, 022, 023 & 024), but had no equivalent of deposit (020).

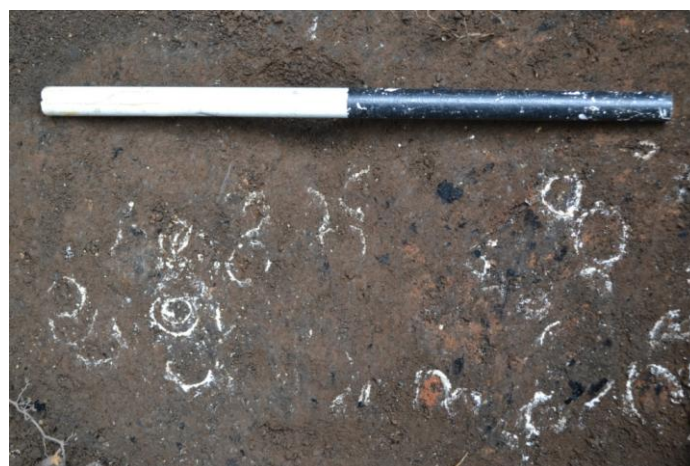
Plate 16: Limpet shells in deposit (040)

The final sondage excavated in T2 was at the eastern corner and was opened to further investigate the wall line identified within S6 & 7. This sondage demonstrated the continuation of the wall line and deposits on the southern side of the wall (the northern side of the wall was outwith the area of this sondage). New context numbers were assigned (038-044) but were all relatable to deposits within S6 & 7, with the exception of (040) which, although unexcavated, appeared to be a discrete midden deposit below (or possibly within) the 'cloister-walk' deposits (030 in S6 & 7, 042 in S10). This deposit (040) was notable for containing large numbers of limpet shells, ash and charcoal (Plate 16).

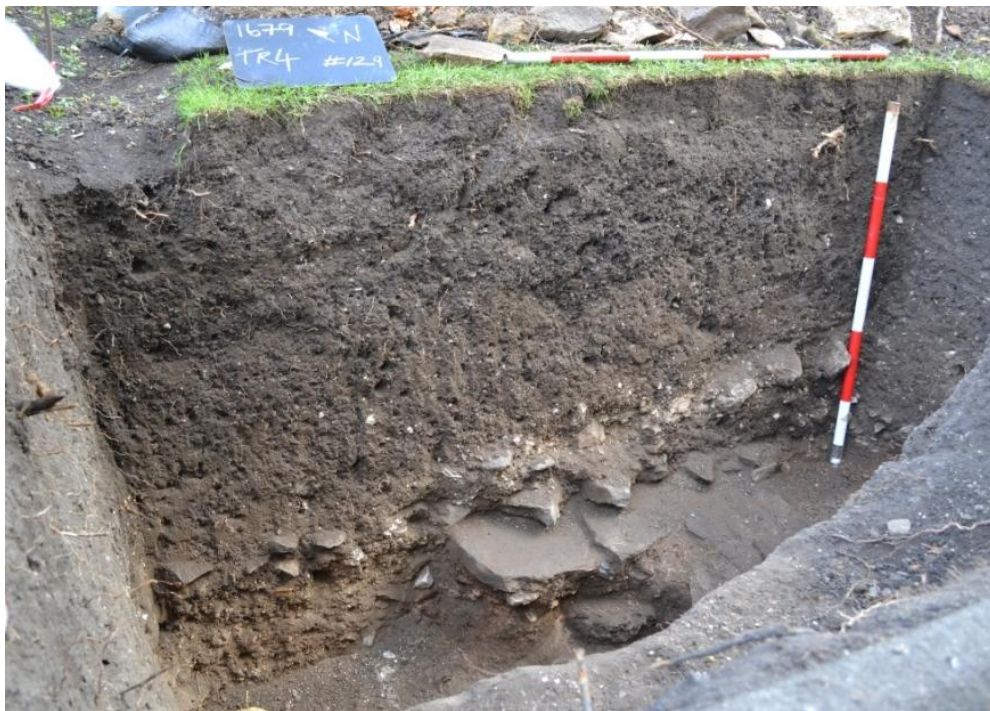
Plate 19: S-facing section and flooring in T4

T2 was located at the eastern edge of the site, on a strip of grass which, at its eastern end, runs along the top of the surviving vaults. This trench was not over a (known) vaulted area, and the upper deposits (001 & 032) were consistent with the modern landscaping deposits seen elsewhere on the site. At a depth of approximately 0.6 m was a deposit of mixed clay, sand, rubble and mortar (036/037) which was interpreted as a demolition deposit. This material also contained a fragment of window glass and a small piece of 'I-section' window lead. This overlaid the remains of a partial floor surface (034) of which 3 sandstone flagstones were revealed. It appears that the rest of this floor within T4 had been grubbed up, but the flagstones formed a convincing floor surface (Plate 19). The floor had been laid upon a deposit of sandy gravel which contained some rubble (035), although only a small area of this was investigated due to the limitations of the size and depth of the trench.
