**NORTHLIGHT HERITAGE** | Practice at Plean

DATA STRUCTURE REPORT: 136 | **Community Heritage Project at Upstanding  
World War I practice trenches**

PROJECT ID: 4435161 | Plean Country Park, Stirling

Data Structure Report

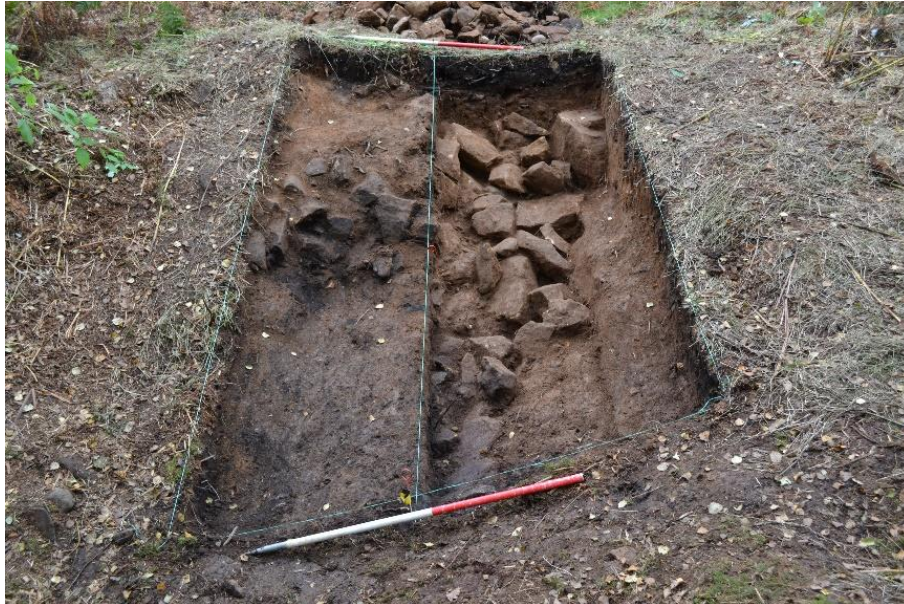
*Illus 5: Trench 1 - Pre-excavation view of stone rubble (008), with cut [014].*

- 6.3. The natural subsoil identified in Trench 1 was a firm, mottled yellowish grey clay (012), observed against the southern baulk section. This was cut by [014], a deep cut with near vertical but irregular sides, interpreted as part of the network of practice trenches. The cut was at least 0.8m wide and was observed to extend beyond the end of the trench. The line of the trench [014] indicates that it was orientated north-west/south-east, and continued through the embankment on which Trench 1 was

- 6.4. The lowest fill identified in the cut [014] was a firm, mottled yellowish brown sandy clay (013). An area c 0.8m by 0.7m in the base of the cut appeared to be redeposited subsoil, which had probably slumped from the sides while the practice trench was in use. Overlying this and filling the rest of the cut [014] was a loose deposit of large, irregular limestone blocks with a small amount of sand and topsoil filling some of the voids (008). The limestone blocks were present across most of Trench 1 over an area at least 0.85m wide and up to 1m deep.

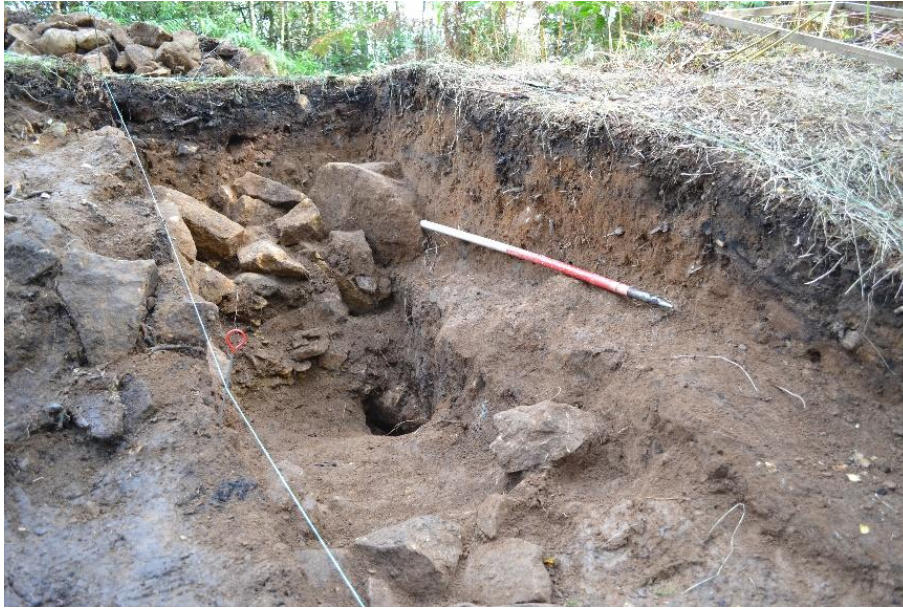
*Illus 6: Trench 1 - Post-excitation view of (008), with backfill (013) and cut [014].*

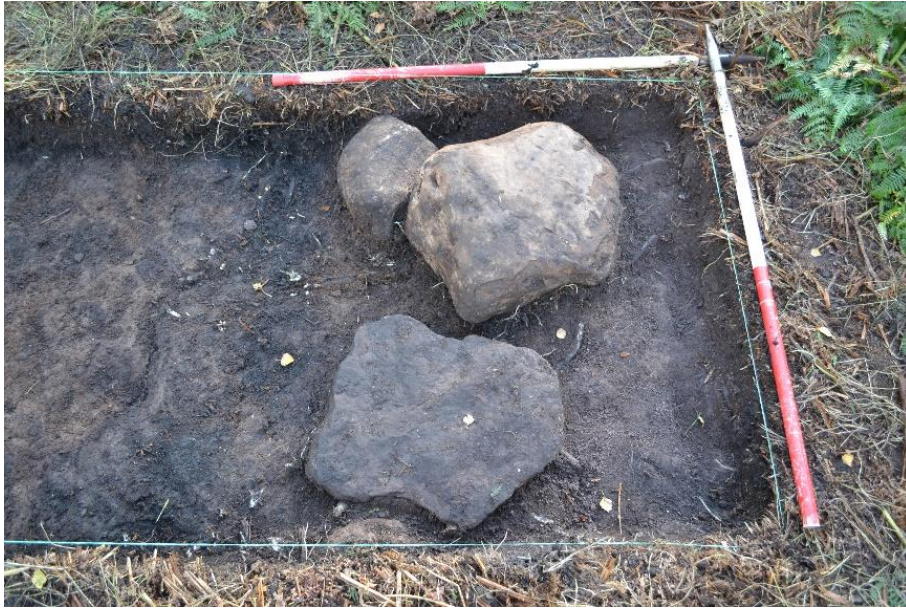
*Illus 8: Trench 2 - Pre-excavation view of (002) possible foundation for sandbags.*

- 6.8. At the western end of Trench 2 was a line of large stones (002), crossing the practice trench on a roughly north/south alignment. Three of the stones formed a rough course about 0.5m wide. They sat 0.5m west of the defined edge of cut [015] and slightly higher than it, creating a low ridge in the ground surface. They seem likely to have been a foundation for a sandbag wall.

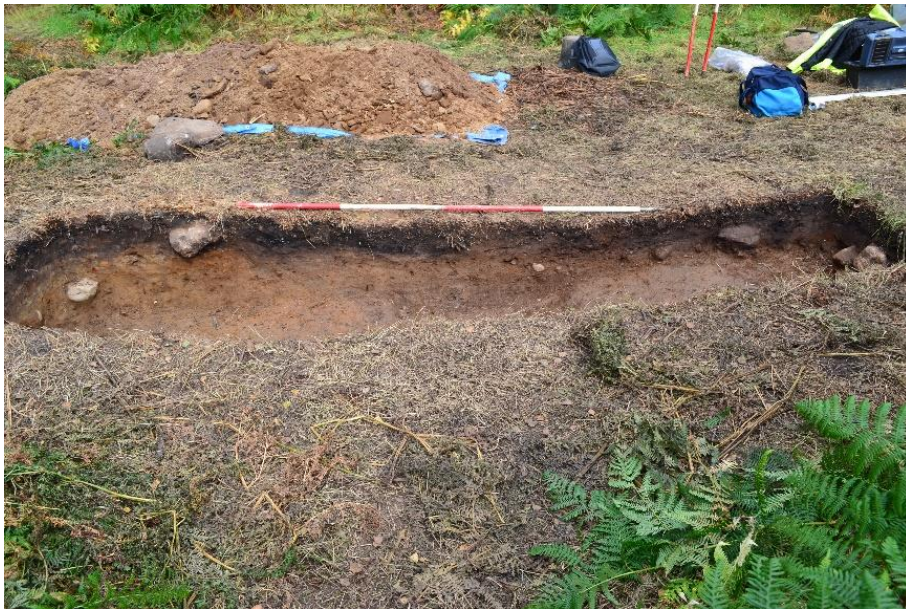
*Illus 9: Trench 2 -South-facing section.*

- 6.7. The natural subsoil identified in Trench 2 was a firm, mottled yellowish brown clay (011). This was cut by a shallow ditch [015] c 0.2m deep and orientated roughly north/south, with a gently sloping western edge but a less distinct eastern edge. Despite its shallow depth, this is also thought to be part of the network of World War I practice trenches. It was filled with a firm, mottled yellowish brown sandy clay (003) which appeared to comprise redeposited subsoil, although it was more heavily re-worked than its equivalent (013) in Trench 1.

- 6.9. Overlying the stones (002) was a friable, very dark greyish brown silty sand (001), which formed the turf and topsoil covering Trench 2, 0.05 – 0.1m deep.

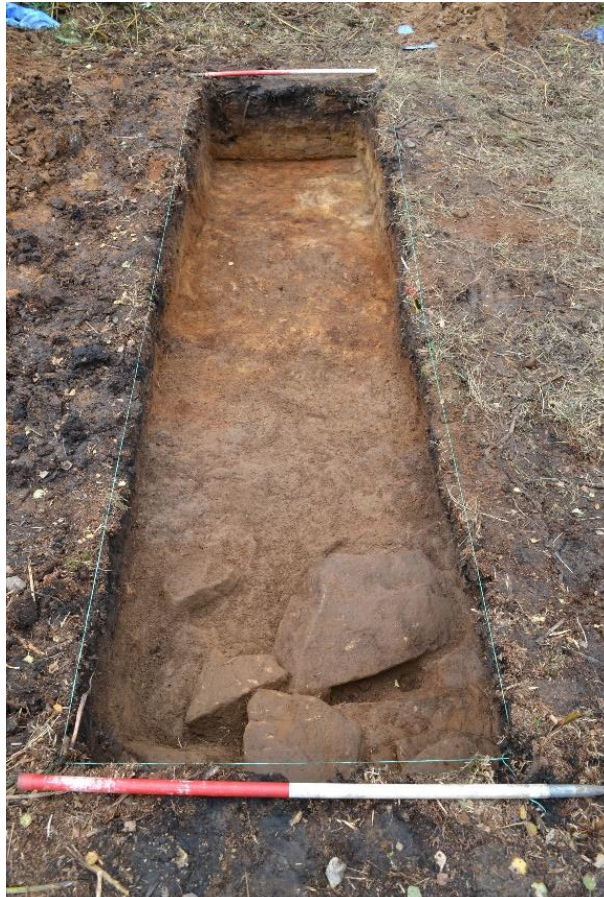
*Illus 10: Trench 3 - Post-excavation view with bedrock (016) in foreground.*

- 6.10. At the south-eastern end of Trench 3, an area of limestone bedrock (016) was encountered at between 0.15-0.4m below the modern ground surface. Overlying this was a cluster of large limestone blocks (009) which were simply fragments of bedrock. Across the remainder of the trench, natural subsoil was identified as a firm, mottled reddish brown clay sand which overlay (009) and (016).
- 6.11. Overlying it was a buried turf layer (017), which consisted of soft, dark grey-brown clay silt. This lay in two patches – one at either end of the trench, each 0.05m deep and extending beyond the limit of excavation. They were separated by a shallow cut [019], c 1.5m wide by 0.2m deep, most likely a continuation of cut [015] for the practice trench exposed in Trench 2 to the north.

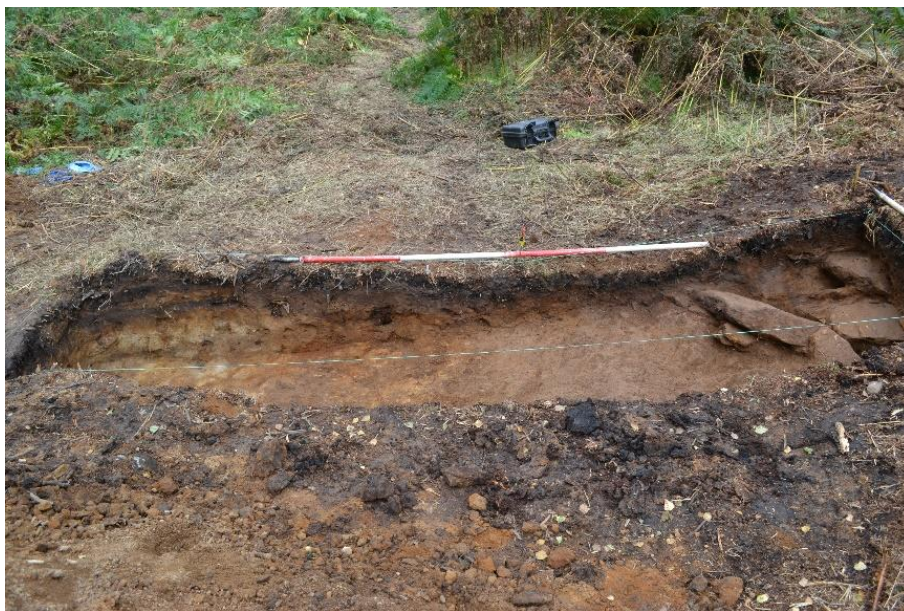
*Illus 11: Trench 3 - South-west facing section.*

- 6.12. On the crest of the north-western and south-eastern edges of cut [019] were deposits of firm to friable mottled reddish brown clay sand (018). These were clearly redeposited subsoil and must have formed as a direct result of digging the practice trench [019]. They were up to 0.1m deep, although generally deeper toward the north-west. These deposits would have originally increased the depth of the practice trench by creating a small bund or rampart on its crest. Unlike in Trench 2, no stones were found on top of these deposits.

- 6.13. Filling the practice trench cut [019] was a firm, dark grey-brown sandy clay (006) up to 0.2m deep. This may have been formed from heavily mixed, redeposited subsoil like (003), but the presence of animal burrowing through it makes interpretation slightly more difficult. A deposit of friable, very dark grey-brown silty sand (005) formed the topsoil across the trench. It was very rich in humic content, particularly bracken roots and leaf mould.
