Seven Lochs Medieval Past

Inchneuk Tower and Steale Family Tomb, Glenboig
Archaeological Evaluation

DATA STRUCTURE RPORT

Data Structure Report
on behalf of
Seven Lochs Wetland Park

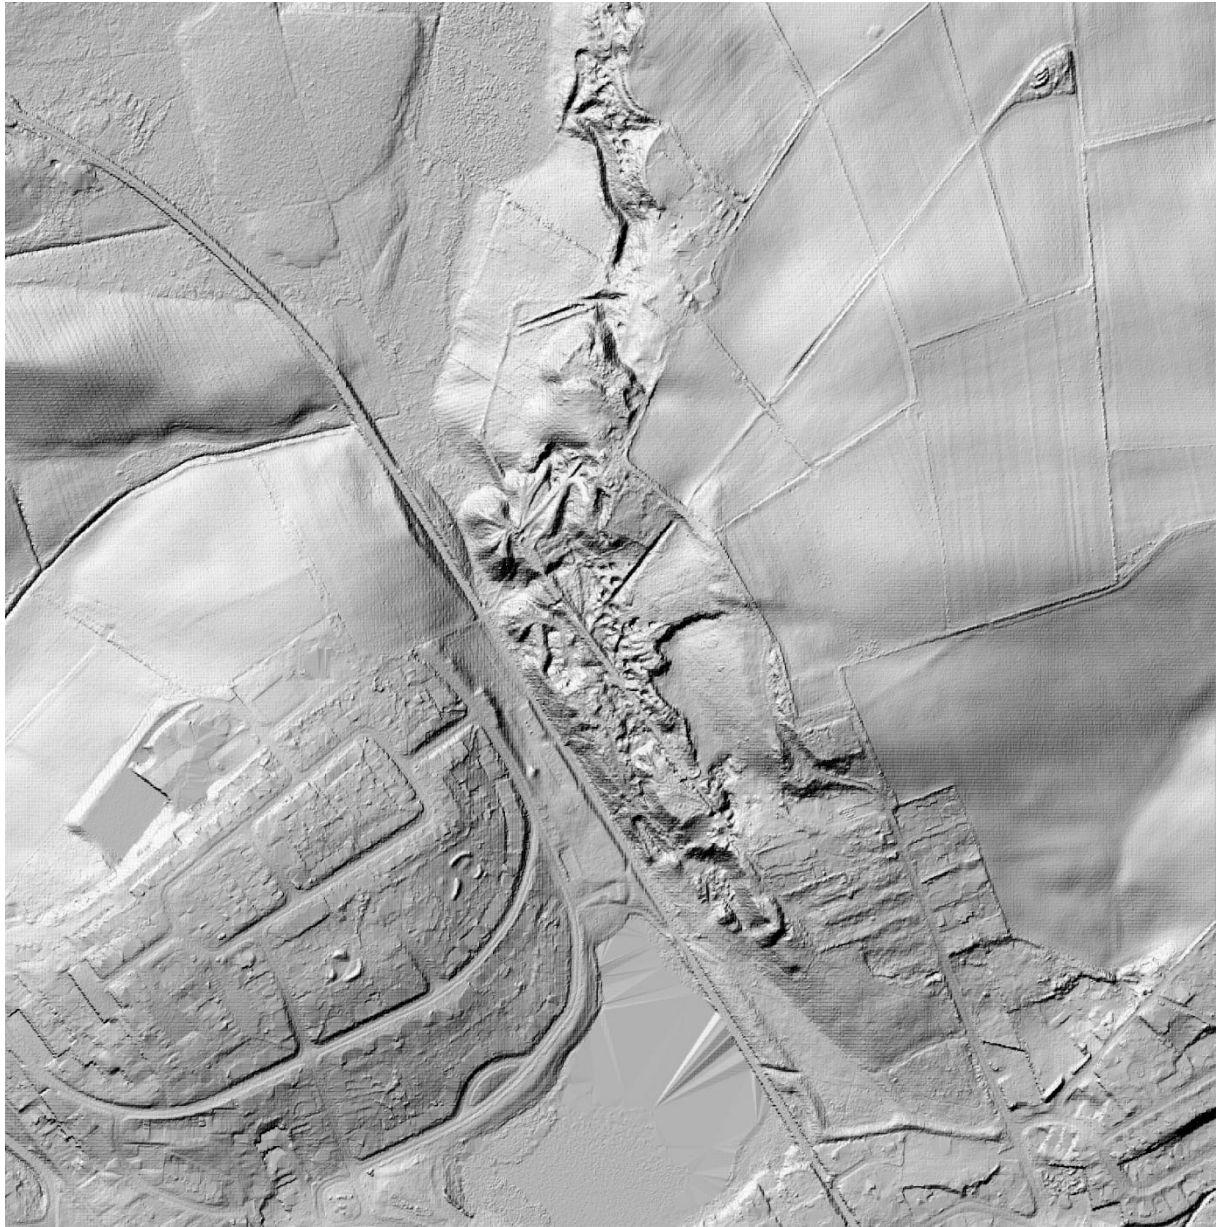
Figure 2: Lidar data for Glenboig (Scotland Phase II DTM NS76. Data collected from November 2012 - April 2014. Copyright Scottish Government and SEPA (2014).

Lidar data for the area gives an indication of the underlying topography, clearly showing old mine workings, waggonways, quarrying and spoil tips.

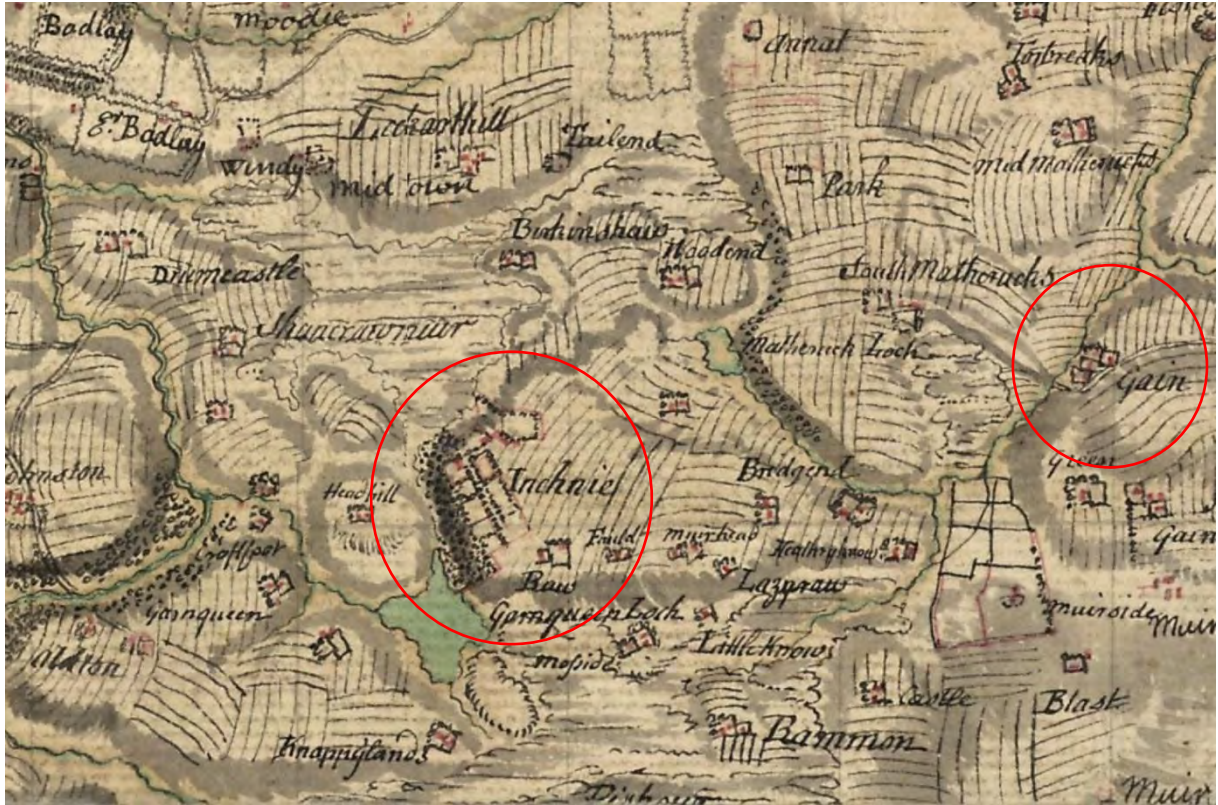
Figure 3: Extract from Roy's Military Survey of Scotland (Lowlands) Roy Map O5/6c

The name's next cartographic appearance is on William Roy's *Military Survey of Scotland* (1747-55), which shows the spelling as 'Inchnie'. By this time, the tower at Inchneuk appears to be surrounded by a wooded embankment to the west and a series of formally laid out enclosures which create an avenue

approaching the site from the south or south-east (on a similar alignment to the current public footpath leading from Inchneuk Road). Many of the associated place names detailed in the historical research are also present on this map. These include 'Gain' and 'Mathrucks' [Medrox]. There is also a clear sense that the site of Inchnoch sits on a raised area of ground surrounded by low-lying bog, marsh and muir.

The Ordnance Survey 1:25 inch first edition map (1858) shows the site in detail. Some elements of the layout can be related back to Roy's map of a century earlier. For example, the rectangular enclosure and track shown on the OS first edition map, immediately south of the tower site, are very likely to be remnants of the rectangular enclosures and formal approach mapped by Roy. On the OS map, the tower is annotated as 'In Ruins'. It is also interesting to note that the name 'Inchnock' has now been clearly attached to the adjacent farm, which was previously labeled as 'Mains', although the spelling is still different to the current form. The railway line to the south-west of the site is also shown. To the south of the tower, a small enclosure with steps leading from the south is annotated as 'Tomb'. This is the first cartographic appearance of the Steale Family Tomb.

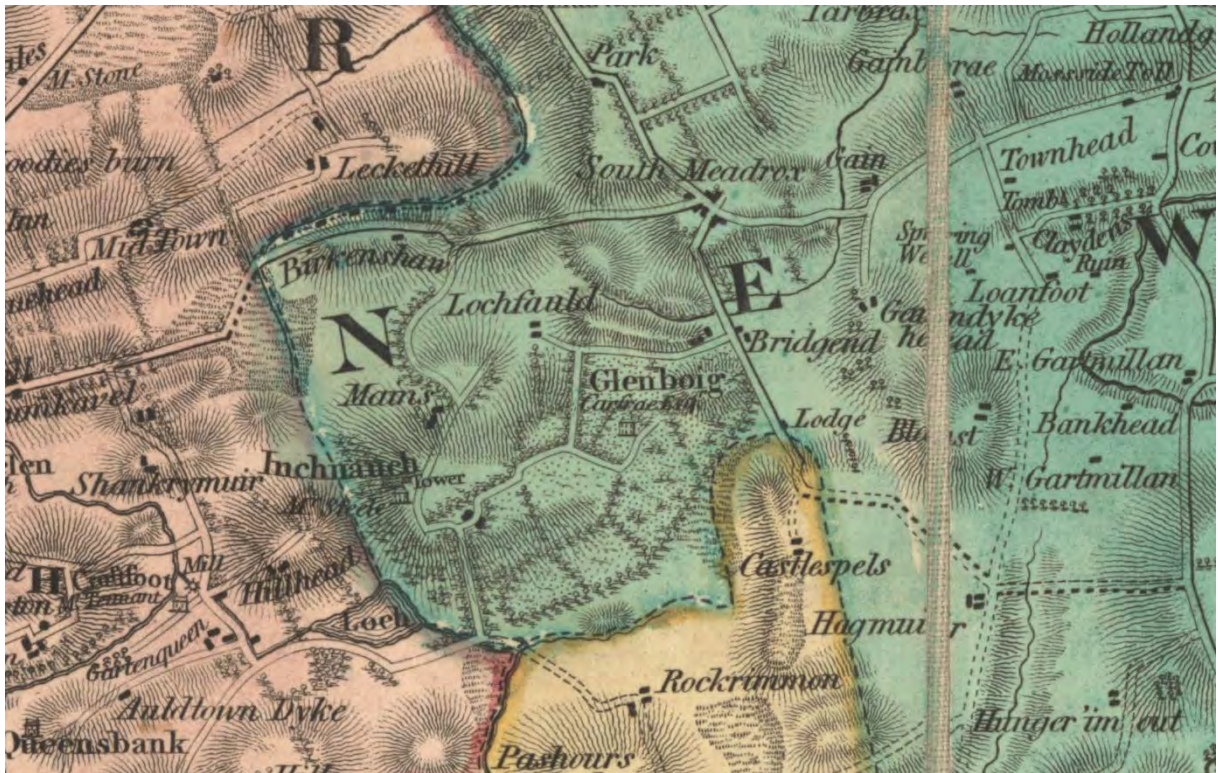
Figure 4: Extract from William Forrest's *The county of Lanark from actual survey*' (1816).

William Forrest's *The County of Lanark from Actual Survey* (1816) shows 'Inchnauch' tower with a notation that it is owned/occupied by Mr Steele. Inchneuk Farm is shown as 'Mains' and the site of 'Muirhead' depicted on Roy's map is now shown as 'Glenboig', occupied by Carbrae Esq. This is the first appearance of the name Glenboig on any map.

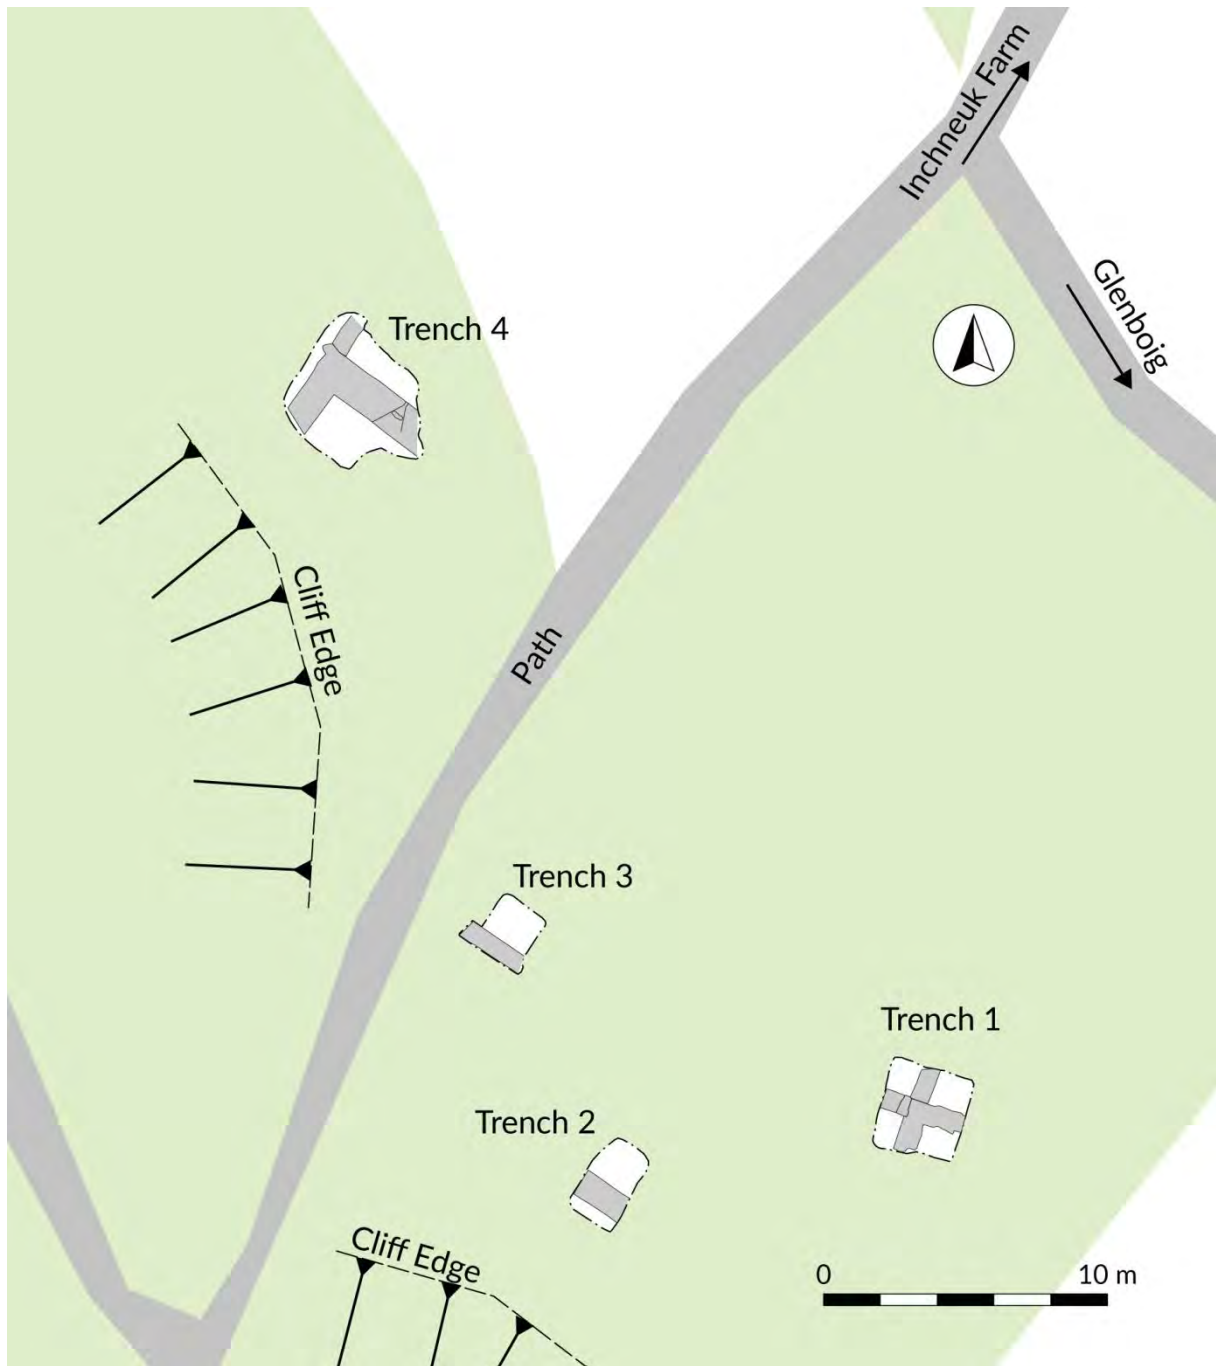
Figure 8: Trench locations.

The locations of trenches at Inchneuk Tower were chosen to answer specific questions relating to the development of the site and the use of different buildings. Trenches were positioned over wall lines and interior areas and over overgrown or unclear areas to test for the presence or absence of associated buildings and occupation deposits. The excavations comprised four trenches arranged around the site, each placed to investigate different structures or aspects of the extant buildings.

Trench 1 was located to investigate what was thought to be the rear corner of a building, as shown on the first edition map. Trench 2 was positioned to assess a substantial wall, also thought to appear on the first edition Ordnance Survey map, and thought to be part of a tower house or peel tower due to its scale. Trench 3 was opened to investigate a narrower wall near the entrance to the site. Trench 4 was positioned to investigate what was suggested to be a pile of rubble to the north of the path.

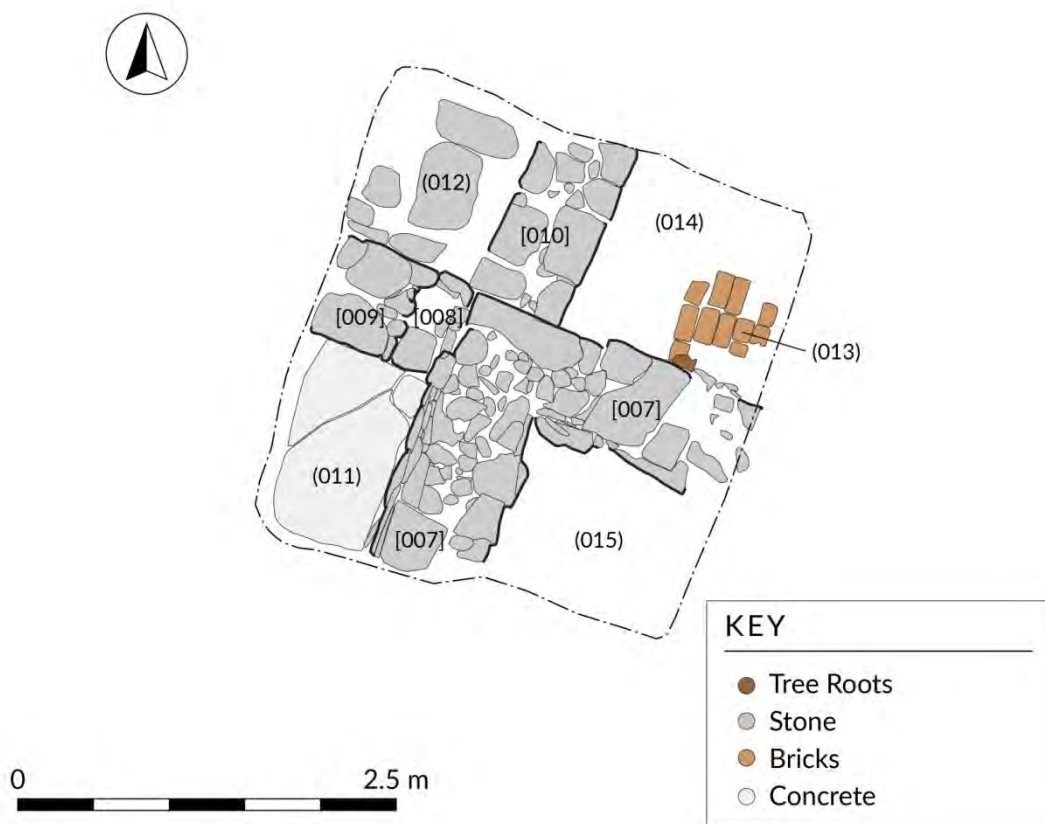
Figure 9: Post excavation plan of Trench 1

Trench 1 measured approximately 3 m² and was located at the south-eastern edge of the site, positioned over what was thought to be the rear corner of a building (see Illus 3). Beneath approximately 0.1 m of friable greyish brown topsoil (001), with abundant angular stones up to 0.3 m in size, were the remains of three walls: [007], [008] and [009] (see Illus 3 below).

Wall [007] was L-shaped and measured 1.9 m south-west/north-east, with the return measuring 2.0 m north-west/south-east. The wall was approximately 0.7 m in width and survived to a height of approximately 0.75 m. It was constructed of a double skin with a rubble core. Traces of light grey lime mortar were observed on the south-western and south-eastern faces.

Abutting wall [007] on the north-east was another wall [010], running south-west/north-east. Approximately 1.2 m of this was exposed and, as with [007], it measured approximately 0.7 m in width, was double skinned in construction with a rubble core and survived to a height of approximately 0.4 m. To the north-west of wall [007] was the third wall in Trench 1, [009], of the same construction and width as [007] and [010]. It was approximately 0.6 m in length and aligned north-west/south-east. A 40 cm gap between walls [007] and [009] had been blocked up or repaired with walling [008]. This later blocking material comprised a combination of large angular stones, in keeping with the other walls in this structure, as well as bricks (see Illus 4 below). It appears that the gap between the two walls did not extend to floor level, as a large stone which was keyed in to wall [009] lay beneath [008].

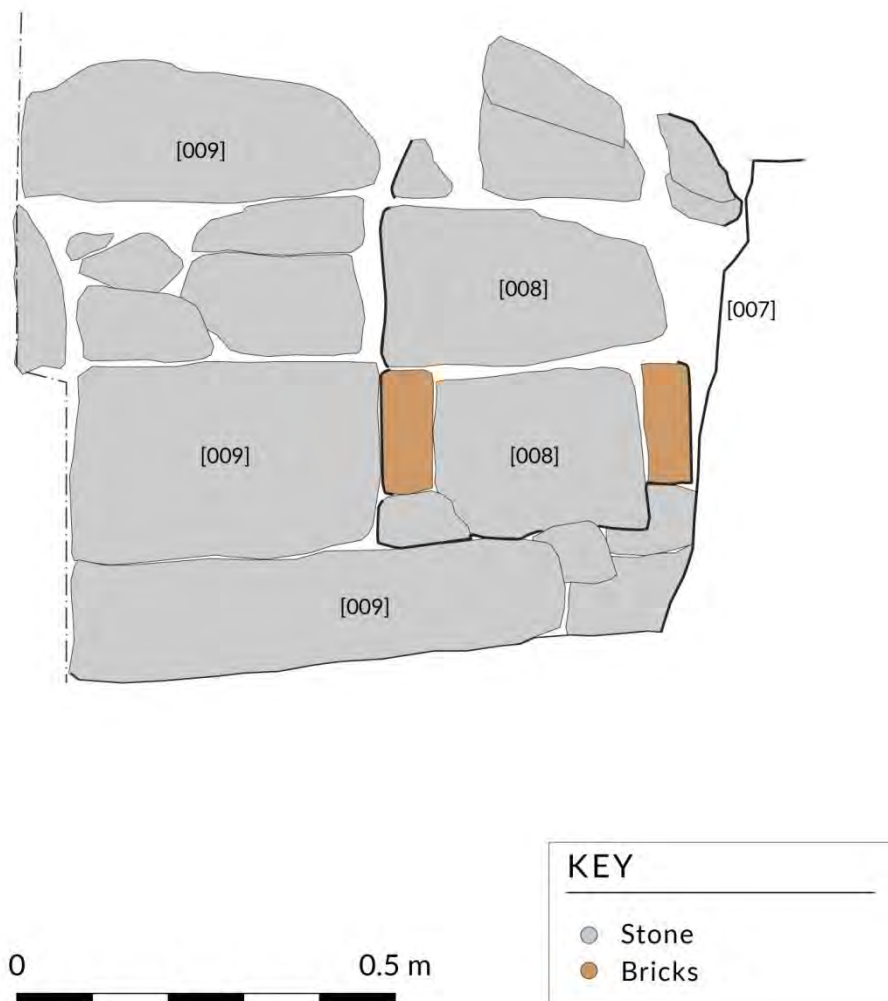
Figure 10: Elevation [008] & [009], Trench 1

Due to the limit of the excavation, it was not possible to determine what these walls rested on and whether that consisted of natural subsoil or an earlier deposit or floor surface. The southern quadrant of Trench 1 was excavated on to a friable, dark yellowish-brown sandy loam deposit (015), which contained

<i>Sheet No.</i>	<i>Drawing No.</i>	<i>Area</i>	<i>Context No's.</i>	<i>Description</i>	<i>Scale</i>
1	001	Trench 1	008 - 009	NW facing elevation of repair/blockage [008] in wall [009]	1:10

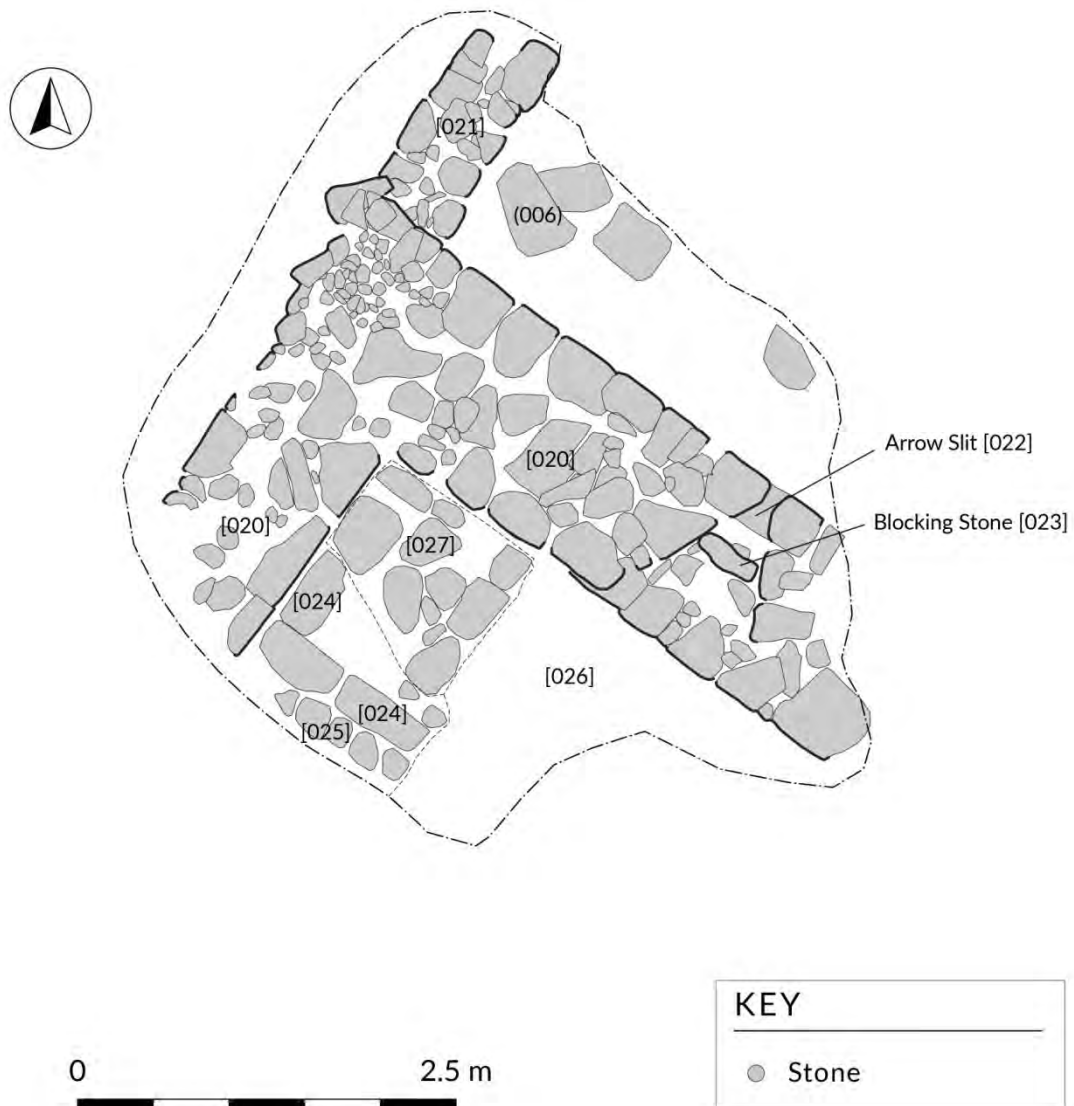
Figure 13: Post excavation plan of Trench 4

The remains of a very large, well-constructed wall [020] were shown to be the remains of the northern corner of a building. One side was approximately 2.8 m in length and aligned north-west/south-east, while the perpendicular return was approximately 3.0 m in length. This wall, which measured approximately 1.20 m in width, was constructed of angular sandstone blocks, ranging in size from 0.65 m by 0.2 m to 0.08 m by 0.17 m, with lime mortar bonding surviving in patches. The wall was observed to survive to greater than 0.9 m in height, as the foundation course was not identified during the excavation. Towards the south-eastern end of the exposed length of wall [020] was an arrow slot [022], measuring 1.45 m in width on the south-western elevation and tapering to 0.1 m on the outer, north-western elevation. At some point, this arrow slot had been blocked off with a large, angular stone [023], which measures c 0.40 m in length by 0.12 m in width and 0.36 m in height.

Abutting the north-eastern corner of wall [022] was a further section of wall [021], on a north-east/south-west alignment of which approximately 1.4 m was excavated (Illus 6). Wall [021] was relatively narrow compared to [022], measuring approximately 0.6 m in width. The wall was constructed

of angular stone ranging from 0.1 m by 0.12 m - 0.3 m by 0.2 m in size and had patches of lime mortar surviving.

In the northern corner of the building, at the interior corner of wall [020], was a slumped deposit of lime mortar and angular stone fragments (019) measuring approximately 1.5 m by 1.0 m and c 0.4 m deep. This deposit overlay a number of relatively flat, angular stones [027], each measuring between 0.2 m by 0.2 m to 0.4 m by 0.2 m in size and covering an area of approximately 1.2 m by 1.1 m. These appeared to be tumbled stones rather than a structural element. These stones (Plate 2) were partially surrounded on the north-western and south-western extent by an L-shaped formation of flat rectangular stones [024]. Each stone in [024] measured approximately 0.6 m in length by 0.23 m in width by 0.2 m in depth and only one course was observed during excavation.

The stone features observed within the internal corner of the wall were not fully investigated but are likely to represent much later additions to the building. On the outer corner, the end of a narrow wall was seen to abut the main structure, but unfortunately there was insufficient time to fully investigate this.

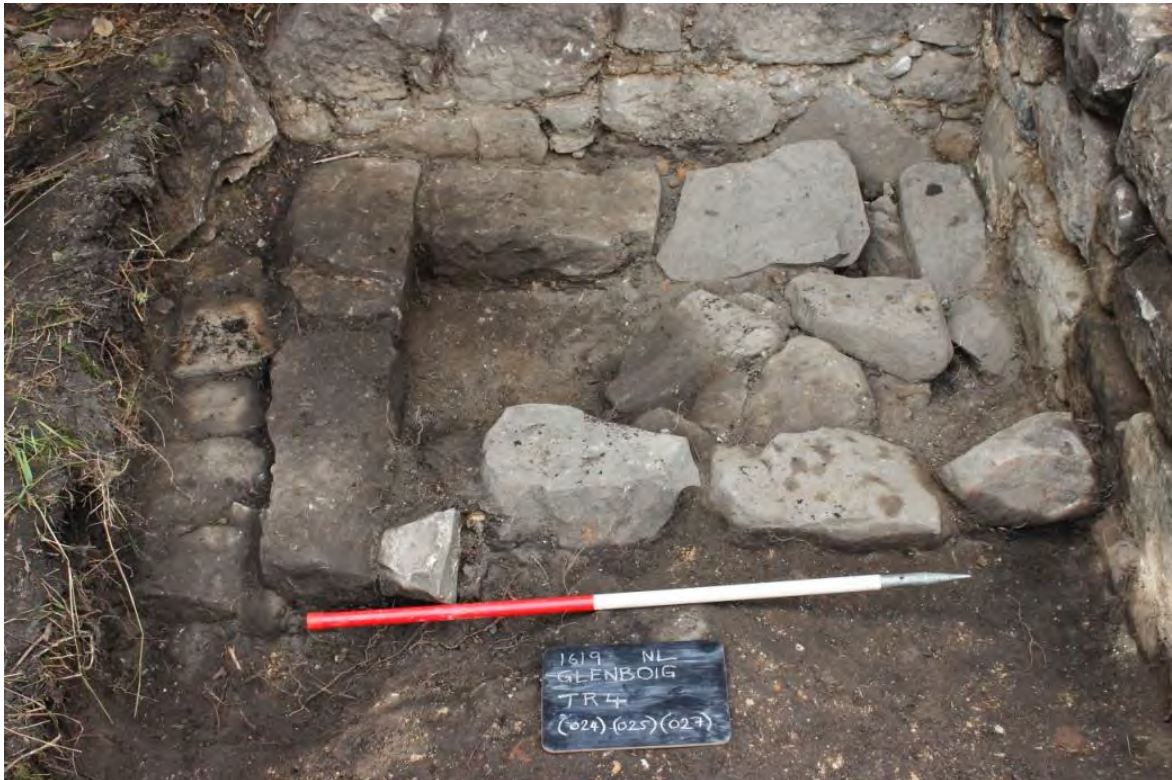
Figure 14: Post excavation of Trench 4, showing deposits [024], [025] and [027]

To the western side of stone feature [024] was a further possible structural element [025], in the form of a row of stones approximately 1.3 m by 0.25 and greater than 0.1 m deep; however due to the limit of excavation these were only partially revealed.

To the south western side of the trench, between wall [020] and deposits [024], [025] and [027], was a level deposit of friable dark greyish-brown sandy loam (026). It is unclear as to whether this was a surface of some kind as due to time constraints it was not investigated.
