Bus Station, Lombard Street, Newark, Notts.

Archaeological Evaluation

NFAC Report No. 0928

January 2011

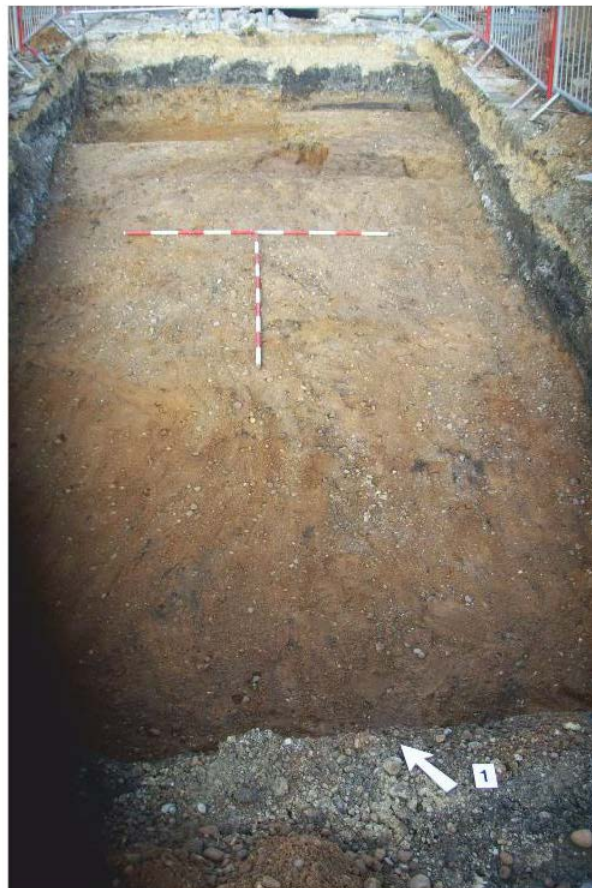
Pl. 2 Trench 1 looking north. Scales 2m

Trench 1 was situated at the north end of the site, close to the modern street frontage on Lombard Street (Pl. 2). The stone paving slabs and underlying crushed limestone bedding (**100**) were 0.25-0.30m thick, and overlay a layer of made ground comprising lenses of black and grey sands and concrete (**101**). This made ground of presumed 20th century date overlay the natural orange sands and gravels, **102**.

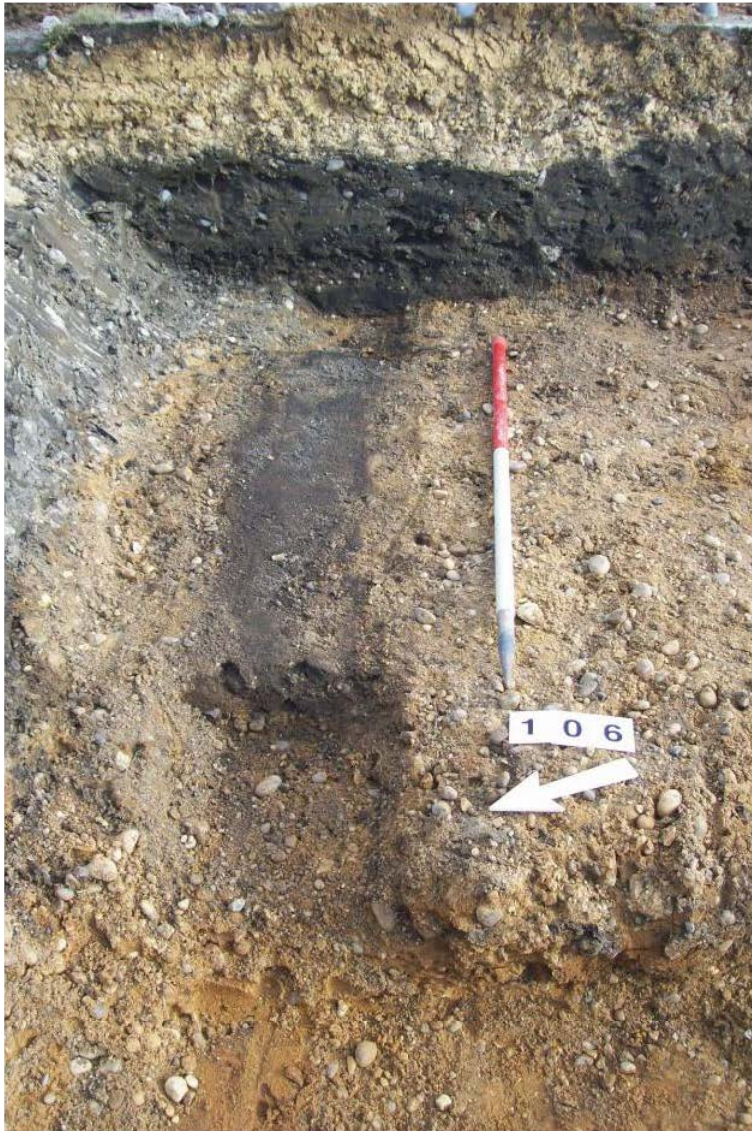
Pl. 3 Gully 106. Scale 1m

Beneath **101** at the north end of the trench, were two gullies which were dug into the natural. Gully **106** crossed the full width of the trench. It was 0.30m wide and 0.08m deep with shallow, sloping sides (Pl. 3). Gully **104** lay 1.60m south of, and parallel to, **106**. It extended westwards for 2.3m into the trench and had a rounded terminal. It was 0.60m wide and 0.50m deep with sloping sides (Pl. 4). The fills of these gullies, 105 and 103 respectively, were a dark grey-brown sand; there were no finds in either feature. A small sondage was dug at the north end of the trench in order to confirm that the deposits encountered were in fact natural.

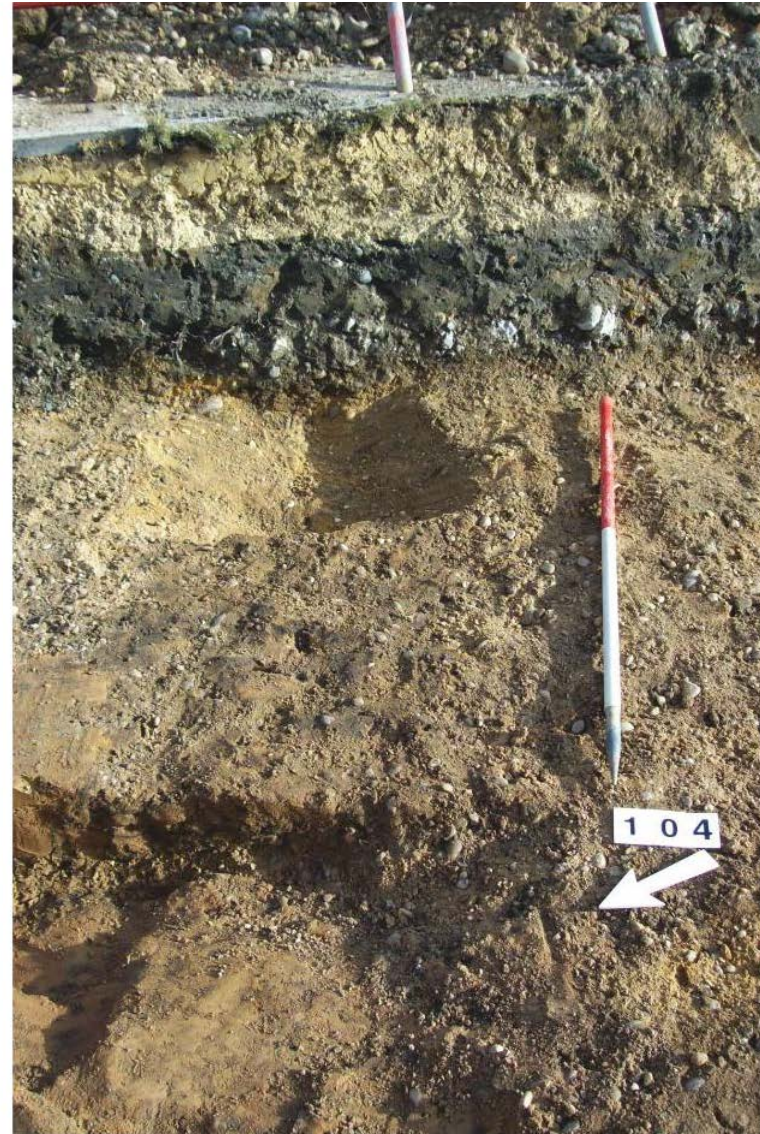
Pl. 4 Gully 104. Scale 1m

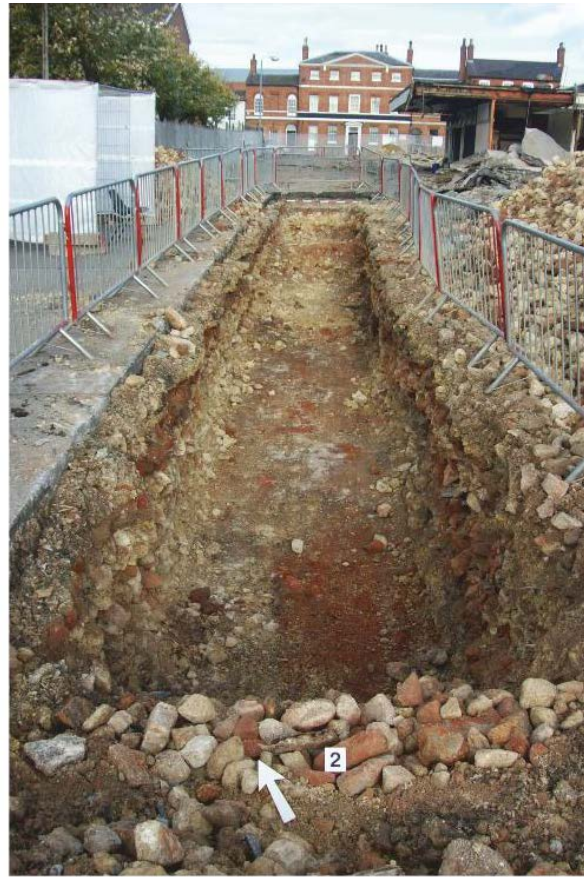
Pl. 5 Trench 2 looking north

crushed limestone hardcore beneath the concrete (**200**) and a mixed deposit of limestone cobbles and brick rubble (**201**) which was a minimum of 0.90m thick. The excavation did not penetrate the base of this deposit (Pls 5 and 6).

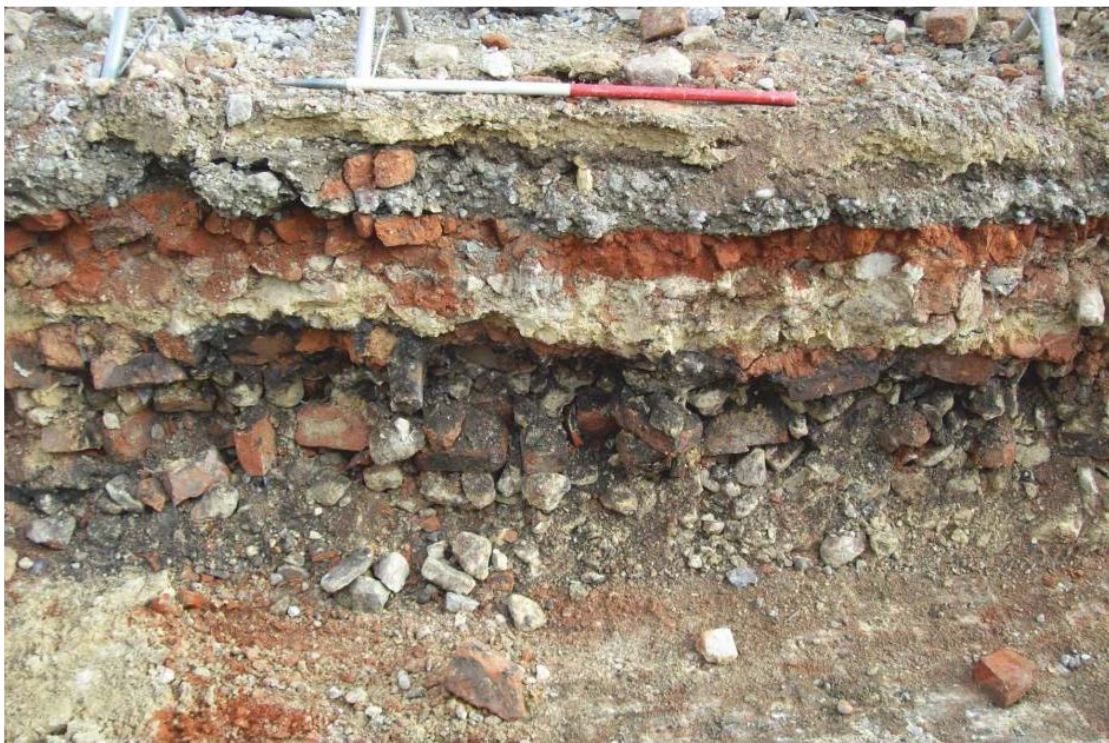
Pl. 6 Trench 2 typical sequence of deposits. Scale 1m

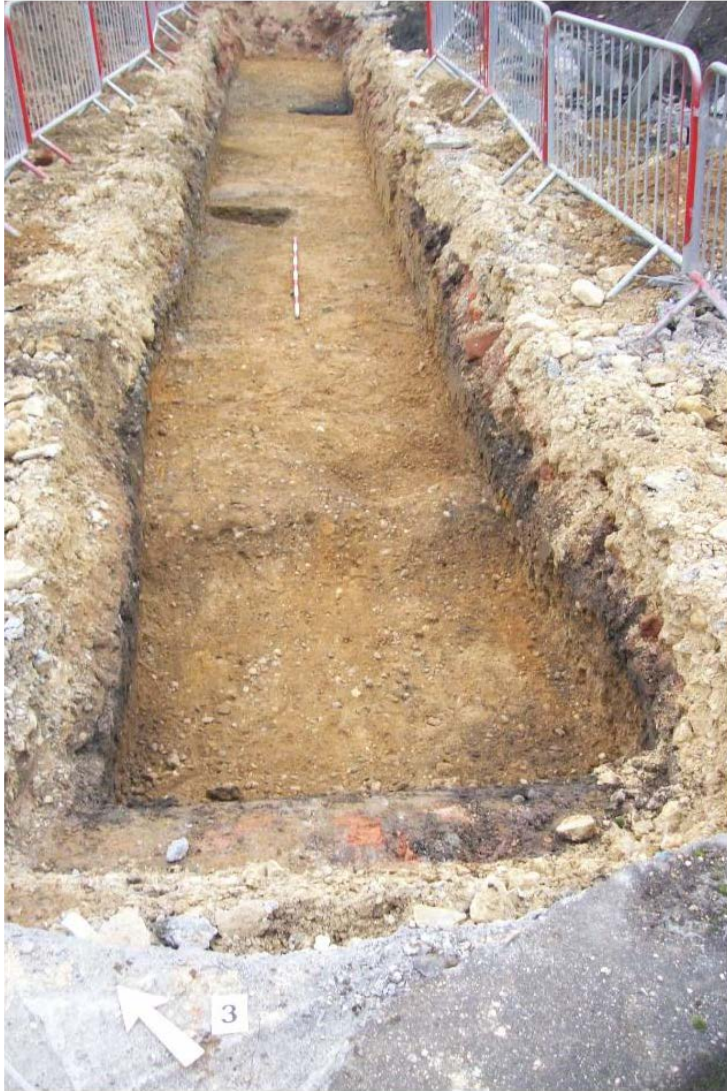
Pl. 7 Trench 3 looking south-west. Scale 2m

Concrete pads and underlying crushed limestone, **300**, was removed to reveal remnants of a dark greyish brown silty soil topsoil **301** which extended over the area of Trench 3 at the south end of the bus station site (Pl. 7). It was 0.20m thick and removed by machine to reveal a soft brown sand subsoil **302** also 0.20m thick. Three features were recorded in this trench. At the south end of the trench was gully **304** which crossed the full width of the trench (Pl. 8). It was 0.60m wide and 0.20m deep with a shallow rounded base. Its fill **303** was a brown sand and gravel. There were no finds. Towards the centre of the trench on west side was pit **306**. It measured 0.75m x 0.90m and was also 0.20m deep. Its fill **305** was a grey sand and gravel and it contained no finds (Pl. 9).

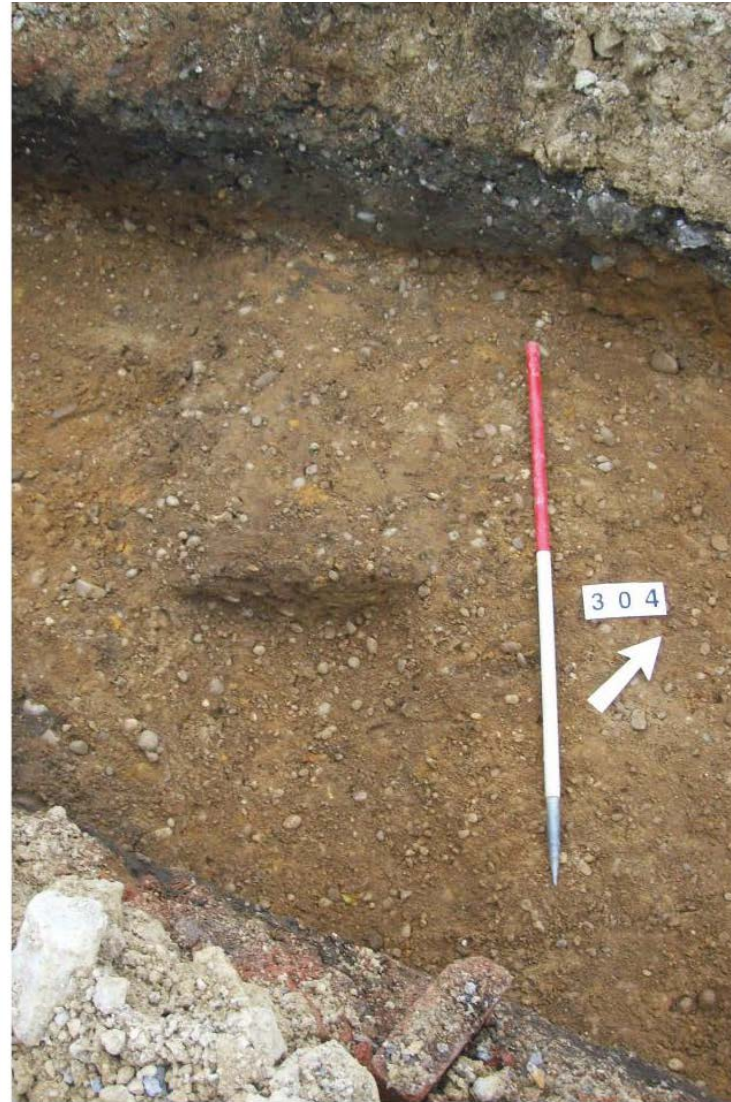
Pl. 8 Gully 304, looking north-west. Scale 1m
