**Static Caravan Site, Mareham Lane, Kirkby la
Thorpe, Lincs.**

Archaeological Watching Brief

NFAC Report No. 0931

February 2011

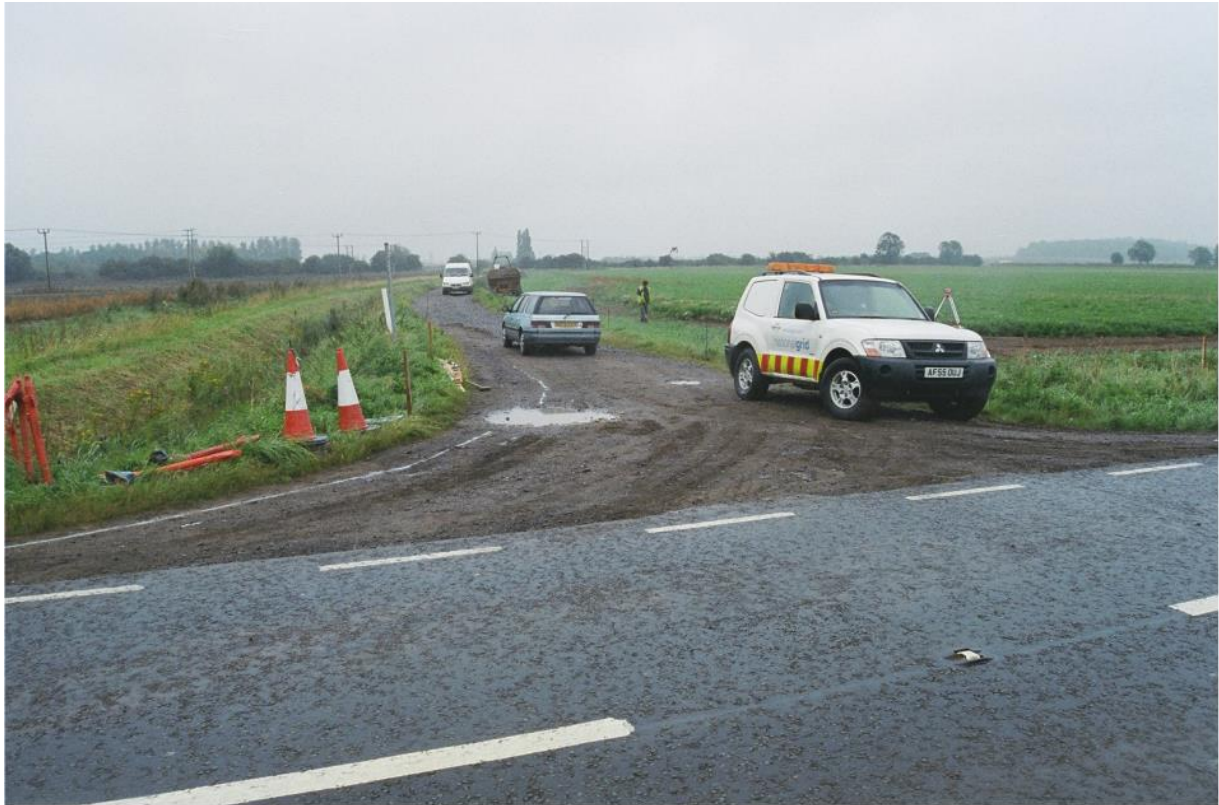
Pl. 1 Farm track at junction with Mareham Lane, prior to stripping and widening for new access road, view east

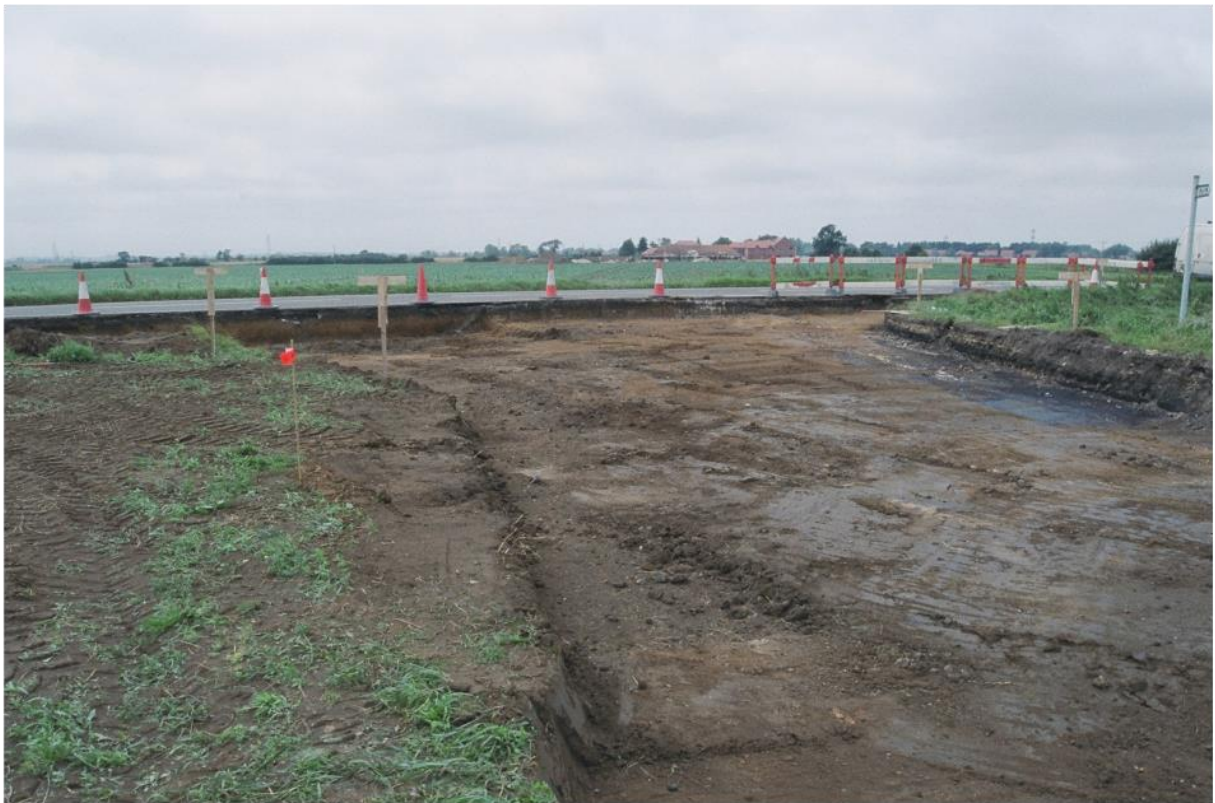
Pl. 2 Entrance to access road off Mareham Lane after stripping, view west.

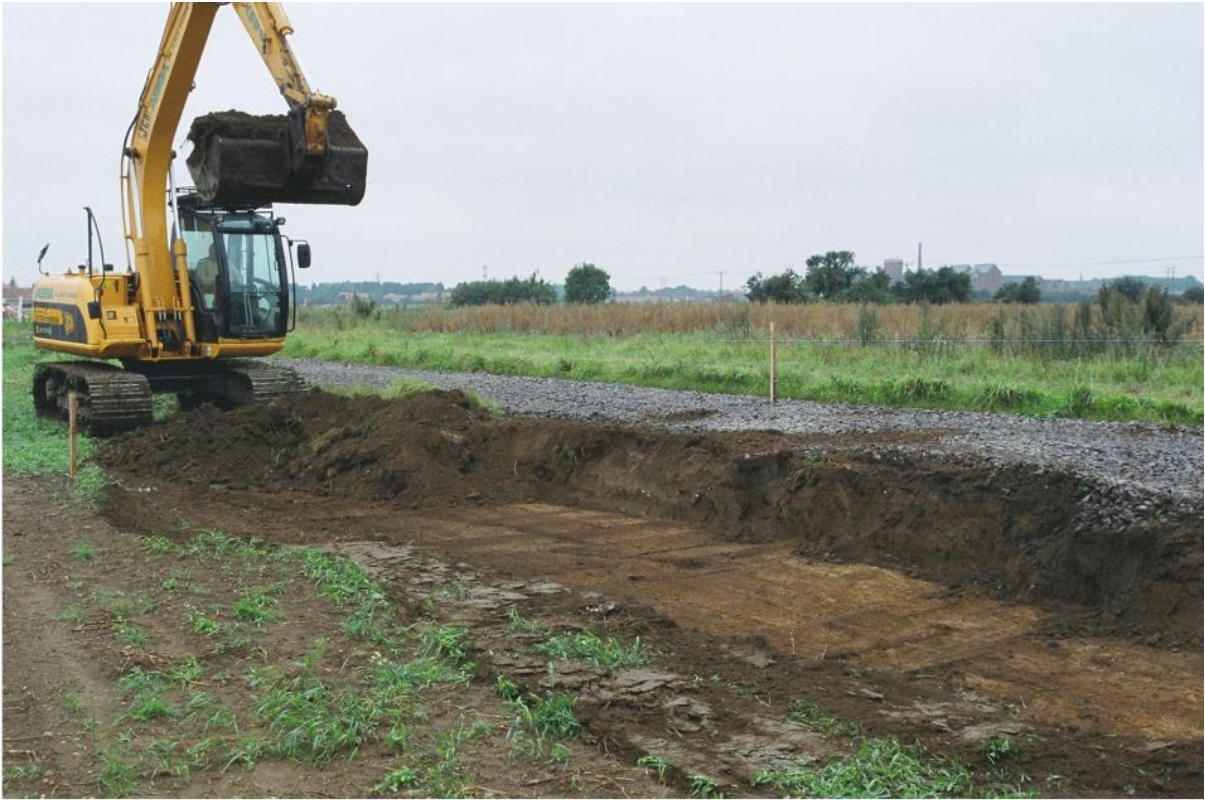
This involved the upgrading an existing farm track. The access road was constructed from Mareham Lane as far as the line of the disused railway track that forms the boundary of the caravan park, but no further (i.e. across one field). The total monitored length was 300m. The existing track was 4.5m wide and had a flanking 7m-wide ditch to north (Pl. 1). There was also a narrower ditch running along the east side of Mareham Lane, which was 3.2m wide. The new access road was 7.8m wide with passing bays on the south side, every 75m. The junction with Mareham Lane was widened and c.0.40m of soil was removed adjacent to the road surface (Pl. 2). Ground along the track was scraped to a depth of up to 500mm before being stoned up (Pl. 3).

Pl. 3 Stripping in progress, view north-west.

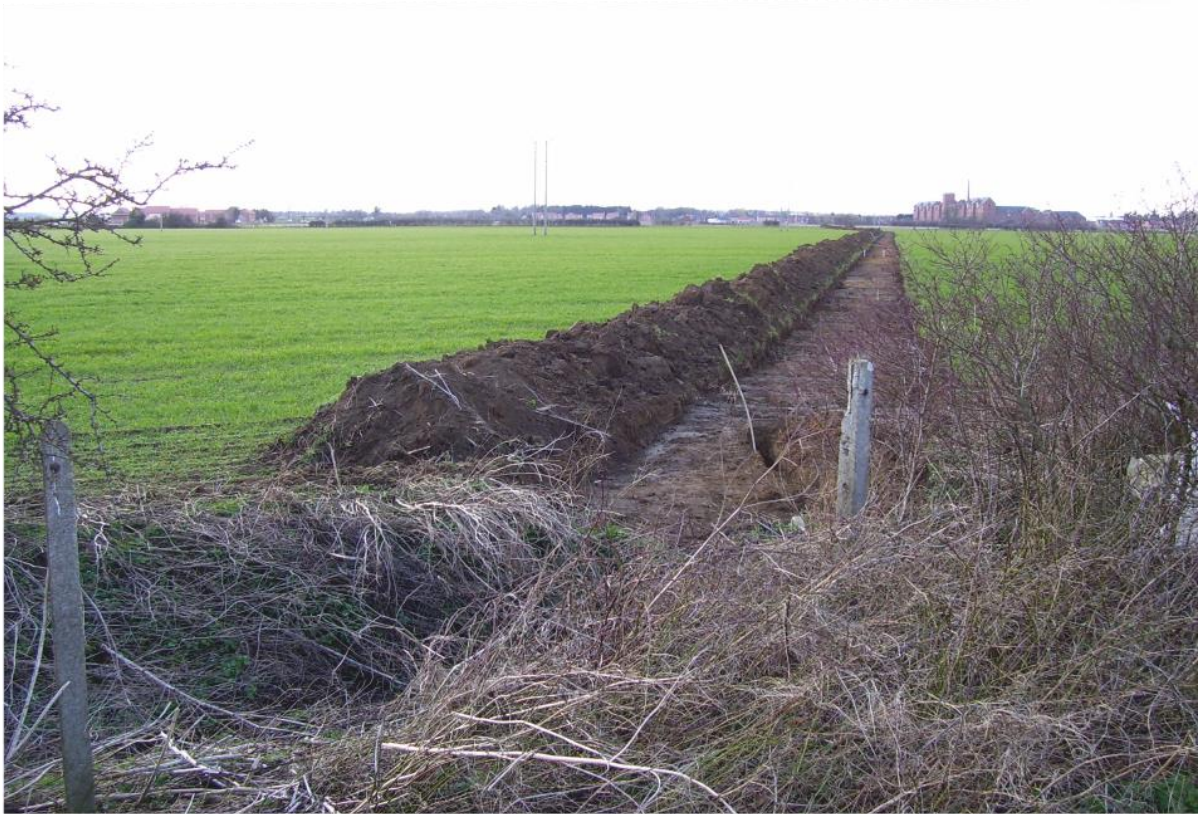
A 3m-wide easement trench was stripped for the installation of a 125mm diameter sewer pipe which ran north-west from a substation adjacent to the old railway line and north of the access road (Pl. 5), across the Roman Mareham Lane and westwards towards a sewage pumping station at the edge of the housing on the modern Mareham Lane (Pl. 10). Excavation began at the east end of the route, at the substation and monitoring continued to a point just west of the parish boundary between Kirkby la Thorpe and Sleaford.

Pl. 5 View from east end of rising main easement, looking west

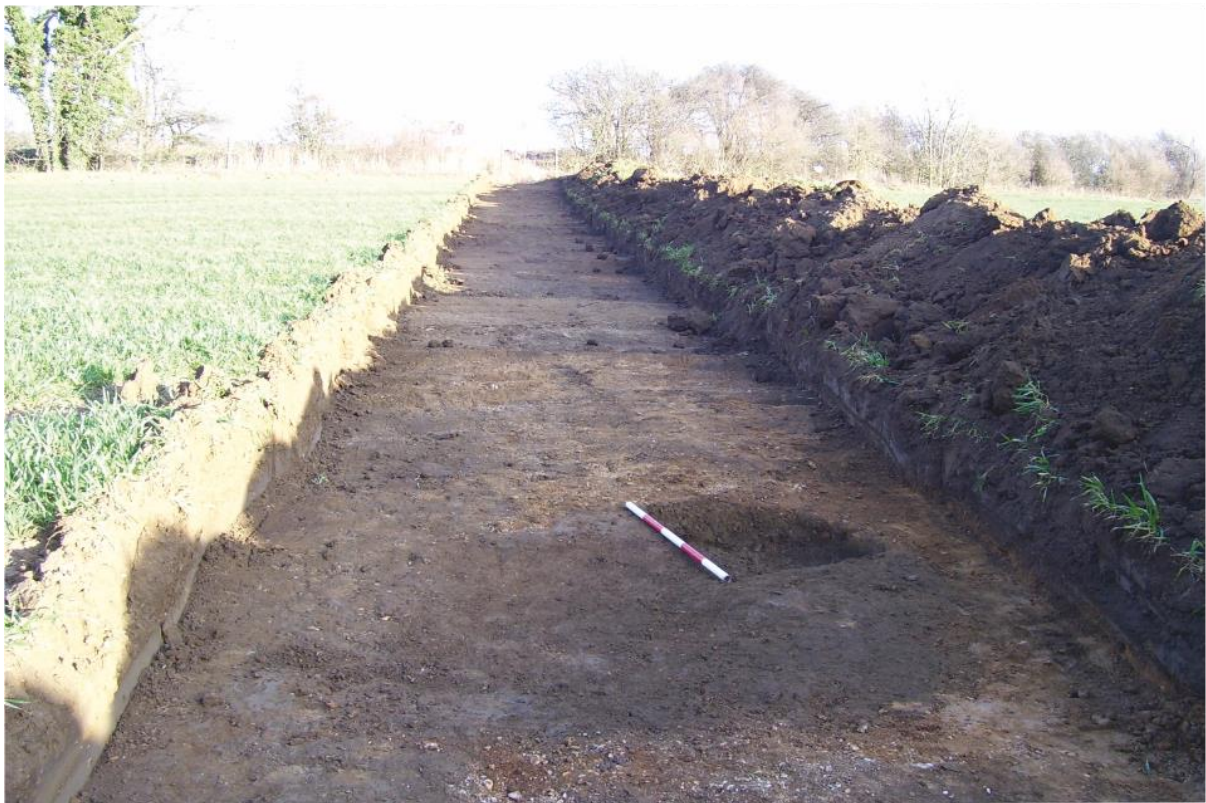
The easement was stripped to an average depth of 0.30-40m. Beneath the topsoil **117** and subsoil **118** was a mixed natural silty clays with bands of sands and gravels **121**. A large pit (**116**) 2m in diameter was recorded 50m west of the east end of the easement (Pls 6 and 7). It contained a dark brown clay loam fill (**115**) similar in colour to the topsoil. It was 0.10m deep at the edge, with a sloping base, giving a maximum depth of 0.30m. There were no finds.

The excavation of the farm trackway to create a more substantial access with improved entrance established that there were no archaeological remains beneath the trackway surface. Pit **116** had a clearly defined edge which means that it was not a tree bole but had been deliberately dug out. Its fill was similar in colour to that of the topsoil which perhaps implies that it is of relatively recent date, but a more certain date and function cannot be suggested as there were no associated finds.

Pl. 6 Pit 116, view looking east. Scale 0.50m

Pl. 7 Pit 116, part excavated , looking north-west. Scale 0.50m

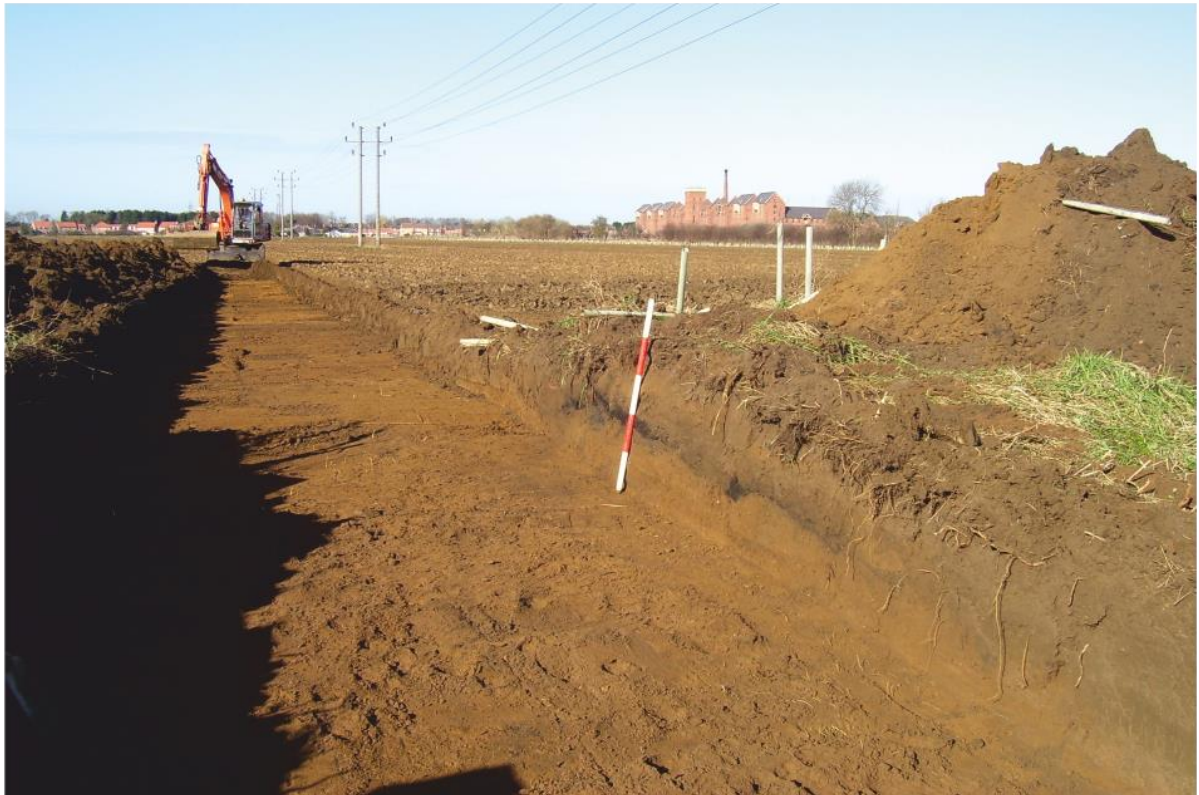
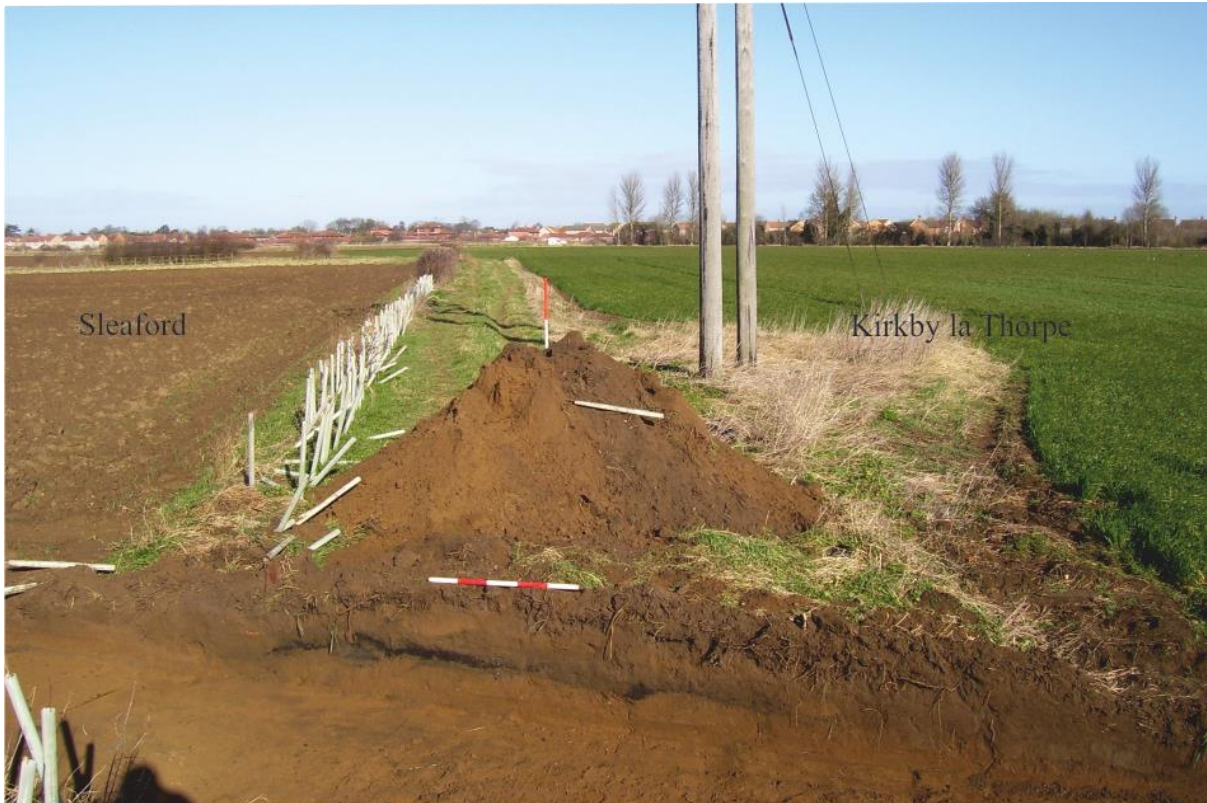
Where the easement crossed the parish boundary between Kirkby la Thorpe and Sleaford there was a low bank which followed the boundary (Pls 8 and 9). Beneath the subsoil 118 was a burnt layer **119**, comprising black ash and fine clinker **120**. This overlay the natural deposits **121**. There was no sign of the Roman road; neither beneath the boundary, nor to one side- the line of the road is shown on Ordnance Survey maps slightly to the west of this boundary.

Of particular interest was the point where the easement for the rising main crossed the parish boundary. The position of the boundary was determined by the route of the Roman road but there was no sign of any ditches or metalled surface either on the boundary itself or to either side. There was clearly a bank along this boundary but the ash deposit recorded in section is probably no more than evidence for the burning of an earlier hedge along the boundary.

Pl. 8 View of easement crossing the parish boundary between Kirkby la Thorpe and Sleaford, looking west. Scale 0.50m

Pl. 9 View along the parish boundary between Kirkby la Thorpe and Sleaford, looking north.
Scale 0.50m

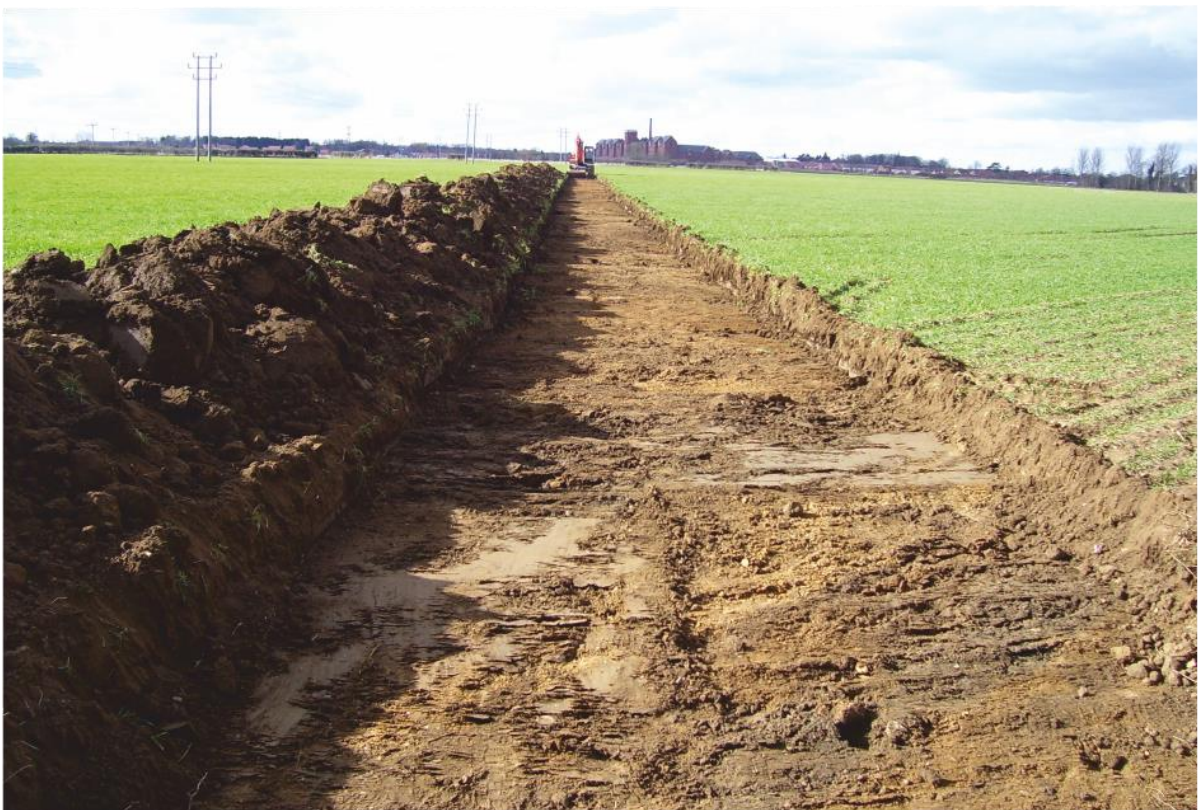
Pl. 10 View along the western part of the easement, looking west towards Sleaford
