**Forth and Clyde Canal
Lock 17, Underwood
Survey and Trial Trenching**

Archaeological Survey and Excavation
August - September 2009

Project Code: BW-FC17-2009-02

Description: Survey and trial excavation of modern overburden on the Antonine Wall.

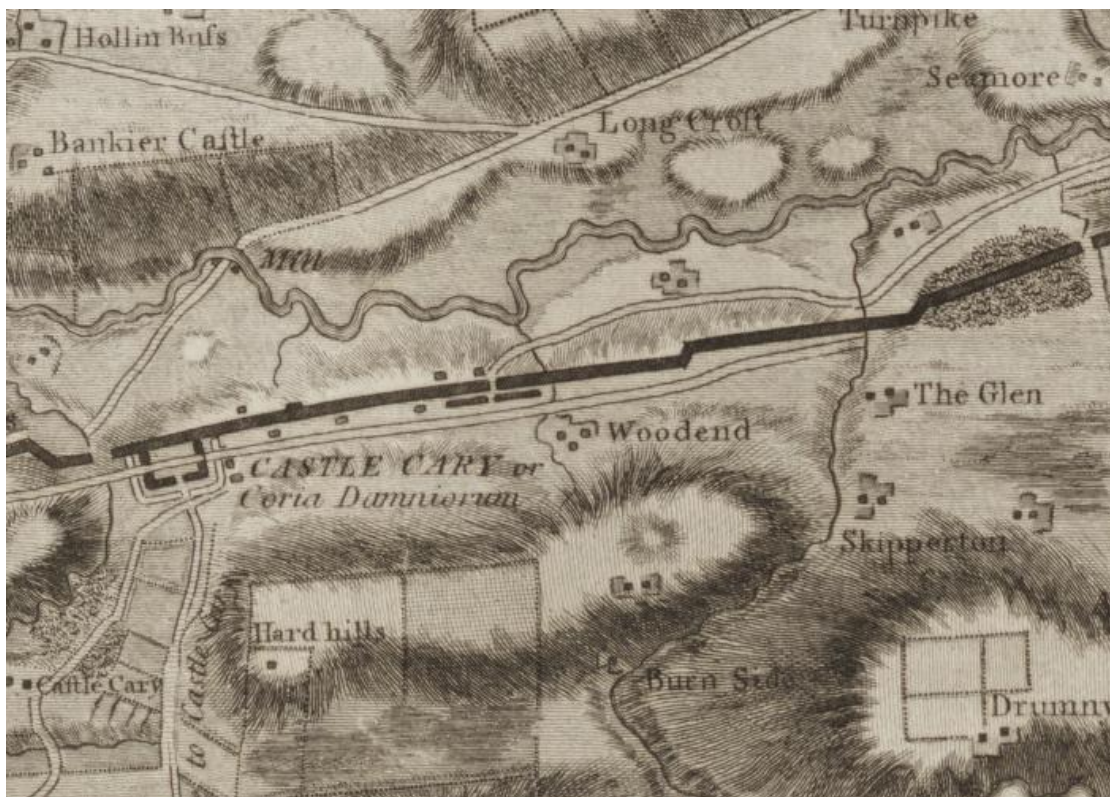
Figure 2: The area before the Canal: a survey by General Roy, published in *The Military Antiquities of the Romans in North Britain* in 1793.

Underwood House and garden lie on the N side of the Canal, immediately adjacent to Lock 17. The house, together with its boundary wall and gate piers, is a Category C(S) Listed Building. Roy's map (figure 2) published in 1793 but surveyed in the mid 18th century shows an unnamed settlement in the approximate location of Underwood and is indicative of an earlier settlement on this site. Grassom's map of 1817 (figure 3) shows that there was a house of some substance on the site by the early 19th century and the present house is a well-detailed and well-preserved mid 19th-century villa. It is also indicative of the successes of the Canal, bringing new industry and increased wealth to parts of Central Scotland. Underwood House was built by Mr Robert Bennie, the owner of a chemical works that lay to the E of the house, at the rear of Underwood Lockhouse. A hostelry was established due to the increased population brought to the area by the works, the Canal and the nearby Stein's Brickwork at Allandale. A bowling green was also established in the grounds of Underwood House. The OS map of 1859 (figure 4) shows that Underwood boasted a walled garden, the external wall of which lines the driveway, and a lodge facing onto the Canal towpath. Towards the end of the 19th century, the chemical works began to fall into disrepair and the fortunes of the Underwood community declined. Underwood House continues to be inhabited, however the walled garden and surrounding property have fallen into disrepair. A farm and new housing occupy the site of the former chemical works.

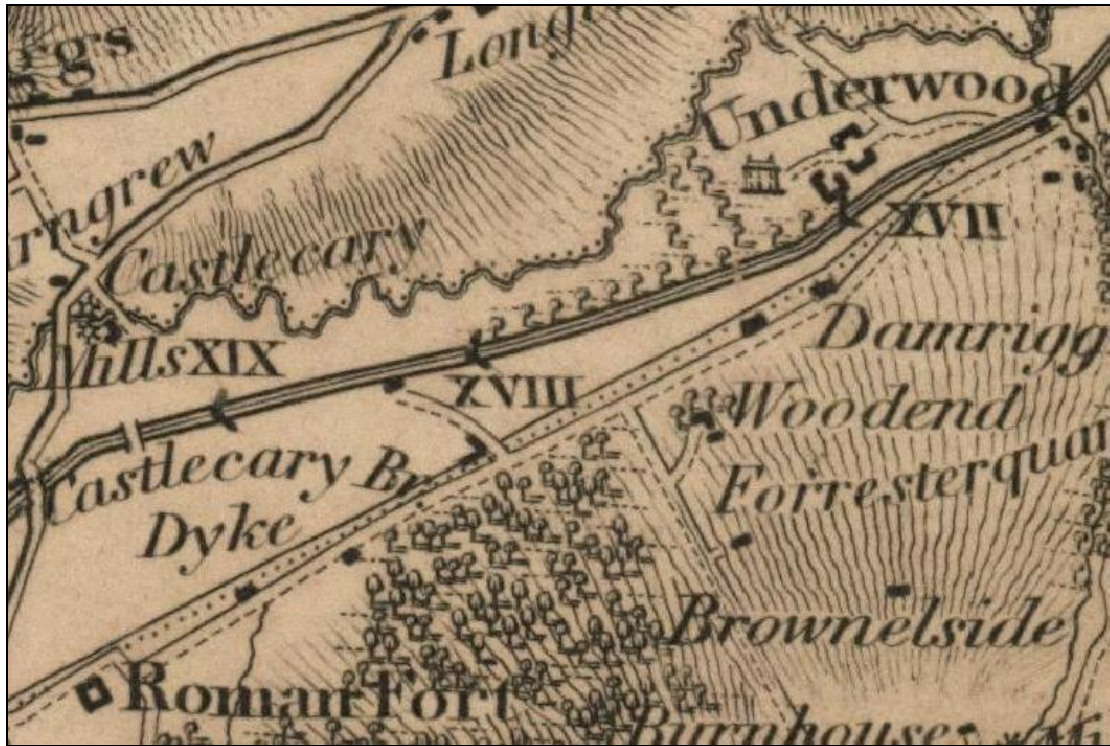
Figure 3: Detail from John Grassom's map of 1817.

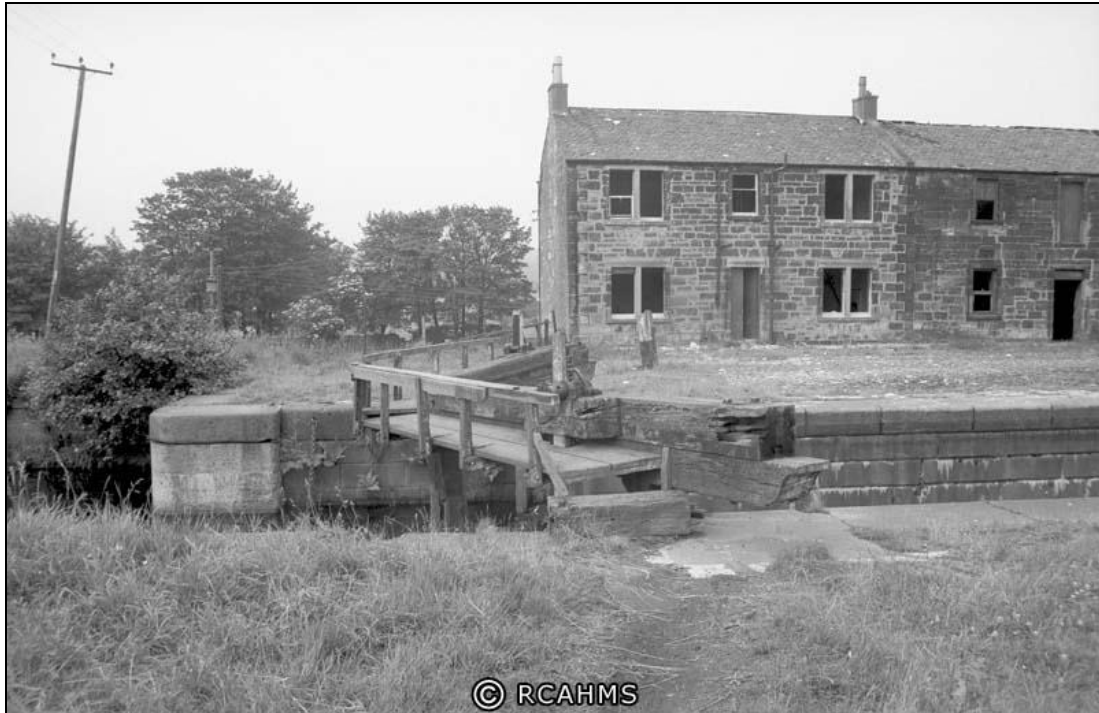
Figure 6: View of 1970 from SSE showing top of W lock gates with part of lock keeper's house and stables in background (RCAHMS SC733396)

Photographs of the lock keeper's house and stables (figures 6 & 7), and the lock itself (figure 8) were taken in 1970 and 1981 respectively and show the buildings prior to their modern refurbishment.

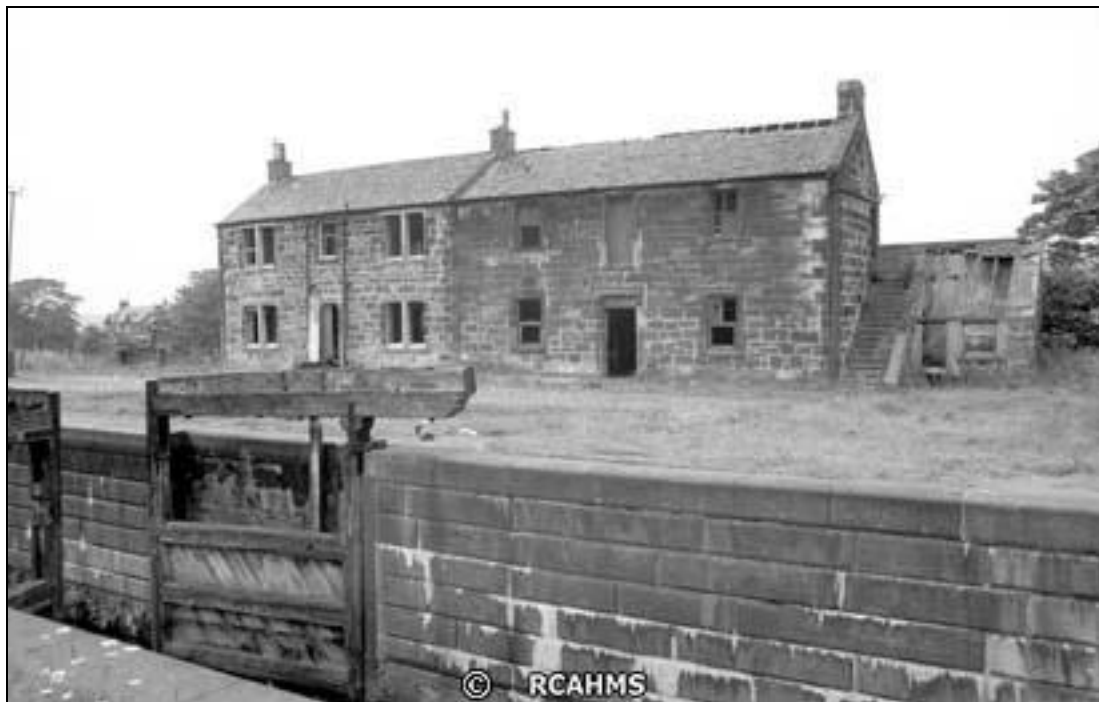
Figure 7: View of 1970 from SE showing SSE and ENE fronts of lock keeper's house and stables with remains of E lock gates in foreground (RCAHMS SC733397)

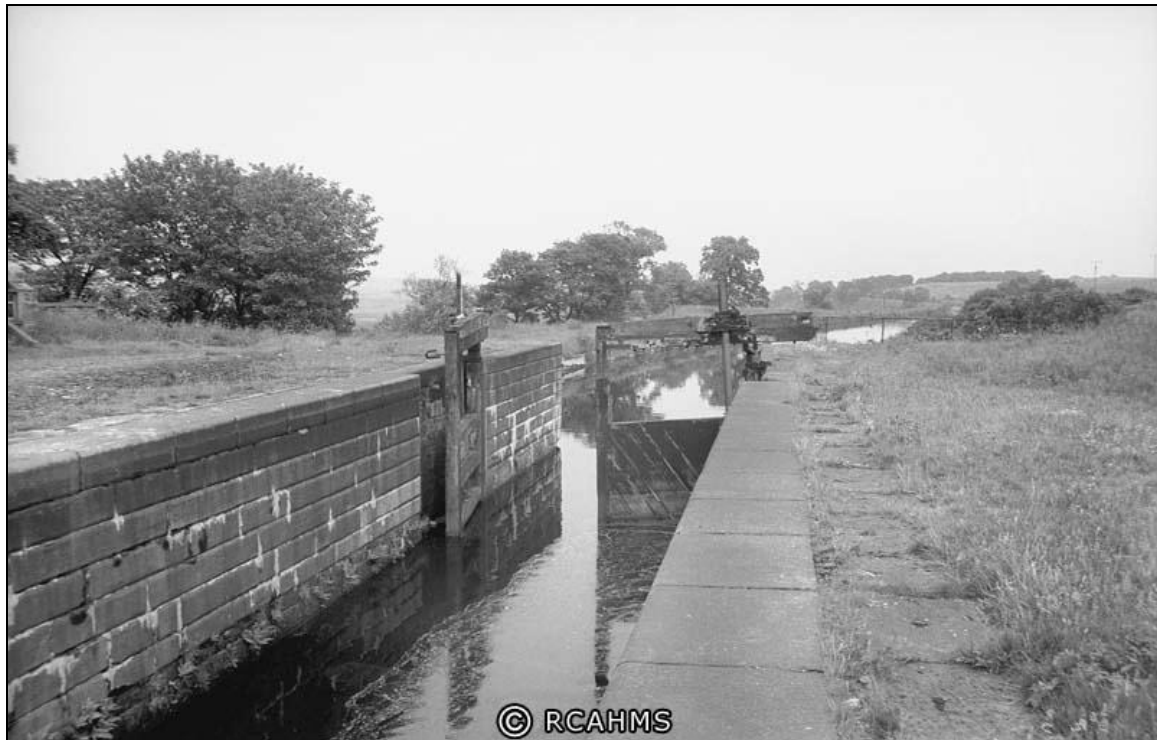
Figure 8: View in 1981 from SW showing WSW front (RCAHMS SC573879)

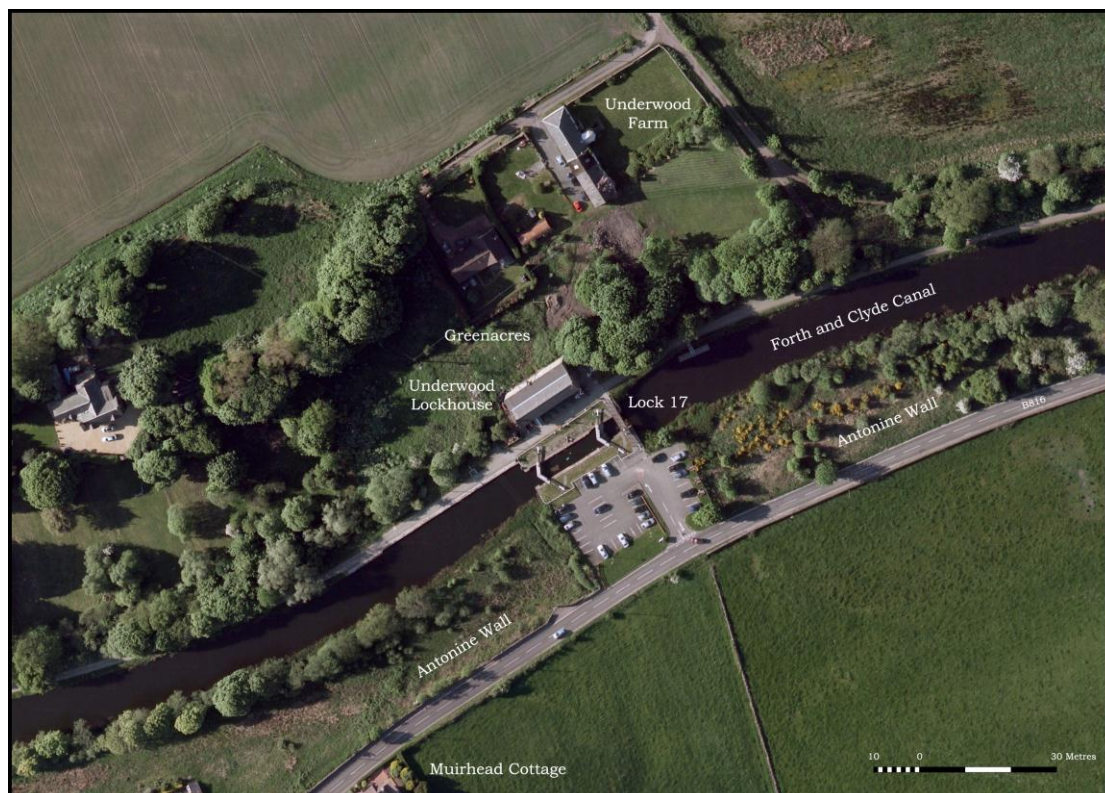
Figure 10: Annotated aerial photograph of the area

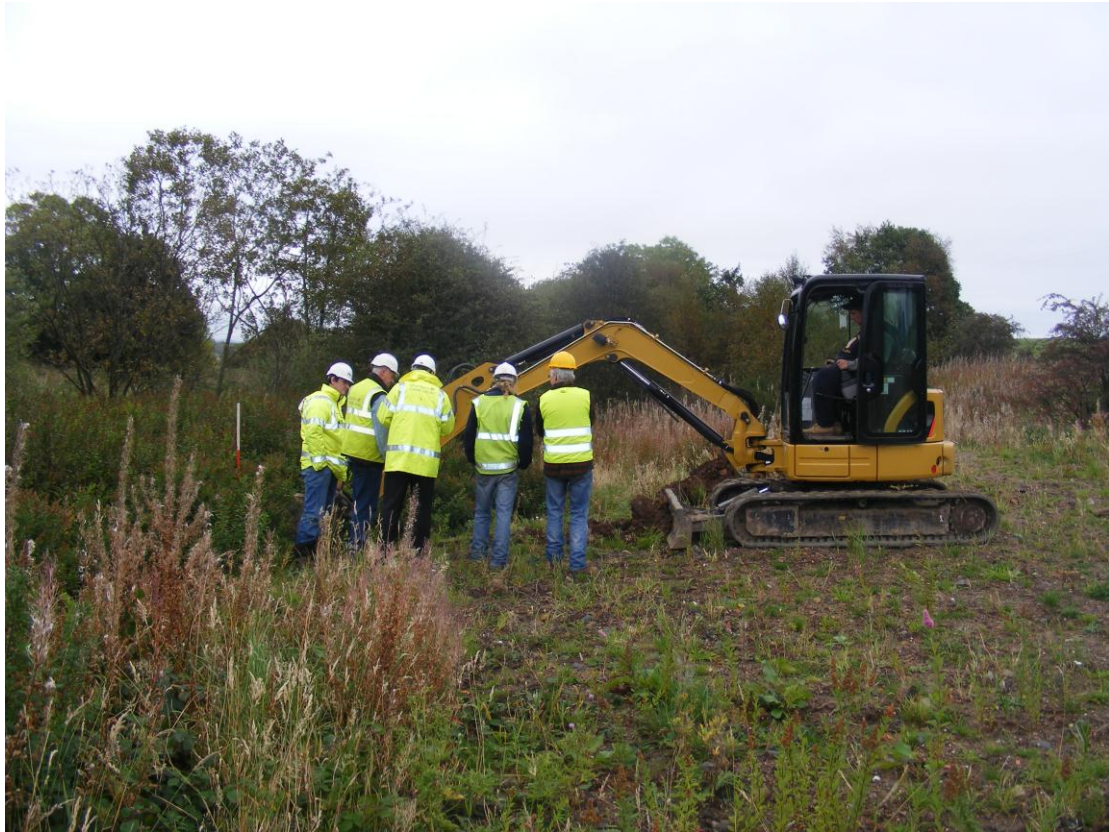
Figure 15: Opening Trench 3

Two trenches were excavated within the area of spoil heap F043, both running from N to S across it. The aim of this exercise was to both quantify and characterise the introduced material and typify the archaeology below it, and it was felt that two machine dug trenches near either end would be most helpful in this. The excavation was carried out by a 7.5 tonne excavator, under archaeological supervision and was monitored by British Waterways Scotland and Morrisons Construction staff

An important aim of this project was of course not to damage any upstanding archaeological remains below the spoil heap. To this end the excavator was fitted with a flat bladed bucket, 550 mm across. For reasons of health and safety, no part was to be hand dug, and the archaeological recording was completed outside each trench. This in turn, constrained the level of detailed recording. However, the excavation was closely archaeologically monitored and W facing trench sections were drawn, photographed and recorded on *pro rata* context sheets.

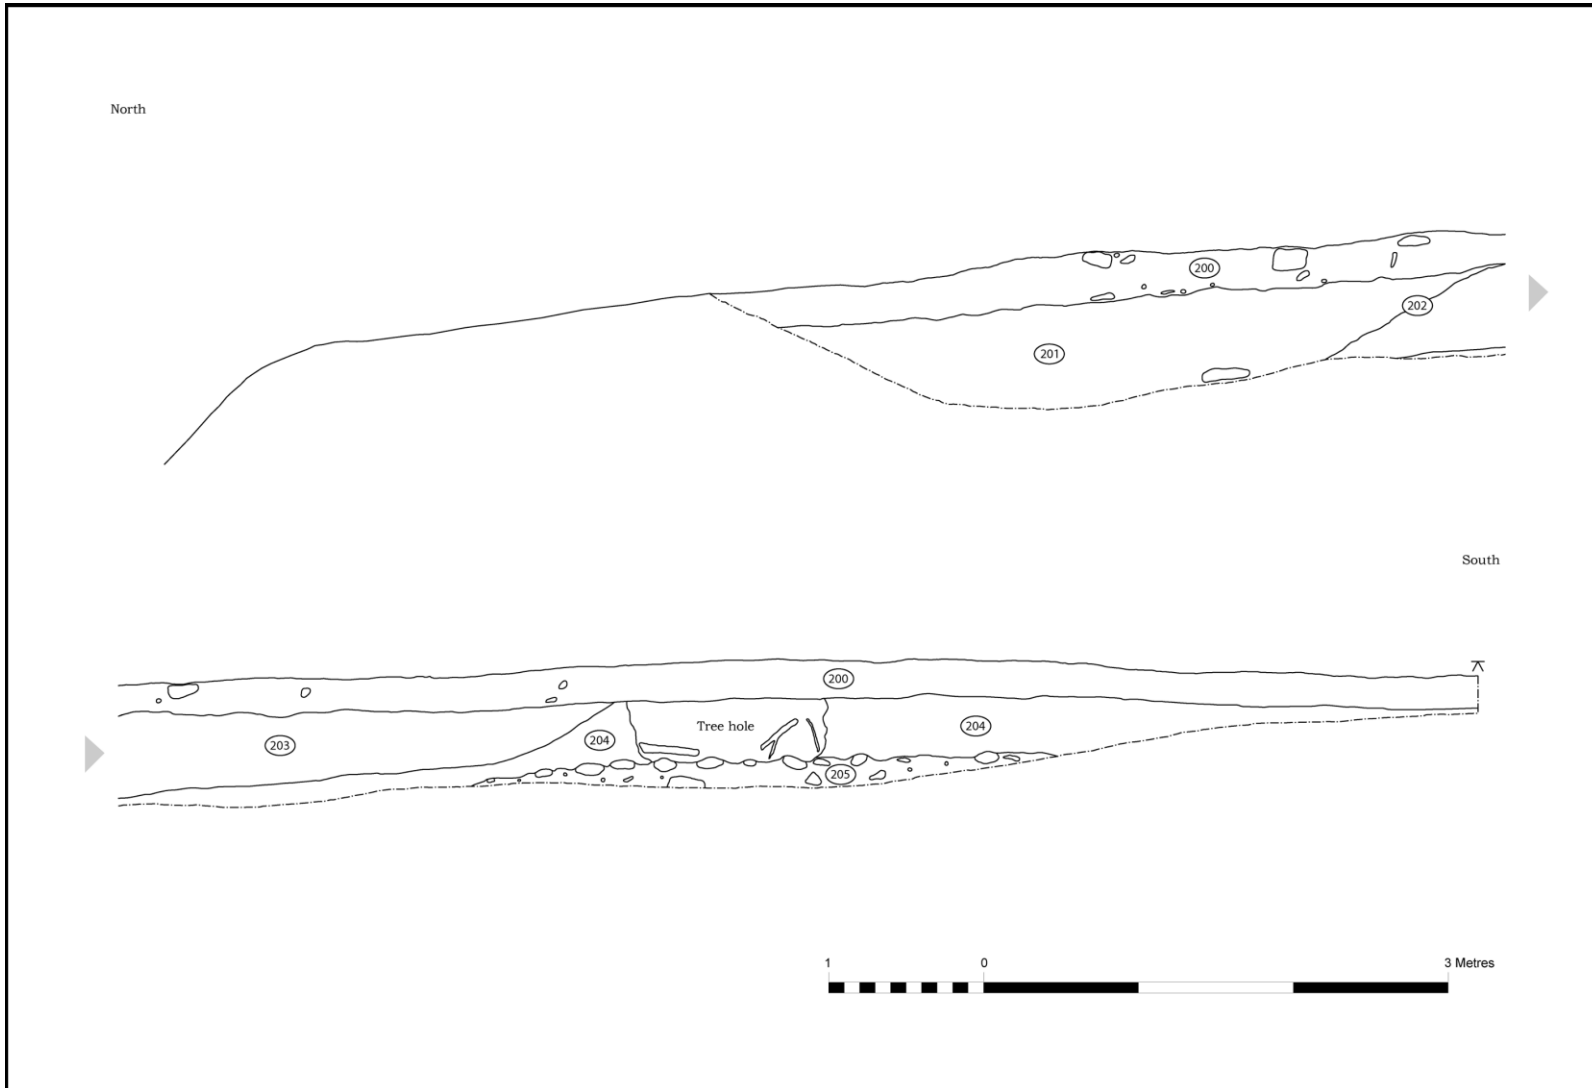
Figure 16: W Facing Section of Trench 2

The northern 5 m (continuing to the N) was filled by **F201**, a mixed deposit comprising principally sub angular whin gravel, with mid brown silty clay and occasional flecks of blaze throughout. This sat in a cut **F202**, only the S edge of which was located in the trench. It had a 45 degree slope for this edge, and was at least 5 m wide and 800 mm deep.

F202 was dug against **F203**, a substantial deposit comprising almost entirely blaze, often powdered but with some larger chunks, with discrete patches of dark grey to brown silty clay throughout it. It was 500 mm thick and some 4.2 m long, although with its N end truncated by **F202**, and its S end disturbed by a tree hole. **F200** ran directly over the top of **F203** away from cut **F202**.

Running under the S end of **F203** was **F204**, a compact very dark grey silty clay with frequent roots (including a large tree hole at the S edge of **F203**). This proved surprisingly thick (up to 400 mm) and was traced over the southern 9.6 m of the trench. Below **F204** was **F205**, only traced for a length of 3.8 m from the S edge of **F203**, but continuing to both N and S. This was fairly compacted pale yellow to brown sandy silt, rich in small to medium rounded and sub angular stones. Little of **F205** was seen, but at its N end it gave the impression of dropping down gently.

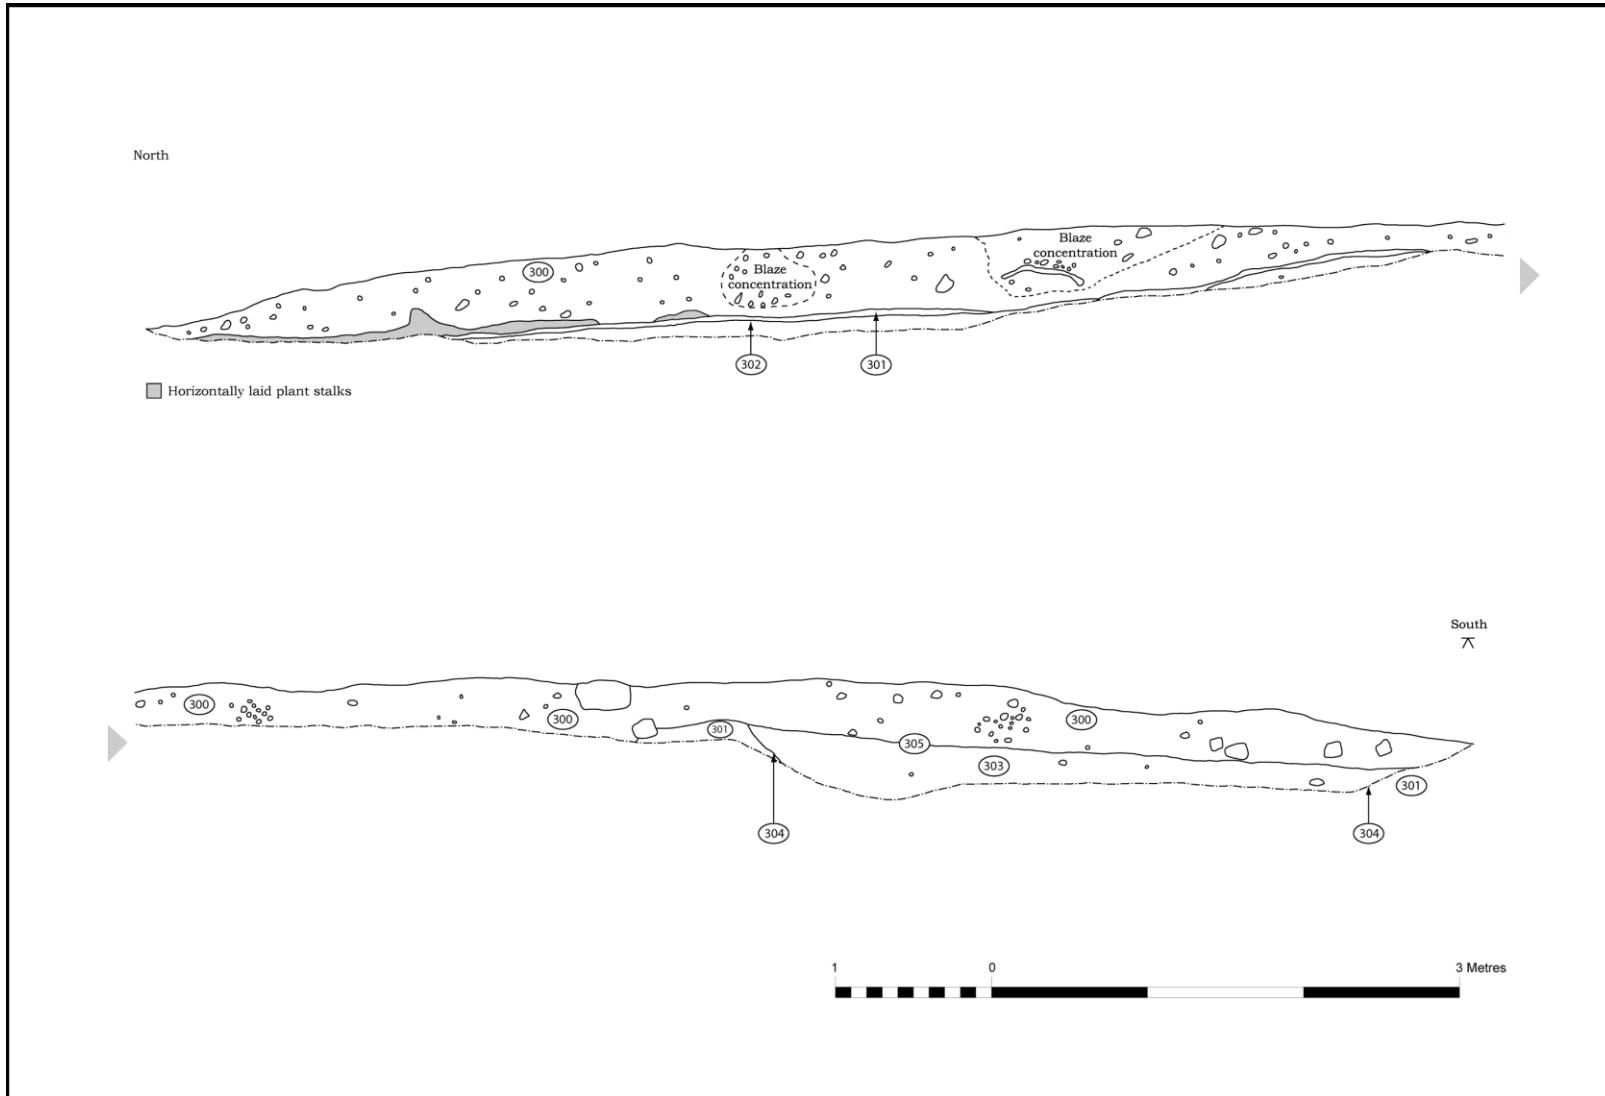
Figure 17: W Facing Section of Trench 3

The overlying deposit along the length of the trench was **F300**. This proved to be a moderately compact mixed deposit, principally mid brown silty clay but with discrete patches of blaze within it. Blaze, tree roots and sub angular stones (up to 500 by 300 mm) were noted throughout, as well as modern finds, which were not retained. The greatest depth of **F300** recorded was at the N end of the trench, where it was up to 500 mm thick, while towards the centre (see figure 16) this reduced to as little as 200 mm, thickening again to the S to a maximum of 400 mm.

Underlying **F300** was **F301**, a thin (100 mm) layer of dark brown to black silty clay. Grass survived within this, and at the N end (where there is thick vegetation today) the crushed stalks of plants forming a thick mat were noted. At the extreme S end of the trench **F301** was reduced to a very thin layer (numbered separately as **F305**), with **F303** below it. This was a pale brown silty clay with occasional small rounded and sub angular stones throughout it. This ran along the southern 4.5 m of the trench and was excavated to a maximum depth of 400 mm. At both its N and S ends **F301** could be seen to drop fairly steeply below **F303**, with just the thin strip of **F305** continuing along at the height of **F301** in the rest of the trench. This drop in height of **F301** was interpreted as a cut, and numbered **F304**, which would make it at least 400 mm deep by some 4.6 m wide at its top and 3.4 m wide at the base of the trench. The sides slope in at around 45 degree angles.

Below **F301** in all but the S end of the trench, **F302** was noted. This was a compact, mid brown, clayey silt with frequent small (up to 100 mm) rounded and sub angular stones throughout. This deposit rose in height in the centre of the trench, and was not seen at the S end, in the area of cut **F304**. Its thickness is unknown.

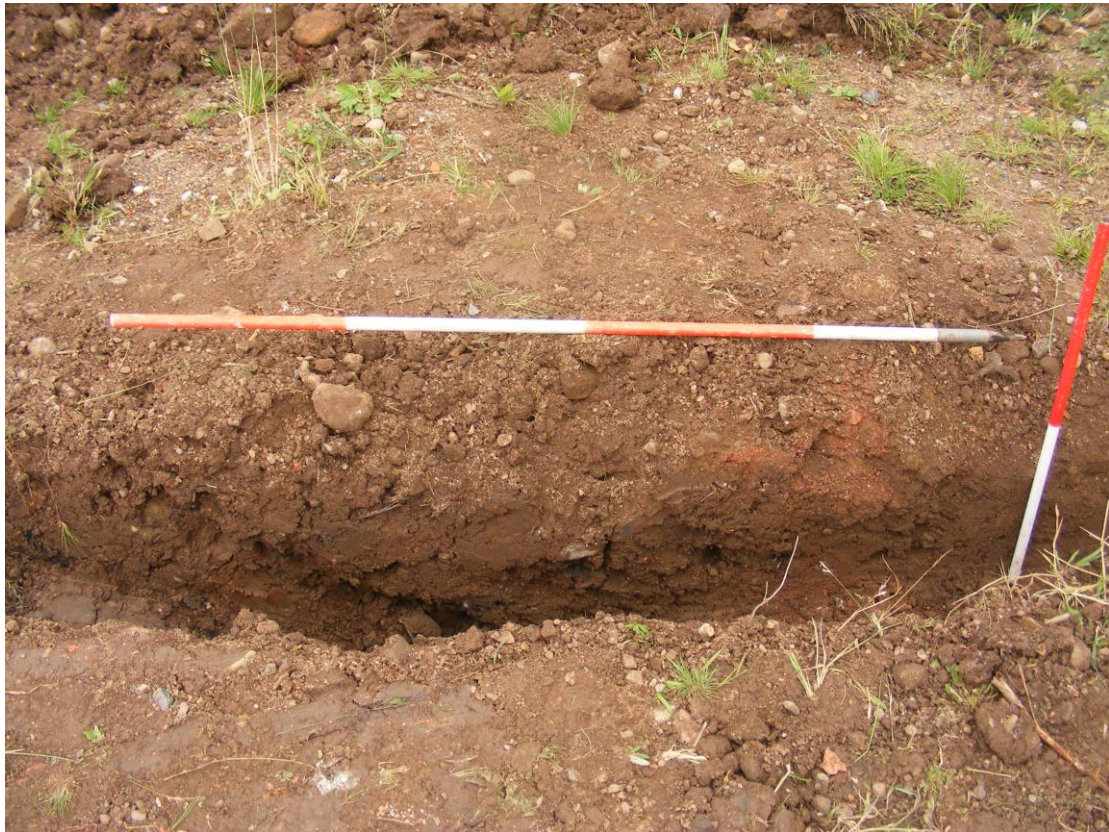
Figure 18: N end of W facing section through cut *F304* (Trench 3)

At this (S) end the thicker topsoil **F301** could be seen to dive down fairly steeply, and deposit **F303** was sandwiched between this and **F305**. This drop in slope was given a cut number **F304**, and this is thought to represent the line of the Roman ditch (F017), corresponding fairly well in both position and dimensions with the traces of this feature noted emerging from the E end of the spoil heap. The implication of this is that **F303** represents an earlier episode of infilling this ditch. No dating evidence for this was recovered, but the thinness of the topsoil **F305** that had formed over it, indicates that this occurred in the relatively recent past. Most likely this occurred in 2003 when work associated with the blaze dam was completed (Period 3)

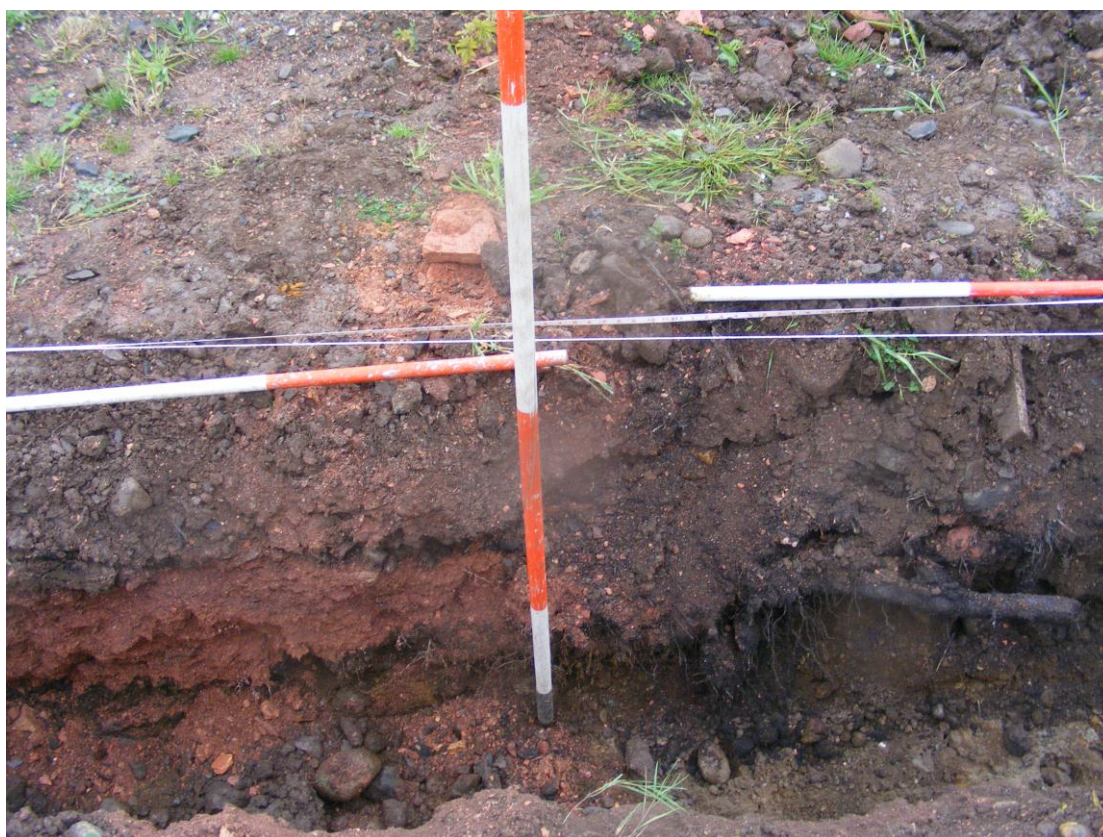
Figure 19: W facing section of Trench 2 showing *F203*, *F204* and the Tree Hole

The S edge of **F202** was dug against **F203**, a substantial deposit of almost pure blaze. This is the remains of the blaze dam created some 5 years ago (Period 3), and traces of the distinctive orange blaze were noted in the recently introduced material in both trenches. No topsoil was noted over the top of **F203**, so this must have been stripped off, or not had time to form on this material of low organic content.
