Maryhill Regeneration Stage 3, Archaeological Works: Data Structure Report

Maryhill Regeneration, Stage 3, Archaeological Works: Data Structure Report

AOC Project No: 20677

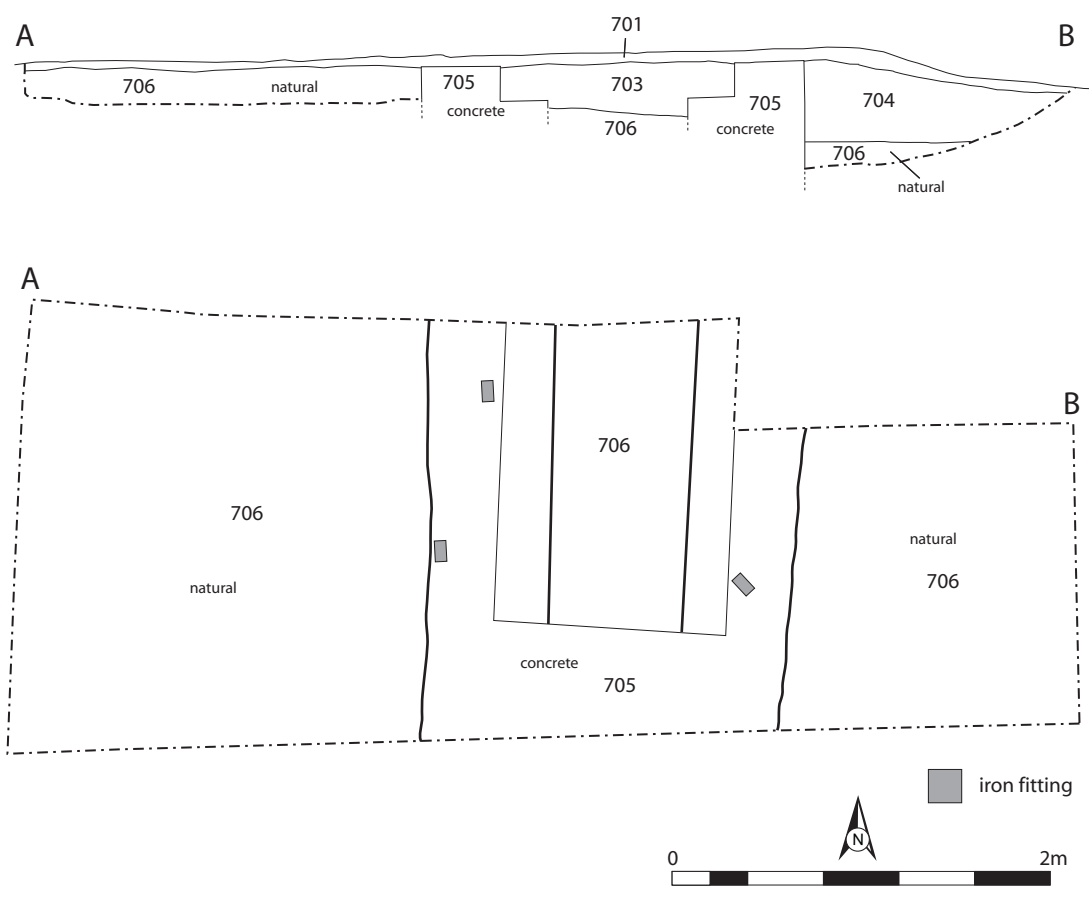
Figure 2: Plan and section of Trench 7

- 4.2.3 Trench 7 (Plates 13 and 14, Figures 2 and 3) was located in the central part of the slope to the east of the Kelvin Dock and measured 5.6 m east/west. It was between 1.6 m and 2.4 m wide. A depth of 0.05 m of topsoil [701] overlay two dark brown mixed loam deposits [702 and 703], a cinder-rich deposit [704] and concrete foundations [705]. Fittings for rail tracks were identified on the concrete surfaces (Plate 15). The above deposits overlay a natural clay deposit [706].

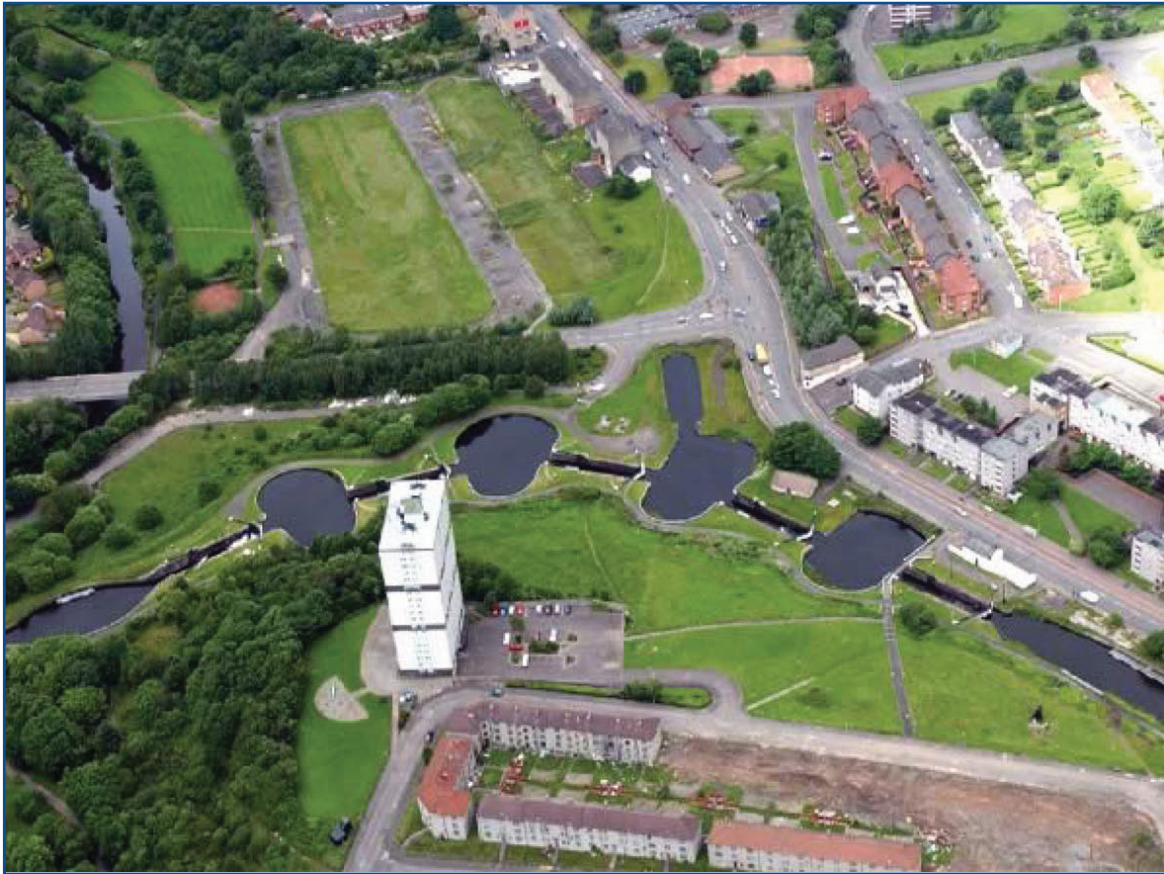
Plate 1: Aerial photograph of the Maryhill Locks

- 1.3.3 Prior to the present works, a site visit was made in January 2009. The Maryhill Locks complex was seen to comprise five restored timber locks linked by four oval basins with an elongated basin in the west linking the locks to the aqueduct (Plate 1). The basins were masonry lined and in a good state of repair. The vegetation either side of the locks had been recently cut and the tow path functioned as part of the River Kelvin walkway. The dry dock and slipway of the old Kelvin Dock are situated on the north side of the basin between Locks 22 and 23. The area west of the locks, where the proposed benches were to be located, was inspected; no archaeological remains were identified. The area north and east of the Kelvin Dock was examined. The remains of the slipway and a path were visible east of the dock (Plate 2). A mound of unknown nature was identified north of the dock (Plate 3). A wall north of the dock, subject to proposed removal, was inspected and photographed (Plates 4 and 5). Several phases of construction/repairs were identified. The eastern wall forming a boundary with Maryhill Road was also inspected and photographed.

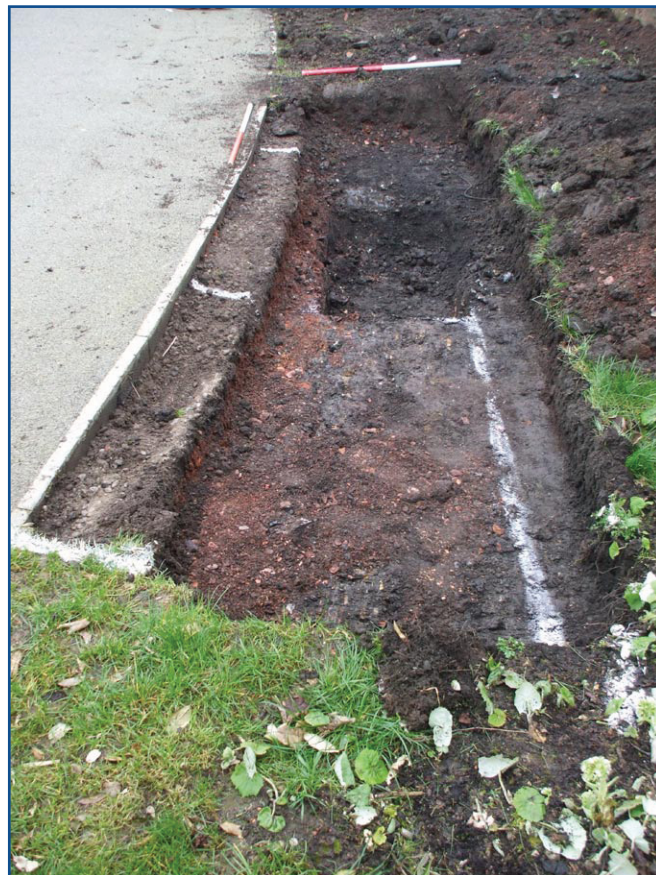
Plate 6: Trench 1 from west

- 4.1.2 Trench 1 (Plate 6) measured circa 4.4 m east/west and circa 1.0 m wide at its east end and 1.4 m wide at its west end. It was 0.3 m deep. A 0.2 m deep slot trench, which measured 0.55 m north/south by 1.2 m east/west, was excavated for the bench foundations approximately 0.9 metres west of the eastern end of the trench. A 0.25 m wide concrete foundation [102] for a tarmac path [101] ran along the trench's northern edge. A 0.2 m wide blaise deposit [103] was located west of the concrete. The rest of the trench was covered by a dark brown loam [104] deposit, which was not fully excavated.

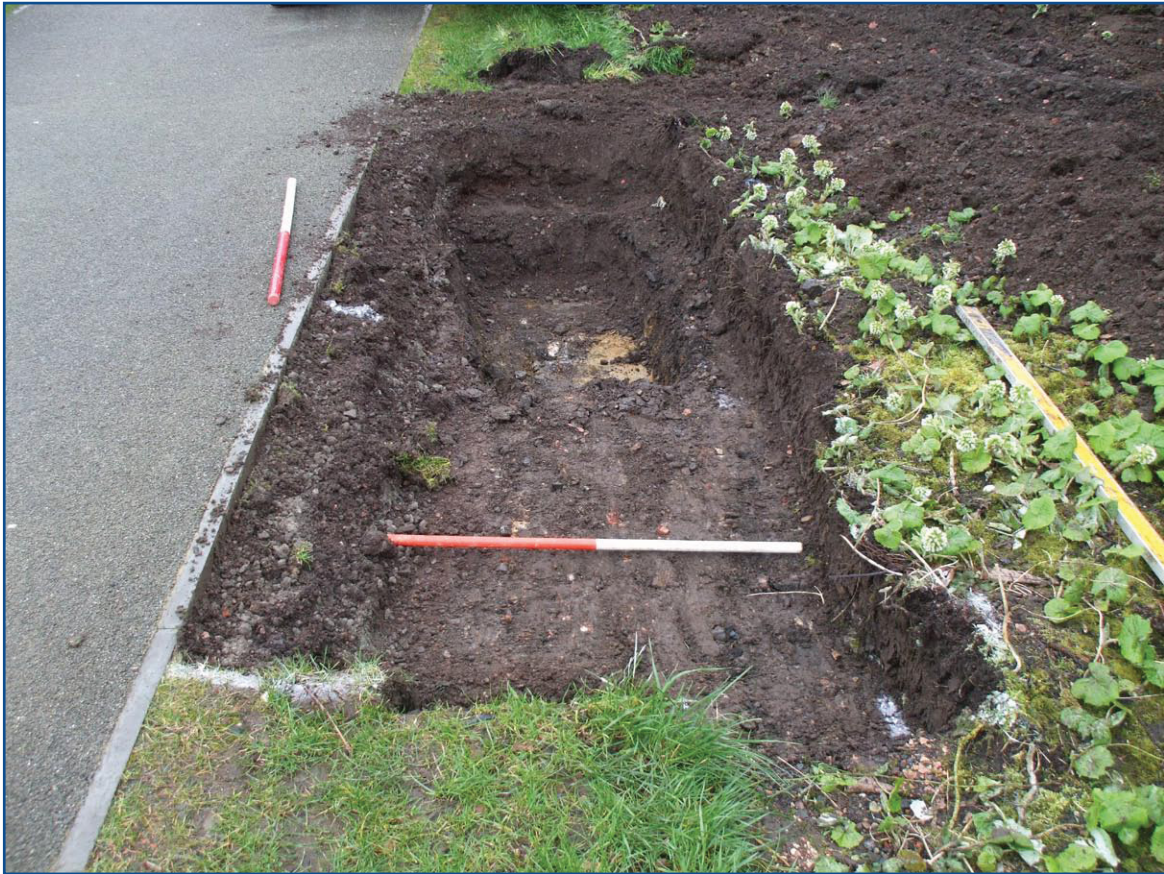
Plate 7: Trench 2 from north

- 4.1.3 Trench 2 (Plate 7) measured 4.3 m north/south and was 1.0 m wide at its south end and 1.4 m wide on its north end. It was 0.3 m deep. A 0.2 m deep slot trench, which measured 0.55 m east/west by 1.2 m north/south, was excavated for the bench foundations, approximately 0.9 metres north of the southern end of the trench. A light brown clay deposit [204], possibly natural, was uncovered in the bottom of the slot. A 0.25 m wide concrete foundation [202] for the path [201] ran along the trench's eastern edge. The rest of the trench was filled with a dark brown loam deposit [203], which was not fully excavated.

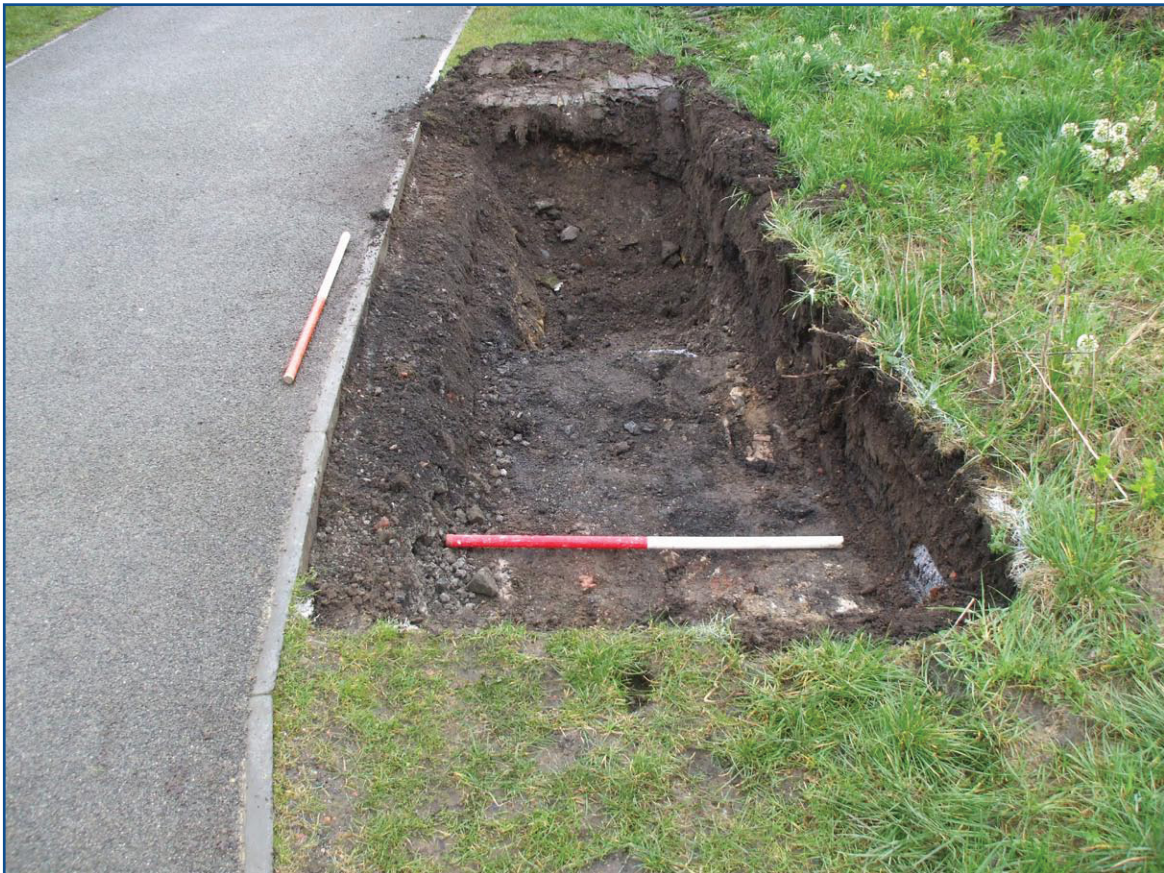
Plate 8: Trench 3 from west

- 4.1.4 Trench 3 (Plate 8) measured 4.4 metres east/west and was 1.0 m wide at its east end and 1.4 m wide at its west end. It was 0.3 m deep. A 0.2 m deep slot trench, which measured 0.55 m north/south by 1.2 m east/west, was excavated for the bench foundations, approximately 0.9 metres west of the eastern end of the trench. A 0.25 m wide concrete foundation [302] for a path [301] ran along the trench's northern edge. The rest of the trench was covered by a dark brown loam deposit with stone inclusions [303], which was not fully excavated.

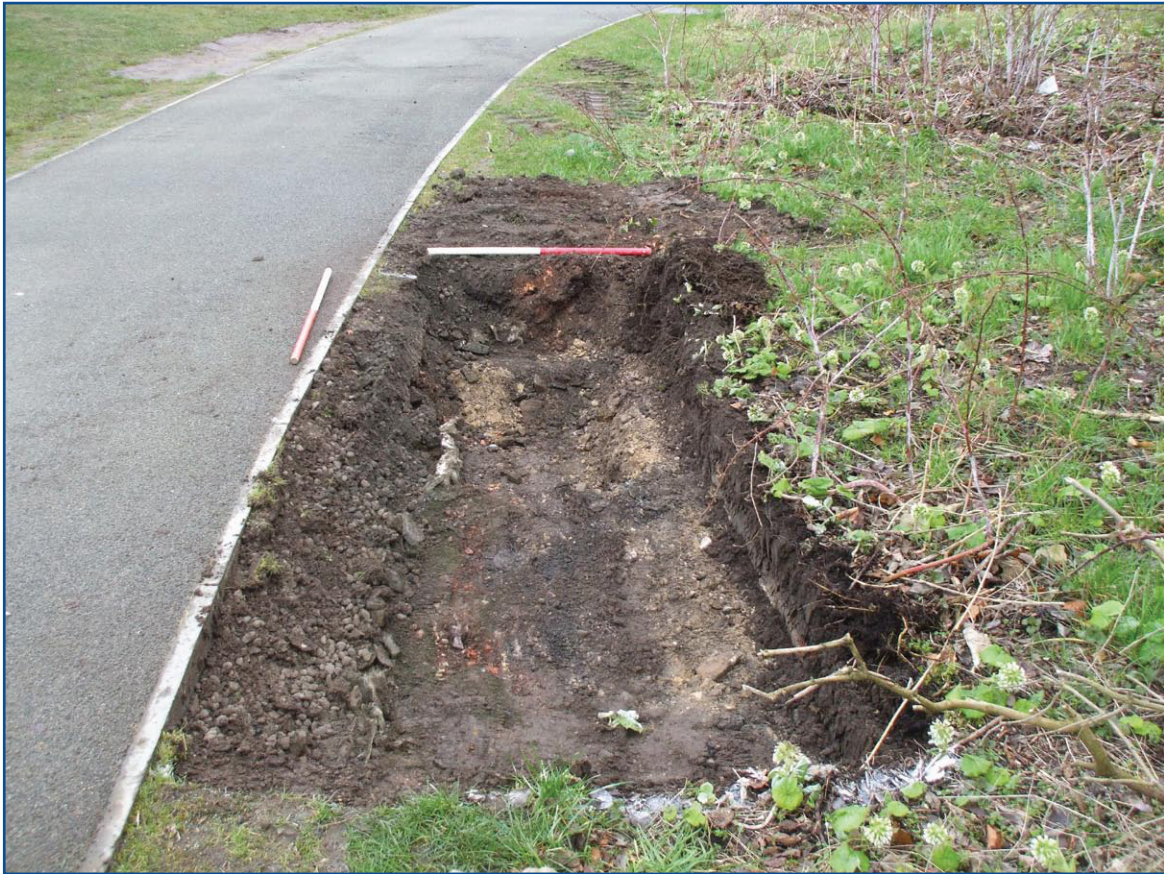
Plate 9: Trench 4 from west

- 4.1.5 Trench 4 (Plate 9) measured 4.3 metres east/west and was 1.0 m wide at its east end and 1.4 m wide at its west end. It was 0.3 m deep. A 0.2 m deep slot trench, which measured 0.55 m north/south by 1.2 m east/west, was excavated for the bench foundations approximately 0.9 metres west of the eastern end of the trench. A 0.1 m wide concrete foundation [402] for path [401] ran along the trench's northern edge. A 0.3 m wide gravel deposit [403] (a modern drain fill) was located to the south of the path. A mixed brown loam deposit with stone inclusions [404] covered the rest of the trench.

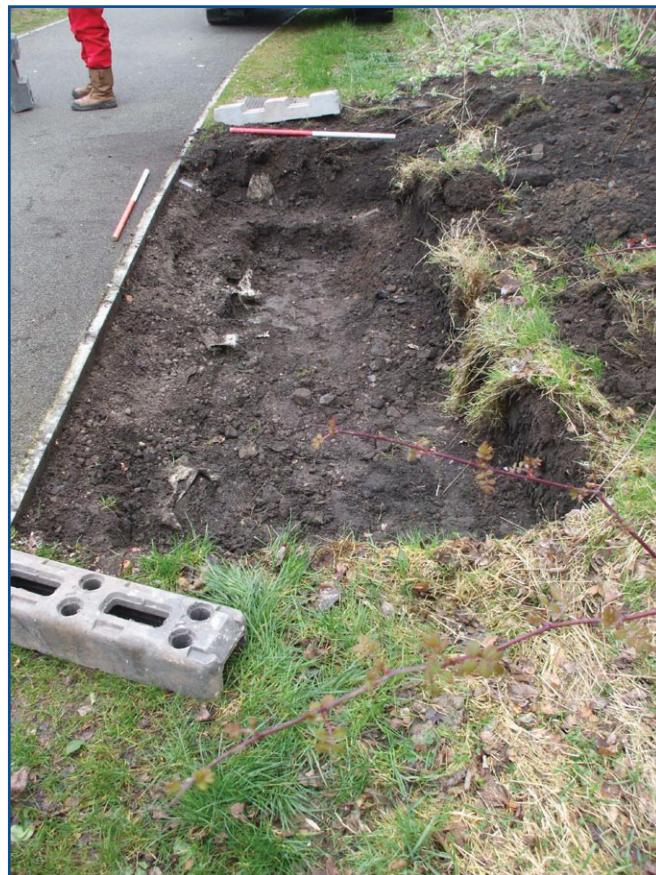
Plate 10: Trench 5 from west

- 4.1.6 Trench 5 (Plate 10) measured 4.2 metres east/west and was 1.0 m wide at its east end and 1.4 m wide at its west end. It was 0.3 m deep. A 0.2 m deep slot trench, which measured 0.55 m north/south by 1.2 m east/west, was excavated for the bench foundations approximately 0.9 metres west of the eastern end of the trench. A 0.2 m wide concrete foundation [502] for path [501] ran along the trench's northern edge. A dark brown loam deposit with stone inclusions [503] covered the rest of the trench.

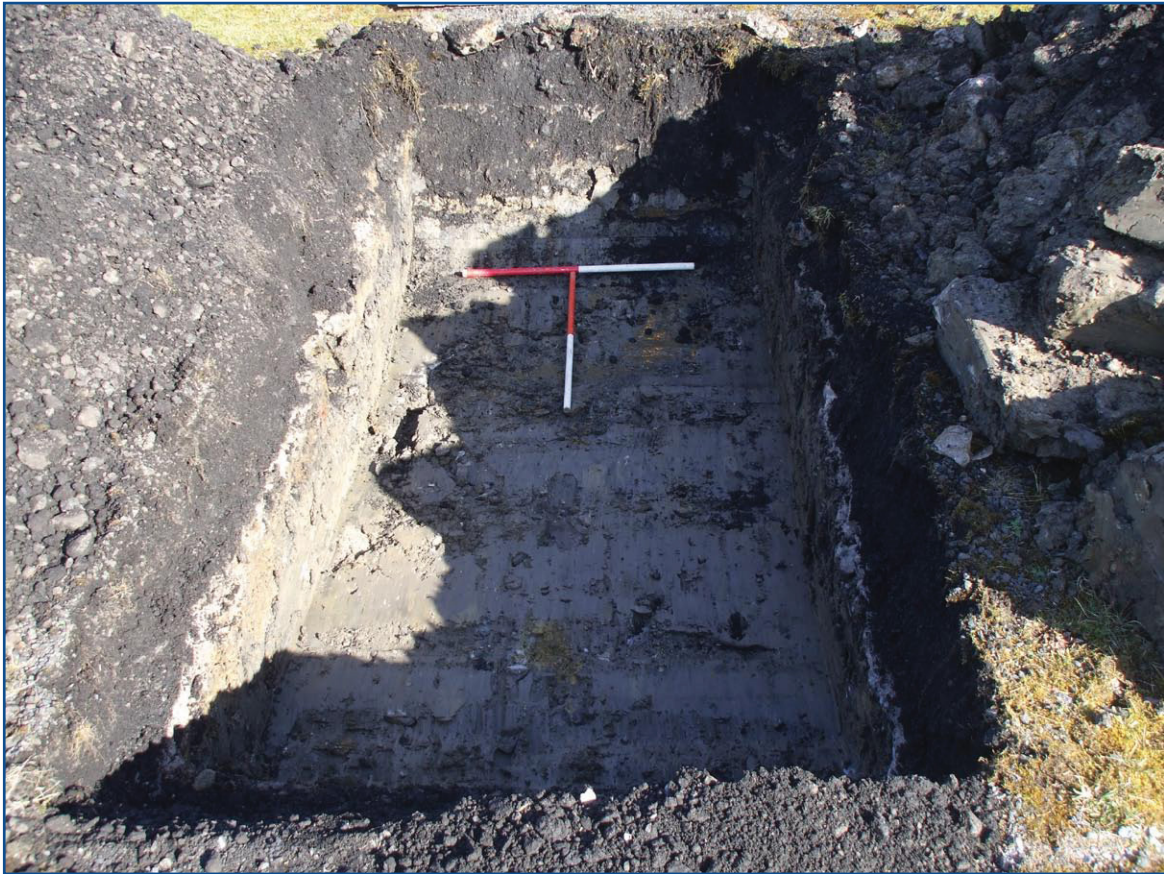
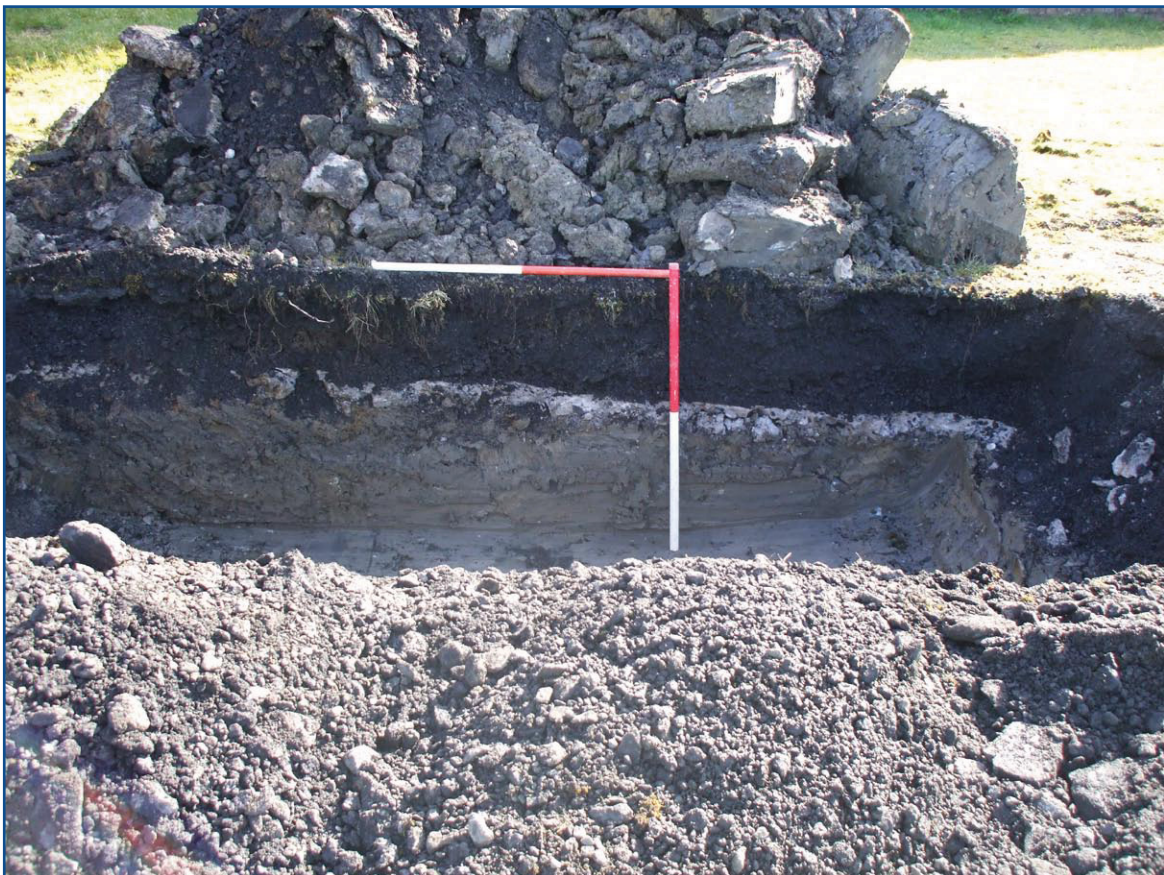
- 4.2.1 Four evaluation trenches were opened to determine the nature of the archaeological remains around the slipway of the Kelvin Dock (Figure 1).
- 4.2.2 Trench 6 (Plate 11) was located on the bottom of a slope on the east side of the Kelvin Dock and measured 4.0 m north/south by 1.6 m wide. It was 1.0 m deep. Three contexts were identified. A cinder-rich deposit [601], which was 0.2 m deep to the north and 0.4 m deep in the south end of the trench, overlay a 0.2 m deep concrete surface [602] which sealed a natural clay deposit [603] (Plate 12).

Plate 11: Trench 6 from south

Plate 12: Trench 6 from west

- 5.2 Evidence of several phases of slipway construction was identified during the evaluation. Concrete surface [602] probably represented a slipway structure that was superseded by a slipway constructed of cinder material [901]. This was the latest phase of slipway construction identified during the evaluation. Another concrete slipway element [705], with rail tracks, was identified in Trench 7, again superseded by a cinder slipway structure. The relationship between slipway structure [602] and the tracked concrete [705] is unclear.

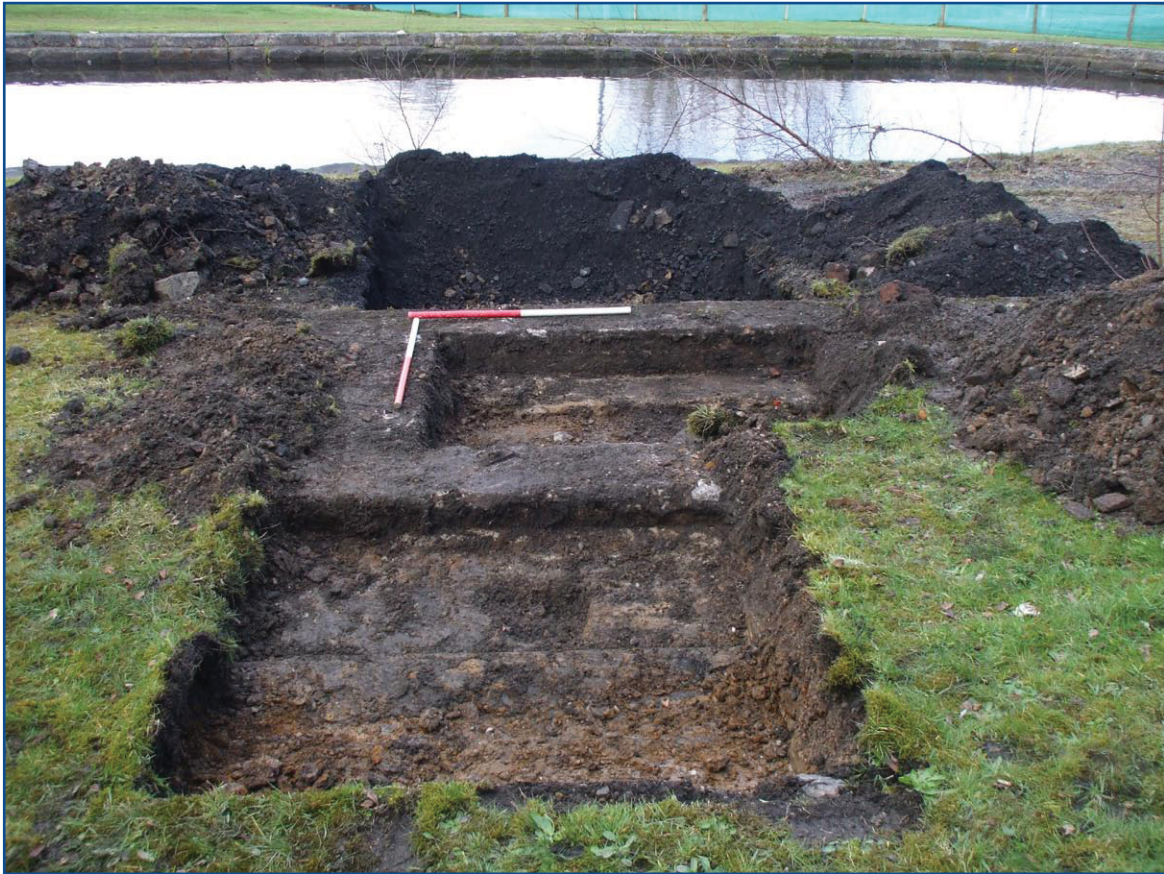
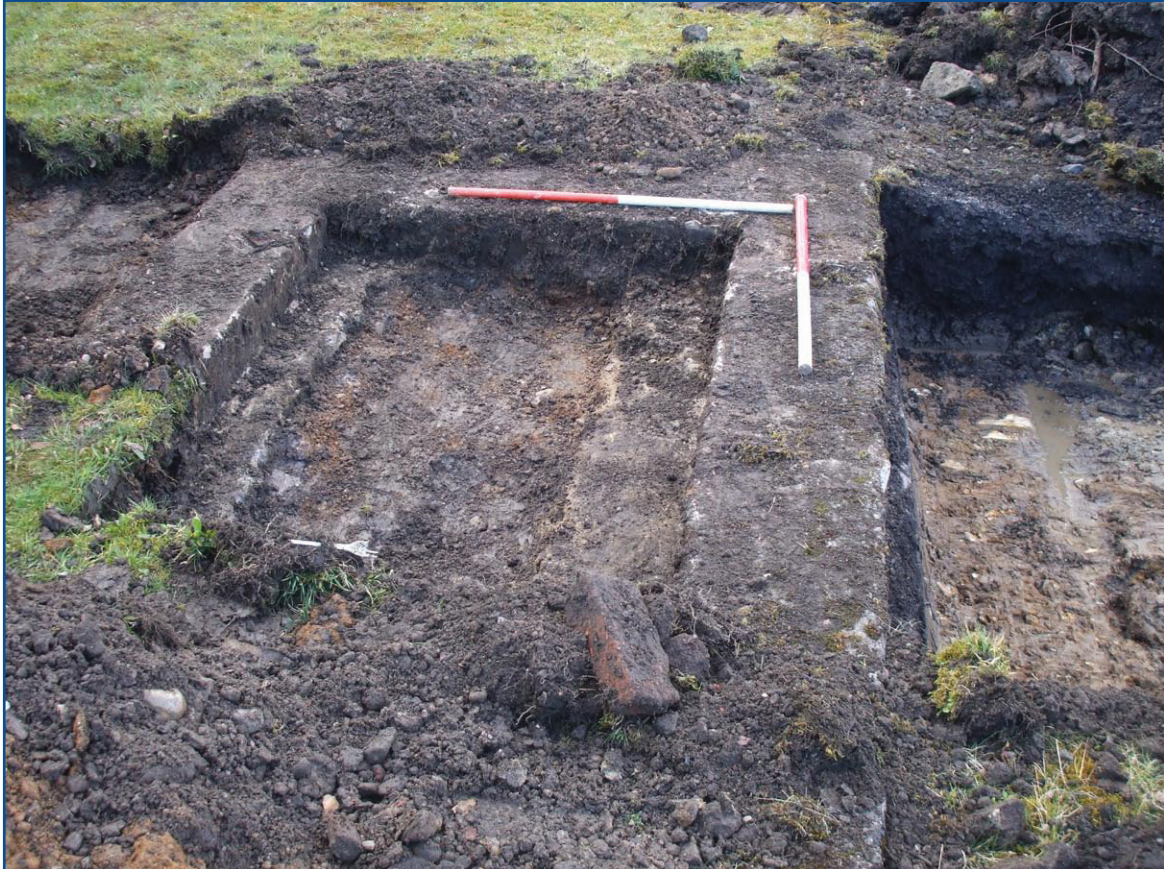
Plate 13: Trench 7 from east

Plate 14: Trench 7 from north

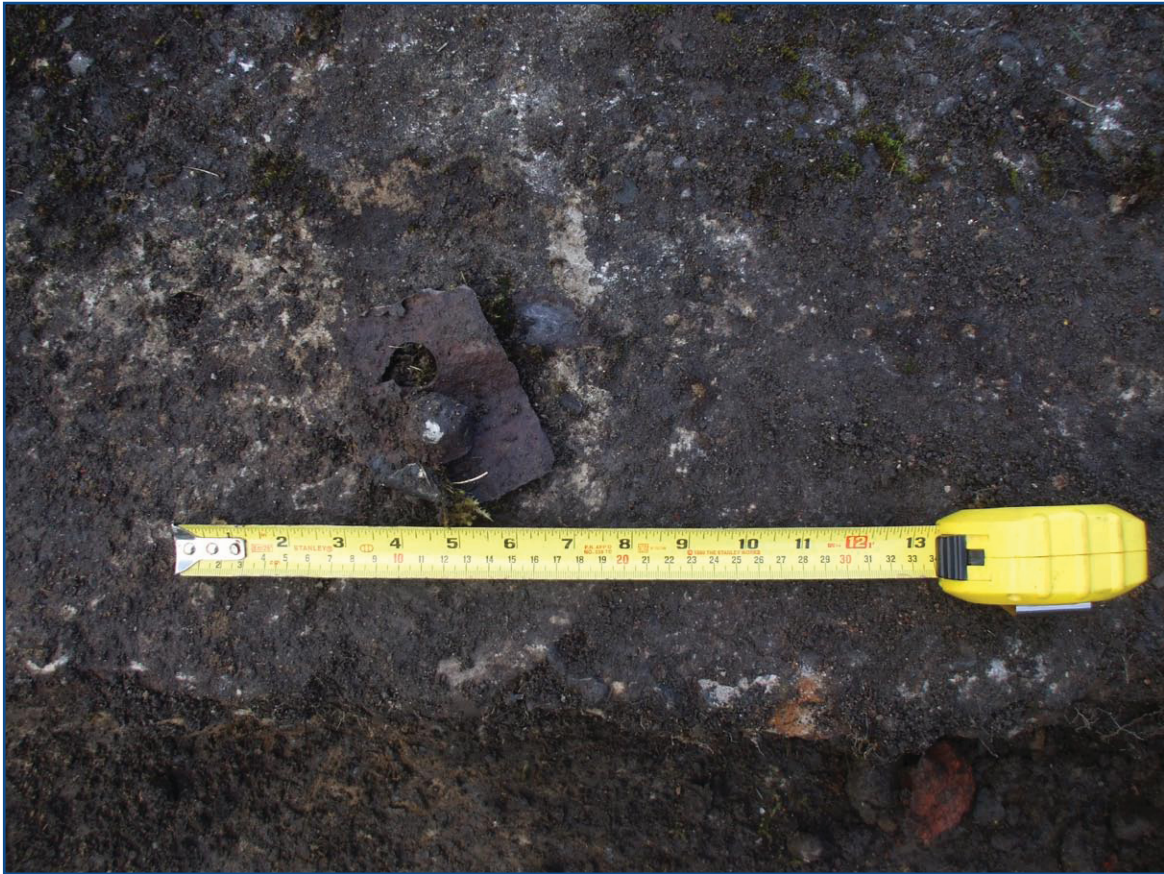
Plate 15: Rail track in concrete surface, Trench 7

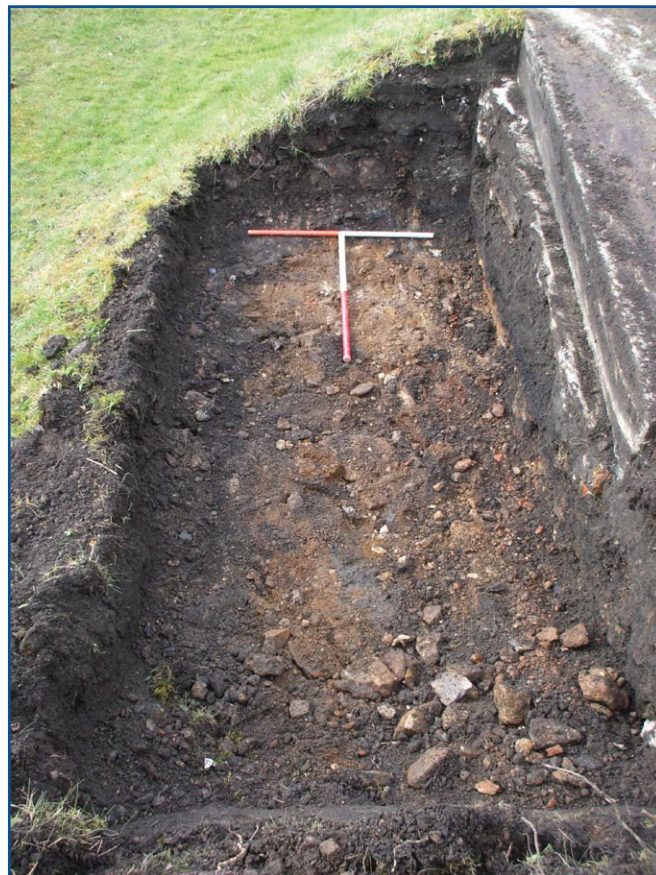
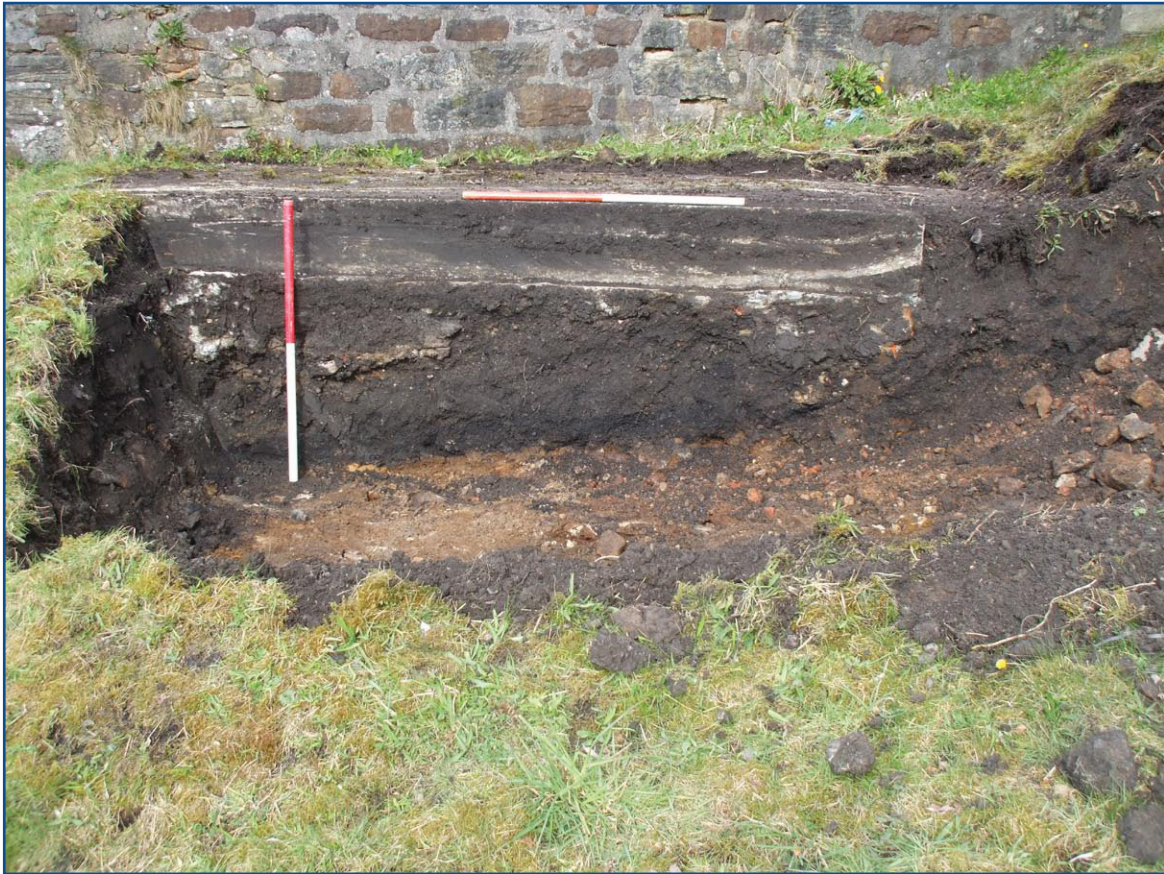
- 4.2.4 Trench 8 (Plates 16 and 17) was located over a mound near the north wall of the Kelvin Dock and measured 4 m NW/SE by 1.6 m SW/NE. A 0.3 m deep concrete platform [801] overlay concrete foundations [802]. Several fittings were identified on the platform's surface (Plates 18 and 19). A 0.8 m deep deposit of grey gravel and sand made ground [803] underlay the concrete and overlay a black cinder deposit [804] which was up to 0.2 m deep. Below this deposit an orange/light brown loam deposit [805], in the base of the trench, was not fully excavated.

Plate 16: Trench 8 from east

Plate 17: Trench 8 from south

- 5.3 A concrete platform was identified on top of the mound in Trench 8. It had fittings on its side but due to its small size its function is uncertain. The higher ground by Trenches 8 and 9 consisted of redeposited material. It was not possible to excavate these trenches to subsoil due to health and safety concerns.

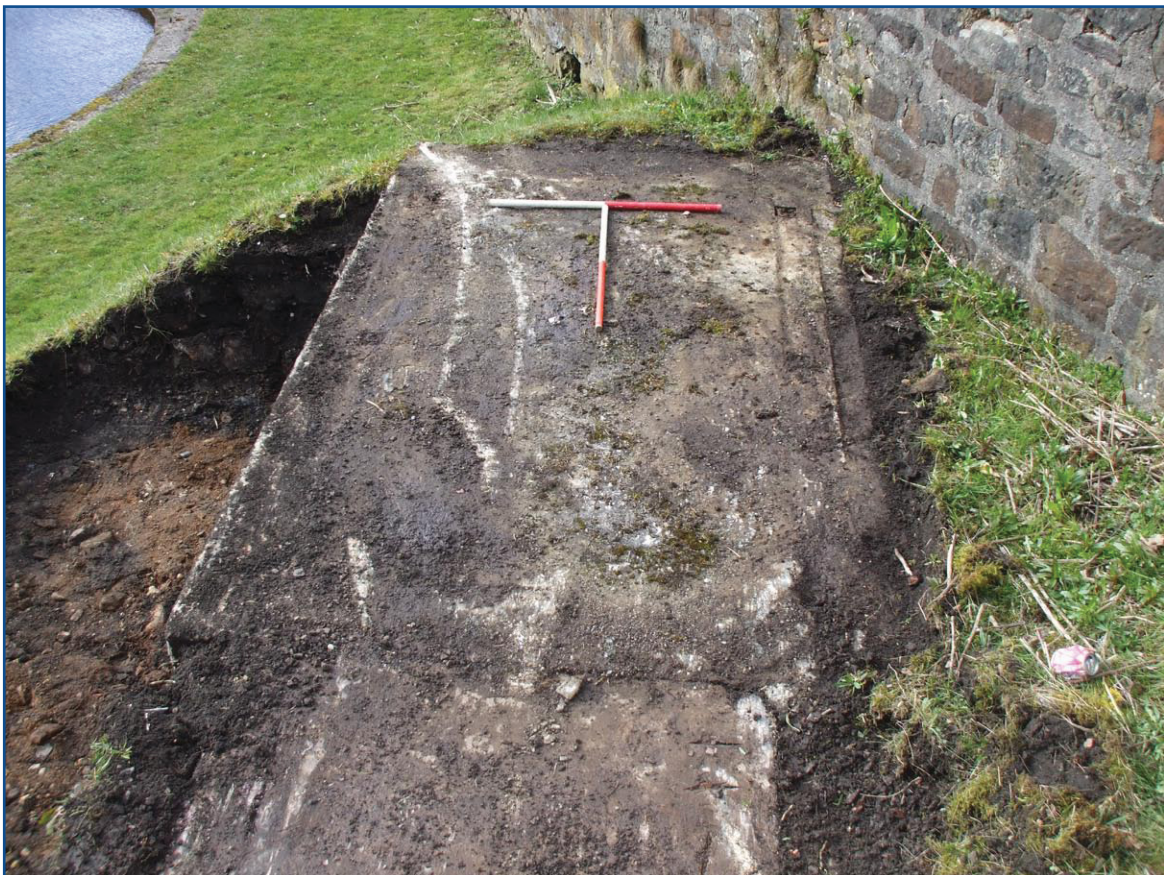
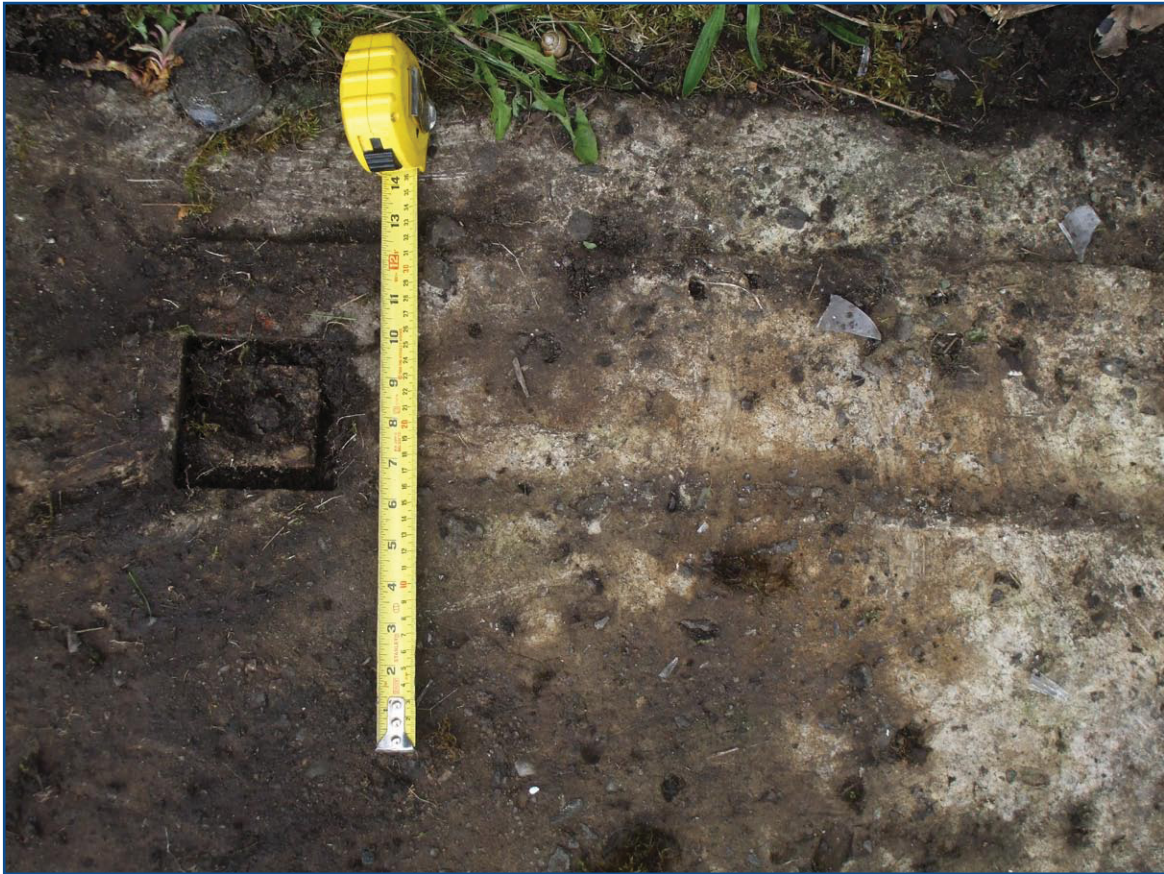
Plate 18: Concrete platform adjacent to Trench 8 from east

Plate 19: Fittings on platform adjacent to Trench 8

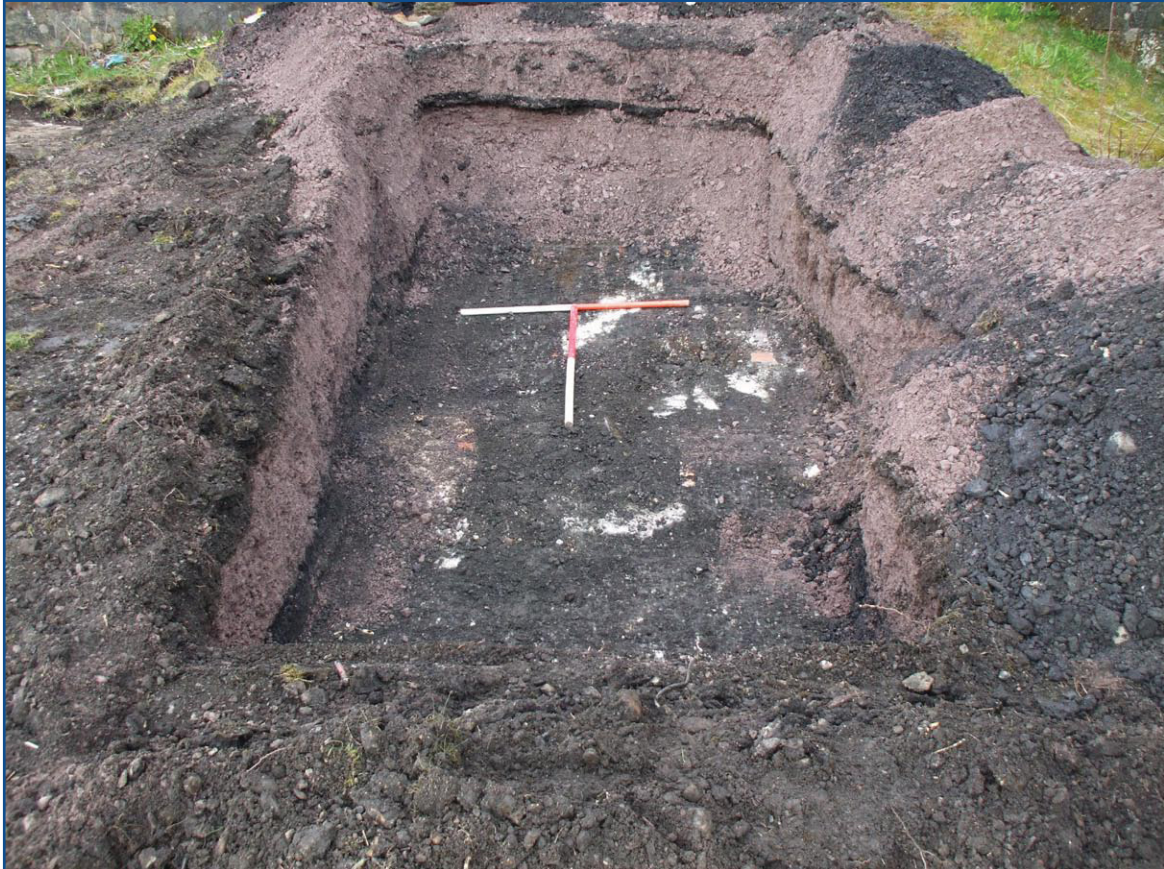
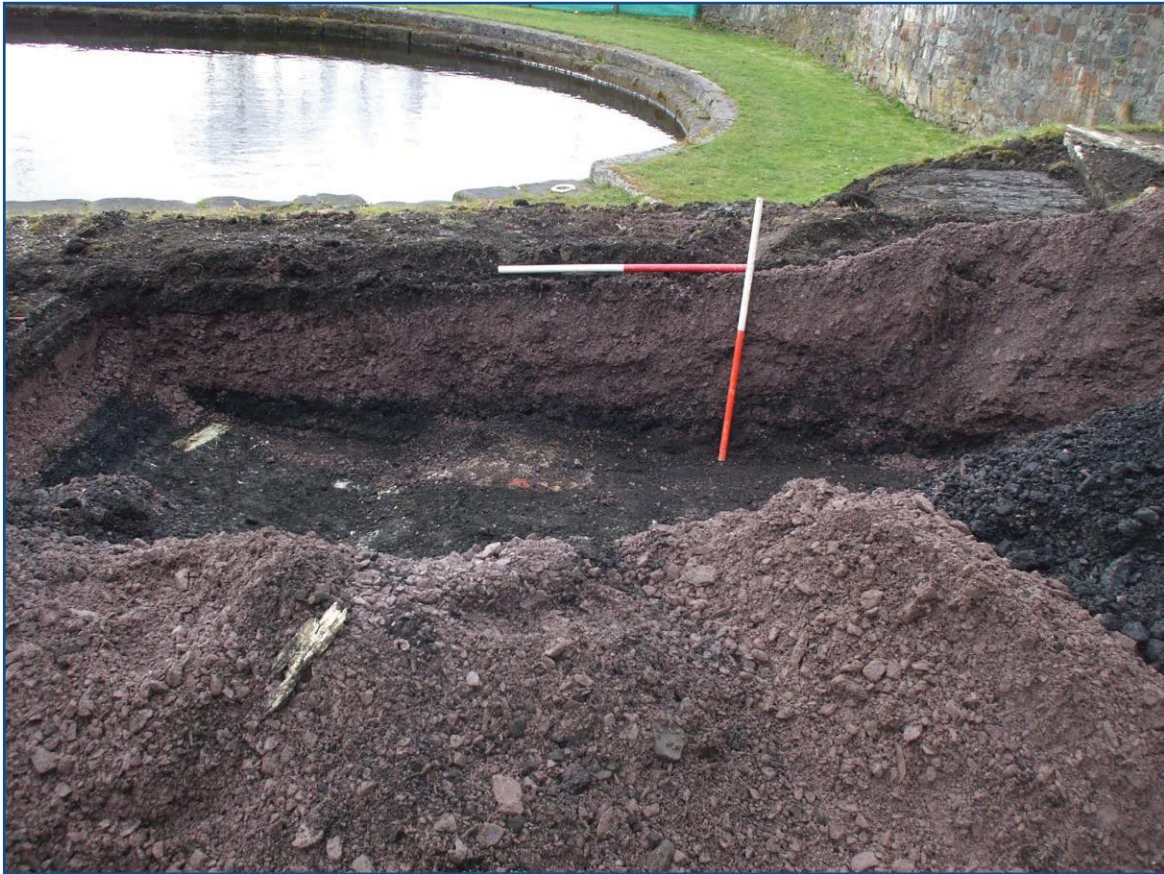
- 4.2.5 Trench 9 (Plates 20 and 21) was located on the upper end of the slope in the vicinity of the gate. It measured 4.5 m north/south by 1.6 m east/west. A cinder-rich deposit [901], which was up to 0.2 m deep, overlay a red gravel deposit [902] that was up to 0.6 m in depth. Another 0.2 m deep cinder deposit [903] underlay this gravel. A rubble deposit [904] was identified at the base of the trench. A docker's hook was recovered from this deposit.

Plate 20: Trench 9 from south

Plate 21: East facing section of Trench 9

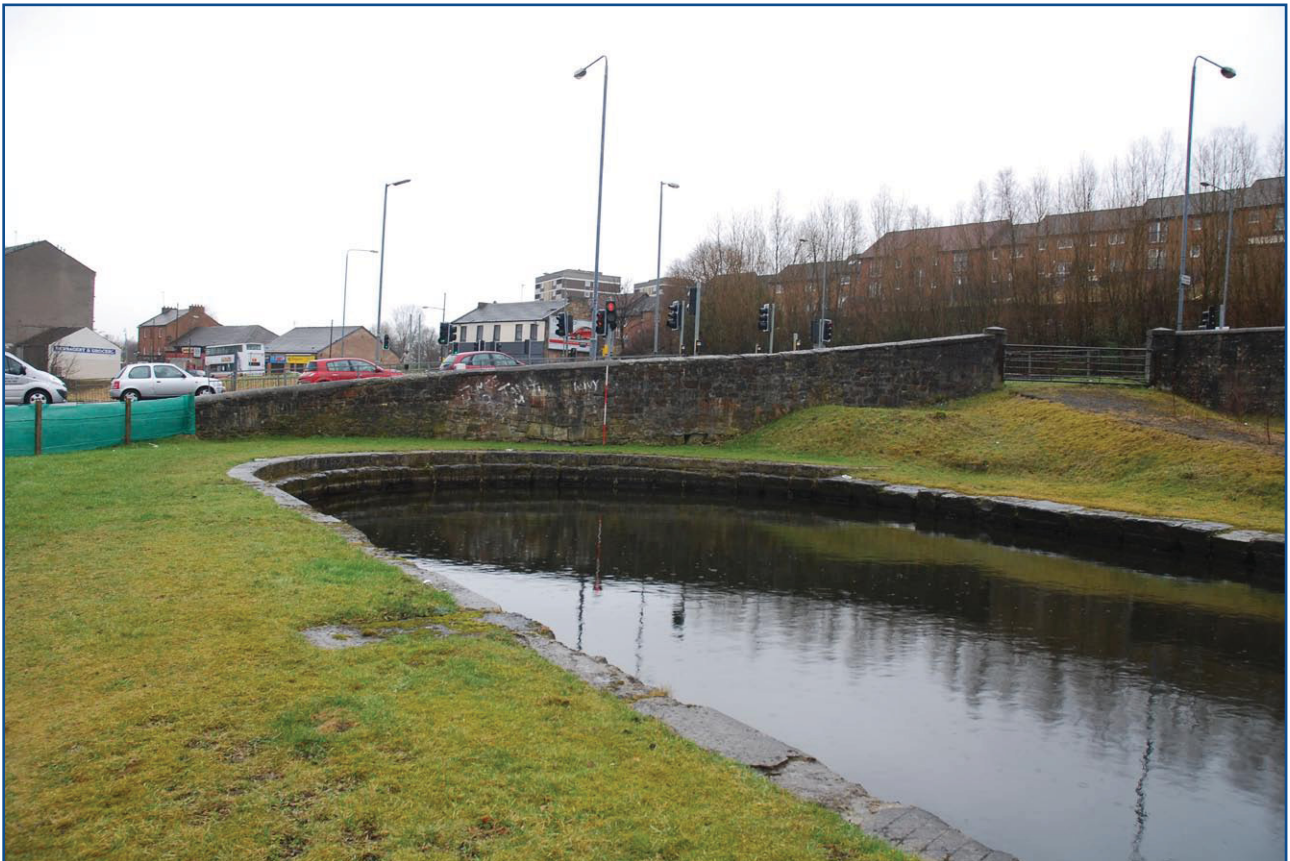
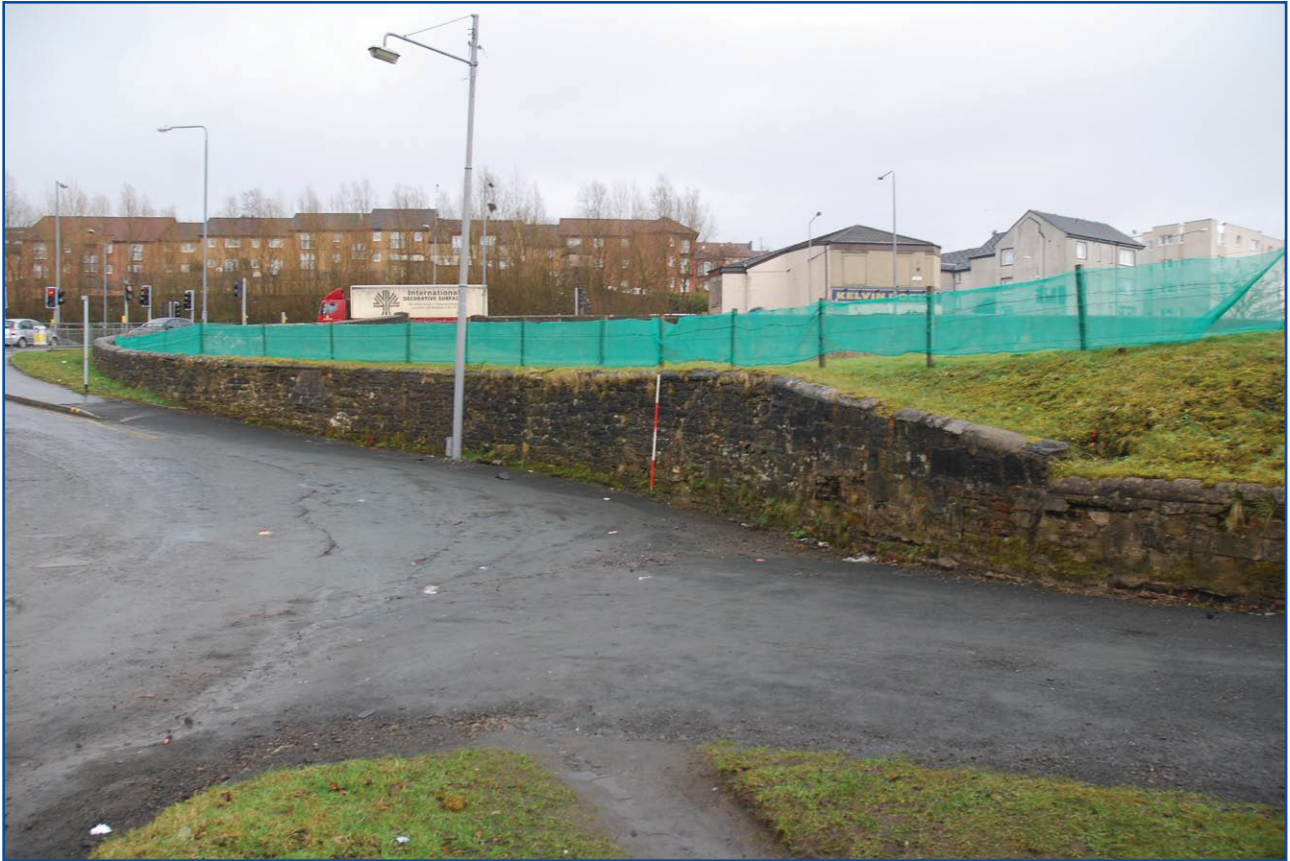
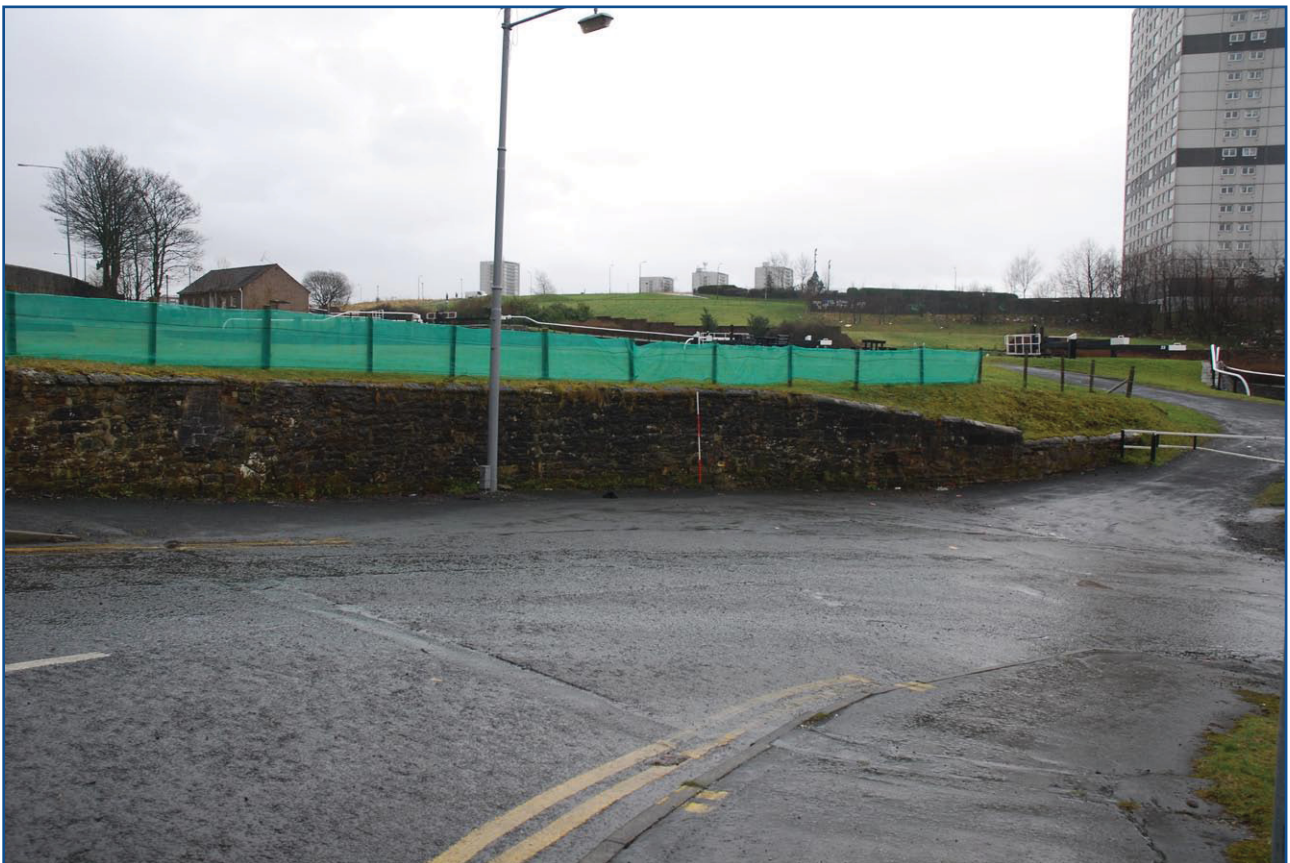
- 4.3.1.1 This small east/west stretch of wall consisted of a heavily re-mortared dressed stone rubble wall with a curved cope (Plates 22-24). There was a lot of evidence of brick repair and the wall was in a generally bad state of repair. Towards its east end, where the ground rose to meet Maryhill Road, it terminated in a dressed gate pier with pyramidal cap (Plate 25).

Plate 22: General view of north wall to Skaethorn Road from south

Plate 23: General view of the north wall to Skaethorn Road from NW

Plate 24: General view of the north wall to Skaethorn Road from NE
