Maryhill Regeneration Stage 3, Archaeological Works: Data Structure Report

Maryhill Regeneration, Stage 3, Archaeological Works: Data Structure Report

AOC Project No: 20677

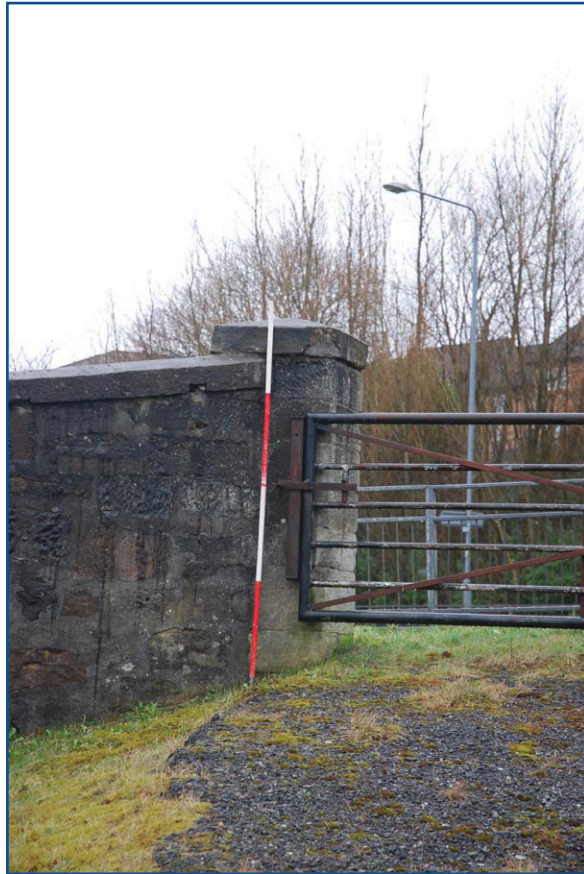
- 4.3.1.1 This small east/west stretch of wall consisted of a heavily re-mortared dressed stone rubble wall with a curved cope (Plates 22-24). There was a lot of evidence of brick repair and the wall was in a generally bad state of repair. Towards its east end, where the ground rose to meet Maryhill Road, it terminated in a dressed gate pier with pyramidal cap (Plate 25).

Plate 25: Detail of the gate pier between the northern and eastern walls from south

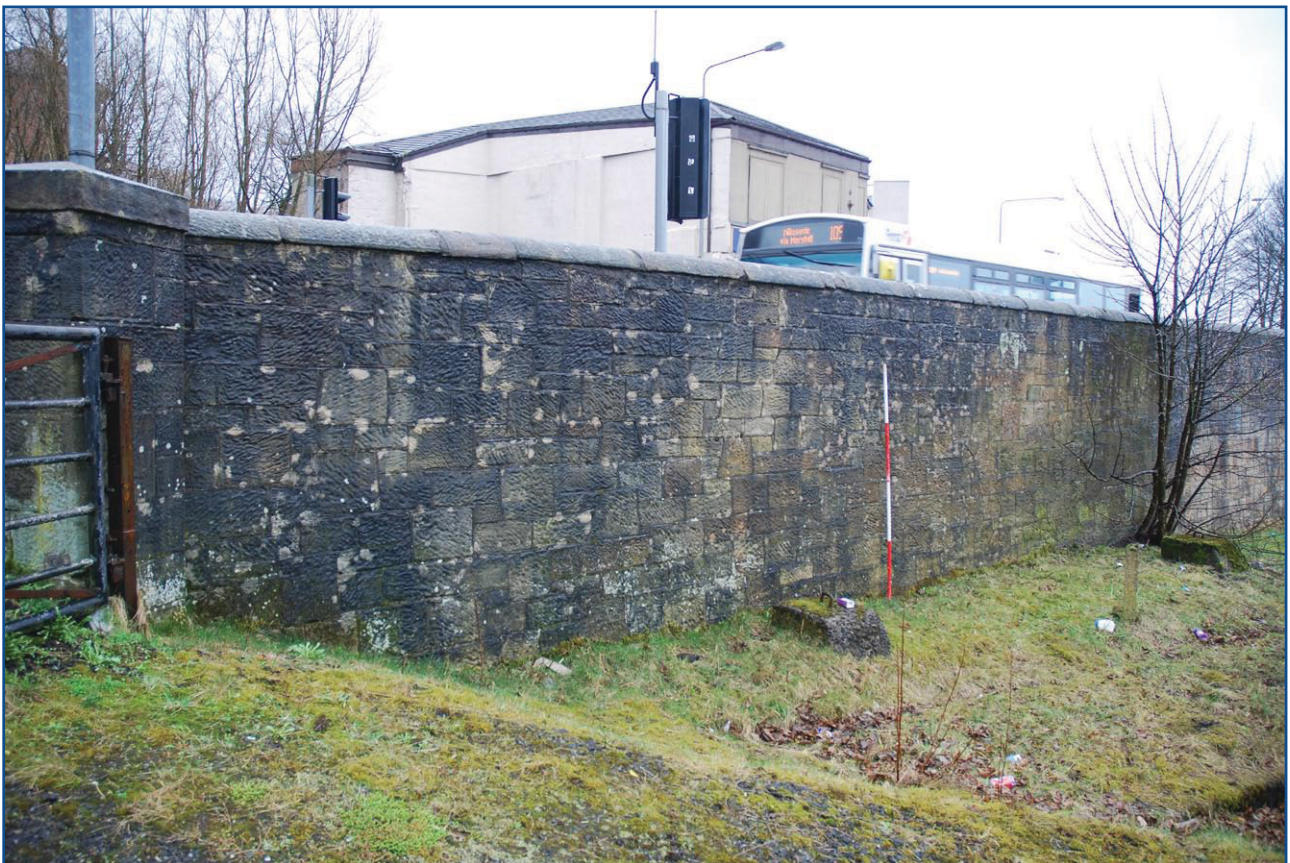
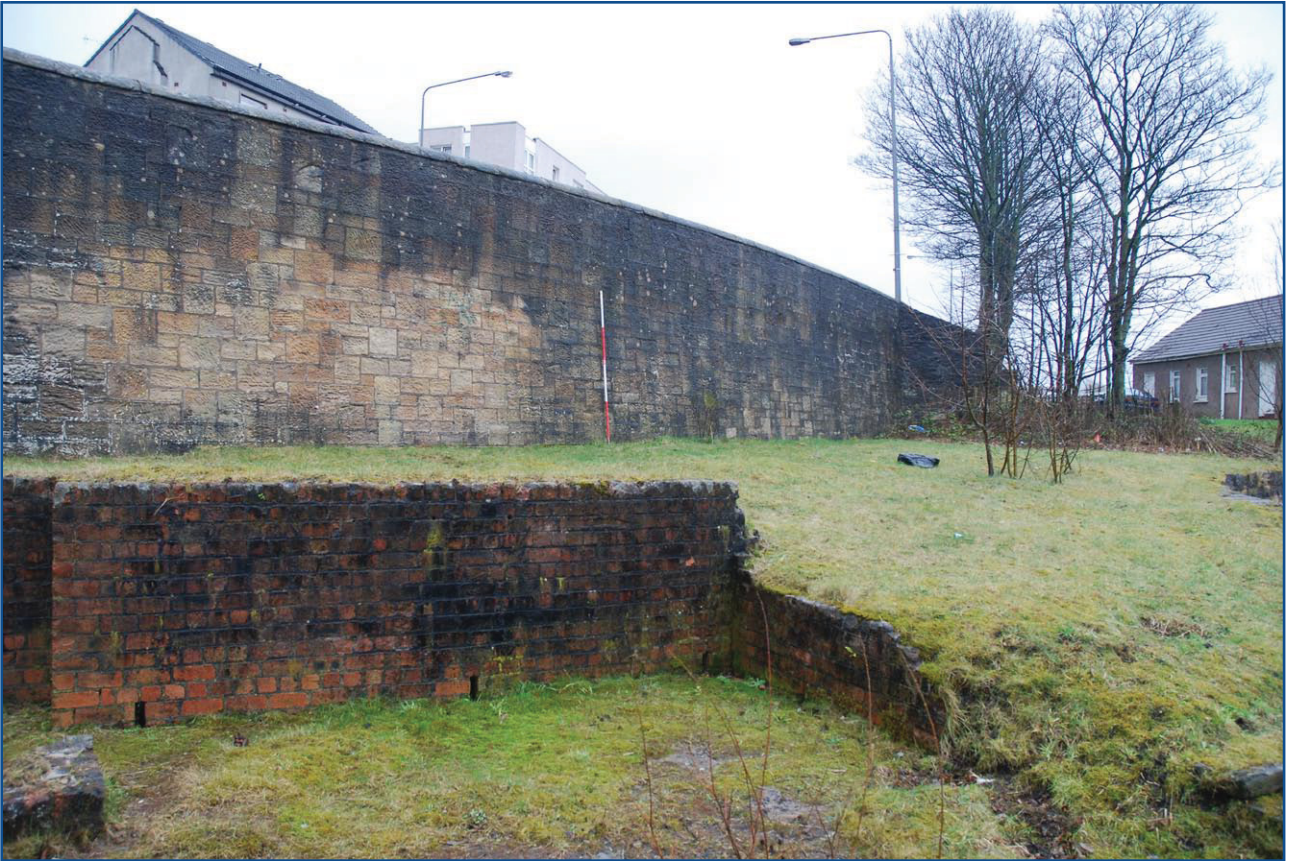
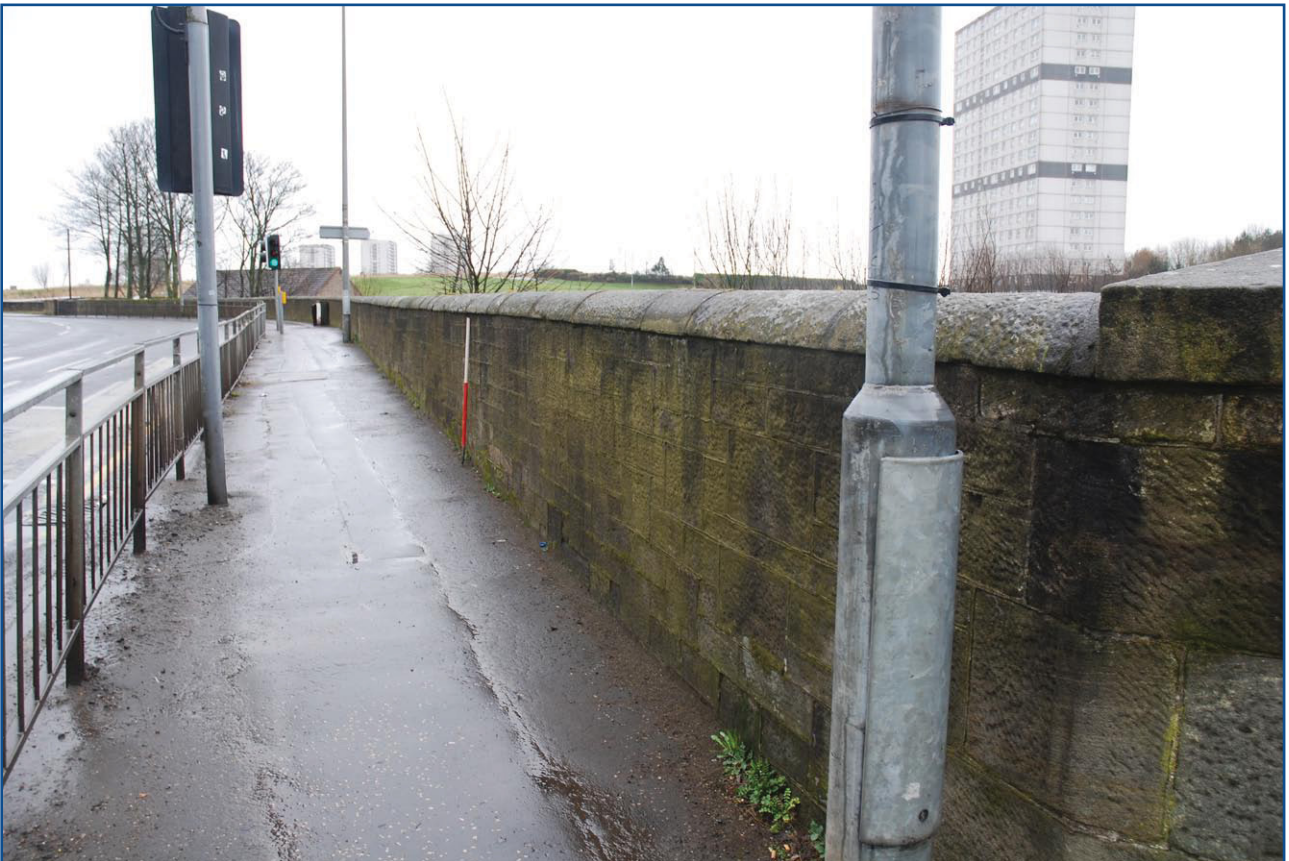
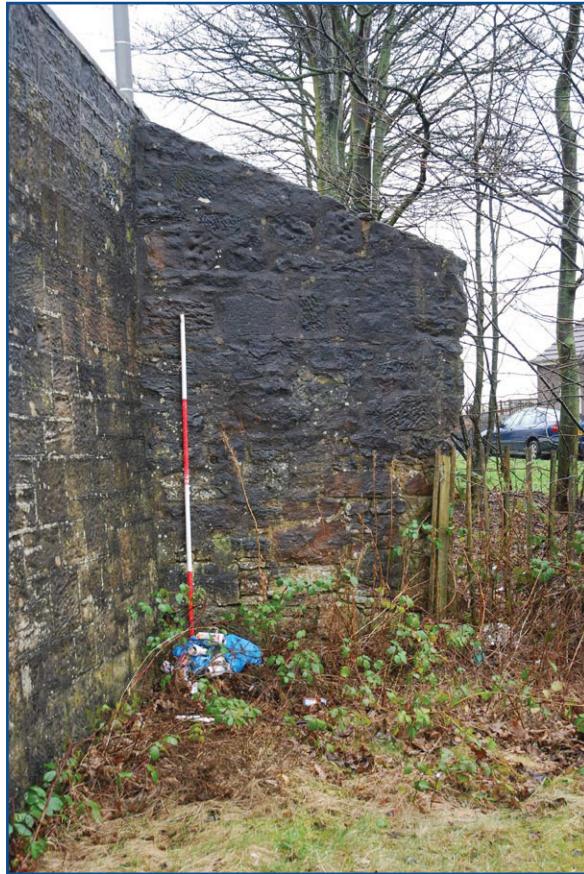
- 4.3.2.1 The east wall to Maryhill Road was a much finer snecked and coursed chisel-dressed wall with rounded cope and swept round towards the former White House to the south of the site (Plates 26-8). There was a small east/west stretch of wall on the inside of this wall, which was in a much cruder stone rubble build (Plate 29) and appeared to be part of a much longer wall.

Plate 26: General view of the eastern wall to Maryhill Road from NW

Plate 27: General view of the eastern wall to Maryhill Road from NW

Plate 28: General view of the eastern wall to Maryhill Road from NNE

Plate 29: Detail of the stretch of wall on southern side of eastern wall to Maryhill Road

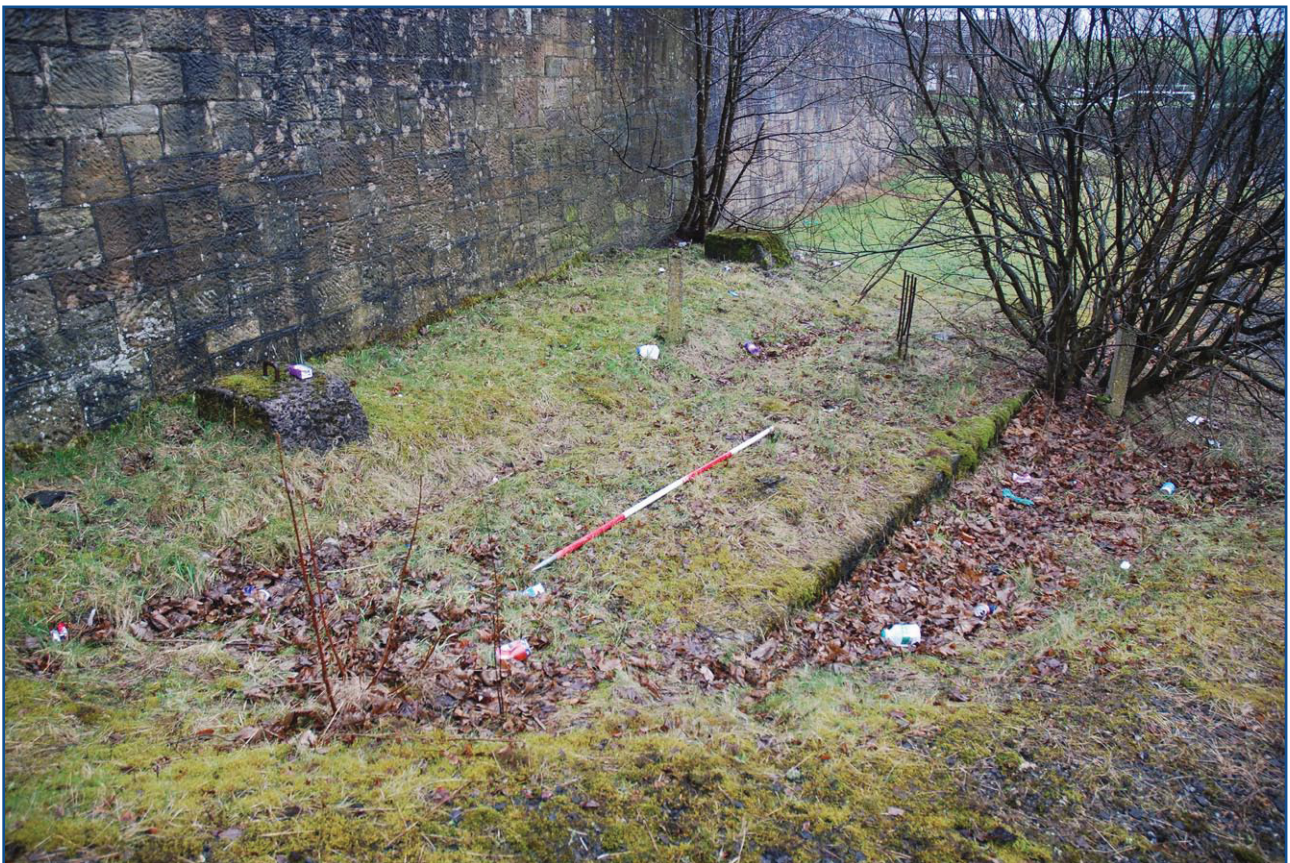
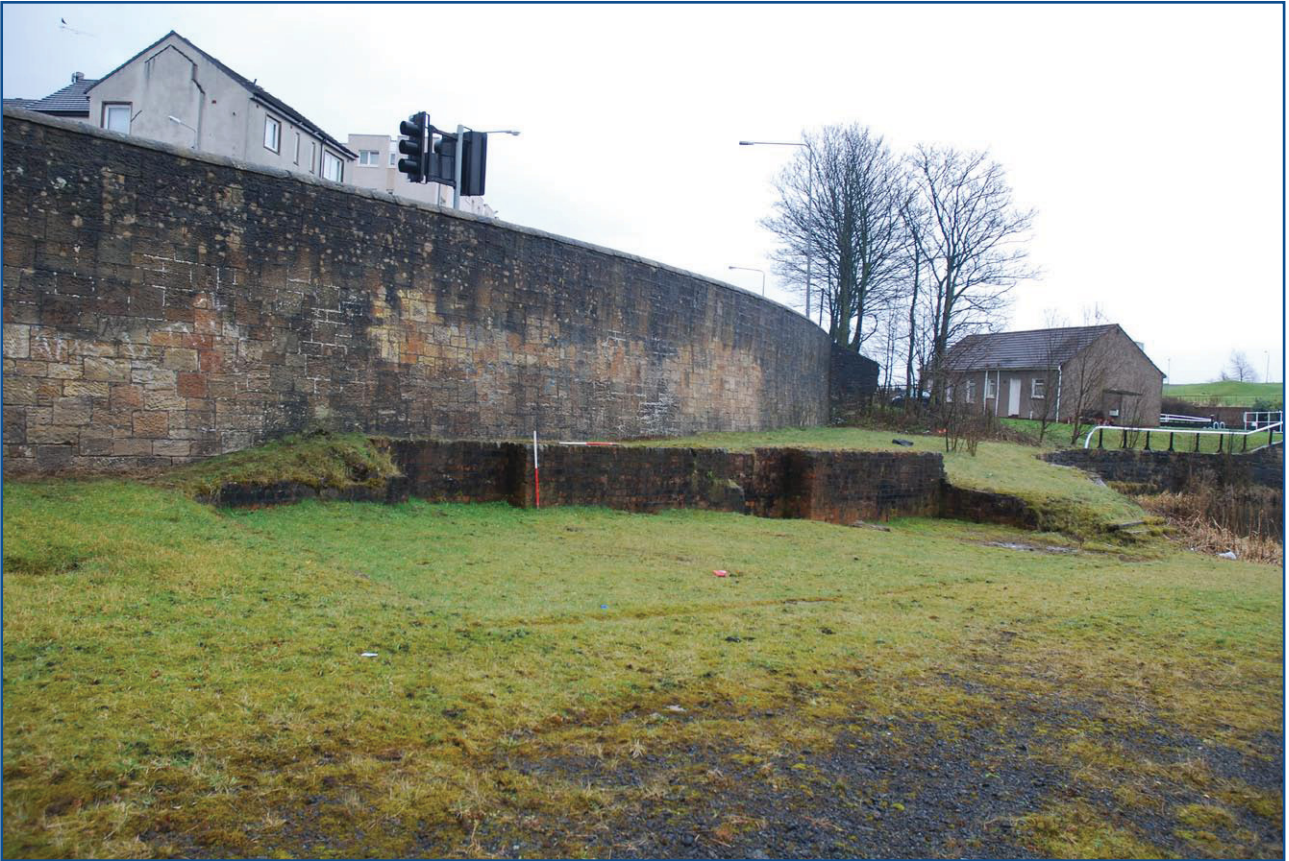
- 4.3.3.1 The brick and concrete structural remains comprised two elements: to the north was a concrete platform with numerous reinforced concrete footings (Plate 30) and to the south was a larger brick enclosure with a concrete surface (Plate 31). To the south of the latter feature were four small timber steps.

Plate 30: General view of the northern side of the slipway, showing concrete footings and associated fittings from NW

Plate 31: General view of the brick enclosure associated with the slipway from NW
