British Waterways Scotland
Archaeological Works 2009

Forth and Clyde Canal
Pinkston Basin

Scoping Survey and Trial Trenching
November 2009

Project Code: BW-PB-2009-01

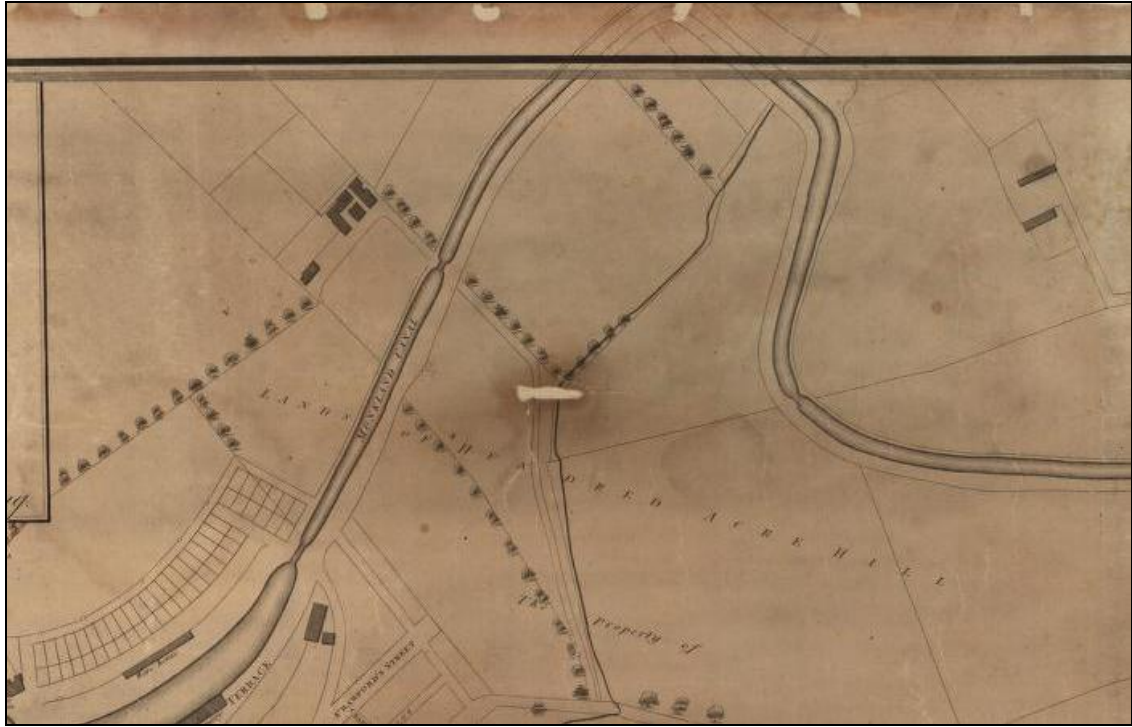
Figure 2: 'Map of the City of Glasgow and Suburbs', by Peter Fleming, 1807 (NLS)

Figure 2 shows another early map with the site visible in the crook of the Cut of Junction. Still largely undeveloped, a diverted burn runs under the canal; to the N is a row of deliberately planted trees.

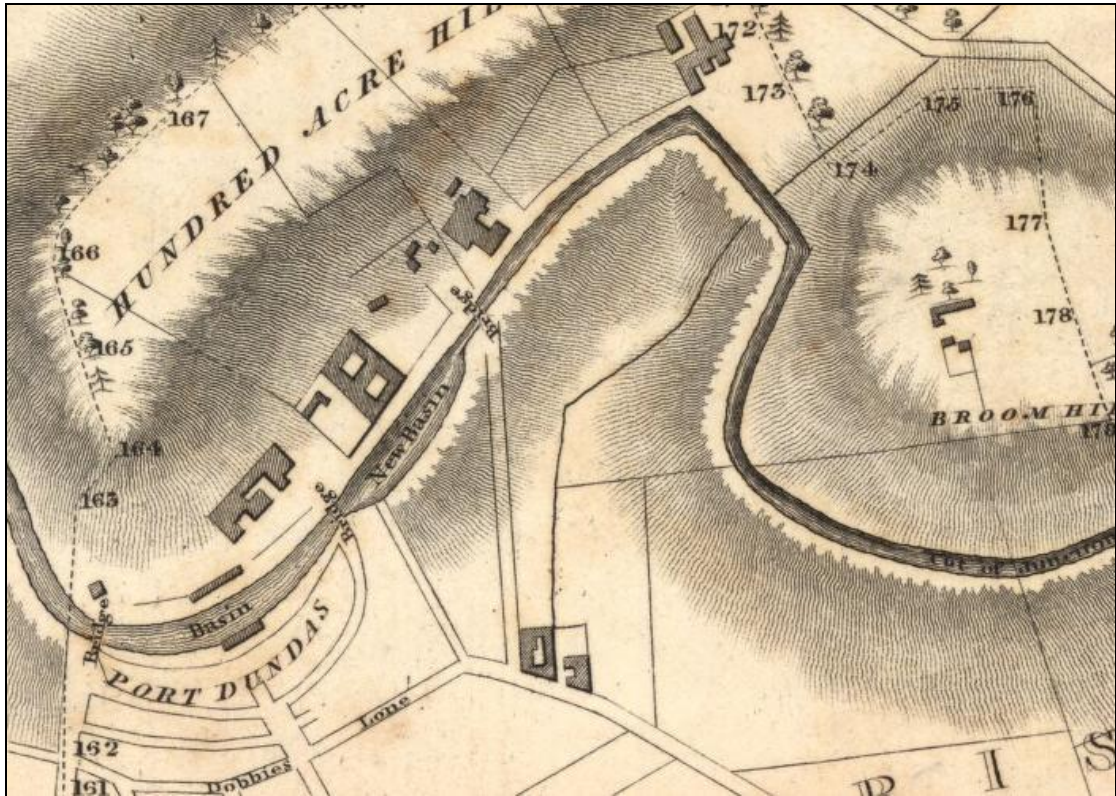
Figure 3: 'This map of the ten parishes within the Royalty and the parishes of Gorbals Barony of Glasgow', by John Wood, 1822 (NLS)

Figure 3 shows a map from 1822 with contour lines; the white areas are flat areas of land from which contours radiate. This map indicates that the sides of the canal are level, but then drop away steeply forming a deep cleft in the crook of the Cut of Junction where the Pinkston Basin was later built. To level the area would clearly have required large amounts of material.

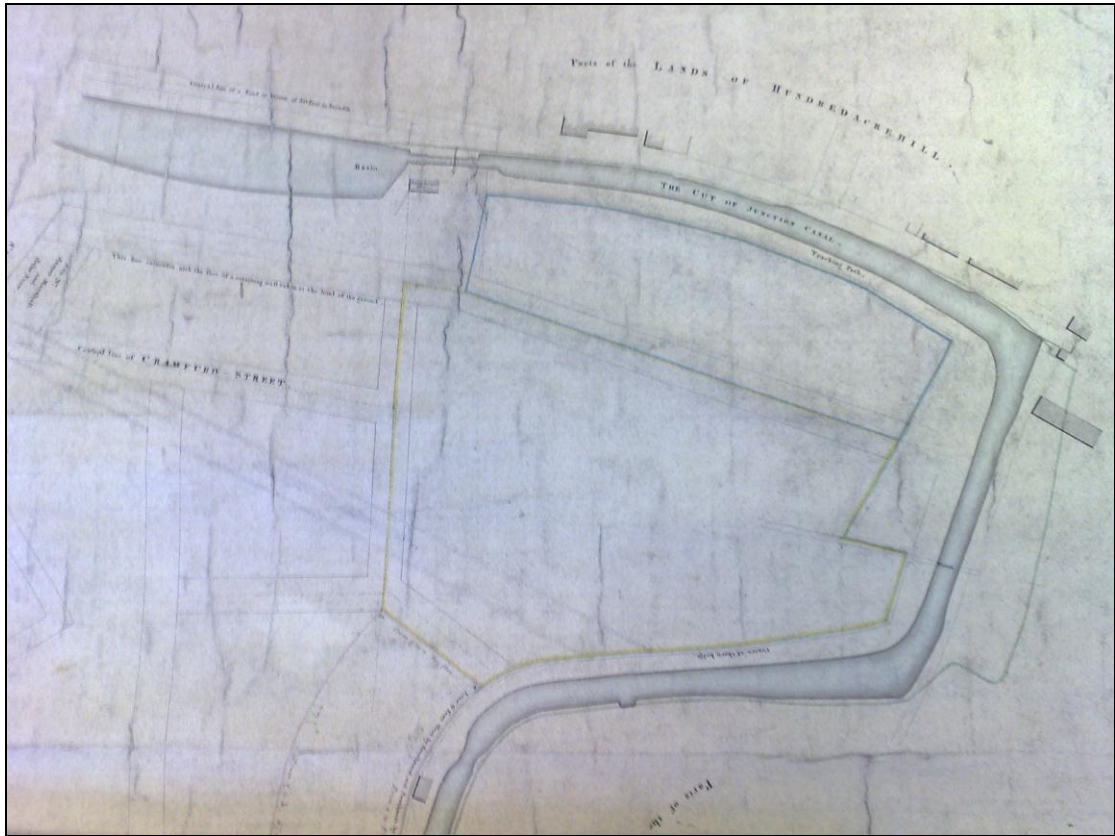
Figure 4: 'Cut of Junction Canal', William Kyle, 1836 (British Waterways Archive, P428)

Figure 4 shows the site in 1836, just prior to the developments of 1842. It shows a 'tunnel' running E-W across the site near to the SE corner of a 'thorn bush' - a planted hedge skirting the 'tracking path'.

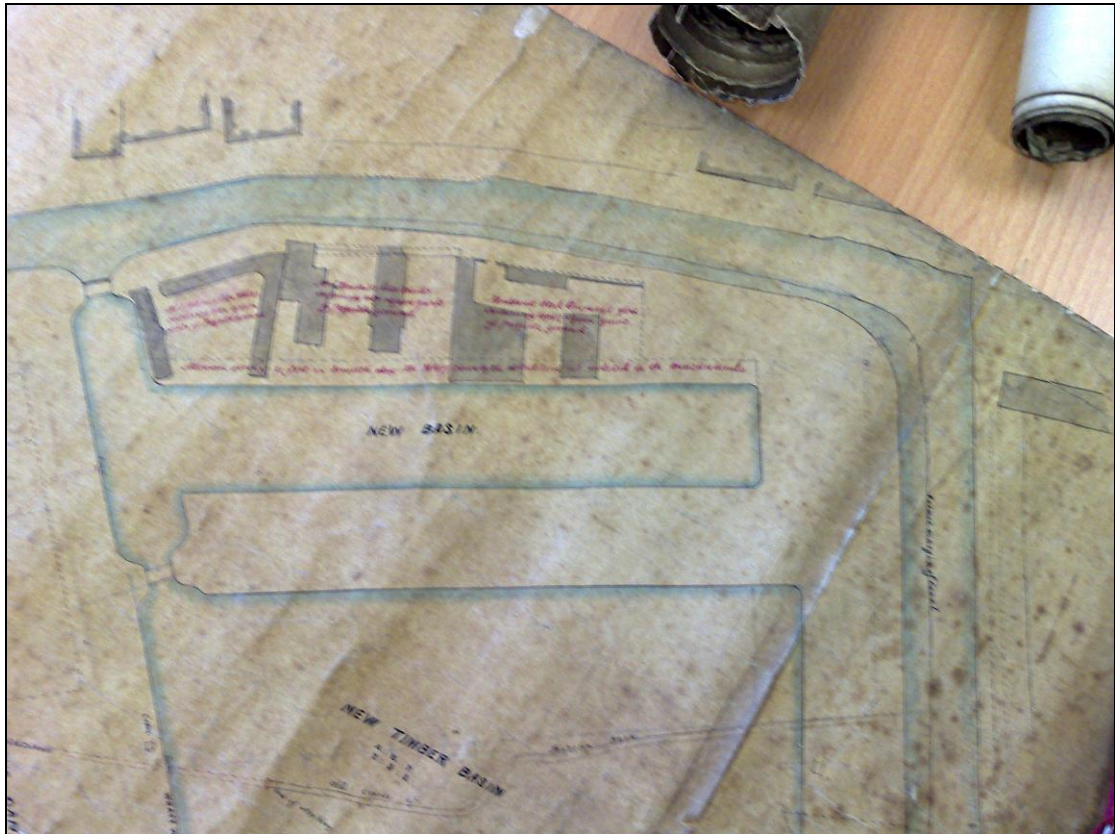
Figure 6: 'Plan of Part of Port Dundas and Cut of Junction Canal as Improved in 1842', Unknown surveyor, Undated (British Waterways Archive P440)

Figure 6 shows the rectangular 'new basin' with a range of buildings on the wharf to the N. The range of buildings to the E are annotated as 'Mr J Watson's Coke Works', those centrally are 'Mr. J Marshall's Coke Works' while those to the E are 'The Monkland Steel Company's Yard'. At this time there are no buildings to the E of the New Basin recorded. The canal was widened to the N and E during this period, and the original line of the canal is annotated.

Figure 7 shows a similar arrangement of buildings to the previous map (Figure 6), with some minor additions, and the absence of a building within the 'Coke Kilns' to the E. The 'Monkland Iron Depot' is greatly expanded from the earlier arrangement of 1842. This expansion may mean that the buildings of 1842 were either absorbed or demolished by the expansion of 1857.

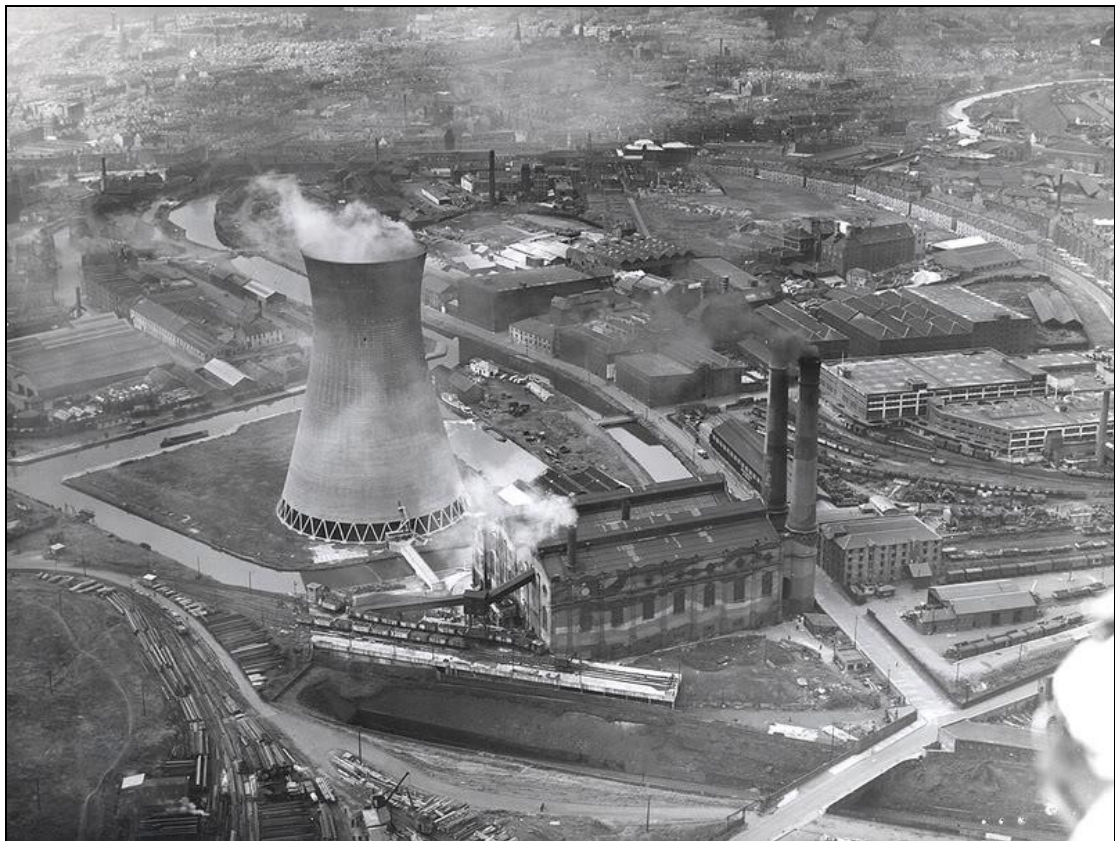
Figure 9: The Pinkston Basin and Cooling Tower, c.1950's

The Pinkston Power Station was built to the E of the Pinkston Basin in 1900. In 1954, a massive cooling tower was added. This was built on the site of the 'new timber basin' of 1842. This photograph shows the N and E wharfs of the basin to the right of the tower. The coke kilns shown on the 1892 OS map have been removed. The three-part Carron Company warehouses are shown at the E end of the basin. The N wharf is occupied by a few buildings to the W. A formal road can be seen running along the S side of the canal E of the N access bridge.

A further building was added at the NE angle of the basin in the 1970's. Both this building and the Carron Company warehouses are now demolished as are the other buildings indicated by this photograph. Traces of these may remain however, along with evidence of the canal infrastructure such as cranes, mooring posts, weighing machines and the towing path.

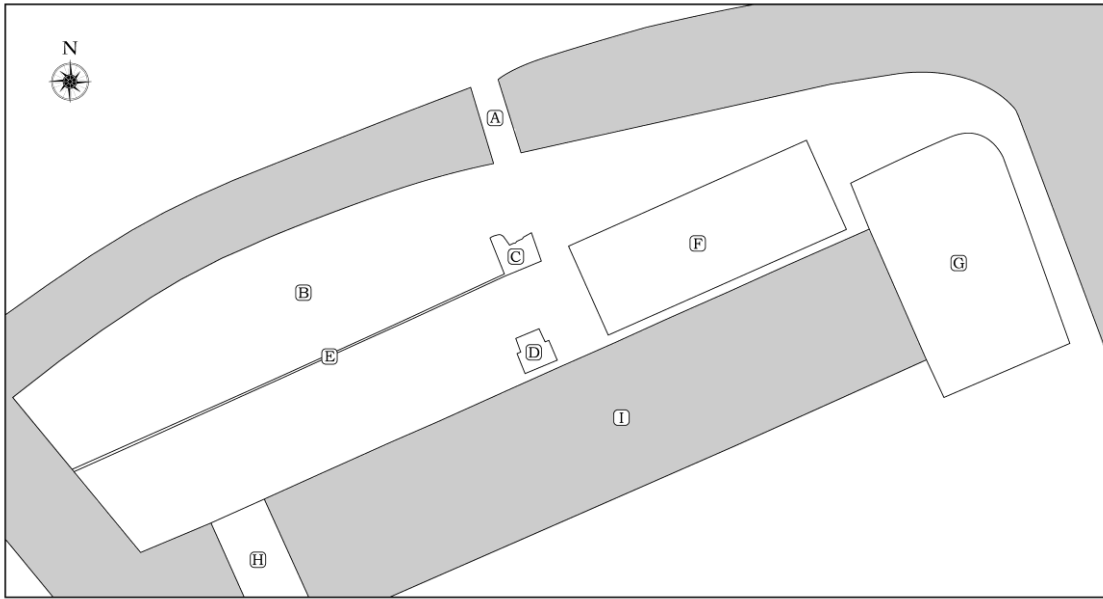
These are the main features (A-I) forming the site at present:

A – N Access Bridge - 20thC

B – Raised Tarmacadam Surface – 1970's / 1980's

C – Demolished Building – 1970's / 1980's

D – Demolished Building – 1970's / 1980's

E – Central Slit Drain running W from [C] – 1970's / 1980's

F – Demolished Building – 1970's

G – Demolished Building – c.1900

H – Modern Temporary Bund

I – The 'New Basin' - 1842

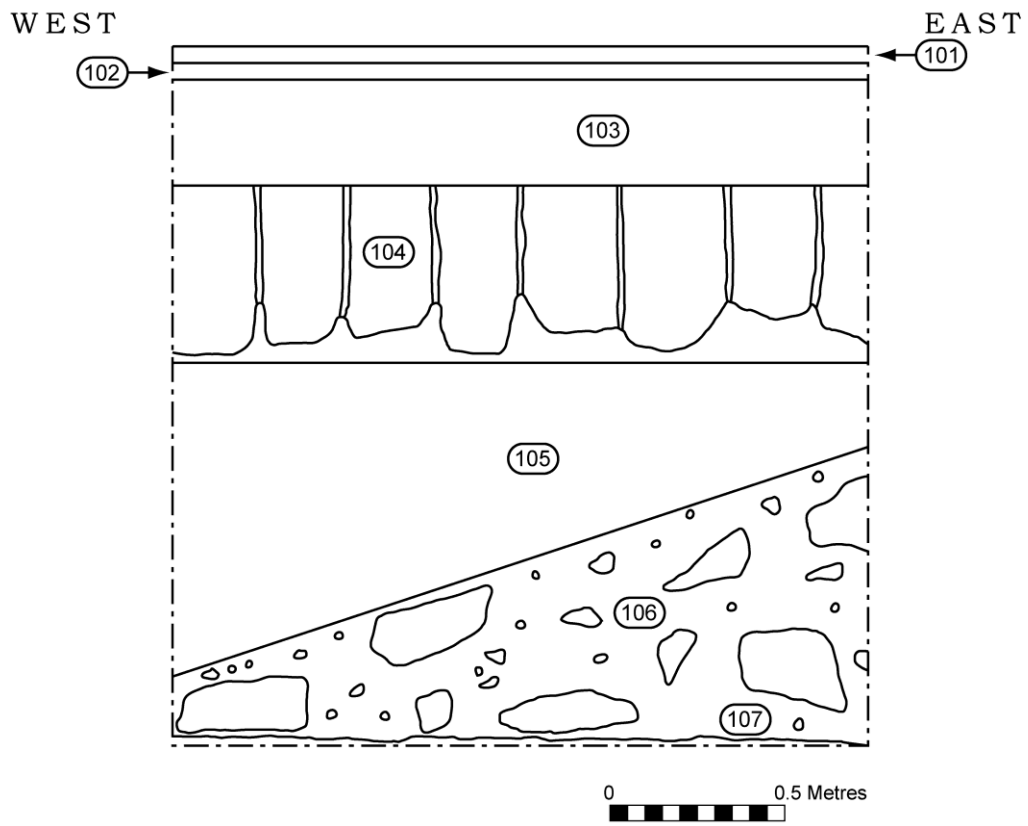
Figure 11: Trial trench 1

TRIAL TRENCH 1 (See Figure 11, Appendix 2)

This trench was approximately 2m E-W x 0.6m N-S and was dug to a depth of 2.4m. The section was composed of a 50mm thick tarmacadam surface **F101** over a 50mm thick sub-base of grey granular finings **F102** bedded on a 200mm thick base of pinkish shale and broken pieces of sandstone **F103**. These upper layers represent the modern raising and levelling of the site. Below these was a layer of laid grey whin setts up to 280mm deep in a grey ash matrix **F104** sitting on a thick layer of greyish puddle clay **F105** 240mm thick to the E and 900mm thick to the W. The puddle clay was bedded on a layer composed of large angular pieces of whin, bonded in a silty matrix **F106** up to 1m deep. At depth a depth of 2.4m a layer of brick and sandstone levelling material **F107** was encountered but not dug through. **F105-F107** are likely to represent the levelling of the site for the construction of the new basin in 1842.

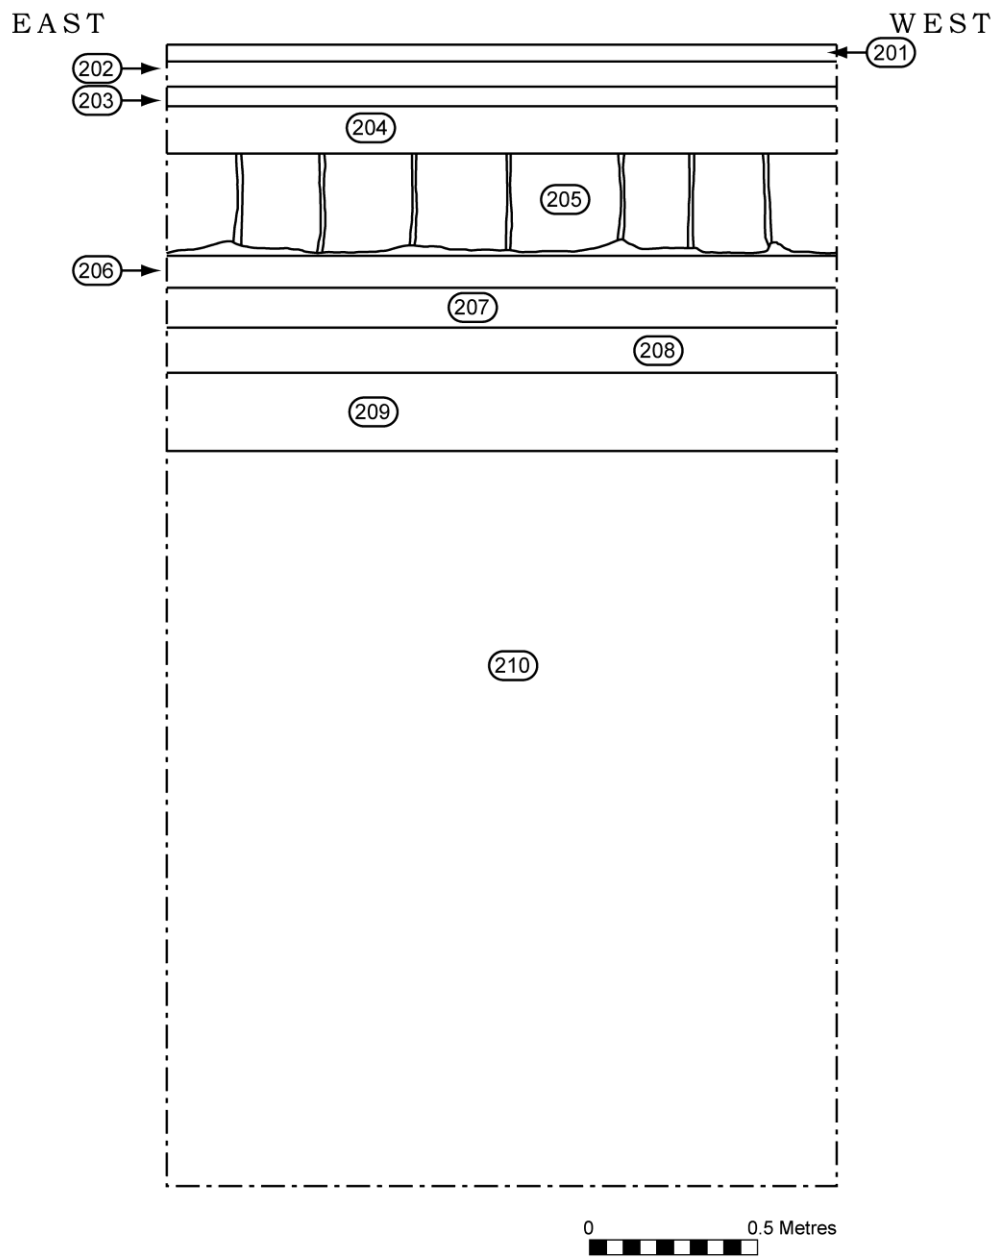
Figure 12: Trial trench 2

TRIAL TRENCH 2 (See Figure 12, Appendix 2)

This trench was approximately 2m E-W x 0.6m N-S and was dug to a depth of 3.4m. The section was composed of a 50mm thick tarmacadam surface **F201** over a 50mm thick sub-base of pink shale **F202** bedded on a 50mm thick base of grey whin dust **F203**. Below this was a 120mm thick base of pinkish shale and broken pieces of sandstone **F204**. These upper layers represent the modern raising and levelling of the site. Below these was a layer of laid grey whin setts up to 280mm deep in a grey ash matrix **F205**. A series of levelling layers sat below the whin setts. **F206** was a layer of bedding sand 80mm thick overlying a 120mm thick layer of crushed grey stone and ash **F207**. Below this was a further layer of yellow sand **F208** 80mm thick over a 220mm thick levelling layer of black ash and red bricks **F209**. These lay over a thick layer of natural grey alluvial clay **F210** exposed to a depth of 2.25m.

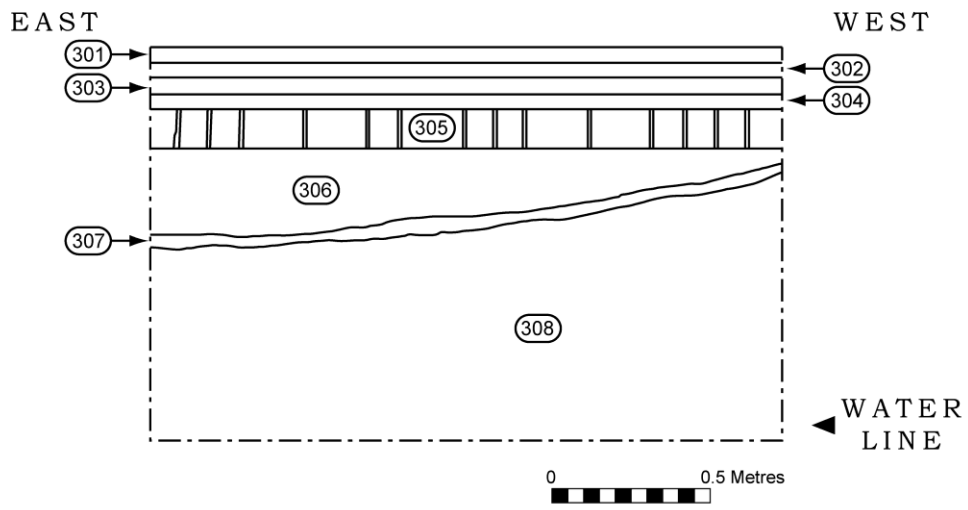
Figure 13: Trial trench 3

TRIAL TRENCH 3 (See Figure 13, Appendix 2)

This trench was approximately 2m E-W x 0.6m N-S and was dug to a depth of 1.25m. The section was composed of a 50mm thick tarmacadam surface **F301** over a 50mm thick sub-base of pink shale **F302** bedded on a 50mm thick base of grey whin dust **F303**. Below this was a 50mm

thick base of pinkish shale and broken pieces of sandstone **F304**. These upper layers represent the modern raising and levelling of the site. Below these was a layer, possibly a floor 120mm thick, composed of red bricks in a black ash matrix **F305**. Below this was an undulating layer (up to 300mm deep) of compact orange brown fused material **F306**, possibly a levelling layer of industrial waste serving as bedding for the brick floor. Below **F306** was a thin layer 50mm thick of grey whin dust **F307** overlying a granular grey layer with moderately (<50mm in diameter) sized pieces of stone within **F308**. This layer was only partially exposed as the water inundated the trench at 1.2m.

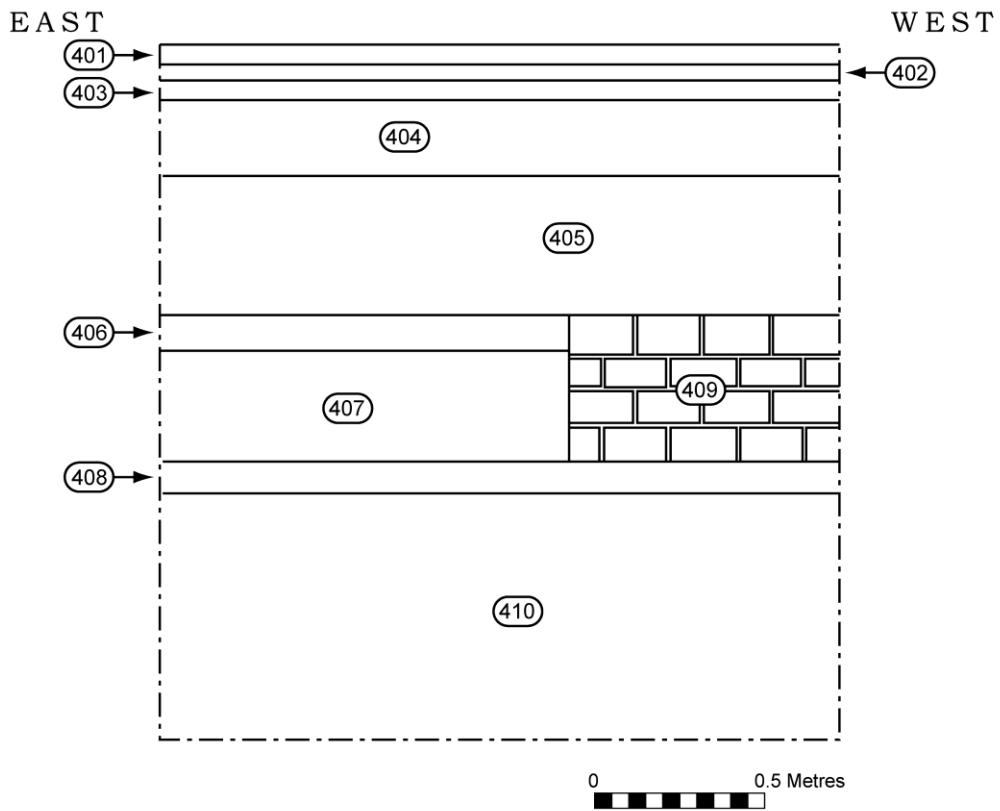
Figure 14: Trial trench 4

TRIAL TRENCH 4 (See Figure 14, Appendix 2)

This trench was approximately 2m E-W x 0.6m N-S and was dug to a depth of 2.04m. The N-facing section was composed of a 50mm thick tarmacadam surface **F401** over a 50mm thick sub-base of pink shale **F402** bedded on a 50mm thick base of grey whin dust **F403**. Below this was a 220mm thick base of pinkish shale and broken pieces of sandstone **F404**. These upper layers represent the modern raising and levelling of the site. Below these was a layer of laid grey whin setts up to 400mm deep in a grey ash matrix **F405**. The setts were sealing a series of levelling layers and a brick structure below. To the E of the brick structure (below the setts) was a layer of broken bricks, bonded together in a black matrix of silt and ash **F406**. This lay over a 330mm thick layer containing large pieces of crudely shaped sandstone in a yellowish brown clay matrix **F407**, which in turn sat on a base of crushed bricks **F408** 80mm thick, atop a layer of natural grey alluvial clay **F410** exposed to a depth of 740mm. Also bedded on **F408** was the bonded remains of a red brick structure **F409** four courses high (430mm). The structure was 600mm wide E-W. The structure may represent the walls of one of the smaller buildings shown on the OS map of 1857 levelled to the E by **F406-F408**. If this is the case then it means that the whin setts post-date the demolition of the building between 1857 and 1892.

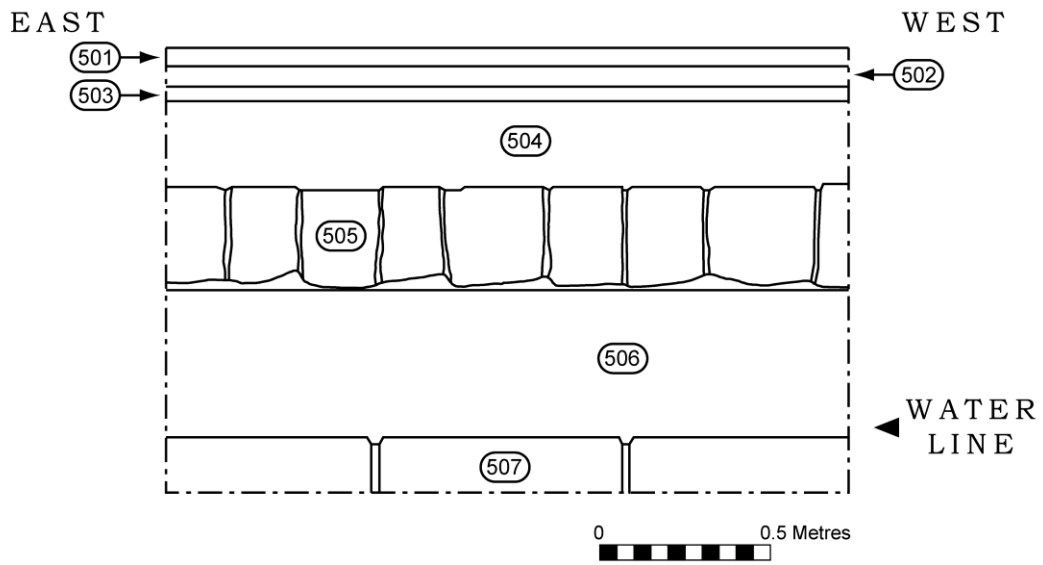
Figure 15: Trial trench 5

TRIAL TRENCH 5 (See Figure 15, Appendix 2)

This trench was approximately 2m E-W x 0.6m N-S and was dug to a depth of 1.30m. The N-facing section was composed of a 50mm thick tarmacadam surface **F501** over a 50mm thick sub-base of pink shale **F502** bedded on a 50mm thick base of grey whin dust **F503**. Below this was a 250mm thick base of pinkish shale and broken pieces of sandstone **F504**. These upper layers represent the modern raising and levelling of the site. Below these was a layer of laid grey whin setts up to 250mm deep in a grey ash matrix **F505**. The setts were bedded on a 300mm thick layer of black granular material **F506** used as levelling over a series of large sandstone slabs **F507**, 1m long x 0.7m wide x up to 0.3m thick. Unfortunately these were only visible briefly as the water level inundated the trench at a depth of 1.10m, but nevertheless they represent a considerable structure which may be of archaeological significance.

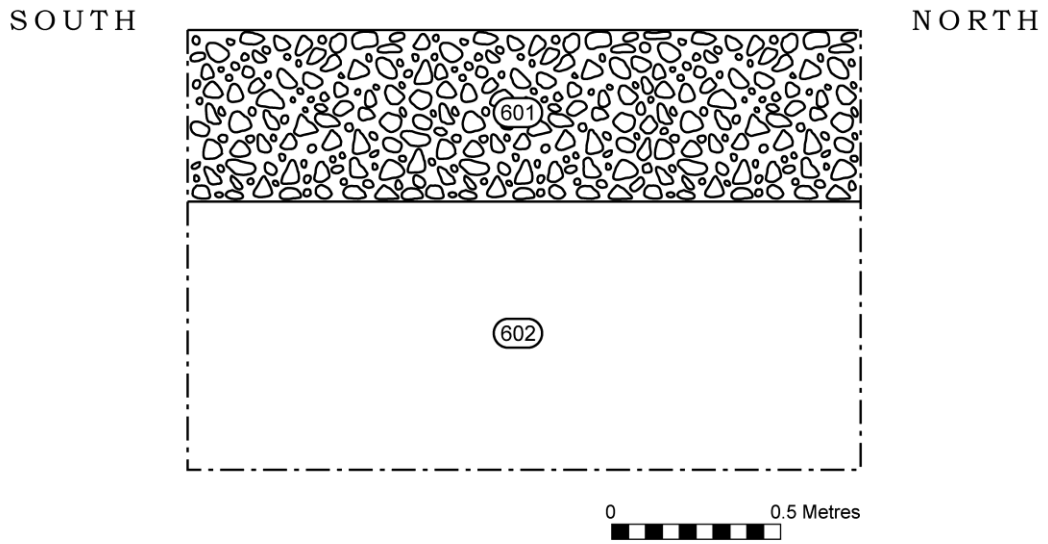
Figure 16: Trial trench 6

TRIAL TRENCH 6 (See Figure 16, Appendix 2)

This trench was situated on the modern temporary bund at the W end of the Pinkston basin and as such is of no archaeological interest. The trench was approximately 2m E-W x 0.6m N-S and was dug to a depth of 1.30m. The top 500mm, **F601**, was Type 2 stone with a mixed fill of silt, clay and brick **F602** below.

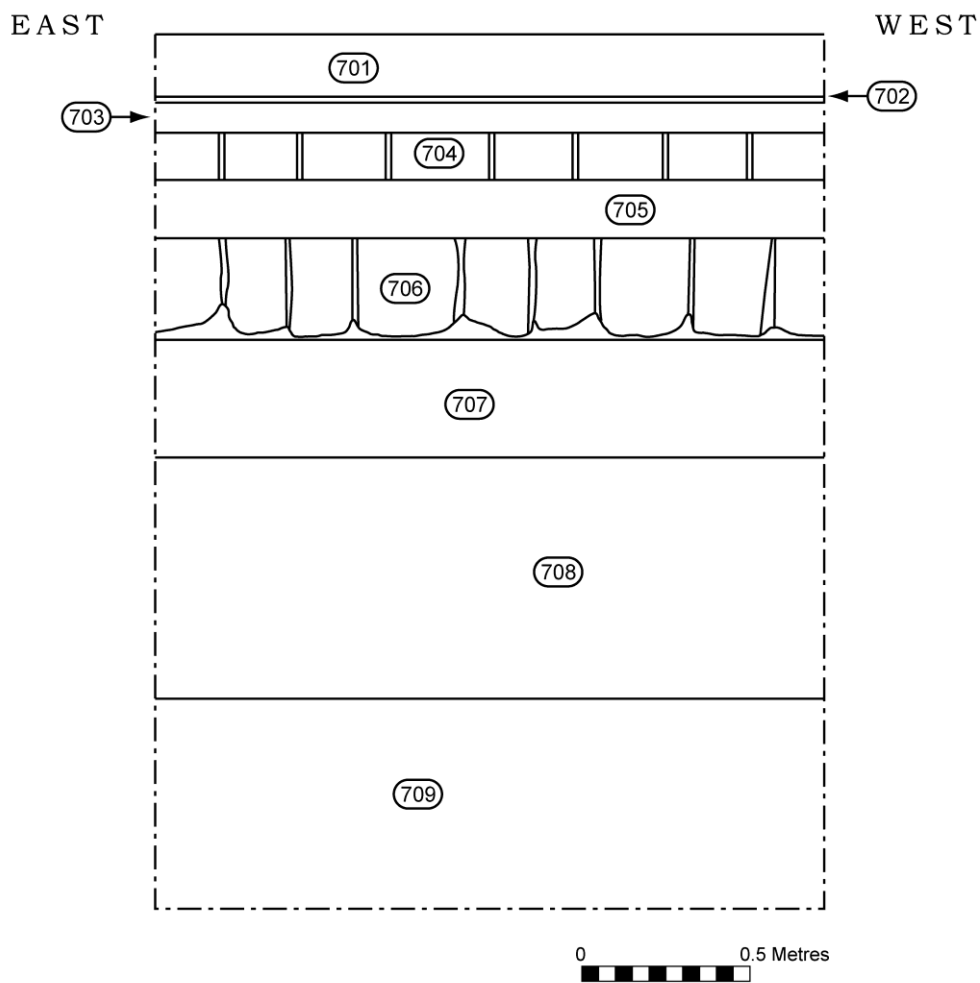
Figure 17: Trial trench 7

TRIAL TRENCH 7 (See Figure 17, Appendix 2)

This trench was sited within the footprint of the large building to the N of the basin and was approximately 2m E-W x 0.6m N-S, and was dug to a depth of 2.60m. The section was composed of a concrete foundation **F701** 180mm thick strengthened with 5mm diameter steel mesh. Below this was a thin plastic membrane **F702** acting as a damp-proof course. Below this was a layer of gritty grey ash **F703**, 100mm thick, covering a layer of red bricks **F704** (although it is unclear whether these were bonded or a levelling layer), sitting on a layer of brick and crushed stone **F705**, 200mm thick. Below this was a layer of laid grey whin setts up to 300mm deep in a grey ash matrix **F706**. The setts were bedded on a 370mm thick layer of black granular material

F707. Under this was a layer of reworked mottled clay **F708** overlying a thick layer of grey alluvial clay natural **F709**, exposed to a depth of 640m.

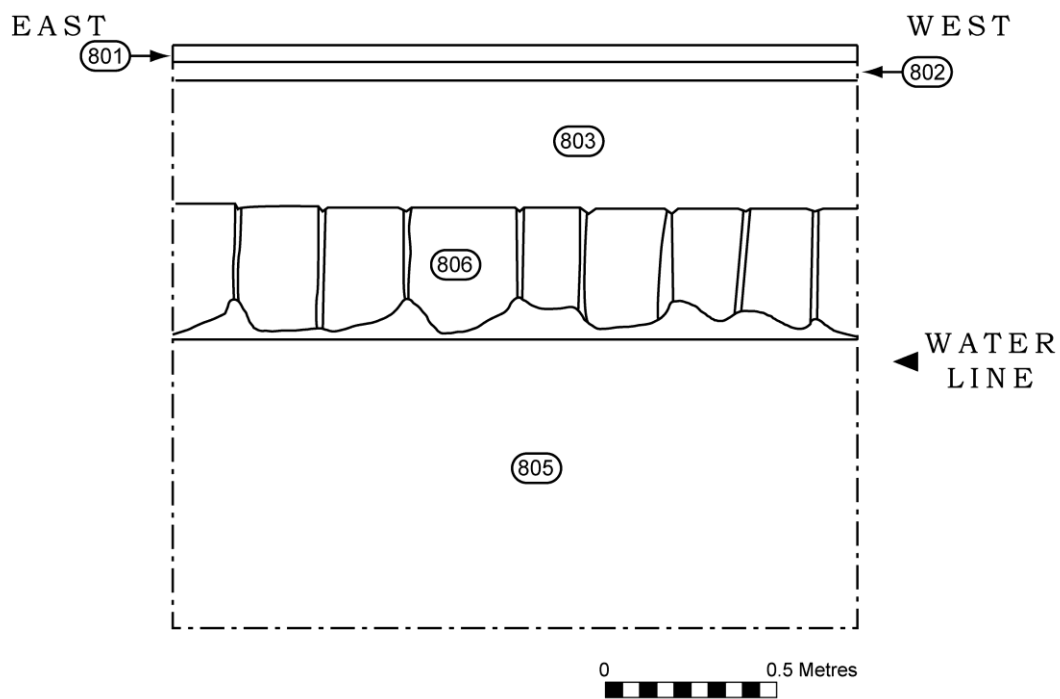
Figure 18: Trial trench 8

TRIAL TRENCH 8 (See Figure 18, Appendix 2)

This trench was approximately 2m E-W x 0.6m N-S and was dug to a depth of 1.7m. The S-facing section was composed of a 50mm thick tarmacadam surface **F801**, over a 50mm thick sub-base of grey Type 2 stone **F802**, bedded on a 360mm thick base of angular grey rubble in a gritty ash matrix **F803**. There were numerous roots at the base of this layer suggesting that it sealed an overgrown surface at some point. This surface was formed by **F804**, a layer of laid grey whin setts up to 390mm deep in a grey ash matrix. Below this a yellowish brown granular layer containing sandstone **F805** was noted, but water inundation at a depth of 930mm prevented precise recording of the deposit.

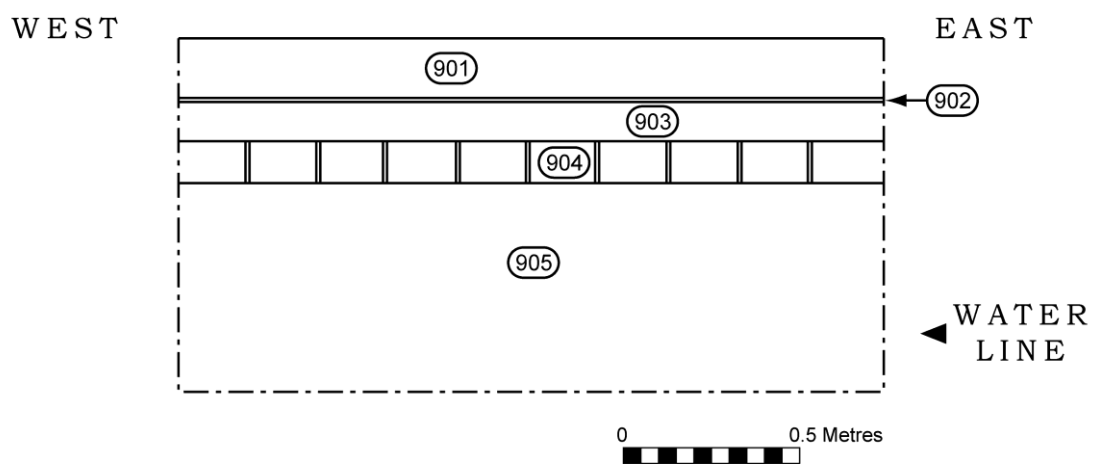
Figure 19: Trial trench 9

TRIAL TRENCH 9 (See Figure 19, Appendix 2)

This trench was sited within the footprint of the large building to the N of the basin and was approximately 2m E-W x 0.6m N-S, and was dug to a depth of 1m. The section was composed of a concrete foundation **F901**, 180mm thick strengthened with 5mm diameter steel mesh. Below this was a thin plastic membrane **F902** acting as a damp-proof course. Below this was a layer of gritty grey ash **F903**, 100mm thick, covering a layer of red bricks **F904** (although it is unclear whether these were bonded or a levelling layer), sitting on a layer of brick and crushed stone **F905**, 420mm thick. A burst pipe inundated the trench with water; the water line was established at a depth of 820mm.

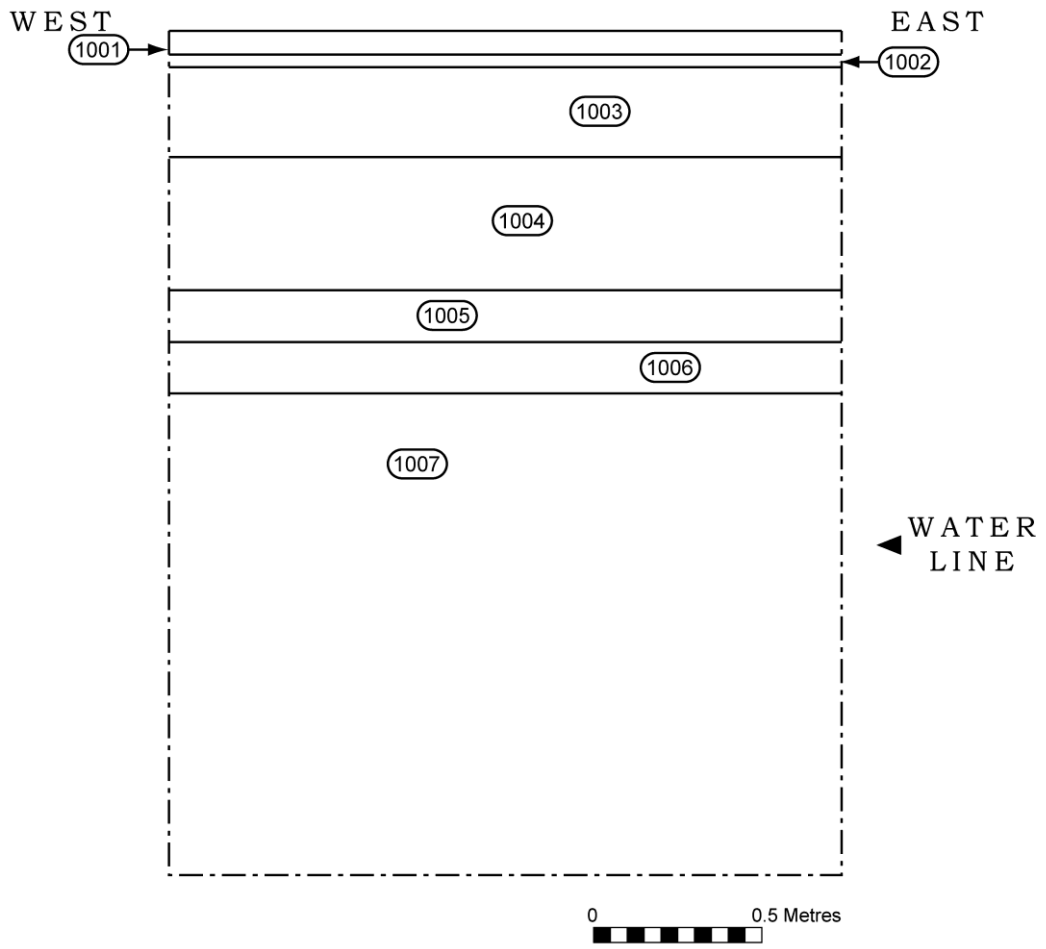
Figure 20: Trial trench 10

TRIAL TRENCH 10 (See Figure 20, Appendix 2)

This trench was approximately 2m E-W x 0.6m N-S, and was dug to a depth of 2.5m. The S-facing section was composed of a 50mm thick tarmacadam surface **F1001**, over a 50mm thick sub-base of grey Type 2 stone **F1002**, bedded on a 260mm thick base of angular grey rubble in a gritty ash matrix **F1003**. Below this was a 400mm thick layer of black ash-rich clay **F1004**, sitting

on a 150mm thick layer of crushed sandstone **F1005**. Below this was a 150mm thick layer of reworked mottled greyish brown clay **F1006**, overlying a yellowish brown granular levelling layer containing sandstone and red brick **F1007**. Its full extent was not established as water began to inundate the trench at a depth of 1.25m.

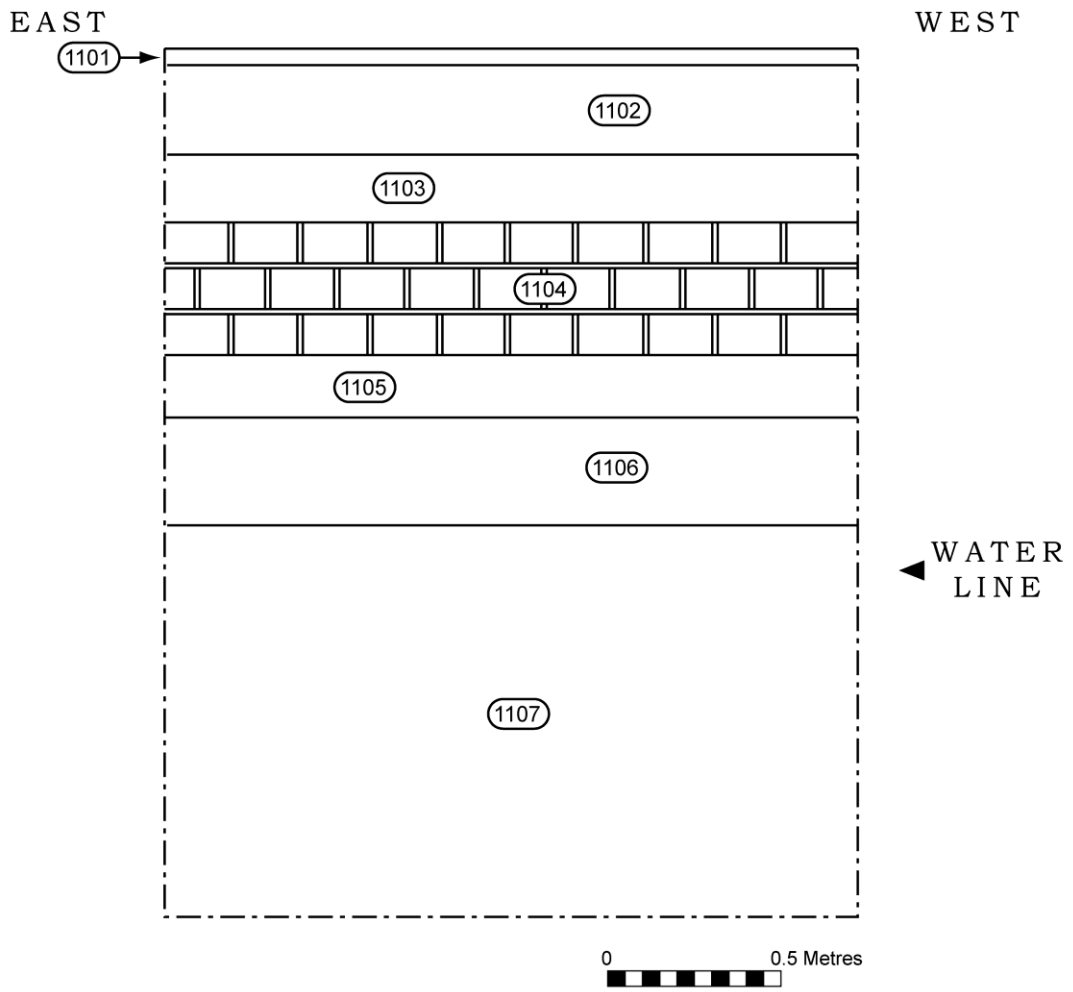
Figure 21: Trial trench 11

TRIAL TRENCH 11 (See Figure 21, Appendix 2)

This trench was sited within the footprint of the large building to the E of the basin and was approximately 2m E-W x 0.6m N-S, and was dug to a depth of 1.8m. The section was composed of a top layer of concrete **F1101**, 50mm deep, resting on a 250mm thick layer of grubbed up bricks and stone **F1102**. Below this lay a levelling layer of greyish grit and ash **F1103**, 200mm thick. This was levelling over a laid brick surface **F1104**, 120mm thick, lying on a bed of grey gritty ash **F1105**. Below the ash was a 300mm thick layer of black granular material **F1106**. Under this was a layer of grey alluvial clay natural **F1107**, only partially exposed as the water began to inundate the trench at a depth of 1.50m.

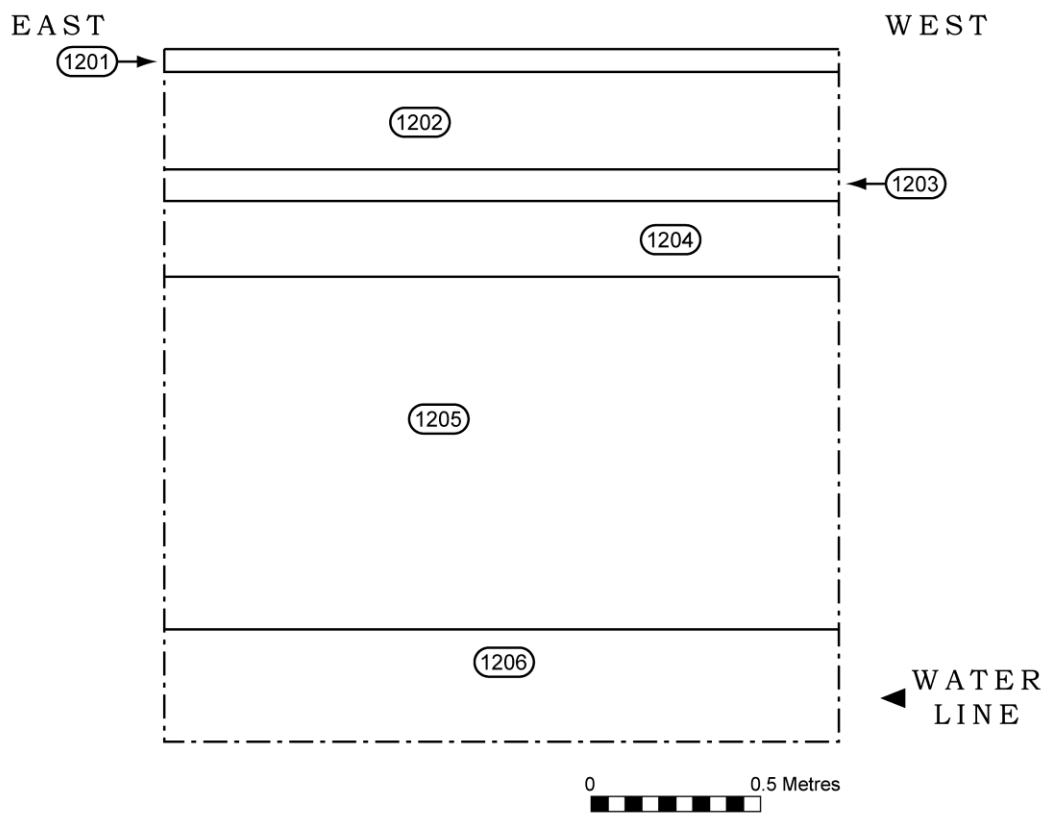
Figure 22: Trial trench 12

TRIAL TRENCH 12 (See Figure 22, Appendix 2)

This trench was sited within the footprint of the large building to the E of the basin and was approximately 2m E-W x 0.6m N-S, and was dug to a depth of 2.04m. The section was composed of a top layer of concrete **F1201**, 50mm thick, resting on a 300mm thick layer of grubbed up bricks and stone, **F1202**. Below this lay a levelling layer of greyish grit and ash **F1203**, 90mm thick. This was levelling over an extremely compact 210mm thick layer of fused, fine-grained material **F1204**, possibly kiln debris. Below this was a 300mm thick layer of black granular material **F1205**. At the base was a layer of grey alluvial clay natural **F1206**, only partially revealed as the water began to inundate the trench at a depth of 1.90m.
