**A Rapid Assessment of the Archaeological
Landscape surrounding Howgrave Hall and
Banqueting House, Sutton Howgrave, North
Yorkshire**

Abby Hunt

Archaeological Survey & Investigation Internal Report

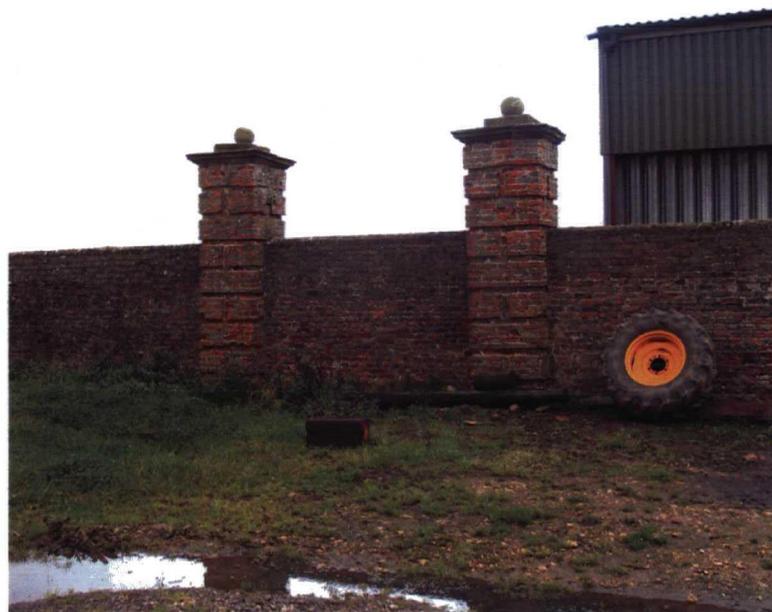
*Figure 2
The wall and gate
piers to the north-west
of the Banqueting
House*

The north-western edge of the walled enclosure is defined by a long stretch of brick wall, which incorporates a pair of gate piers close to its north-eastern end. This is a listed structure and is believed to date to c1700 (Listed Building UID 332650), making it broadly contemporary with the Banqueting Hall. Approximately 9m to the south-east of this wall, following a parallel course within the enclosure, is a hedgerow which defines a narrow strip of land. This hedgerow does not appear on the historic maps up to the 1830s but is shown on the Ordnance Survey First Edition map of the area (c1850).

The wall, incorporating a pair of gate piers, to the west of Howgrave Hall and the Banqueting House are Listed (Grade II - UID 332650; Figure 2). The earthworks in the fields to the south-west and south of the farm complex form a Scheduled Monument (UID 53665; NMR no. SE 37 NW 12).

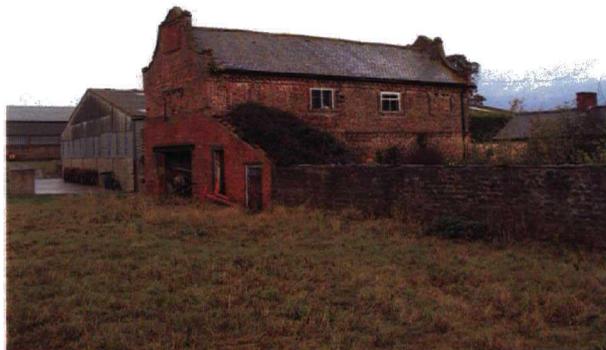
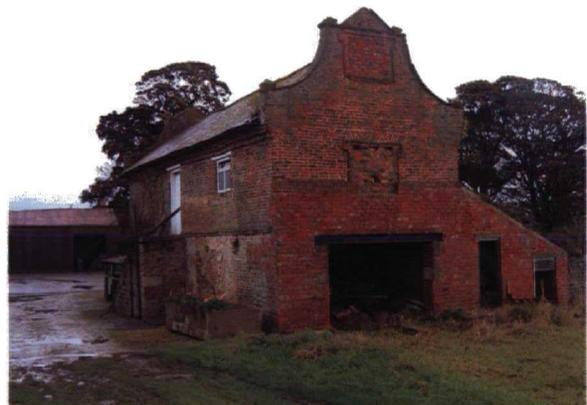
*Figure 3
Top: The Banqueting
House from the south.
These two elevations
would have been the
'show' faces of the
building.*

*Bottom: The
Banqueting House
from the west. The
exterior staircase
giving access to the
upper storey can be
seen to the left.*

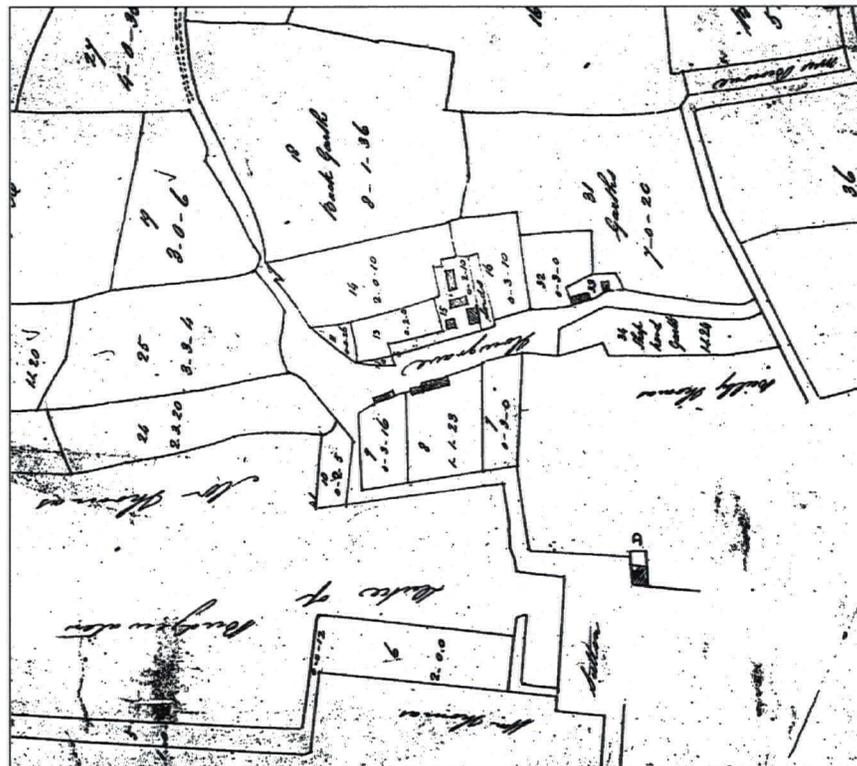
Figure 4
Extract from the 1760
plan of the estate of
Philip Bendlowes at
Sutton cum Howgrave.
Reproduced by
permission of
North Yorkshire
County Record Office.

A nineteenth-century copy of a plan of the estate of Philip Bendlowes at Sutton-cum-Howgrave originally dating to 1760 is held in the North Yorkshire County Record Office (NYCRO) (Ref: ZM1 132 MIC 1497/164-166; Figure 4). The plan shows that the walled enclosure containing the Banqueting House was, at this date, divided by a boundary on a north-east to south-west alignment. However, the long, narrow strip of land at the north-western of edge of this enclosure was apparently not in existence in 1760.

This plan also shows that the land occupied by the former village site was still subject to division at this point, with three unequal plots depicted, two of which have structures at their north-western ends. There is also a broad open area between these enclosures and the wall defining the walled enclosure and the extent of Howgrave Hall, labelled 'Howgrave'. This open area is accessed by a 'routeway from the west/north-west (labelled 'Public Bridle Route') and by another routeway from the north-east. The fact that this is a broad open area with access from both ends, adjacent to a row of plots, strongly suggests that it was originally a green associated with the former village. Although the plan does not extend far enough south to cover the whole of the area now occupied by Sutton Howgrave, it does show another open area here, this one labelled 'Sutton', in roughly the same location as the present village green. The existence of these two village greens concurs with the evidence

from the Domesday Survey that there were in fact two manors here. To the south-east of the plots (tofts) of Howgrave village, the plan shows a routeway, which is identifiable as the hollow way observed on the ground to the south of the large, rectilinear block of earthworks (Figure 6 - C).

The course of the 'Public Bridle Route' to the north-west of Howgrave Hall and the associated field boundaries shown on the 1760 plan create an anomalous curvilinear pattern in the landscape, which is distinctive from the other more regular field boundaries in this area. It may be that the bridleway was an established feature of some antiquity, in regular use at the time when the land was enclosed. The fields would thus have respected its course. Alternatively, the curvilinear boundary may perhaps have been a park boundary, creating an open landscape visible from the banqueting house, but requiring general traffic to and from the village to be diverted around the outside of it, hence the development of the bridleway. This curving field boundary no longer survives as an extant feature in the landscape, but has been fossilised as part of the course of the parish boundary of Howgrave CP.

It is interesting to note that there is apparently no road immediately to the north-east of the former village tofts shown on this plan, indicating that the present road, which is now the main routeway through the village, was in fact a post-1760 insertion.

A pair of rounded depressions were observed adjacent to, and cut through by, the south-eastern boundary of this part of the field. At the time of the site assessment, the larger of the two features was holding a small amount of water, giving a strong indication that it was formerly a pond. The smaller depression may also have been a pond. On the 1760 plan of the village, the curved boundary between fields 10 and 24 suggests that it is following the edge of an existing feature, probably the larger pond (see Figure 4).

west to south-east alignment. These correspond with the boundaries shown on the 1760 plan of the village (Figure 4), which, in turn, most likely respect and fossilise boundaries which originally formed part of the medieval village here. On a similar alignment is a deep rectangular hollow at the north-eastern end of the block of earthworks; this is approximately 1m deep in places (Figure 7). A slight bank within the hollow defines a shallow ditch around the interior of the feature. This may represent the location of a large building, perhaps an early incarnation of the manor house. The survival of the ditch would suggest that the building had subsequently been robbed out, with a trench dug to remove foundation stone. However, the ditch may be a little too regular and 'neat' to fully support this theory. Alternatively the feature may be later than the village remains, although their shared alignment suggests a degree of contemporaneity. A more detailed examination of this feature may bring a clearer idea of its original function.

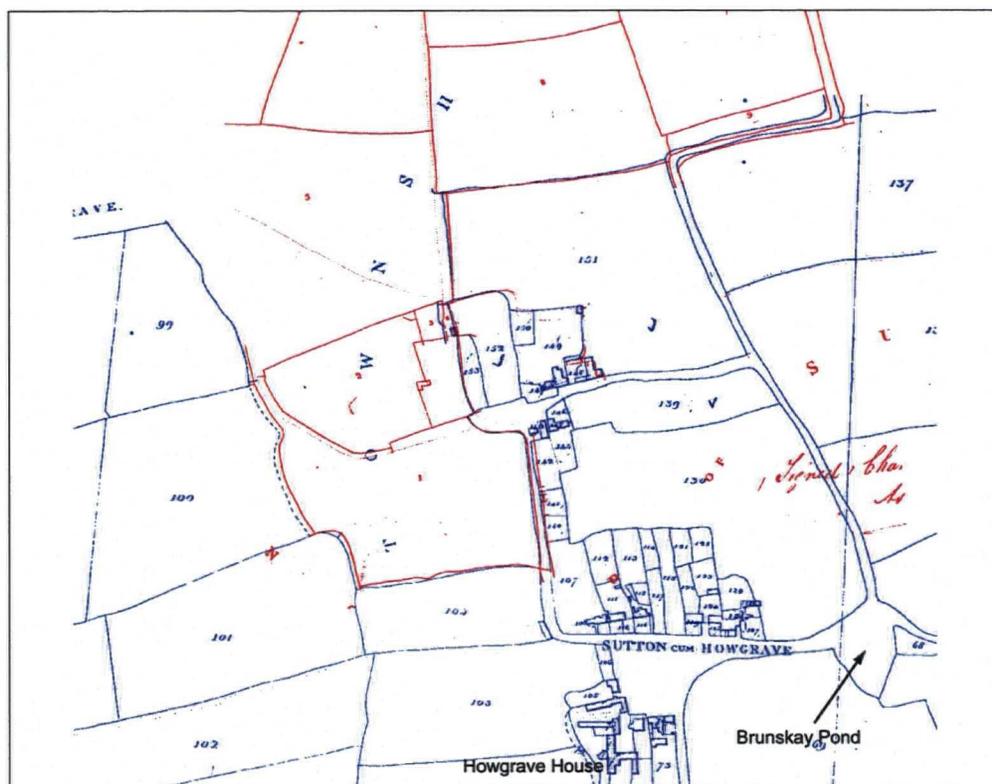
Figure 5
 Extract from the tithe maps for Holme cum Howgrave (shown in red) and Sutton cum Howgrave (shown in blue). Reproduced by permission of North Yorkshire County Record Office.

As mentioned above, Howgrave originated as two separate manors, a division which has been reflected in later parish divisions. The tithe maps for the village, dating to the 1830s, are thus similarly split, with the area of the present village of Sutton Howgrave shown on the tithe map of Sutton cum Howgrave (NYCRO Ref: Tithe Map MIC1801/196), and the Banqueting House and the field of earthworks on the tithe map for Holme cum Howgrave (NYCRO Ref: Tithe Map MIC1794/313) (Figure 5). The layout of Sutton cum Howgrave on the first of these maps is close to the present village plan, although the rectilinear village green north of Howgrave House appears to have been much larger in the nineteenth century than it is today. The houses on the north-western side of the village green are also depicted on the tithe map with their associated plots of land and although some plots have been subdivided, their elongated, rectilinear plan is clear, indicating a medieval origin. This is also

the form that the plots of the former Howgrave village, now reduced to earthworks, would originally have taken. The distinctive road pattern, that of the road enclosing a large part of Sutton cum Howgrave village, is shown on the tithe map, confirming that the road between the existing village from the former village of Howgrave had been inserted by this date. Just beyond Sutton cum Howgrave village, the road leading eastward from the north-east end of the village green broadens out. This broadening corresponds with the location of Brunskay Pond on modern maps. The position of the pond suggests that in the nineteenth century it was a common resource for the villagers, most probably originating in the medieval period. It seems that this layout was mirrored to the south-west, with the former village of Howgrave also having an associated pond at the end of a village green (see Section 4 below) - further evidence of the existence of two adjacent, and yet distinct, medieval settlements.

The tithe map for Holme cum Howgrave is somewhat less detailed than the Sutton map. The field divisions are depicted, but there is little detail beyond that. There is no depiction of any features within the field containing the village earthworks. There is also only one building shown in the area of Howgrave Hall; an L-shaped structure, which does not immediately correspond with any of the buildings known to have stood here from earlier cartographic evidence. The walled enclosure is no longer divided by a boundary, but the curving field boundary to north-west of Howgrave and its associated bridleway is still depicted on this map.

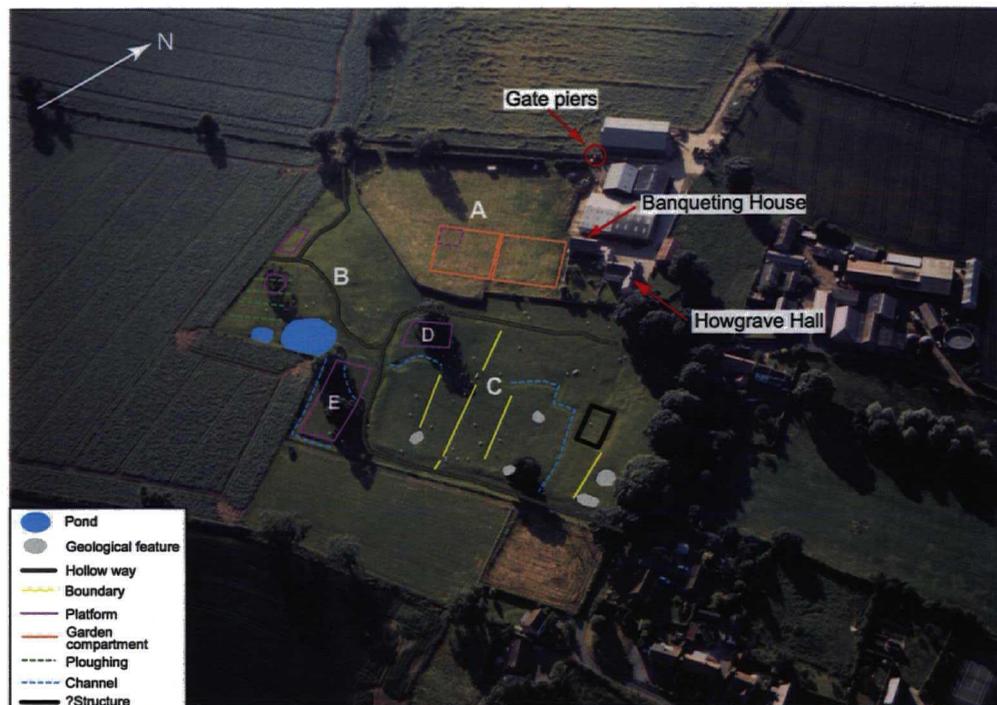
Figure 6
Annotated aerial
photograph of
Howgrave Hall
showing a schematic
depiction of the
principal features
observed during the
walk-over survey.
Photograph: ©English
Heritage. NMR 17288/
17 SE 3179/5 08-Jul-
1999

The features observed at the time of this site visit are shown as Figure 6, in schematic form superimposed on an aerial photograph of the site.

The Walled Enclosure (Figure 6 - A)

The north-western part of the walled enclosure is fairly level, with no particular features of note. However, the south-eastern part contains better defined earthwork remains. Parallel with the south-western end of the Banqueting House is a strong scarp, lying at right angles to the south-eastern enclosure wall. This defines a rectilinear area abutting the structure, probably a garden compartment, set at a lower level than the surrounding area. To the south-west of this is another rectilinear area, defined by a very low earthwork bank to the

south-west, also at right angles to the enclosure wall. This second compartment is on a higher level than the first and has faint traces of a rectilinear depression in its western corner, possibly the site of a building. A previous suggested interpretation of this upper compartment is that it was the site of an earlier manor house. However, it is possible that it was a second garden compartment associated with the Banqueting House, perhaps containing a garden structure, such as a summer-house. A brief inspection of the Banqueting House itself strongly suggests that the south-east and south-west facades were the 'show' aspects of the building, supporting the theory that the juxtaposition of the Banqueting House and gardens would have created a formal landscape setting.

The earthworks in the east of the field represent the site of the medieval village of Howgrave. As mentioned previously, there is a large rectilinear area defined on three sides by the arms of the principal hollow way (Figure 6 - C). Within this rectilinear area are at least four parallel boundary features, indicating that the area was divided up into rectangular plots, on a north-

In the western corner of the block defined by the hollow ways a rectilinear platform was also observed (Figure 6 - D). It is well-defined on three sides, but its south-eastern edge has been cut into by a channel (see below). There is presently a tree growing on this platform which is surrounded by stone fragments and a dense area of nettle growth, suggesting that it may be the remains of a former structure.

Situated in the corner of the modern field beyond the south-western edge of the large rectangular block of earthworks is a further rectilinear platform, close to the larger of the two ponds (Figure 6 - E). The platform is defined by the principal hollow way on two sides and by another linear hollow to the south-east and south-west. The latter is somewhat different in

form to the principal hollow way and has the appearance of a water-cut channel. Cutting across the northern corner of the platform is a shallow channel, possibly leading from one of the ponds. There are no obvious structural remains on the platform, but one possibility is that this may have been the site of a mill connected with the village. However, this platform is shown as a paddock on the 1760 plan of the site. In order to prove or disprove the suggestion of the mill location, a better understanding of the water management in this area is needed.

From this brief assessment of the field remains, it seems clear that the site would benefit from further in-depth investigation. A survey of the surviving earthworks at 1:1000 scale would allow a more detailed analysis of the layout of the former village and an understanding of the chronology of the earthwork remains. This survey work would be most appropriately undertaken in tandem with further study of the plan of the present village. It is possible that the application of geophysical survey could further enhance any detailed work on the site. In particular, the rectangular depression and other possible building locations could benefit from this kind of survey to get a better indication of the nature of any sub-surface remains.
