# BRITISH GYPSUM SITE SHERBURN IN ELMET NORTH YORKSHIRE

A Report on an  
Archaeological  
Watching Brief

by Gareth Dean

December 2005

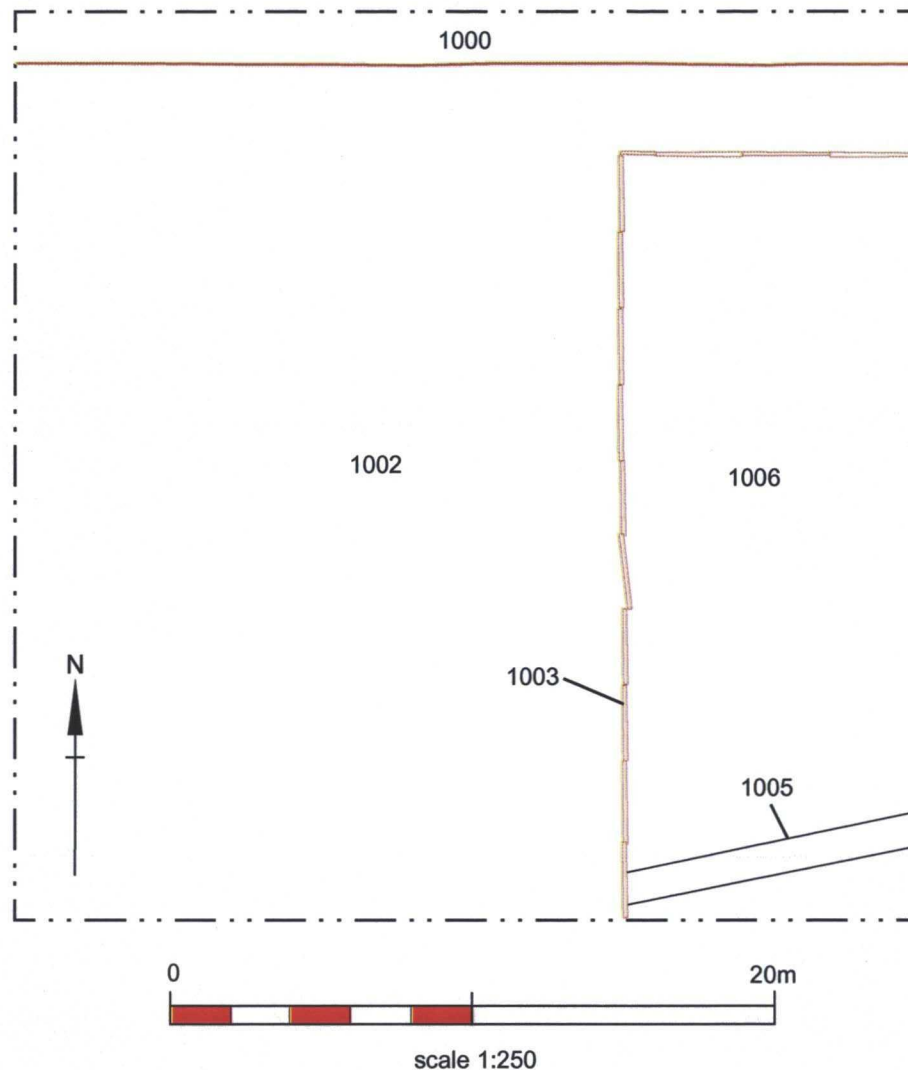
Fig.3 Plan of 30m x 30m trial trench

Within the 30m x 30m area, the earliest deposit was the natural plastic clay (1006). Cut into this was a ditch (1005) between 1-1.4m wide that was filled with a firm dark grey silt with occasional charcoal flecks (1004) that produced fragments of 19<sup>th</sup> century pottery. The ditch was aligned roughly east-west and was probably associated with an old field boundary.

Overlying this ditch and the natural topsoil was the former topsoil (1000) which consisted of a firm, dark grey silt sand. Into this had been cut a haul road (1001) which was associated with the original layout of the factory. The haul road existed as a series of timber planks (1003), set on edge to form a kerb for a road way and possible turning circle. The surface of the road and compound had been filled with a mix of crushed stone and gypsum waste (1002).
