LAND SOUTH OF OUSEGATE, SELBY, NORTH YORKSHIRE

WRITTEN SCHEME OF INVESTIGATION FOR ARCHAEOLOGICAL EXCAVATION & RECORDING

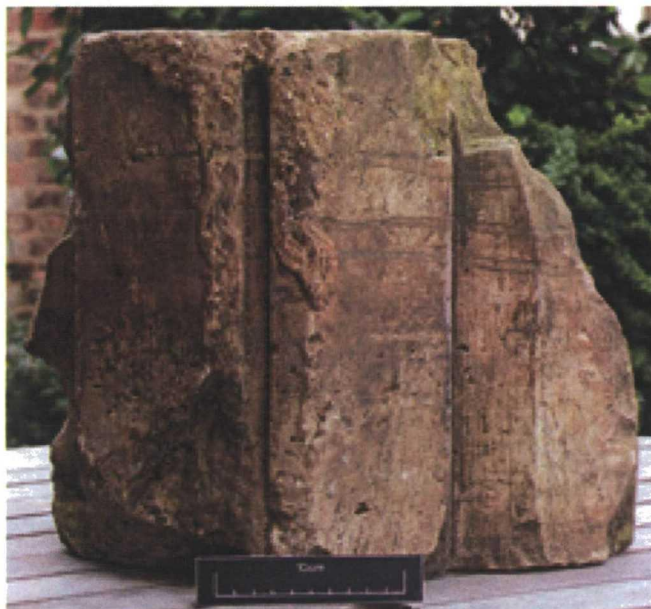
The fragment, (Plate 4, right) found within Context 10013 (see section 5.1.9) is a window mullion in Magnesian Limestone. The exterior surface has broken off, but all remaining surfaces survive. The top and base of the block each have a setting out line and claw tooling. The vertical sockets to carry the glazing survive on both sides of the block. All the surviving faces are decorated with chamfers and rebates. The overall shape suggests Decorated architecture of 1270-1350.
