LITTLETHORPE POTTERIES, LITTLETHORPE.

REPORT ON AN ARCHAEOLOGICAL WATCHING BRIEF.
OSA REPORT No: OSA05WB17.

JANUARY 2006.

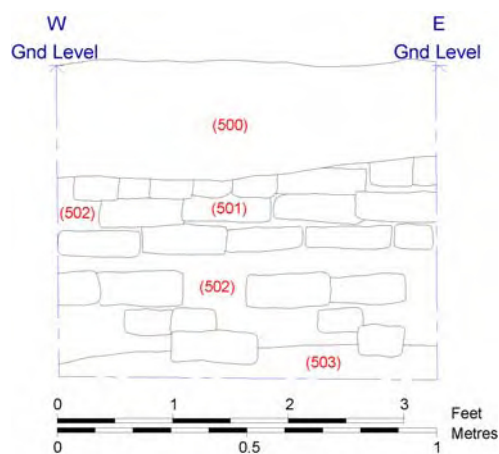
Figure 4. South facing section of trench 5. (Scale 1:20).

The firm clay natural (503) was the earliest deposit in Trench 6. Above this was a 0.50m thick, very compact brown slightly clayey silt (502) with occasional sherds of misfired early modern pottery. An east/west brick wall (501) cut through the subsoil and natural with the lowest course of bricks cutting up to 0.11m into the natural (Plate.4). These foundations were present in the westernmost limit of Trench 5 and continued eastwards for 6.50m until truncated by modern north/south orientated kerbstones and paving. The wall was a minimum of 0.50m thick as it was visible in both section edges of Trench 5. Foundations (501) were up to 0.60m deep and consisted of handmade, irregularly fired unfrosted bricks ranging in size from 0.24m x 0.12m x 0.08m to 0.21m x 0.10m x 0.07m. Up to four courses survived relatively intact with a further two disturbed courses beneath. The uppermost course was largely composed of headers with the other courses being mainly footers. However, the headers and footers were interspersed randomly. Many of the bricks displayed a cream render on one face. A hard creamy lime based mortar with chalk inclusions bonded them. The foundations (501) were sealed by a 0.28m thick layer of loose greyish brown silt topsoil (500).

The topsoil ended 6.50m east of the western limit of the trench. Beyond this point, the stratigraphy was very similar to that in Trench 3 with the natural overlain by a 0.38m thick layer of brown clayey silt with frequent fragments of discarded sherds of pottery (504), the same as (303). Overlying (504) was a compact band of a mixed material of a dark brown/grey silt (505) with fragments of pottery, coal and slag. It was 0.20m thick and identical in appearance to (302). Above this was a 0.06m band of fine light brown sand with grey patches of sand (506) and a 0.15m thick layer of hardcore and pebbles forming part of the surface of the courtyard of the pottery complex (507).

The foundations of an east/west aligned brick wall survive to a depth of 0.50m beneath the topsoil of the western 6.50m in Trench 5 and turn to run north/south for 2.5m south down Trench 6. This is probably mid-late 19th century in date and may be part of the foundations of a building that lay parallel between Pottery Lane and the current clay preparation shed (Unit A) and marked on early OS maps (building 11a, Figure 9, Carlton 2000).

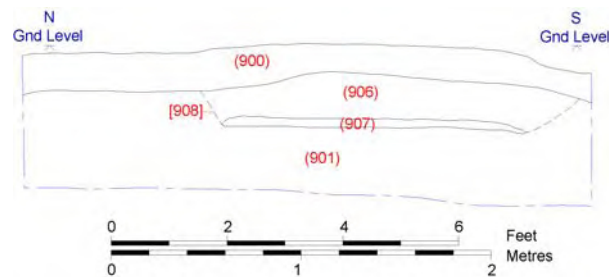
Figure 5. West facing section of trench 9. (Scale 1:40).

The earliest deposit within Trench 9 was a slightly orange brown firm clay (901). This was deeper at the southern end of the trench as the base fell towards the stream to allow water to drain.

Four east to west orientated linears cut through the natural in Trench 9. These formed banks visible as earthworks in the field. The cuts of the linears, [917], [914], [908] and [905], occurred at 11.0m, 15.30m, 23.95m and 32.70m from the northern edge of the trench. Linear [905] was 3.30m wide. The others varied in width from 1.90m-2.0m with moderately sloping sides falling to break sharply to a flat base.

A layer of topsoil up to 0.18m thick covered all the earthworks. Beneath this, the uppermost fill of the earthworks, contexts (903), (906), (911) and (915) from the linears running south to north, was a loose mixed backfill of greyish brown silt with patches of brown clay. This varied in thickness across the linears from 0.26m to 0.29m. Beneath this were a lens of a dark grey to black gritty silt with patches of reddish brown iron staining, contexts (904), (907), (912) and (916) respectively in each of the linears. These were all of approximately the same thickness, namely 0.05m to 0.07m. In linear [914], context (913) laid beneath the black gritty silt (912). This was 0.04m thick and consisted of small angular limestone fragments 0.01m-0.04m in diameter. They were bonded by a soft creamy mortar and lay on the natural (Plate.7).

A possible pit or linear [910] measuring 1.10m wide and 0.70m deep with moderately sloping, concave sides falling to a flat base was found immediately south of earthwork [914]. It was filled by a greyish brown soft loose silt (909).

Only two layers were visible in the majority of Trench 9; the topsoil and natural. However, four east/west linears cut through the natural in Trench 9 and reached a depth of 0.43-0.50m below the ground surface. These are probably the remains of disused and decayed waggonways, which have been buried under a layer of topsoil. The lens of dark grey/black gritty silt with iron patches in each of the linears was probably the remains of the wagon rails with the limestone band in linear [914] a levelling deposit or earlier metalled surface.

The form and function of feature [910] is unknown and no dating evidence was recovered. It reached a width and depth of 1.10m and 0.70m respectively. It may represent the infilling of a clay pit or be the remains of a natural feature.

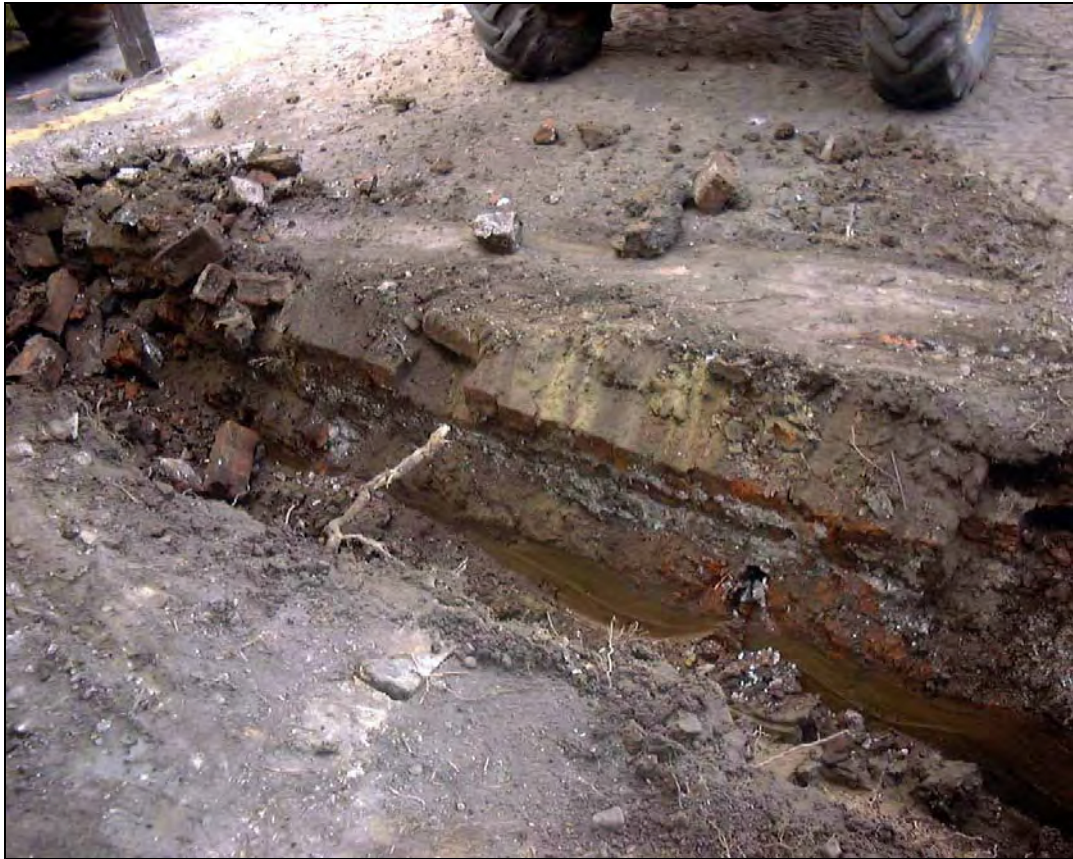
The earliest deposit encountered in Unit B, Trench 1 was the clay natural. The natural comprised laminated bands of a firm, plastic greyish brown yellow and grey clay (103). In the southernmost strip 2-3 courses of an east/west orientated brick wall (102) with three skins were observed cut into the natural (Plate.1). These foundations extended for 7.50m and were up to 0.35m wide and 0.34m deep. The foundations were overlain by a 0.20-0.45m thick very mixed layer (101). Context (101) was a gritty reddish brown silty clay with brick fragments, sherds of pottery and occasional fragments of slag and coal. A grass covered brownish grey clayey silt topsoil 0.05m thick (100) was present in the southern extreme of the trench.

Plate 1. Trench 1, east/west oriented brick wall foundations (102) from the southern elevation of Unit B.

Context (101) was a mixture of demolition material from the demolition of Unit B with misfired and discarded pottery sherds. This overlay a firm clay natural. There thus appears to have been no activity on this site prior to the construction of Unit B, the brick foundations of the southern elevation (102) being visible in the southernmost strip. No archaeological features or deposits were encountered and there were no deep fills suggestive of infilled clay pits. Indeed borehole investigations by Geoinvestigate Ltd on June 2nd 2005 in the central courtyard had found no evidence of infilled clay pits (Geoinvestigate Ltd 2005) and it was considered unlikely that any would be found in the close vicinity.

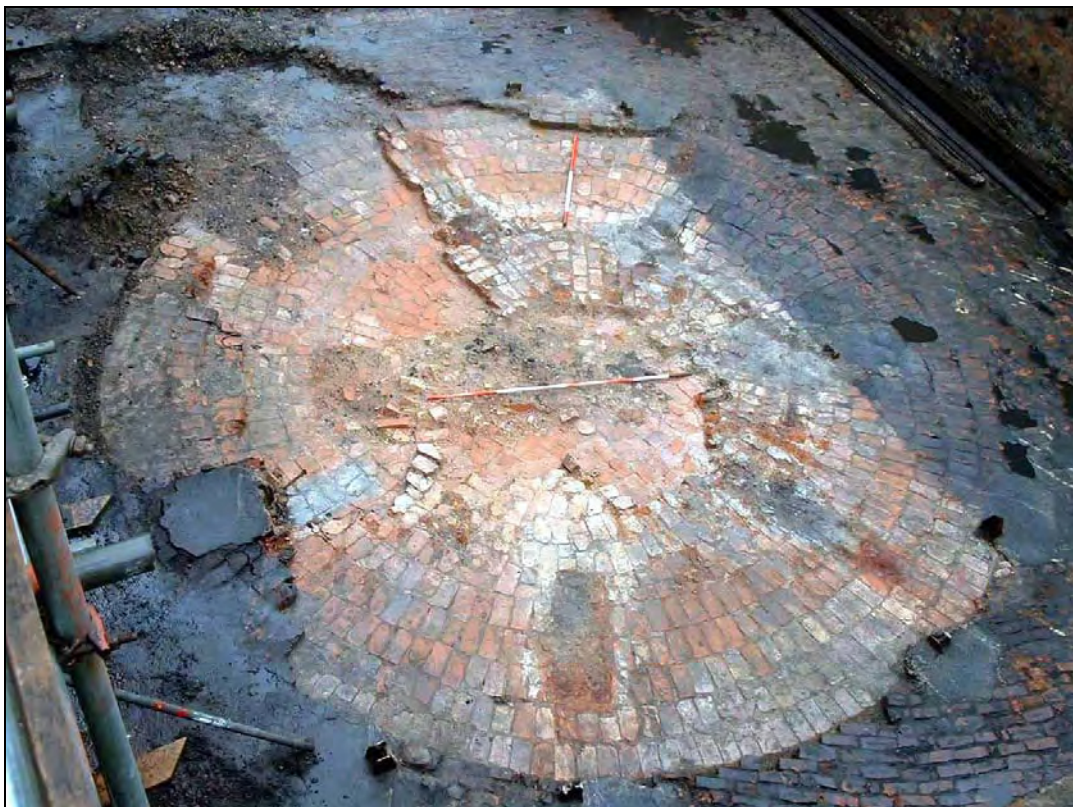
The earliest deposit within Unit A, Trench 2 was a grey brown clay natural (218). The circular brick foundation wall of a bottle kiln (217) was cut into this (Plate.2). The removal of a concrete base of one of the iron supports of the Newcastle-type kiln at the northeast of the wall revealed that the foundation courses reached a depth of 0.29m below the natural. The diameter of the foundation walls was 6.20m. The foundations of the walls had been reduced to the level of the floor surface (216), or at the north were one course higher.

The floor surface (216) within (217) was composed of concentric circles of bricks with 15 circles east of [215] and 11 to the west (Plate.2). This surface was 0.90m down from the level of the floor surface of the new build to the north. The bricks were very regular in size. However, their edges were slightly curved, as opposed to completely straight and crisp, suggesting that they were probably hand made in a mould. They were bonded by a yellow/pink heat affected brittle lime based mortar with fine sand inclusions. The surface bricks were also heat discoloured to a yellow/pink/cream colour. There were 5-6 linear patches 1.0m - 1.50m in length and 0.35m wide of burnt bricks. These bricks had been exposed to very high temperatures and they were brittle and damaged with parts of the bricks missing and cracked. The bricks had been burnt to a dark red or grey colour, often forming bands within the linear patches. The surface of the southern 1.30m section of (216) was also discoloured. The bricks were stained a dark grey black and lay under 10-30mm of coal fragments, coal dust and soot (Plate.2).

A rectangular rubble filled vertical sided cut [215] 2.35m x 0.90m was located in the centre of (216). Loose stamped machine made bricks lay fallen atop a brick rubble fill (214) within [215] (Plate.2).

Plate 2. Trench 2, bottle kiln (217). (Scale of 1m & 2m).

Evidence of the demolished Newcastle-type kiln is visible on Fig.4 and Plate.2. Firstly, the area of black staining on the bricks in the southern 1.30m of the kiln shows that this was the location of the coal shutes in the Newcastle-type kiln and that this part of the floor surface of the bottle kiln would have been exposed to the coal fragments and soot that layered the ground in this area. The straight east/west division between the black stained bricks and the yellow and pink heat affected bricks reveals the exact location of the southern elevation of the Newcastle-type kiln. Secondly, the concrete columns with iron fragments reveal the location of the iron bands that would have helped hold together the brick elevations of the Newcastle-type kiln when it was being put under immense heat during firing.

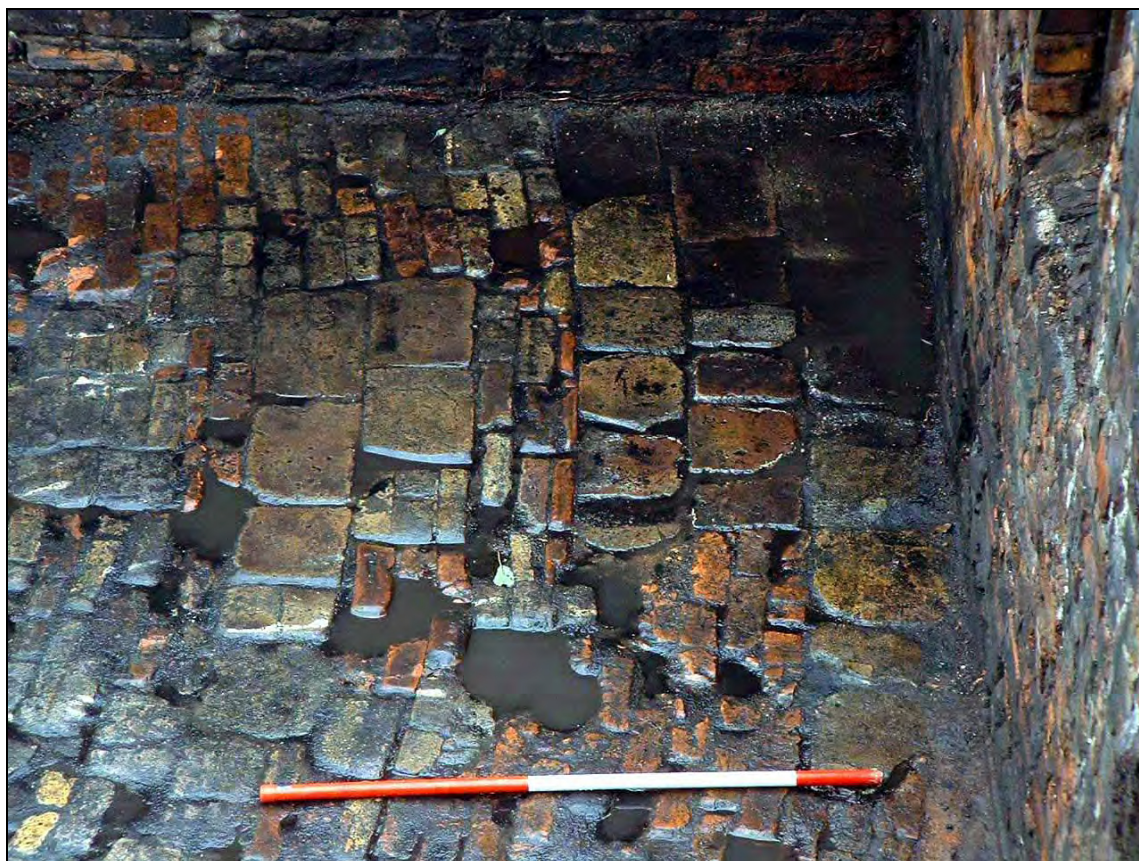
Surrounding the outside of (217) was (213) a later brick and tile floor surface measuring a maximum of 10.30m by 9.25m (Plate.3 shows a detail of part of the best preserved area of this floor). This floor butted against (217) and was largely composed of red handmade bricks with an average size of 0.22m x 0.07m. However, in the southern third of Trench 2 there were areas of (213) that comprised handmade yellow bricks and stone tiles with occasional

ceramic tiles. The tiles varied in size from 0.13m x 0.23m to 0.37m x 0.23m. The bricks that form (213) are of a poorer quality than those within (217). The surface was uneven and worn and many of the bricks were split or had a depression in the surface. The bricks were bonded with a silty clay with occasional fragments of pottery between the more widely spaced of the bricks.

Plate 3. Trench 2, floor surface (213). (Scale of 1m).

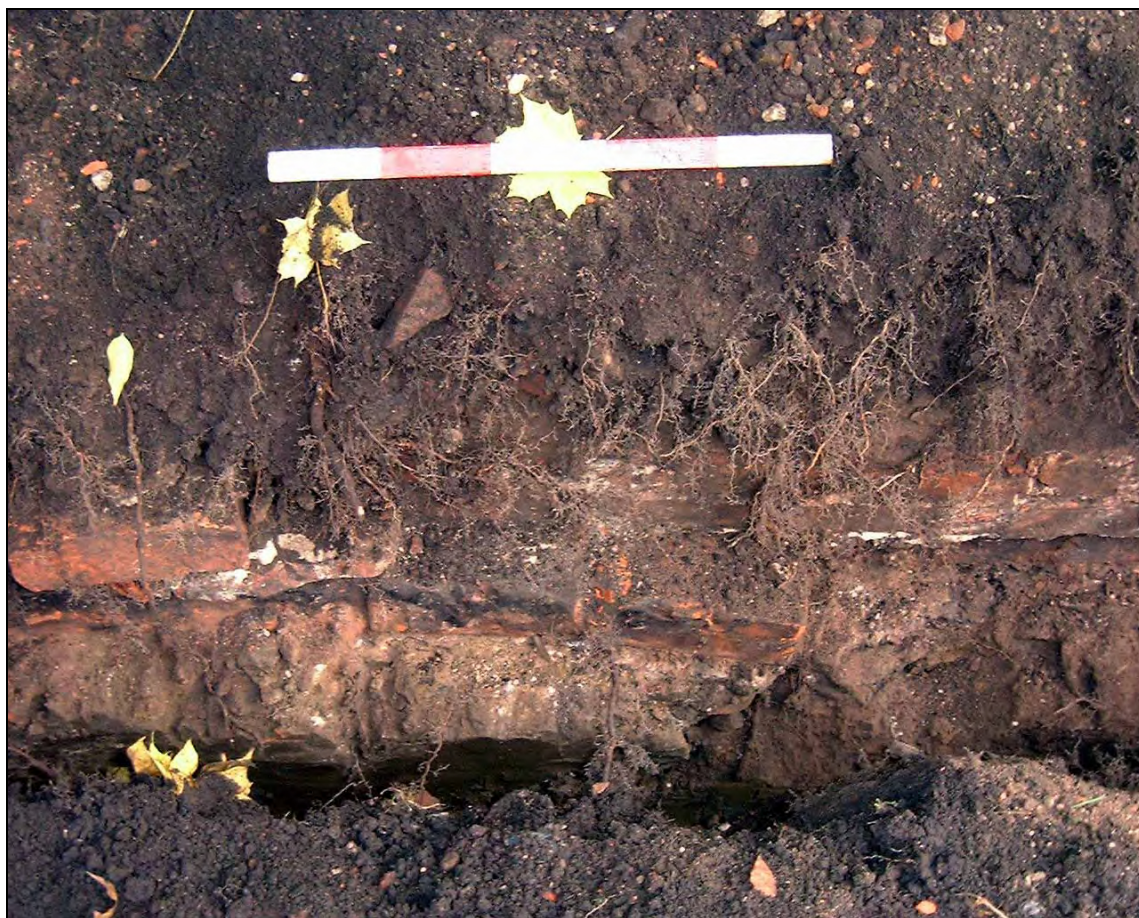
Plate 4. Trench 5, brick wall foundations (501). (Scale of 0.5m).

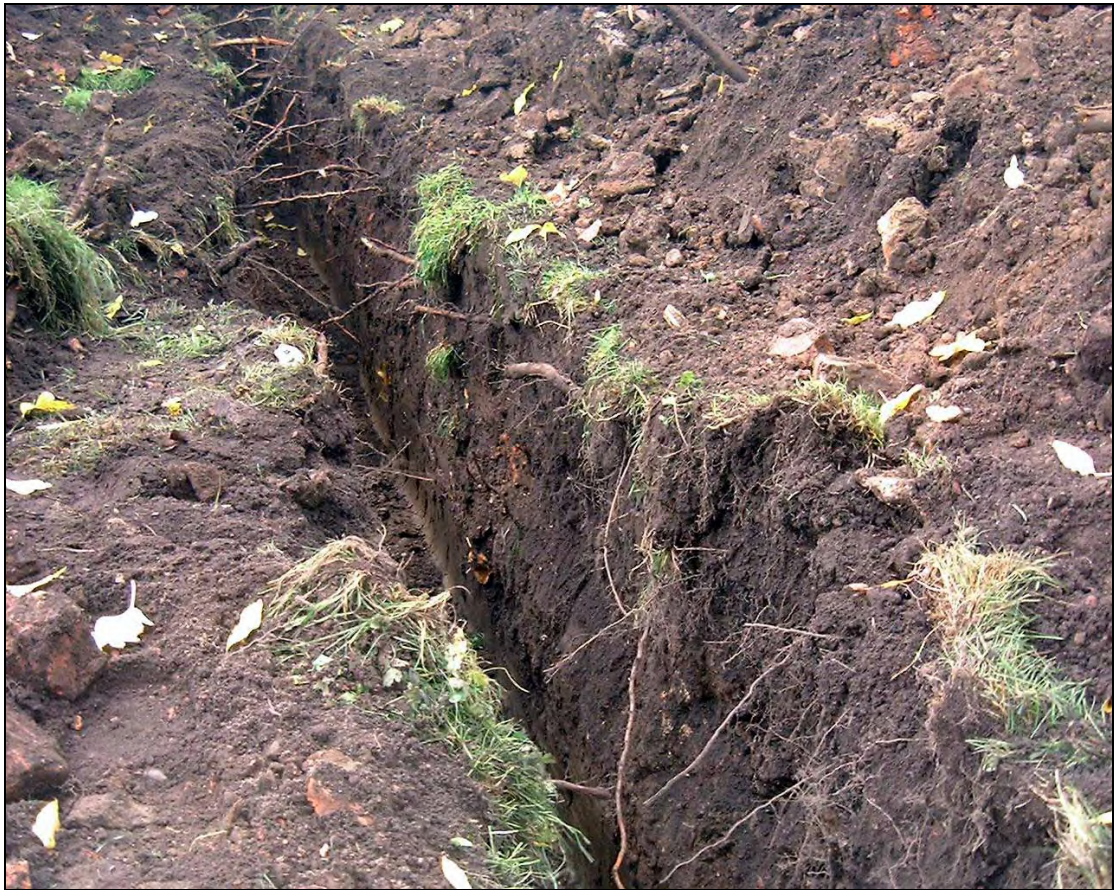
The earliest deposit in Trench 6 was the clay natural (602; Plate.5). Cut into the natural were the foundations of a northwest/southeast aligned brick wall (601). This wall was the same as (501) in Trench 5 and the join between Trenches 5 and 6 revealed the northwest corner of this structure. The wall (601) extended for 2.5m before disappearing into the eastern baulk edge of Trench 6. It was 0.35m deep. Contexts (602) and (601) were overlain by a 0.35m thick layer of a grass covered soft, loose dark grey silt topsoil (600).

Plate 5. Trench 6, typical section of trench.

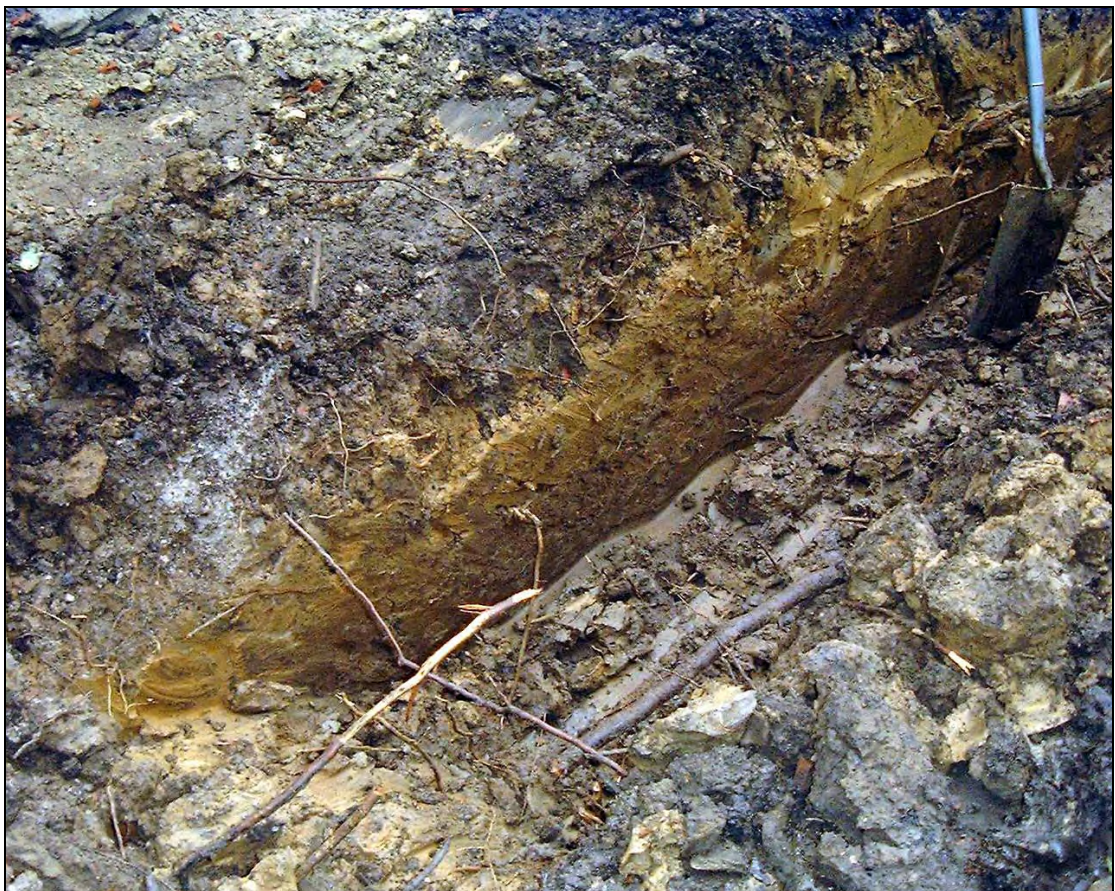
The earliest deposit in Trench 7 was a firm yellow clay natural with a band of grey clay natural beneath (701). This was sealed by 0.20m thick layer of brownish grey silt topsoil (700) containing a few fragments of 20th century machine made bricks and ceramic field drain fragments (Plate.6).

Plate 6. Trench 7, typical section of trench.

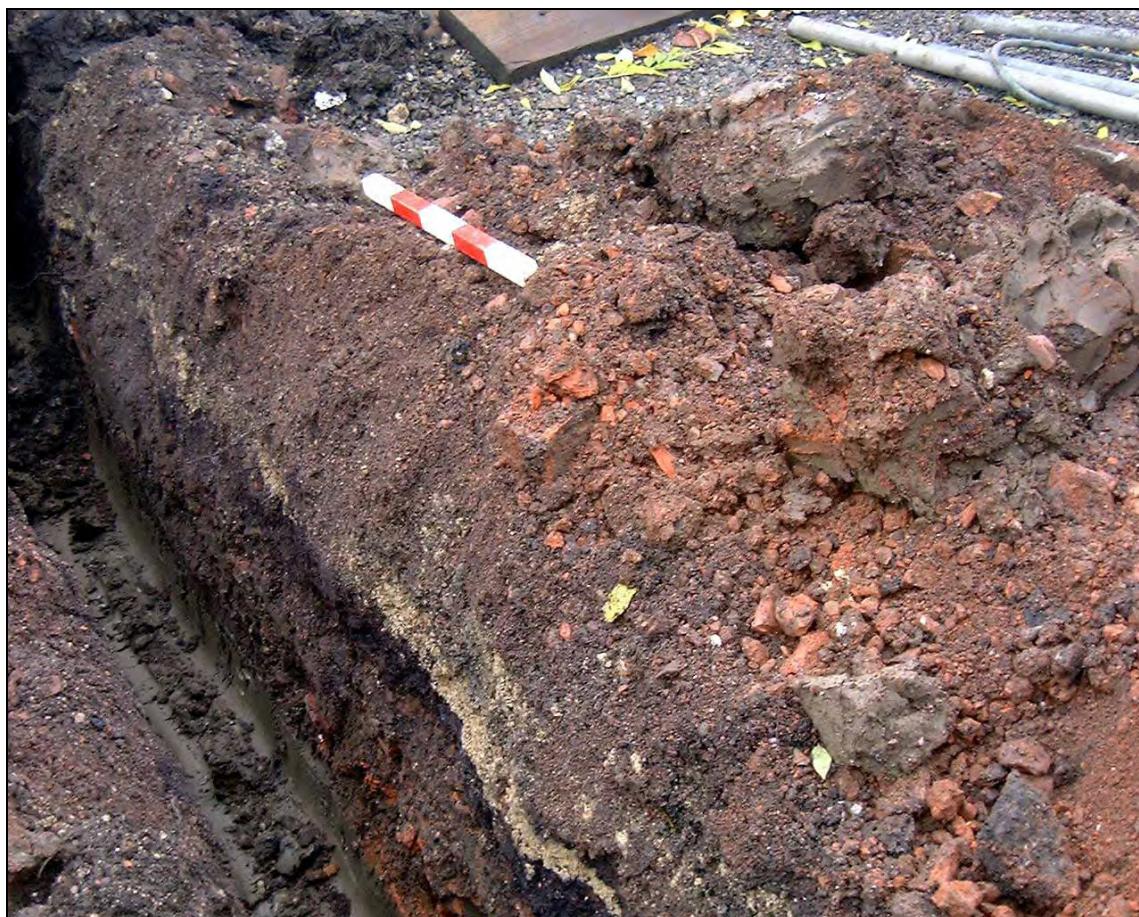
Plate 7. Trench 9, west facing section showing earthwork [914]. (Scale of 0.5m).

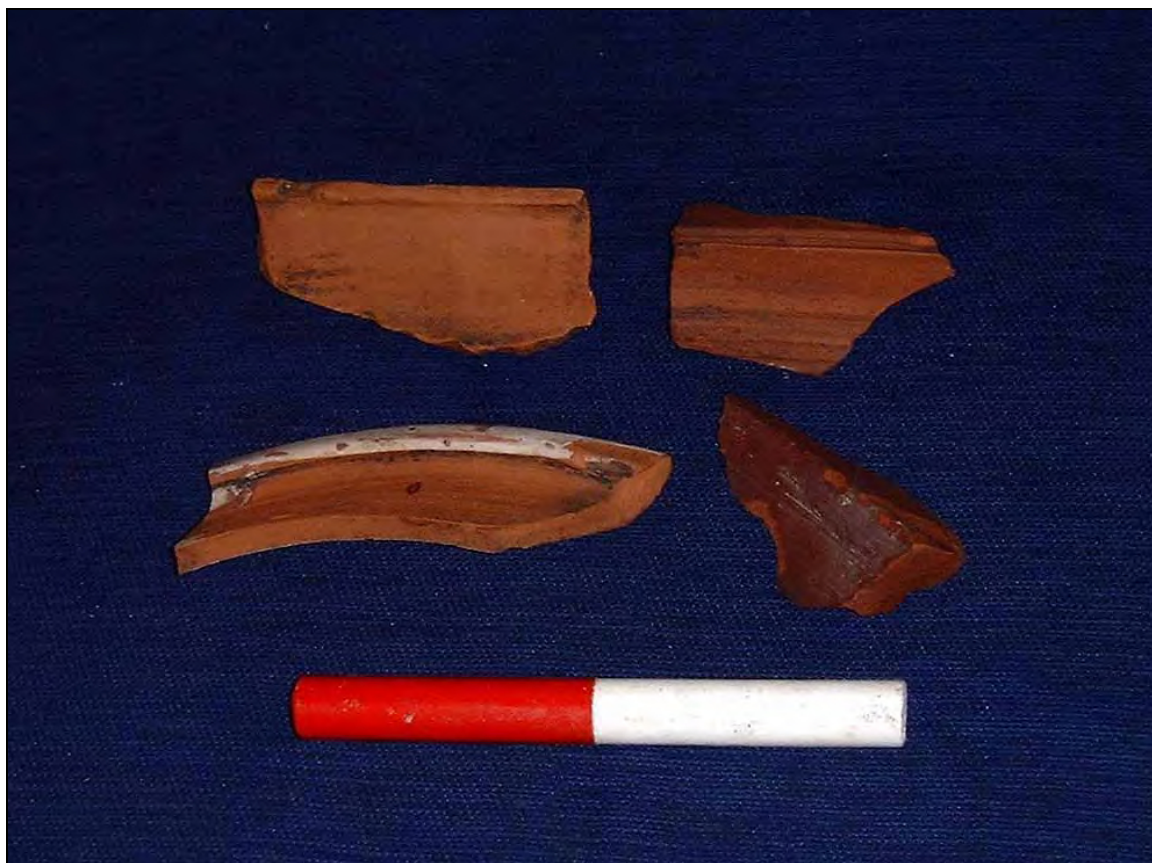
Plate 8. Sample of pottery from deposit (203). (Scale of 0.2m).

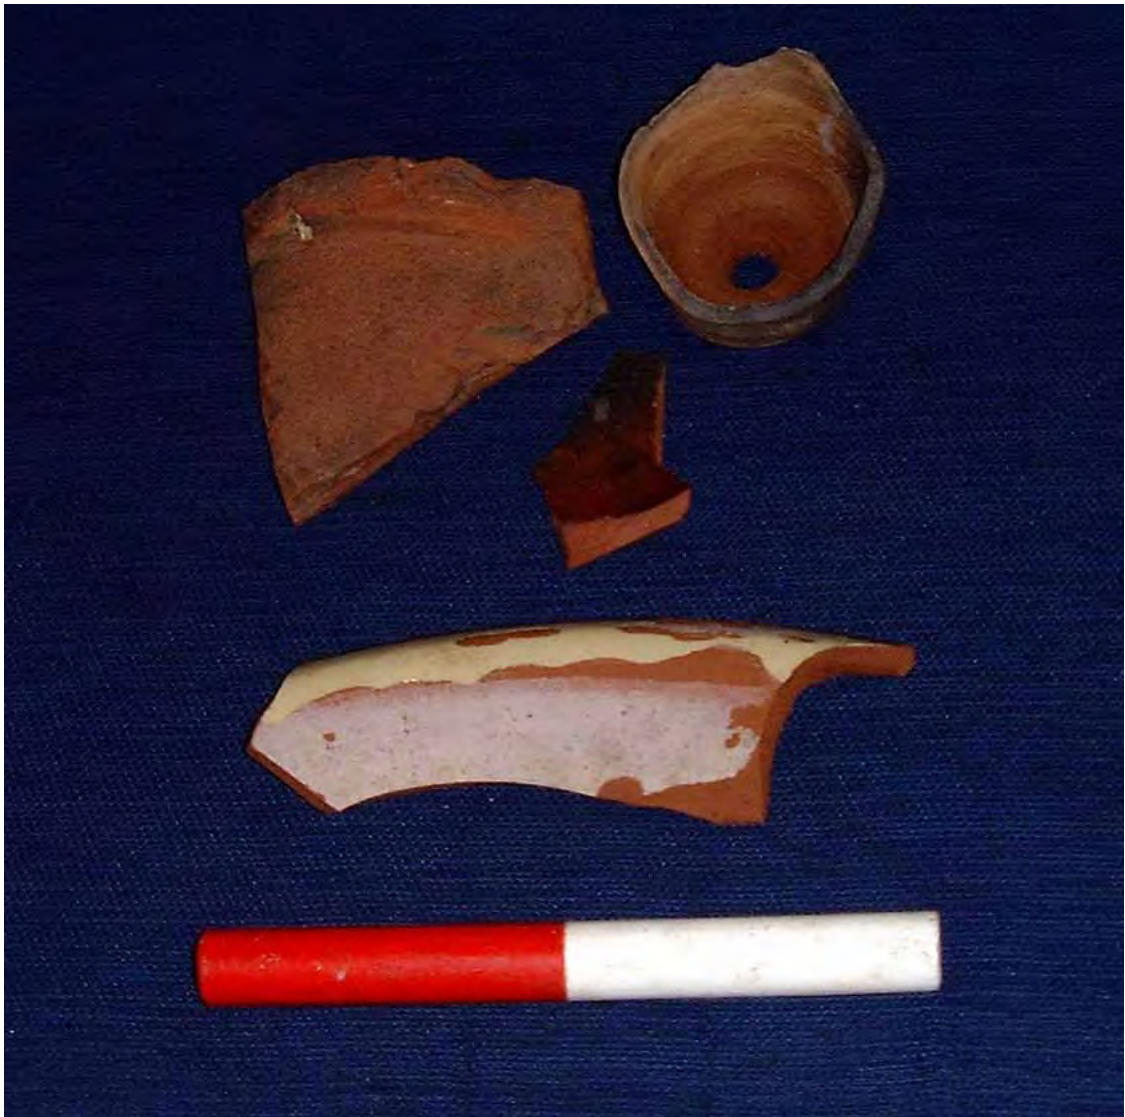
A small sample of 25 ceramic fragments were recovered from contexts (900) and (303). These sherds were representative of those unearthed during the watching brief. They comprised sherds from the rims and bases of wide shallow bowls, steep sided jars such as flower pots, undiagnostic body sherds and fragments of land drains. Several of the ceramics were glazed; most frequently with a pale yellow glaze, however, one fragment was covered in a dark grey slip and another with a brown glaze. These forms and glazes were identical to pottery forms still under production at Littlethorpe Potteries. Mr Curtis confirmed that he discards broken and unsatisfactory pottery in the area around the manufacturing shed (pers. comm. October 2005), hence these sherds are from the pottery and date to the 20th century.

Plate 9. Sample of pottery from deposit (900). (Scale of 0.2m).
