**Yorke Square car park, Richmond,
North Yorkshire**

archaeological evaluation

Richmondshire District Council

Report 1346

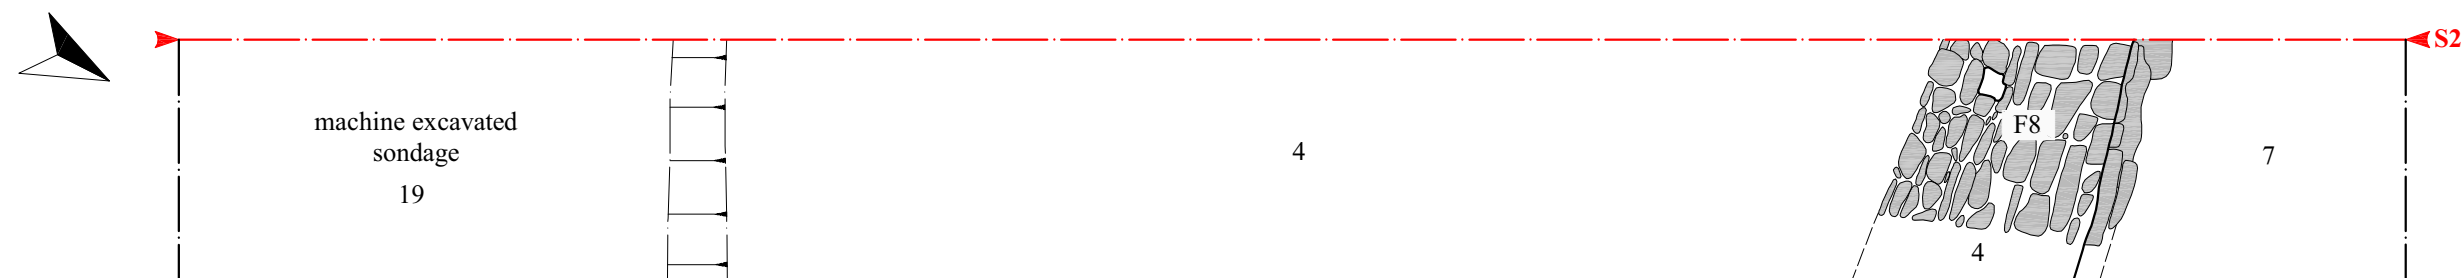
Trench 1, plan

- 5.2 This trench was 14.6m by 1.6m in size, and was aligned north-south cutting into the slope in the northwest corner of the site. A natural glacial till [19] of sand and clay was identified in the southern end of the trench at 107.62m O.D. this was not reached anywhere else in the trench due to the depth of building debris covering the site. At the northern end of the trench a substantial stone foundation was uncovered [F8] (Figure 7); it was 1.5m wide and at least 1.02m deep. The foundation was constructed from four courses of edge-set, sub-rectangular sandstone blocks, bonded with a strong cement mortar. Towards its eastern end, a rectangular hole had been formed during its

construction, possibly for a reinforcement bar. This foundation is interpreted as the remains of the rear wall of the northernmost stable block; while it does not appear to be on the alignment of the original building it may have been disturbed during its demolition. Overlying, and to the north of, foundation [F8] was a firm orange-brown clay silt [7: 0.96m excavated depth]. Cutting through this to the north of the foundation was a pit or gully [F6: 1.25m wide by 0.71m deep]. The cut had a 'U'-shaped profile and was filled with a firm dark grey clay silt [5]; both this cut and deposit were only present in the western section of the trench. Butting up to this on the southern side of the foundation was a layer of loose demolition rubble [4: 0.71m deep]. Both deposits [5 and 4] lay beneath a thin cover of topsoil [1: 0.23m deep].

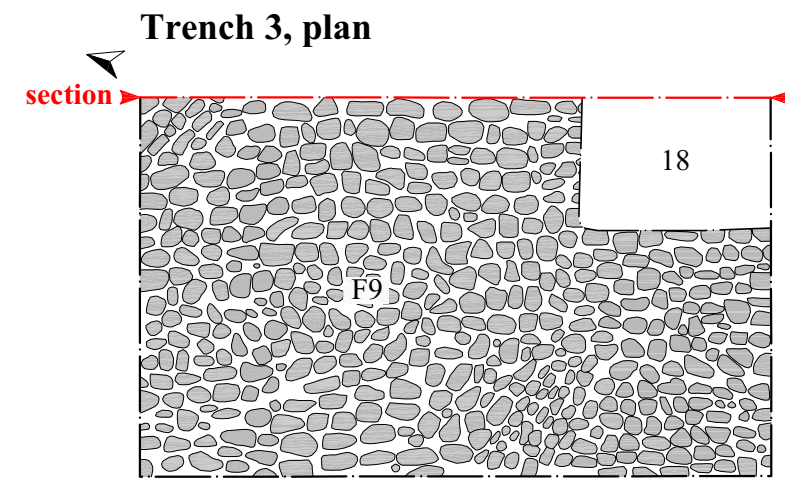
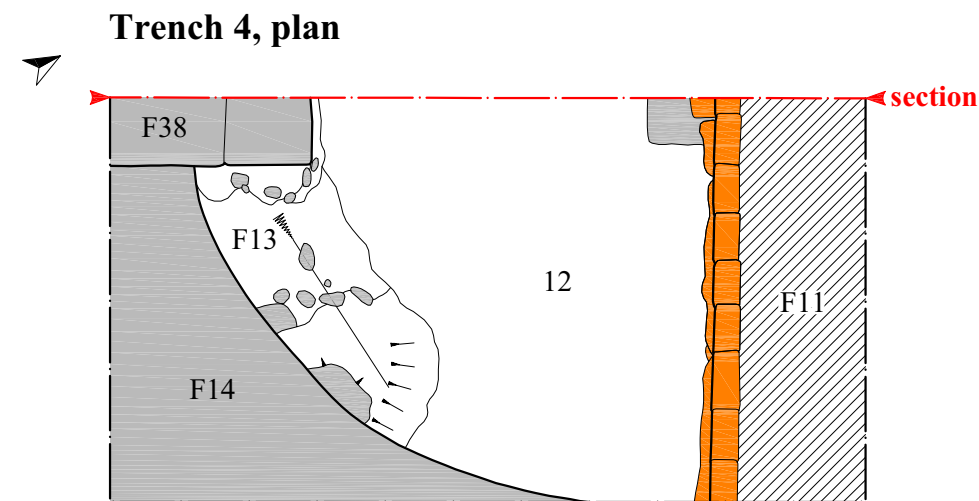
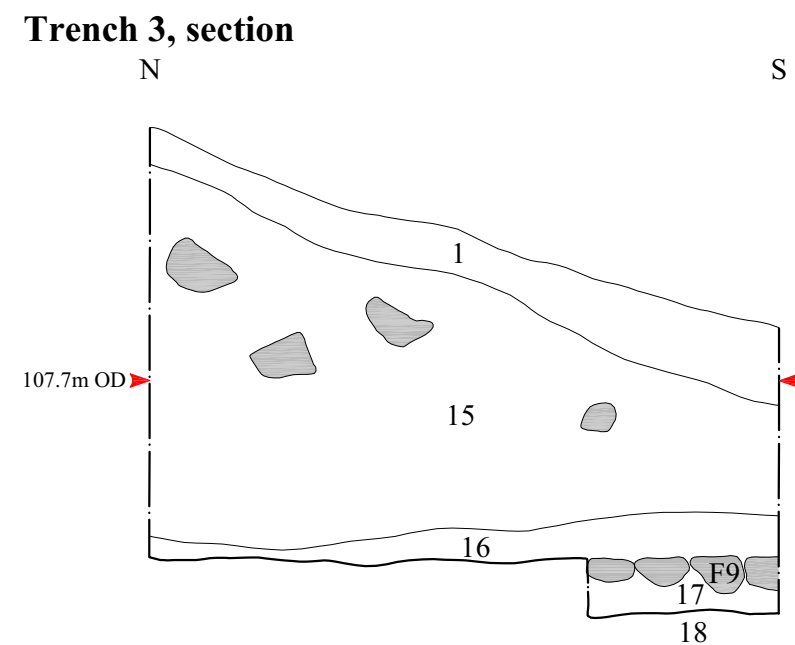
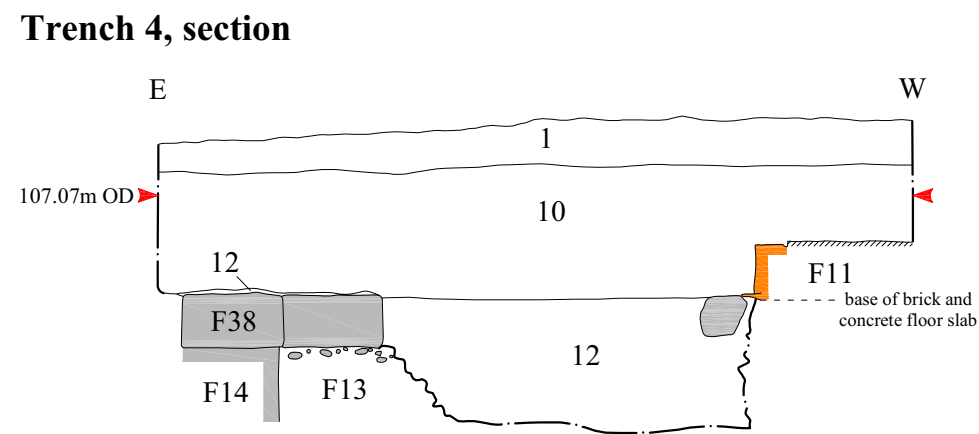
Plans and sections of Trenches 3 and 4

- 5.4 Trench 3 was 2m wide by 3m long and was machine excavated to a depth of 1.72m below ground level (bgl) at its northern end and 0.9m bgl at its southernmost point. The trench lay south of Trench 2 near the foot of the slope. A test pit was excavated in the southeast corner of the trench to a depth of 106.77m O.D.; at its base natural glacial till [19] was identified. Overlying this was a c.0.1m thick layer of clean sand [17], into which a cobbled surface [F9] had been set. The cobbled surface extended over the entire base of the trench and is assumed to be a portion of the courtyard between the northern and southern stable blocks. Directly over the cobbles was a compacted layer of building rubble [16: 0.17m deep]. Overlying this was a deposit of loose building rubble [15: 1.48m deep], and topsoil [1: 0.25m deep].

- 5.5 Trench 4 was 3m long by 1.6m wide and was excavated to a depth of 1.2m; it was located on a level area of grass in the west of the site. The earliest deposit identified was a layer of dressed sandstone blocks [F14] which were covered with a concrete mortar. These blocks formed half of a semi-circular structure 2.02m east-west and 1.62m north-south; its interior was excavated to a depth of 0.55m revealing three courses of stonework. This construction [F14] has been identified as an entrance to a cellar. Against the interior of this structure was a foundation deposit of compacted light grey-brown coarse mortar containing numerous small sub-rounded pebbles [F13]. This deposit was 0.5m wide and was excavated to a depth of 0.55m; it followed the circuit of the stone work descending from 106.5m O.D. at the southern edge of excavation to 106.12m O.D. at its northernmost point. Set onto foundation deposit [F13] were two dressed sandstone blocks [F38], probably the remains of steps descending to cellar [F14]. The cellar appears to have been in-filled with a deposit of compacted light grey mortar containing crushed brick rubble [12].

This indicates that the cellar predates the cottage conversions, but no direct links with the stable blocks can be established. A concrete slab edged with brick [F11] was overlying this deposit. This floor or yard, was probably part of the late 19th or early 20th-century conversion of the stable blocks into cottages. Over the entire trench was a deposit of stone and building rubble [10: 0.49m deep] and a topsoil [1: 0.17m deep].

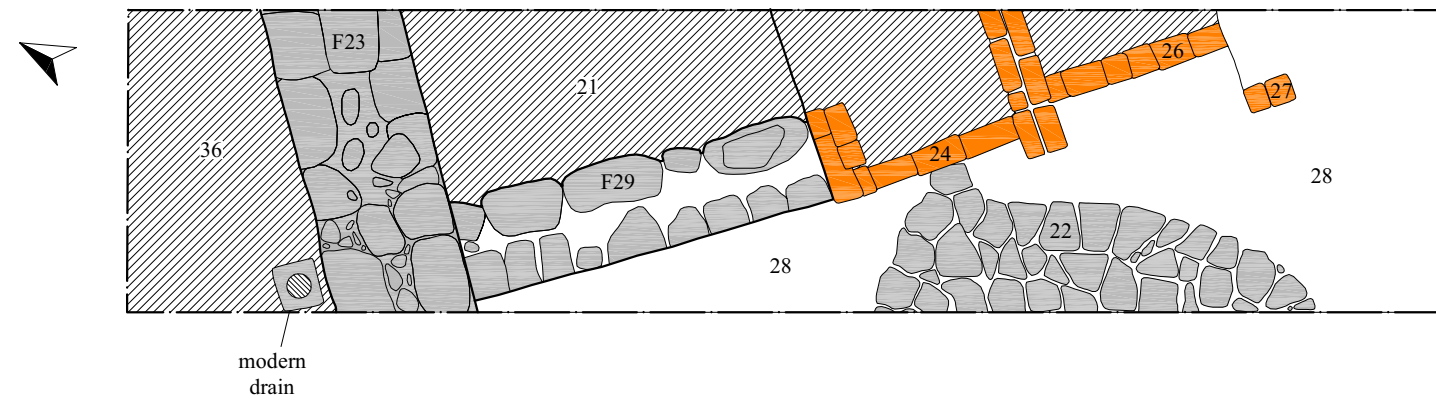
Trench 5, plan

- 5.6 Trench 5 was 7m long and 1.6m wide and was positioned on the block paved car park, towards its northern end. A natural glacial clay [19] was identified within this trench at 106.36m O.D.; this appeared to have been truncated to provide a level building surface. At the north end of the trench the construction trench [F32] and its backfill [33] for a northeast-southwest aligned foundation [F23] was cut directly through the natural clay. The foundation [F23] was 0.6m thick and constructed from sub-rectangular sandstone blocks bonded with a lime mortar. Butting up against foundation [F23] was a northwest-southeast aligned foundation [F29]; this was 0.53m thick, 1.95m in length, and constructed in the same way as [F23]. These walls are contemporary and represent the rear and one internal wall of the southern stable block. Within the area enclosed by these adjoining walls were the partial remains of a sandstone floor [F30], laid directly onto the truncated natural ground surface. The flags butted up to foundation [F29] and were laid over construction cut [F32], and so they are assumed to be contemporary with the earliest phase of construction. Directly above the flagstone floor was a 0.29m deep deposit of stiff dark brown clay [31] onto which had been laid a concrete surface [21].

- 5.7 To the northwest of foundation [F23] was a concrete slab [36] for a yard surface into which was set a metal drain. To the southwest of foundation [F29] was a deposit of stiff dark brown clay [28] into which were cut concrete and brick structures [24, 26 and 27], one of which [24] was possibly a fireplace inserted into the internal wall, and serving the eastern room. Also set into the clay [28] was a sub-oval surface of sub-angular sandstone flags [22] in the western room. All of these features were assumed to be associated with the late 19th/early 20th-century change from stable blocks to cottages.

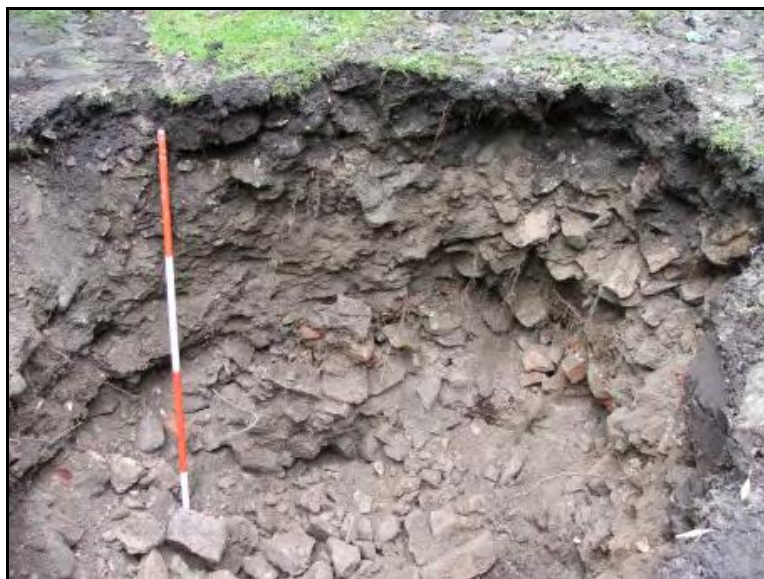
Figure 8
West facing shot of
Trench 2

- 5.3 Trench 2 was 2m wide by 3m long and was excavated to a depth of 2.6m; it was located at approximately the mid-point of the east-west wall at the top of the slope, in the northern end of the site. With the exception of the topsoil layer [1: 0.15m deep], this trench was entirely filled with stone demolition rubble and modern building debris [2]. This trench was not cleaned or recorded due to the dangerous state of the loose material, as a consequence it was backfilled immediately.
