## **5.2 The South-Eastern Soakaway, Drain Run and Gutter Replacement (Figs 2-3)**

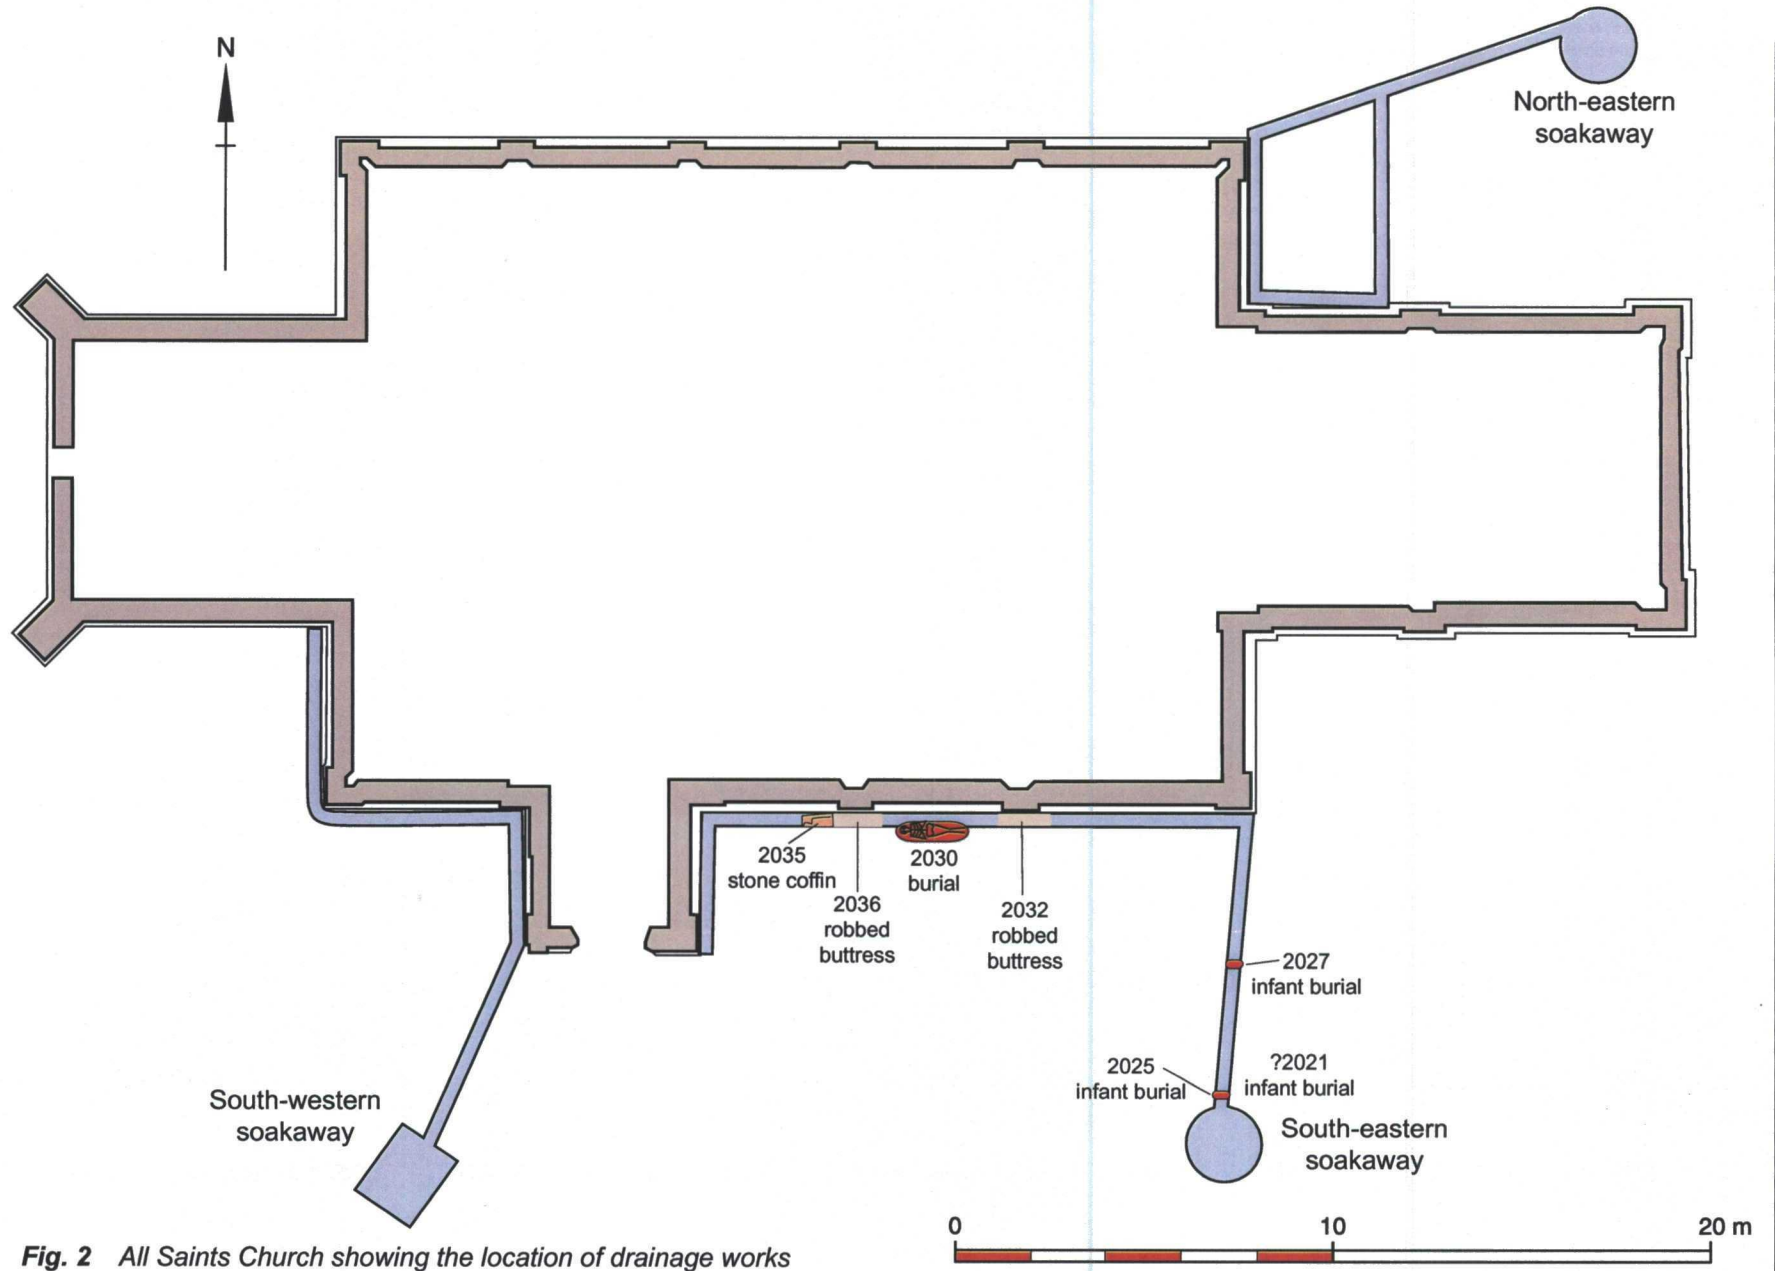
Fig. 2 All Saints Church showing the location of drainage works

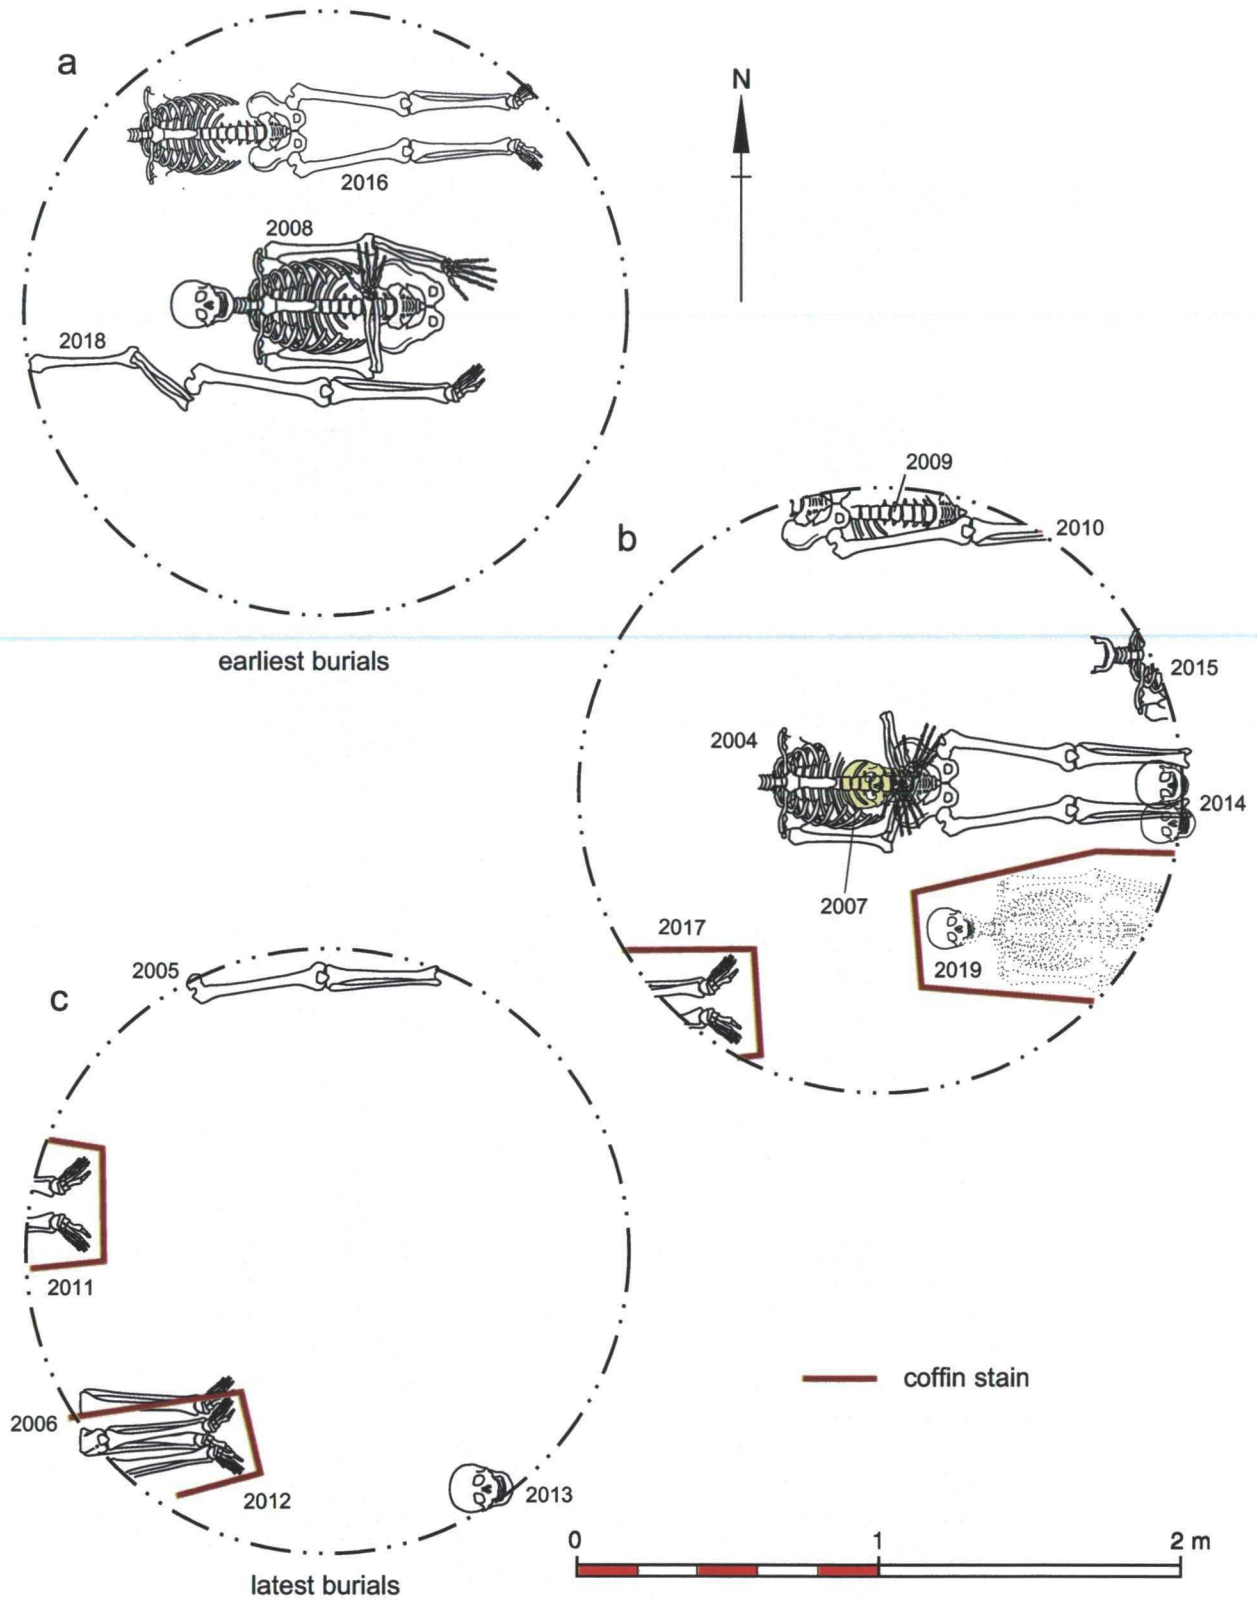
Fig. 3 Burials in the south-eastern soakaway

Later than 2018, and in the south-east part of the trench, were the in-situ remains of a female skeleton (2019; Fig. 3b). Only the cranium was exposed and much of the skeleton lay beyond the limit of the trench. A staining forming a regular pattern around the head, at the west end, seemed to indicate a burial within a coffin. Possibly contemporary with 2019, and lying at the northern limit of the trench, was an articulated right leg and part of a pelvis (2010), possibly part of an east-west burial with the head to the west. At a broadly similar stratigraphic horizon, and lying in the centre of the excavation, was an isolated human cranium (2007). No other bone was found in the vicinity so it would appear that this may have been reburied in this location as the result of the disturbance of an earlier grave. Also at this level, protruding from the eastern edge of the trench, were two skulls (2014) one somewhat crushed and partially over the other. It was not possible to establish if these were formal burials and they may be displaced remains similar to 2007.

Later than 2009 and 2015 was a nearly complete skeleton (2004; Fig. 3b) from which was missing the head, the left humerus and the left ribs. The arms were crossed over the pelvis. Examination of the pelvis suggested a female burial. This body was aligned east-west and the missing head clearly originally lay to the west. A greenish stain running close to and north and south of 2004 was probably the remains of a coffin. Possibly roughly contemporary with 2004, and protruding a very short distance into the trench, was a dark rectilinear stain, almost certainly a coffin stain. Within the eastern limit of the stain was a single articulated foot (2017), perhaps belonging to a skeleton most of which lay to the west.

Later than 2004, along the northern limit of the soakaway, was an articulated right leg and foot (2005; Fig. 3c). This seemed to indicate an east-west burial with the head to the west but this could not be confirmed since any further remains lay beyond the limit of excavation. Possibly roughly contemporary with 2005 and just within the north-western limit of the soakaway was a pair of articulated feet (2011). A rectilinear stain around the feet probably indicated the remains of a decayed coffin aligned east-west. At a similar level, and protruding from the south-west limit of the soakaway, was a pair of articulated lower legs and feet (2012) within a dark stain also suggesting a coffin. This burial was slightly unusual as it

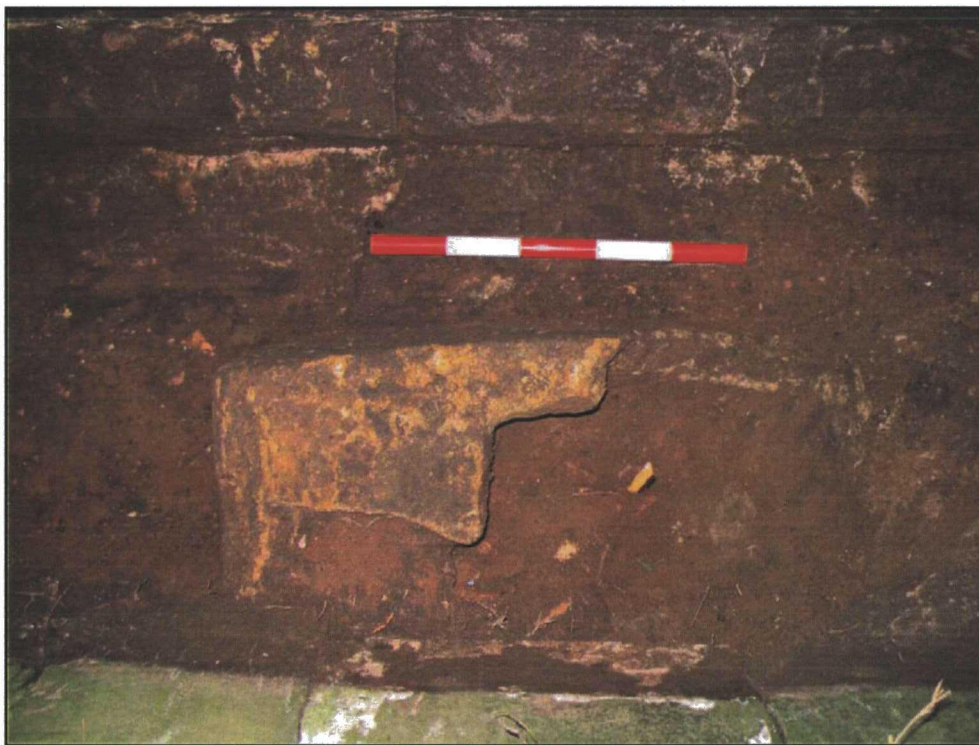
**Plate 2** Stone coffin (2035) adjacent to the south wall of the church

Cut into the graveyard soil described above, although no separate cut number was assigned, was the grave cut for a stone coffin (2035; Pl. 2). The grave and coffin were located roughly 2.75m east of the east wall of the porch. They lay immediately to the south of the south aisle wall foundations and extended into the south edge of the new drain trench. No complete dimensions for the coffin could be taken, but it was at least c.0.83m x 0.35m x 0.25m, and it was left in-situ. No lid was noted but the coffin did have a separate niche for the head at the west end of the coffin. No attempt was made to empty the coffin, largely due to time constraints and reluctance to disturb any more than necessary.

The eastern half of this coffin had been completely truncated by a feature backfilled with a mixture of light brown mortar and mid brown sandy silt containing limestone fragments (2036) interpreted as a backfilled robber cut for a buttress. The full dimensions of this cut could not be ascertained but it was around 1.3m across, east-west. Between c.5.45m and
