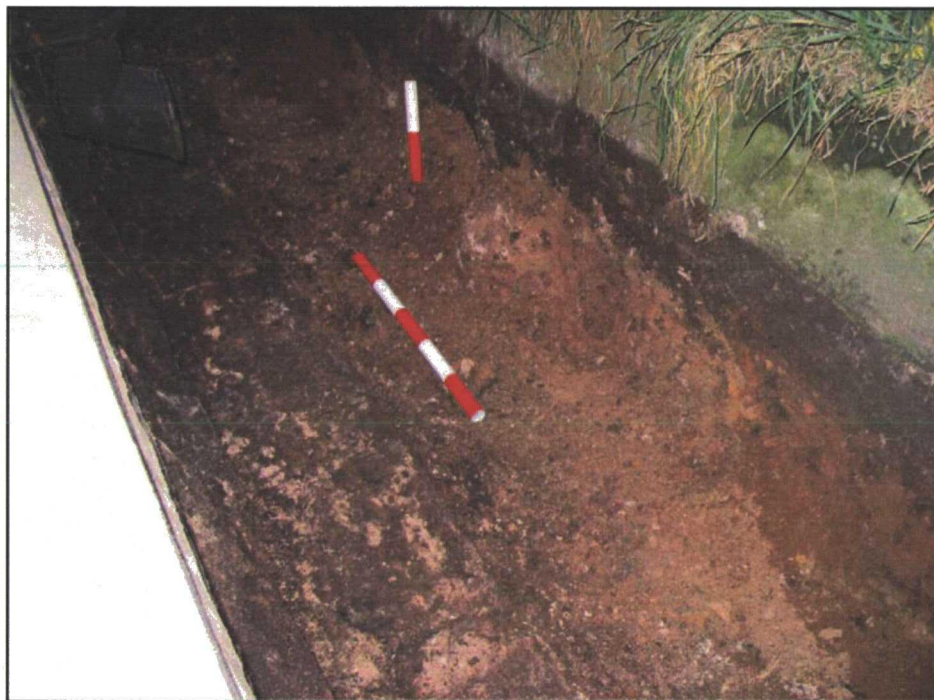
Plate 3 Eastern robbed buttress (2032), looking north-west

6.85m west of the south-east corner of the south aisle there was seen in the base and north-facing section of the trench, a mixture of light brown mortar, pinkish-brown mortar and mid reddish-brown sandy silt containing large pieces of limestone (2032; Pl. 3). The nature and position of this deposit, coupled with pictorial evidence, suggests that this deposit may represent the robbed foundations of another buttress with a maximum width of 1.4m. Both of these robbed buttresses can be seen on one of the few surviving images of the church, before its major rebuild, and offer further evidence of its original form.

It was immediately apparent that the rebuild of the nave and aisles in 1855 had caused a great deal of disturbance to the earlier church structure, but the location of the site of two robbed buttresses has added a little evidence to knowledge of it and confirms evidence in early views.
