**Sutton Stables  
Sutton Street  
Norton  
North Yorkshire**

**Archaeological Recording Brief Report**

**Sutton Stables  
Sutton Street  
Norton  
North Yorkshire  
SE 7945 7115**

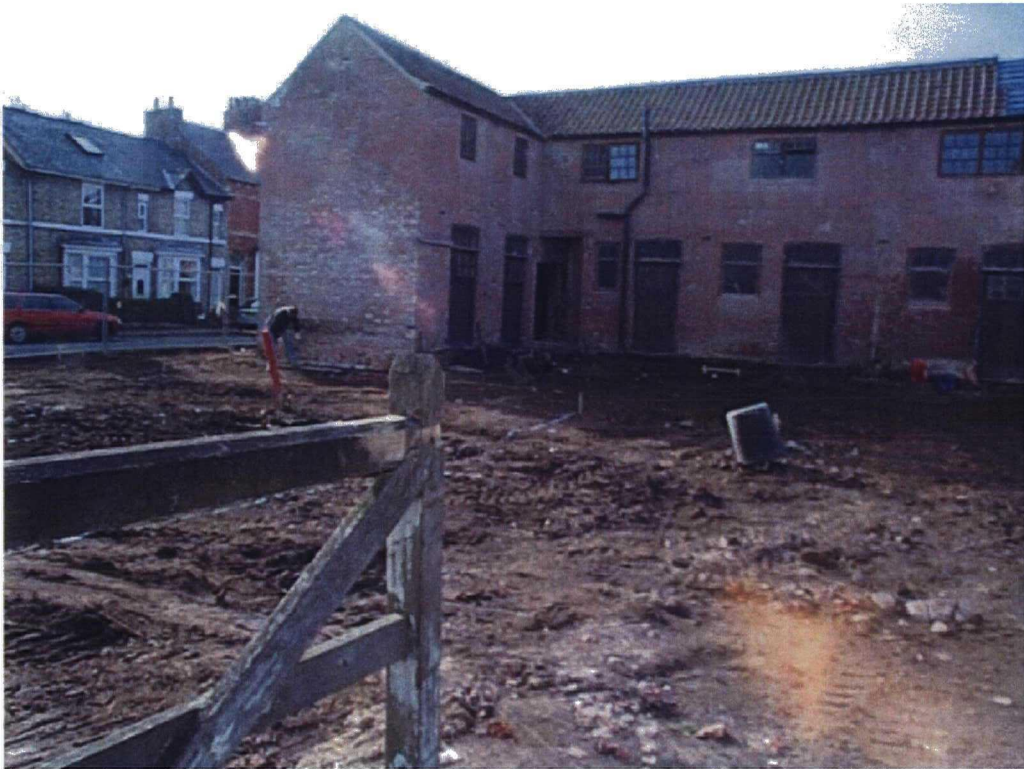
Plate 1. General View of Site. Facing South East

- 2.1 The site is situated in the central part of the town of Norton, on the north-eastern side of Langton Road, approximately 100m to the north of the parish church of St. Peter. The development site covers an area of approximately 26m x 27m and is bounded by residential properties on all four sides.
- 2.2 The site lies on soils of the Landbeach Association, which consist of permeable calcareous and non-calcareous loamy soils, overlying a solid geology of chalky glaciofluvial and river terrace drift (Mackney, 1984, 194).
- 2.3 At the time of the Recording Brief the site had been partially stripped of topsoil (Pl.1).

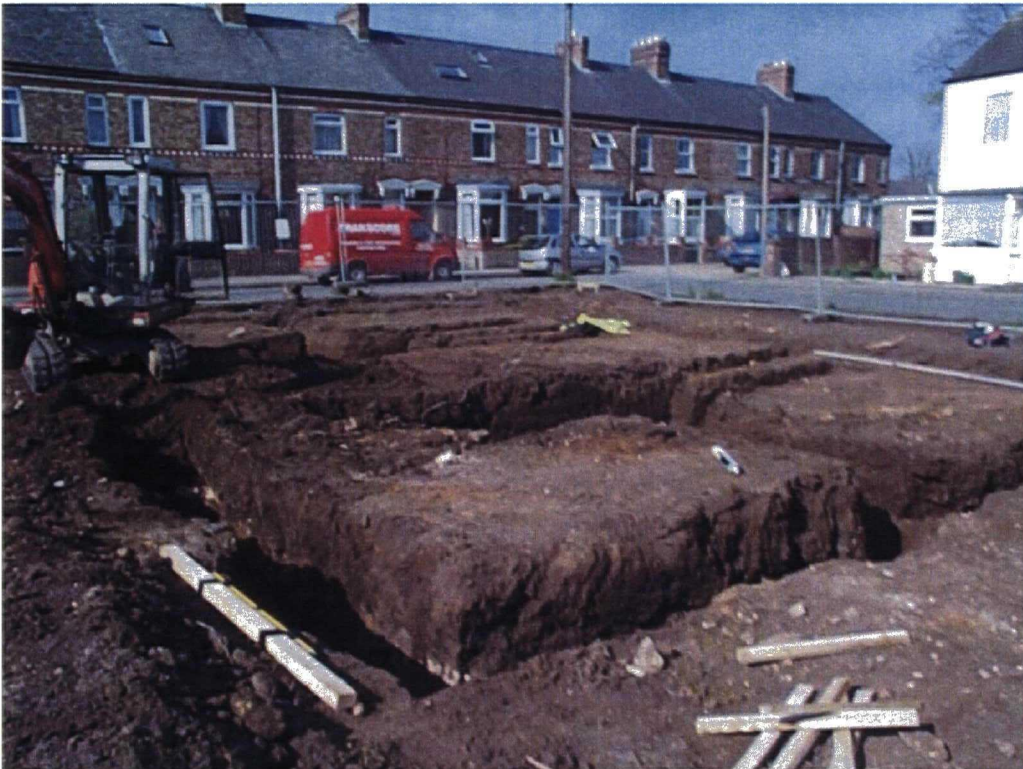
Plate 2. General Working Shot. Facing North East

- 6.1.1 The foundation trenches in Plots 1, 2 and 3 were excavated to a mean depth of 1.10m (Pls. 2,3,4). Excavations revealed the natural subsoil (context 1005) to have been

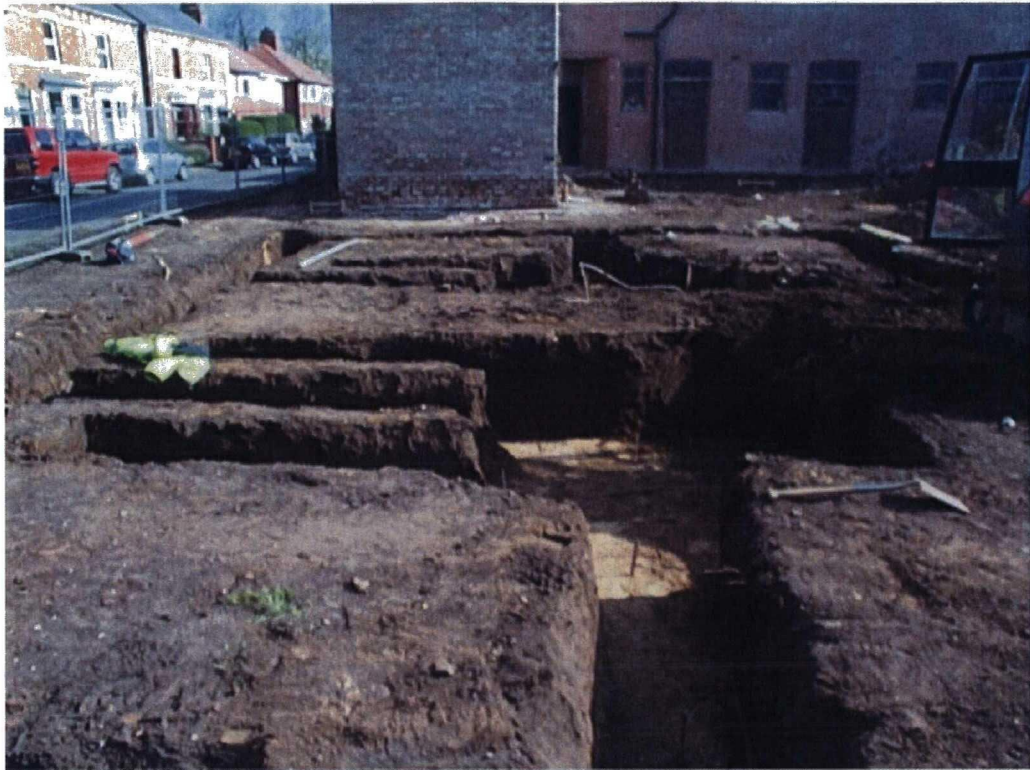
**Plate 3.** General Working Shot. Facing South

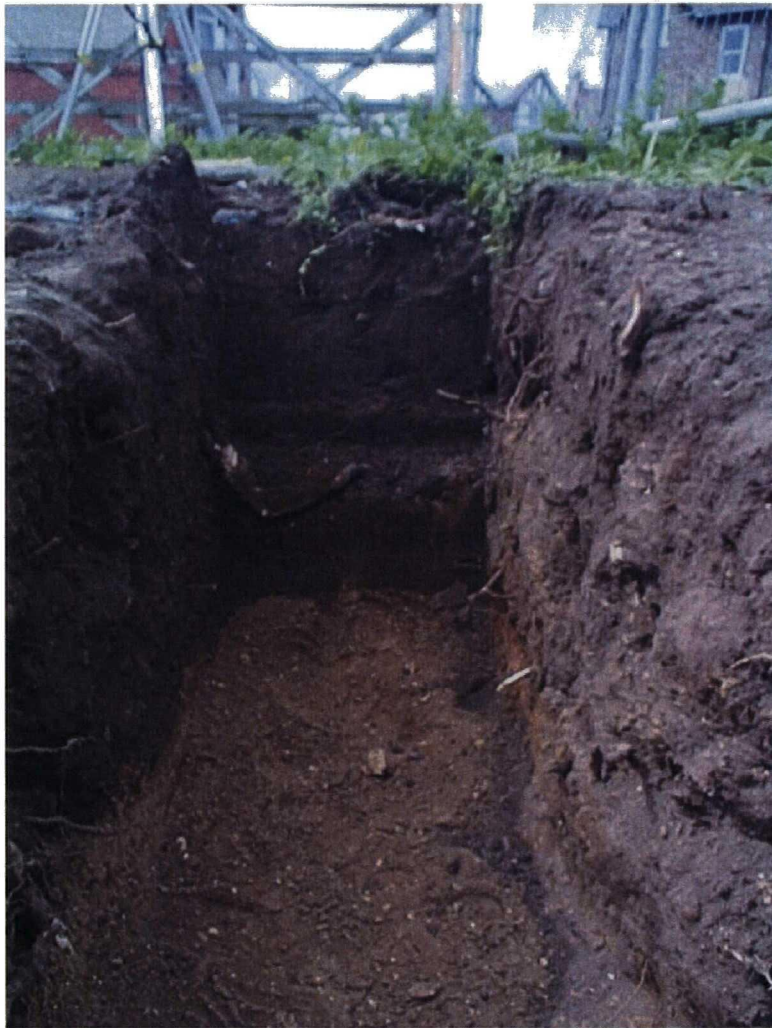
**Plate 4.** Section Showing Context 1000 and 1001. Facing West

truncated by a 0.70m wide pit (context 1004, Pl. 6) that was filled by a deposit of sand (context 1003). Deposit 1005 was also partially sealed to the north-east by a lens of sandy silt (context 1002, Pl. 5). Neither Deposit 1003 nor Deposit 1002 contained any finds, and both were sealed by a silty subsoil (context 1001) that underlay the modern topsoil (context 1000).

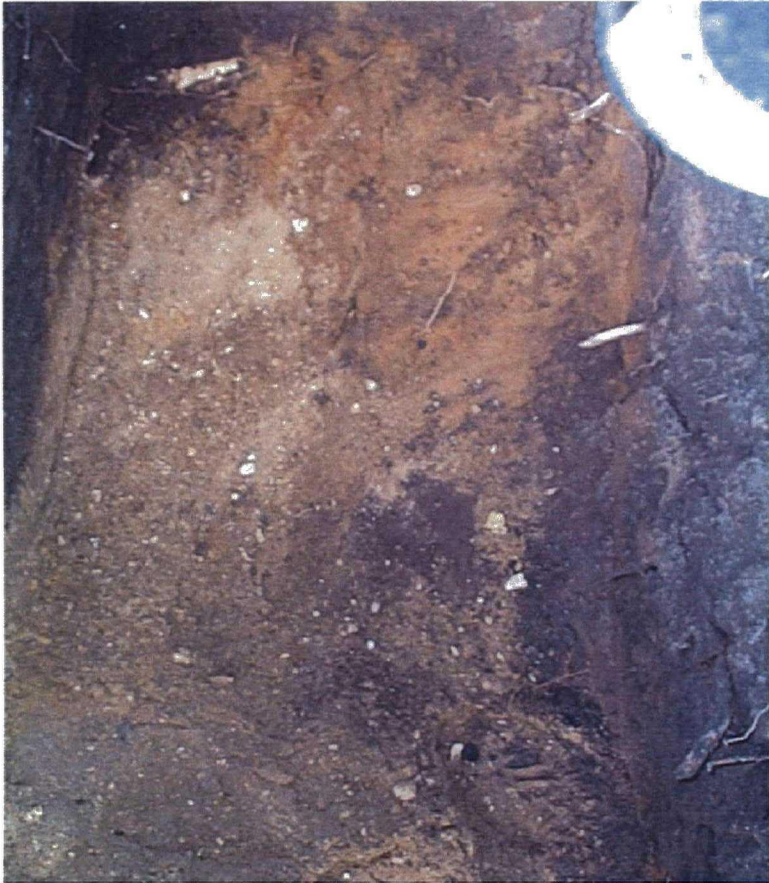
**Plate 5.** Context 1002 Half Sectioned. Facing West

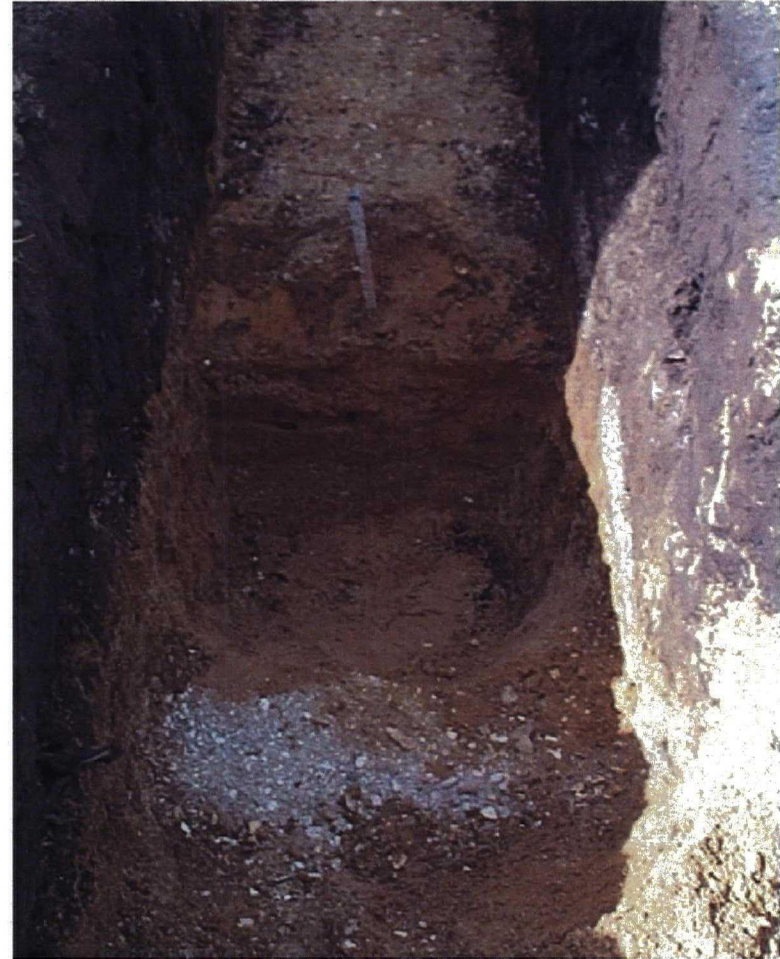
**Plate 6.** Context 1004 Half Sectioned. Facing West

7.1. The Recording Brief at Sutton Stables revealed a limited amount of archaeological activity that was located at a depth of 1.10m below existing ground level. The interpretation of this feature is somewhat problematic given both the lack of dateable finds and the limited extent of the deeper groundworks, but it is probable that it relates to Romano-British activity associated with the settlement at Norton.

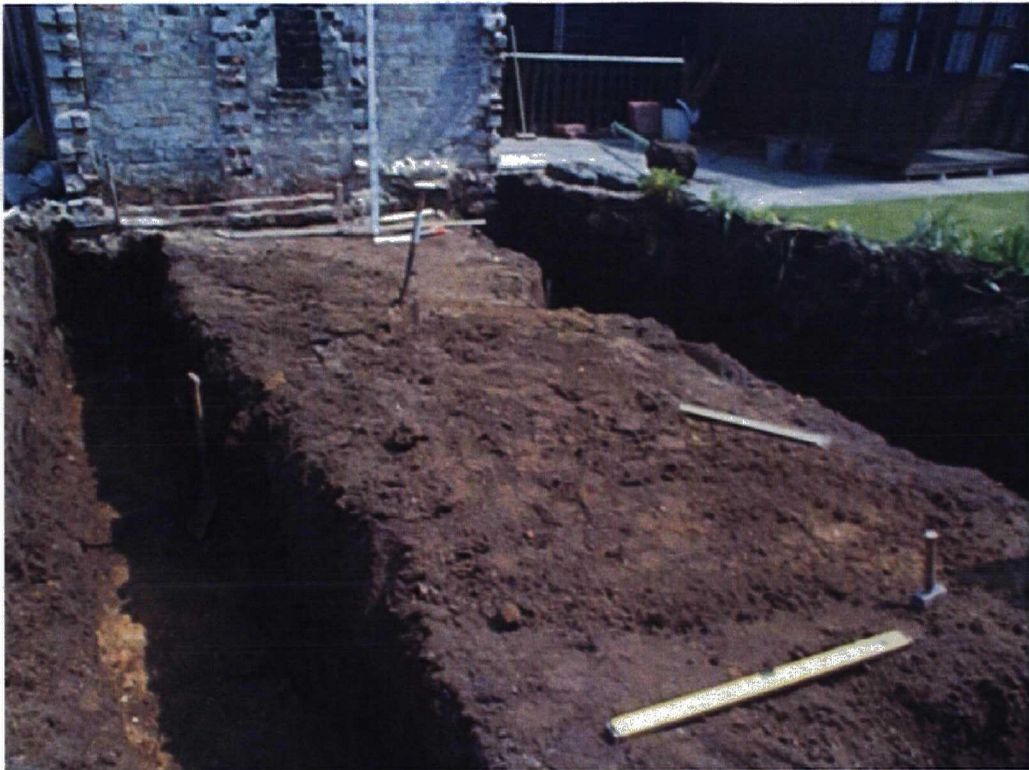
**Plate 7.** Post-Excavation Photo of Plot 4 Foundations. Facing East

6.2.1 The service trench and foundation excavations for the building in Plot 4 consisted of 0.70m wide strip trenches that were excavated to a depth of 0.80m (Pls. 7, 8). The stratigraphy exposed was consistent across the whole of the site and consisted of undisturbed natural gravel deposits (context 2003) that were situated at approximately 0.80m below the existing ground level. Deposit 2003 was sealed by a deposit of heavily mixed silty rubble (context 2002). A 0.20m deep deposit of mid brown silt (context 2001) overlay Deposit 2002 and was sealed by a 0.30m deep deposit of silty topsoil (context 2000). No archaeological features were observed during this phase of the Recording Brief.

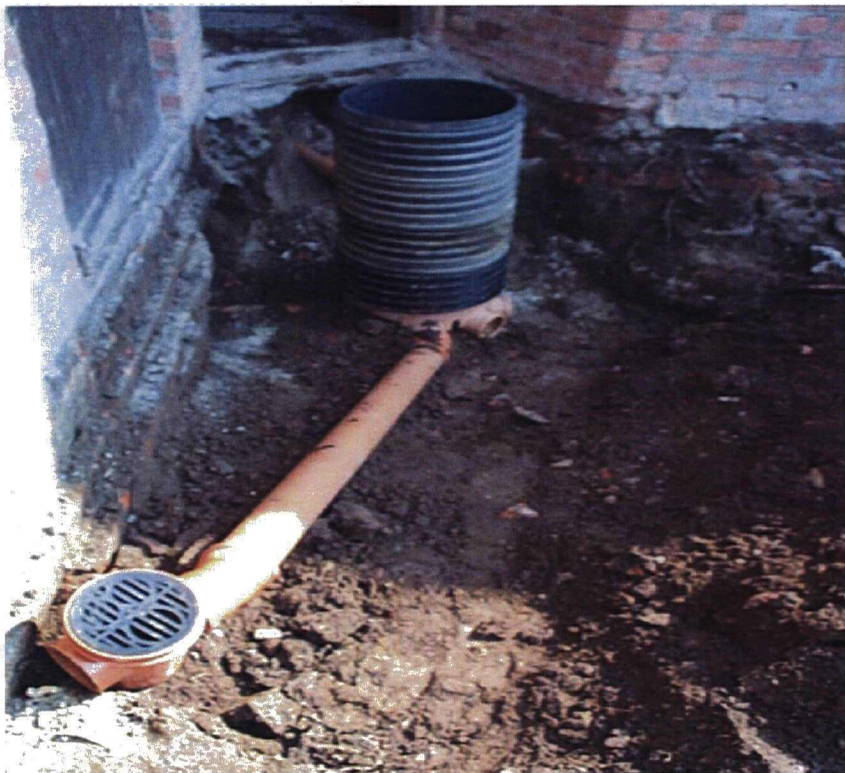
**Plate 8.** Post-Excavation Photo of Man-Hole Services. Facing South
