***In connection with Planning consent no 1/43/11H/FULL***

**A report to Harrison & Johnson, Architectural Consultants**

**10th July 2006**

**ARCHAEOLOGICAL WATCHING BRIEF at  
CHURCH LODGE, STANWICK St JOHN,  
NORTH YORKSHIRE**

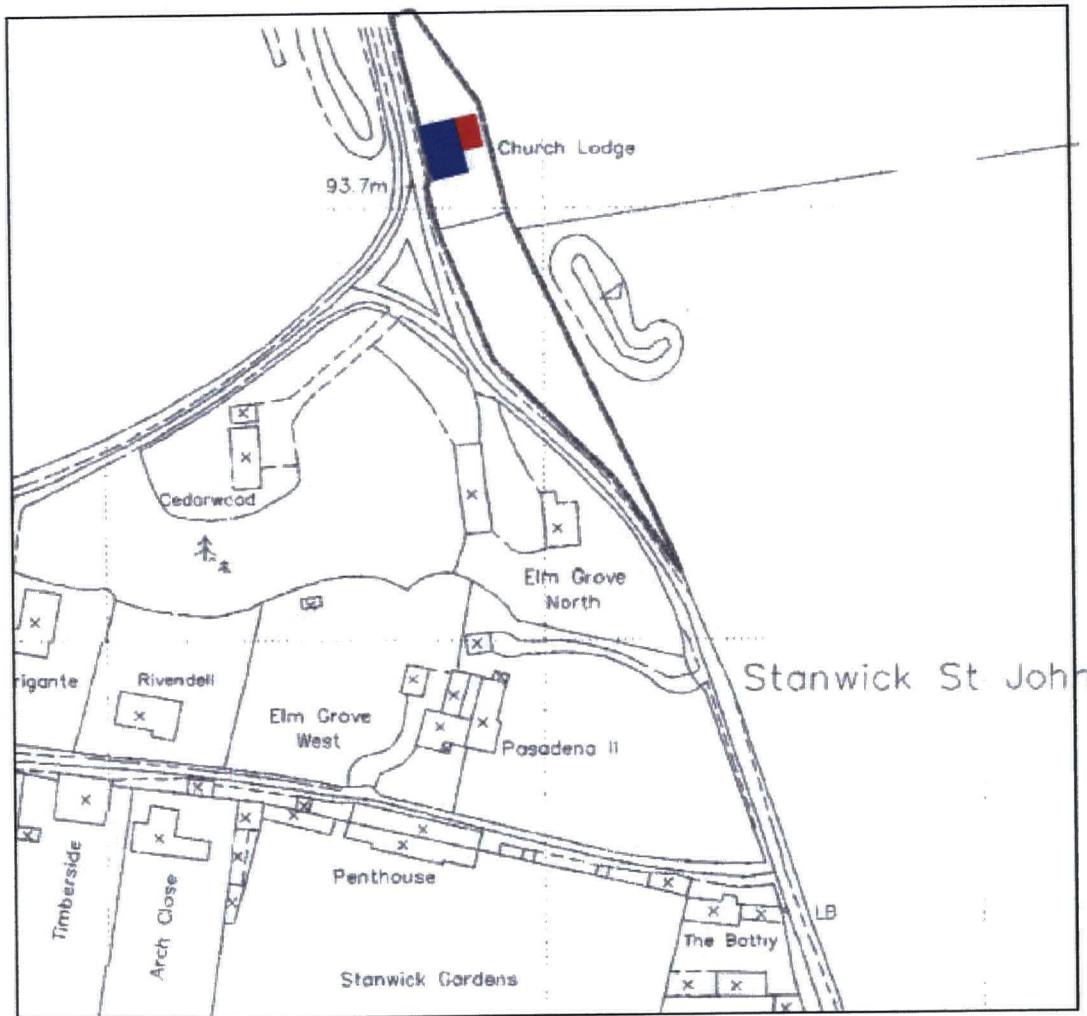
**Church Lodge, Stanwick**

Scale: 1/1,250

3. The development comprises a small extension, for living accommodation with basement, to the rear (east) side of the existing building. Church Lodge is a two-storey stone structure of 19<sup>th</sup> century date, constructed in the semi-formal local style associated with the former Prudhoe (Northumberland) estate (Location, Fig. 1).

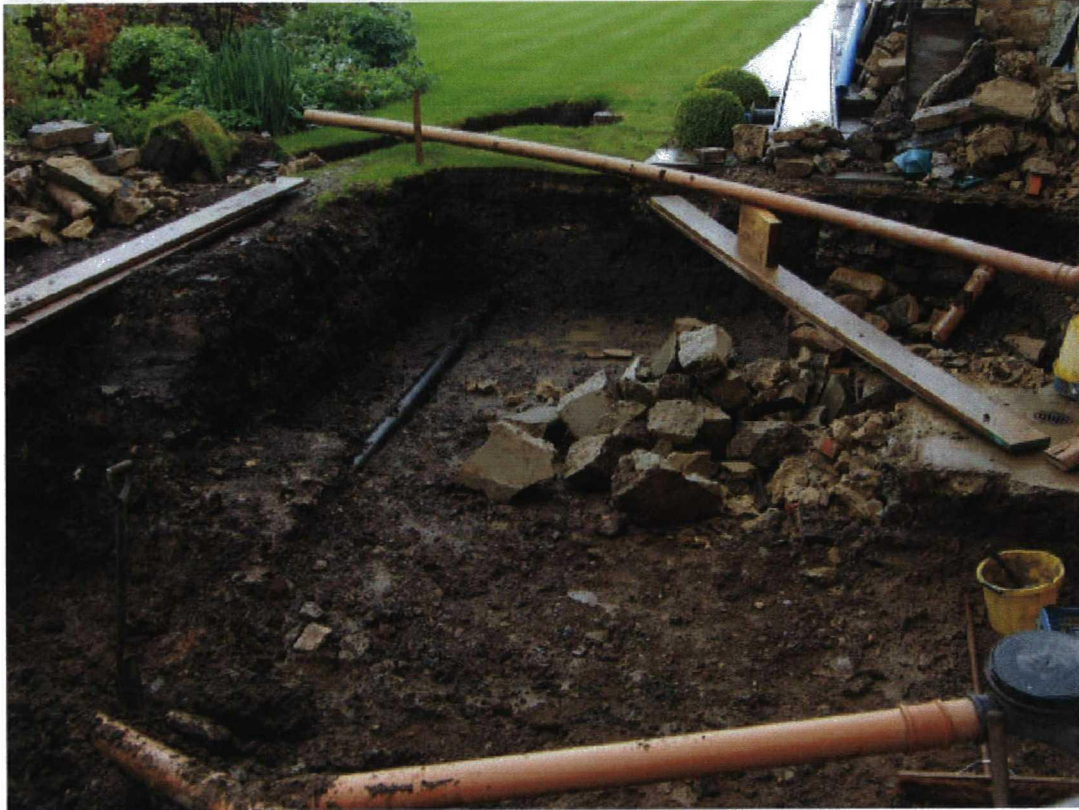
**Fig. 2**

5. When first notice of this watching brief was received, the whole footprint of the new extension was found to have been excavated down to the lowest level of the basement slab: it was, however, possible to make a detailed examination of all surfaces and sections. The entire yard area proved to have been extensively disturbed, mainly by the excavation of old drain and service trenches, and no deposits of any archaeological significance could be noted anywhere in the trenches; nor was any object recovered of a date earlier than the 20<sup>th</sup> century (Fig. 2). 19<sup>th</sup> and 20<sup>th</sup> century disturbance was general to an average level of circa 60 cms below ground surface.
6. The footprint of the building was stripped right into the natural yellow-brown clay: no trace could be seen of any cut feature.

**View of excavated site, looking south**

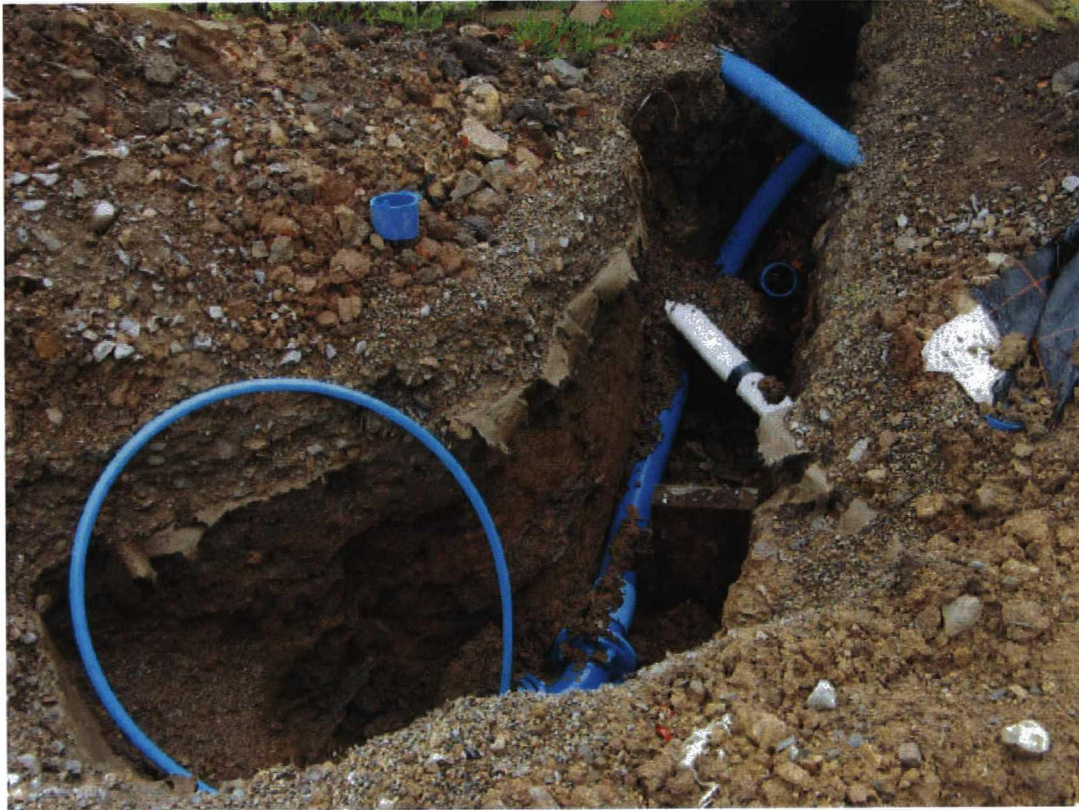
**Fig. 3**

7. A short length of service trench, north of the main development, was also monitored: this appeared largely to re-use an existing trench, and no trace of archaeological deposits could be seen (Fig. 3).

**Excavated service trench on north side.**
