## 5.0 MAP ANALYSIS

## 6.0 BUILT HERITAGE

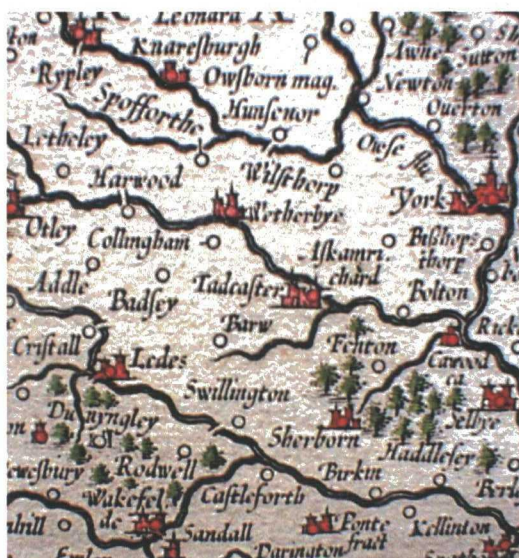
Plate 8: Extract from Mercator's 1620 map

- 5.2 The Gerard Mercator map of the Leeds, York and Knaresborough area (1620; Plate 8) is drawn to a very large scale, and the town of 'Selbye' is shown by a symbol resembling the Abbey.

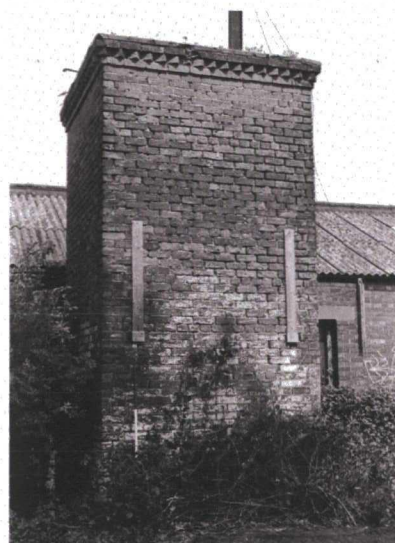
Plate 10: Providence Mill chimney

- 6.2.1 Elements of the original Providence Mill do survive within the present complex, although heavily altered.
- 6.2.2 To the south of the site stands a large brick chimney, square in plan with dogtooth eaves detailing. The chimney survives to a height of c.4m, but has lost much of its context with the demolition of the mill (Plate 10).

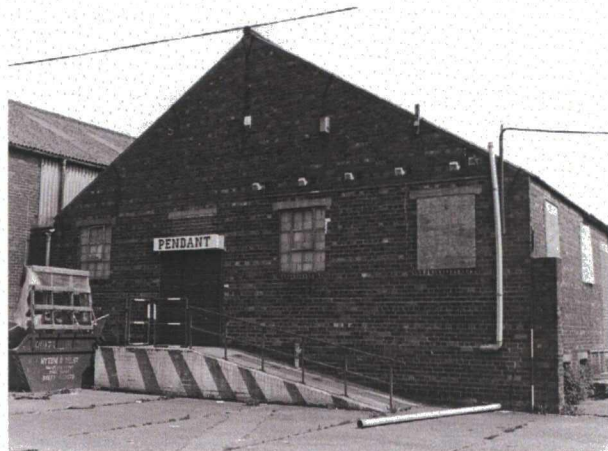
Plate 12: Mid-20<sup>th</sup> century warehouse

6.3.1 Extending west from the mill is a single-storey warehouse, replacing the earlier mill structure. The building dates to the mid-20th century, appearing on the 1968 Ordnance Survey map. It is constructed from red brick with concrete dressings and an asbestos roof. Access is provided through a large roller door in the west elevation. This has been inserted into an existing window opening with surviving windows to the north and south. These represent iron-framed casements with concrete lintels. All have been blocked with breeze-blocks.

6.3.2 The south elevation contains a series of similar window openings, now boarded. Arranged alongside these are three large loading doors. Those to the west are blocked with modern brick, while that to the east retains its wooden plank door. A fourth, pedestrian door survives at the centre of the elevation. Occupying a position at ground level are two pairs of openings with concrete lintels. The north and east elevations are concealed by extant buildings.

6.3.3 Internally, the building represents a single open space with no surviving fittings or fixtures. The roof trusses are iron king-post examples, supported on shallow brick pilasters.

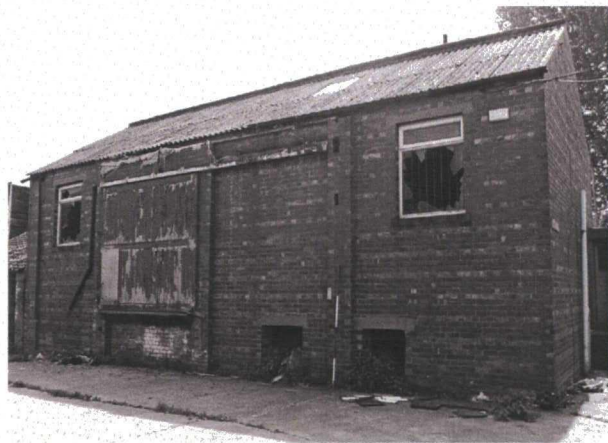
Plate 13: Depot building

6.4.1 Located to the south of the site is a single brick range aligned east-west. The single-storey structure dates to the mid-20th century and appears on the 1968 Ordnance Survey map.

6.4.2 The building is constructed from red brick with concrete dressings and an asbestos roof. While the east and west elevations are blank, the north and south elevations are architecturally divided into four bays by shallow brick pilasters. Within the north elevation are two windows occupying the outermost bays. Although the openings are original, the windows are later replacement. A large roller door dominates the remainder of the elevation with timber plank door surviving *in situ*. Towards the base of the elevation are two small openings under concrete lintels. The south elevation mirrors that to the north with two window openings flanking a large door opening. There appears to be no physical connection with the neighbouring chimney.

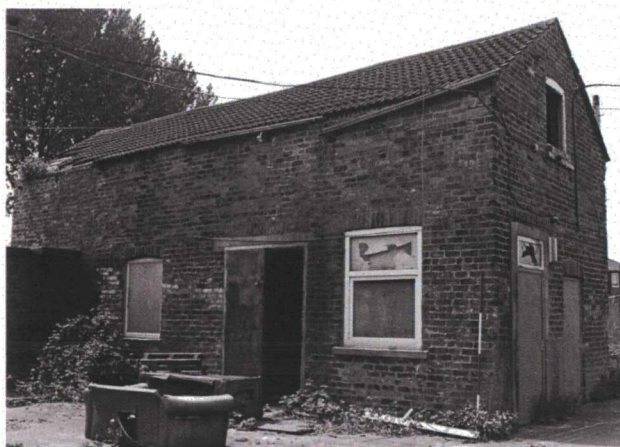
Plate 14: Late 19<sup>th</sup> century outbuilding

- 6.5.1 Situated along the southern boundary of the application site is a single outbuilding aligned north-south. The building is two-storeys and constructed from red brick with a replacement tile roof. The structure reveals successive phases of building with openings to both the east and west. The west elevation contains two windows at ground-floor level. Both are later insertions, with that to the south cutting an earlier opening. The frames are modern replacements. A single, inserted, window survives at first-floor level.

- 6.5.2 The east elevation contains a large double door at ground-floor level, flanked by two window openings, both boarded. That to the north is a later insertion. The door has been inserted into an earlier, smaller opening and its concrete lintel suggests a mid-to late 20th century date. A second door is located to the south, leading into a small extension providing welfare facilities.

- 6.5.3 The north elevation contains two doors at ground-floor level, with that to the east representing a later insertion. At first-floor level is a single window, occupying the position of an earlier loading door. The south elevation has been heavily altered with the insertion of large window openings at both ground- and first-floor levels.

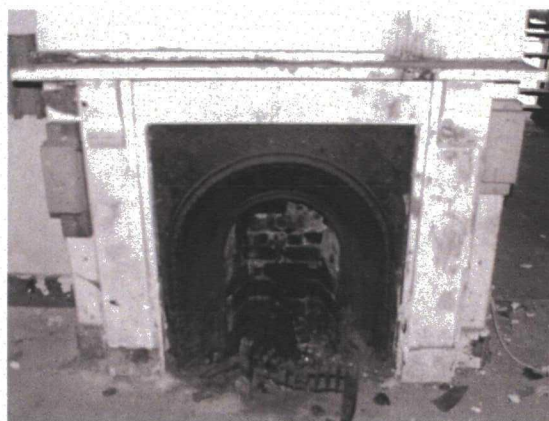
Plate 15: Surviving fireplace

- 6.5.4 Internally, the building has been substantially altered with the introduction of modern partitions, particularly at first-floor level. The original layout is more visible on the ground floor. This area is divided into two rooms with an inserted stair along the east elevation. The northern room is much larger but devoid of original fittings and fixtures in the south elevation. To the south is a small room with surviving cast iron fireplace to the north (Plate 15).

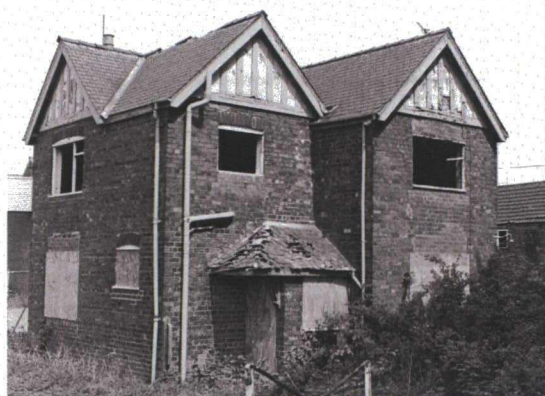
Plate 16: River View Cottage

- 6.6.1 Situated at the entrance to the site is River View Cottage. This structure dates to the early 20th century, first appearing on the 1908 Ordnance Survey map. The building is two-storeys and constructed from red brick with mock Tudor gable decoration. The building is currently vacant and in a poor condition with extensive evidence of fire damage. Internal access was not possible.

6.6.2 The building is formed by two parallel ranges, gabled to the north and south. Decorative detailing is provided by mock timber framing in the gablets. The exterior shows evidence of alteration throughout with the insertion of replacement windows, all of which have subsequently been removed. Access is provided through a small porch in the south elevation, now boarded. A second door survives to the east providing access to the external sanitary accommodation.
