**ARCHAEOLOGICAL RECORDING at the  
PLAYING FIELDS, LEEMING LANE,  
CATTERICK, NORTH YORKSHIRE**

(SE 23622 98642)

**A report to Richmondshire District Council**

**11th September 2006**

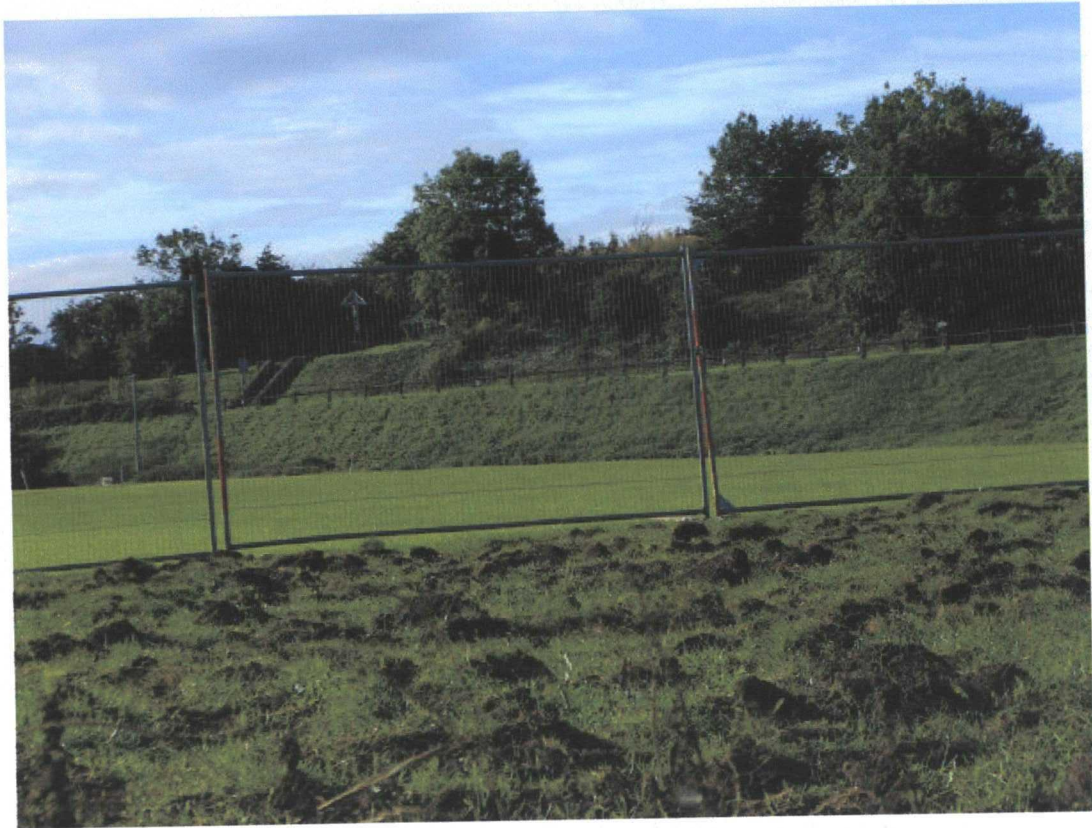
**Fig.2**

**View to south-west, showing bank along edge of site**

5. The southern edge of the part of the site to be stripped and landscaped is marked by a fairly steep bank, which becomes less pronounced to the east and which peters out close to the eastern edge of the arable field. To the west, it curves progressively to the south and becomes part of a substantial embankment along the side of Leeming Lane (Fig. 2). It seems fairly clear that this bank marks the edge of a palaeochannel, representing an early course of the Swale: there is, however, nothing to suggest that it dates from recent times (from the last couple of millennia, for

instance). The bank has certainly been modified, perhaps by digging into it for the sand and gravel which are accessible as bands of colluvial material visible in the side of the bank.

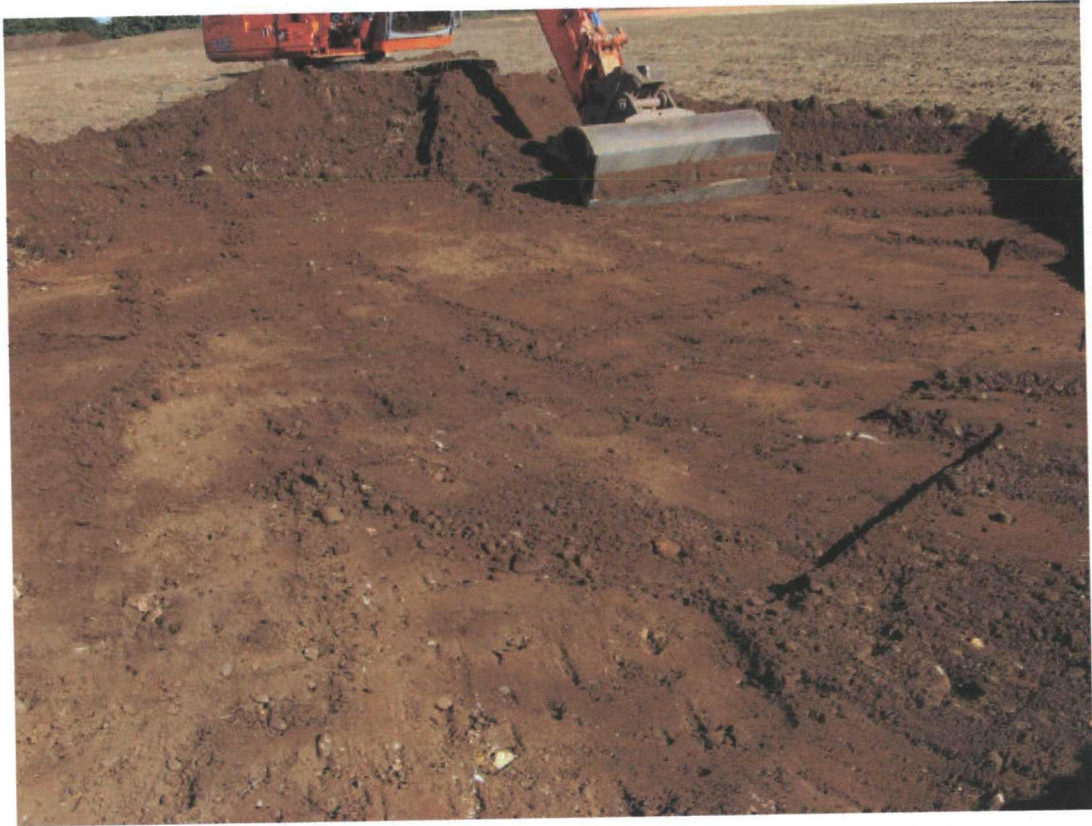
**Fig.3**

**Typical stripped surface**

8. A sandy loam topsoil was spread over the entire field, progressively varying from an average thickness of circa 20 cms at the northern end of the field to about 32 cms at the southern edge of the stripped area: the difference may be explained entirely in terms of soil creep on the natural slope under an arable regime. At the base of the topsoil was a paler sandy subsoil, effectively a zone of interface between the topsoil and the natural gravel and sand; this 'subsoil' had a constant thickness of 5 cms.

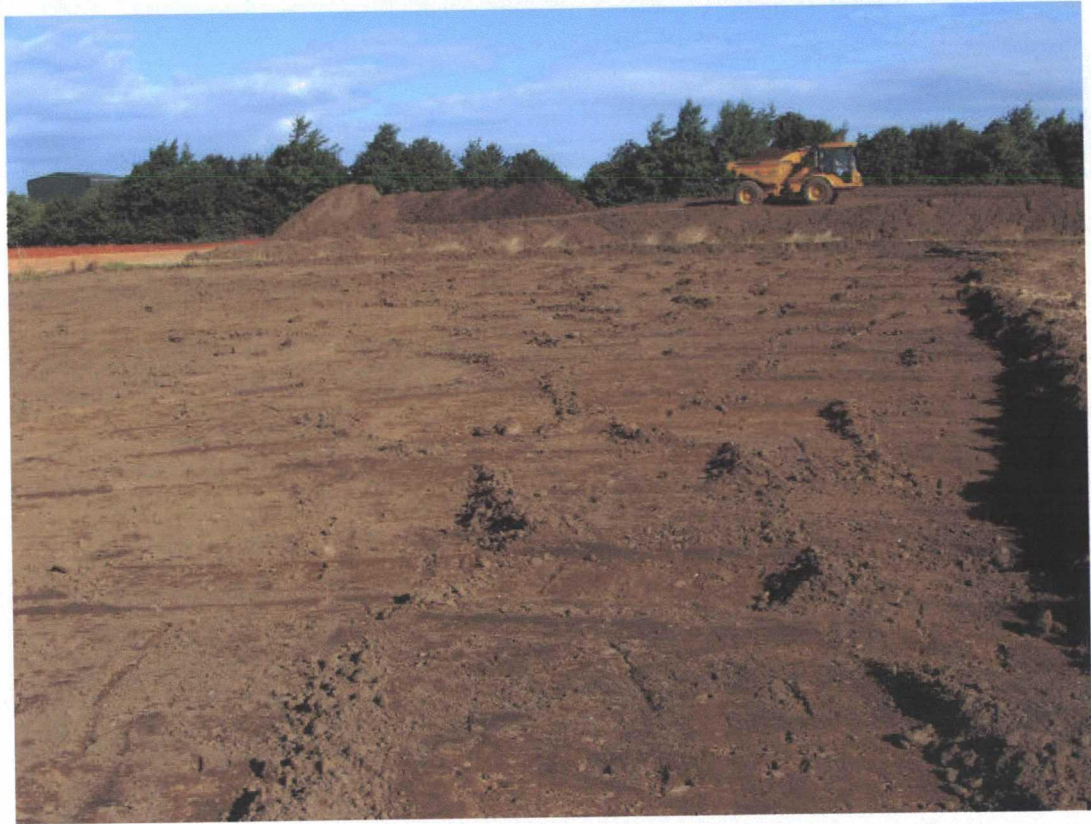
**Fig.4**

**View across site, looking north**
