2.15 RESULTS BY LOCATION WITHIN THE CITY OF YORK COUNCIL ADMINISTRATIVE AREA

This section itemises those archaeological locations within that part of the route which passed through the area administered by the City of York Council. It comprises the southern seven kilometres of the route from the southern side of the A166 just to the east of Stamford Bridge, to Elvington water treatment works in the south. (See Figure 2).

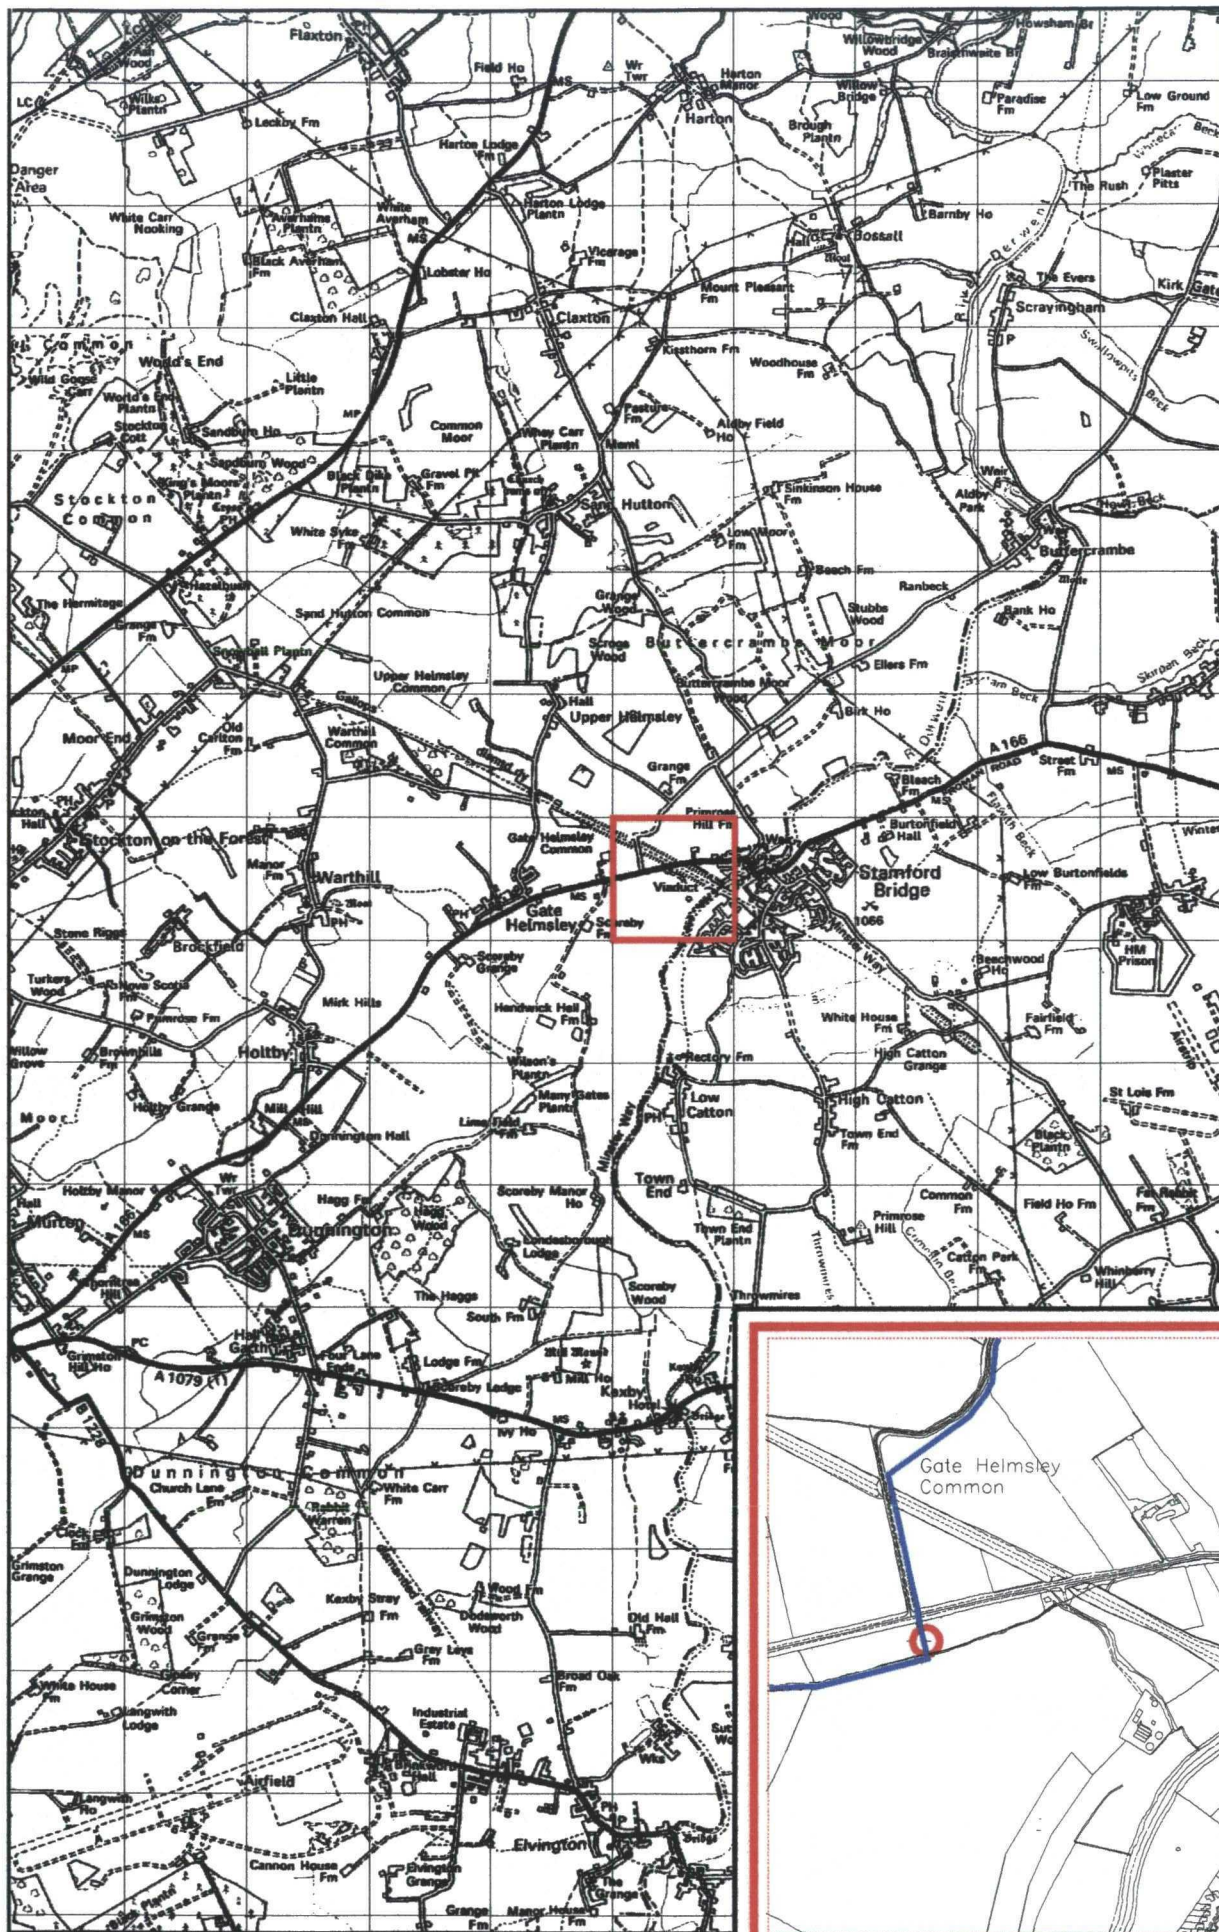
Figure 15. Location 13.

2.16 Location 13. Field to the south of the A166 (Site Records: Field 29) Figure 15

2.16.1 Site Description: Linear ditch

Ditch on a south-west - north-east alignment, although frequent tree root disturbance prevented the definition of the feature overall but a very short length. Width approximately 1.20 metres, depth 0.75 metres.

Interpretation: Undated field boundary

1. Inclusion in the Sites and Monuments Register. See above Section 2.1.2 and below Task 38.

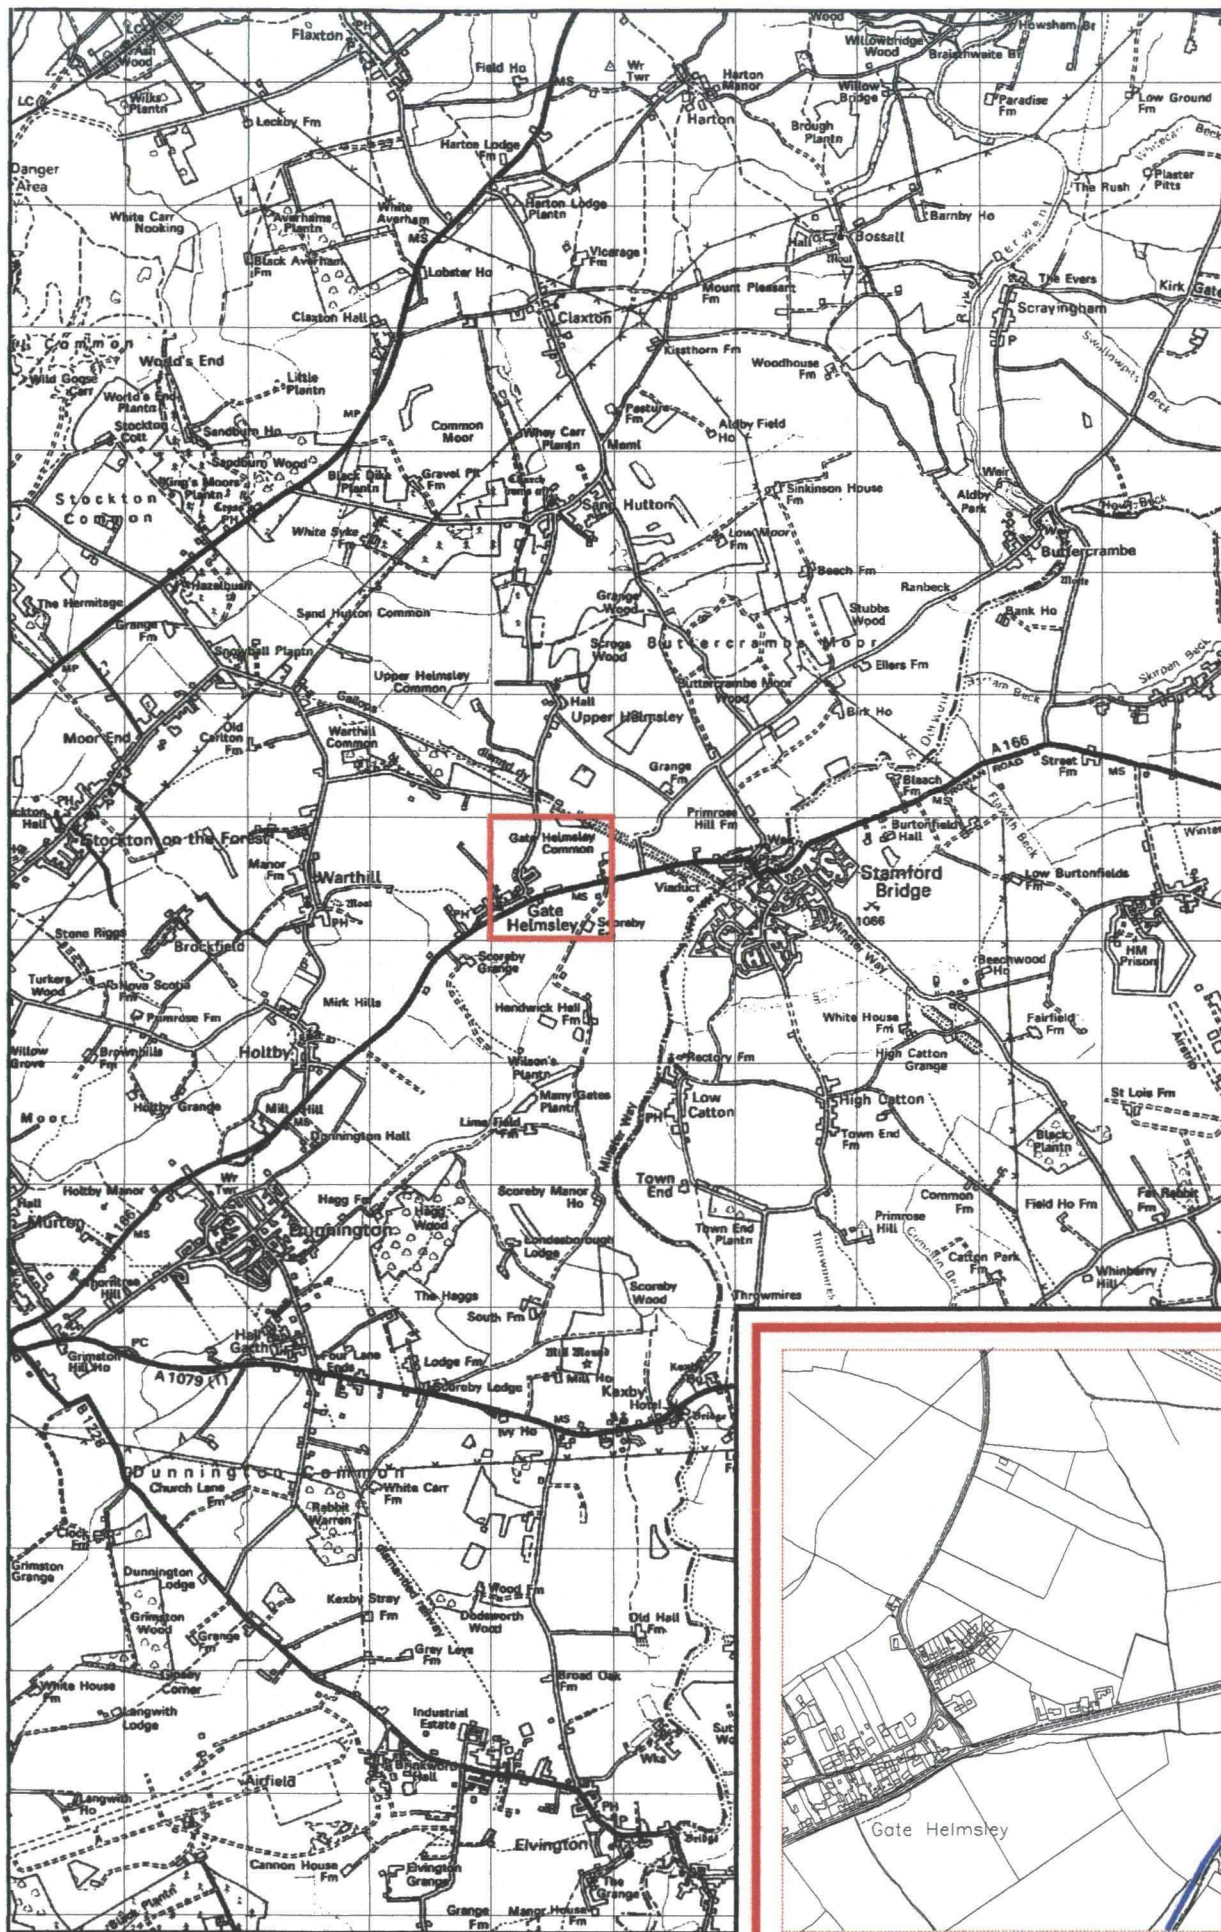
Figure 16. Location 14.

**2.17 Location 14. Field to the north of Scoreby Farmhouse (Site Records: Field 31)
Figure 16**

2.17.1 Site Description: Linear Ditch

Ditch running parallel with Scoreby Lane. Fill contained modern pottery, glass, and partially decayed wood. Presumably remains of a previous field/lane boundary.

Interpretation: Modern field boundary

1. Inclusion in the Sites and Monuments Register. See above Section 2.1.2 and below Task 41.

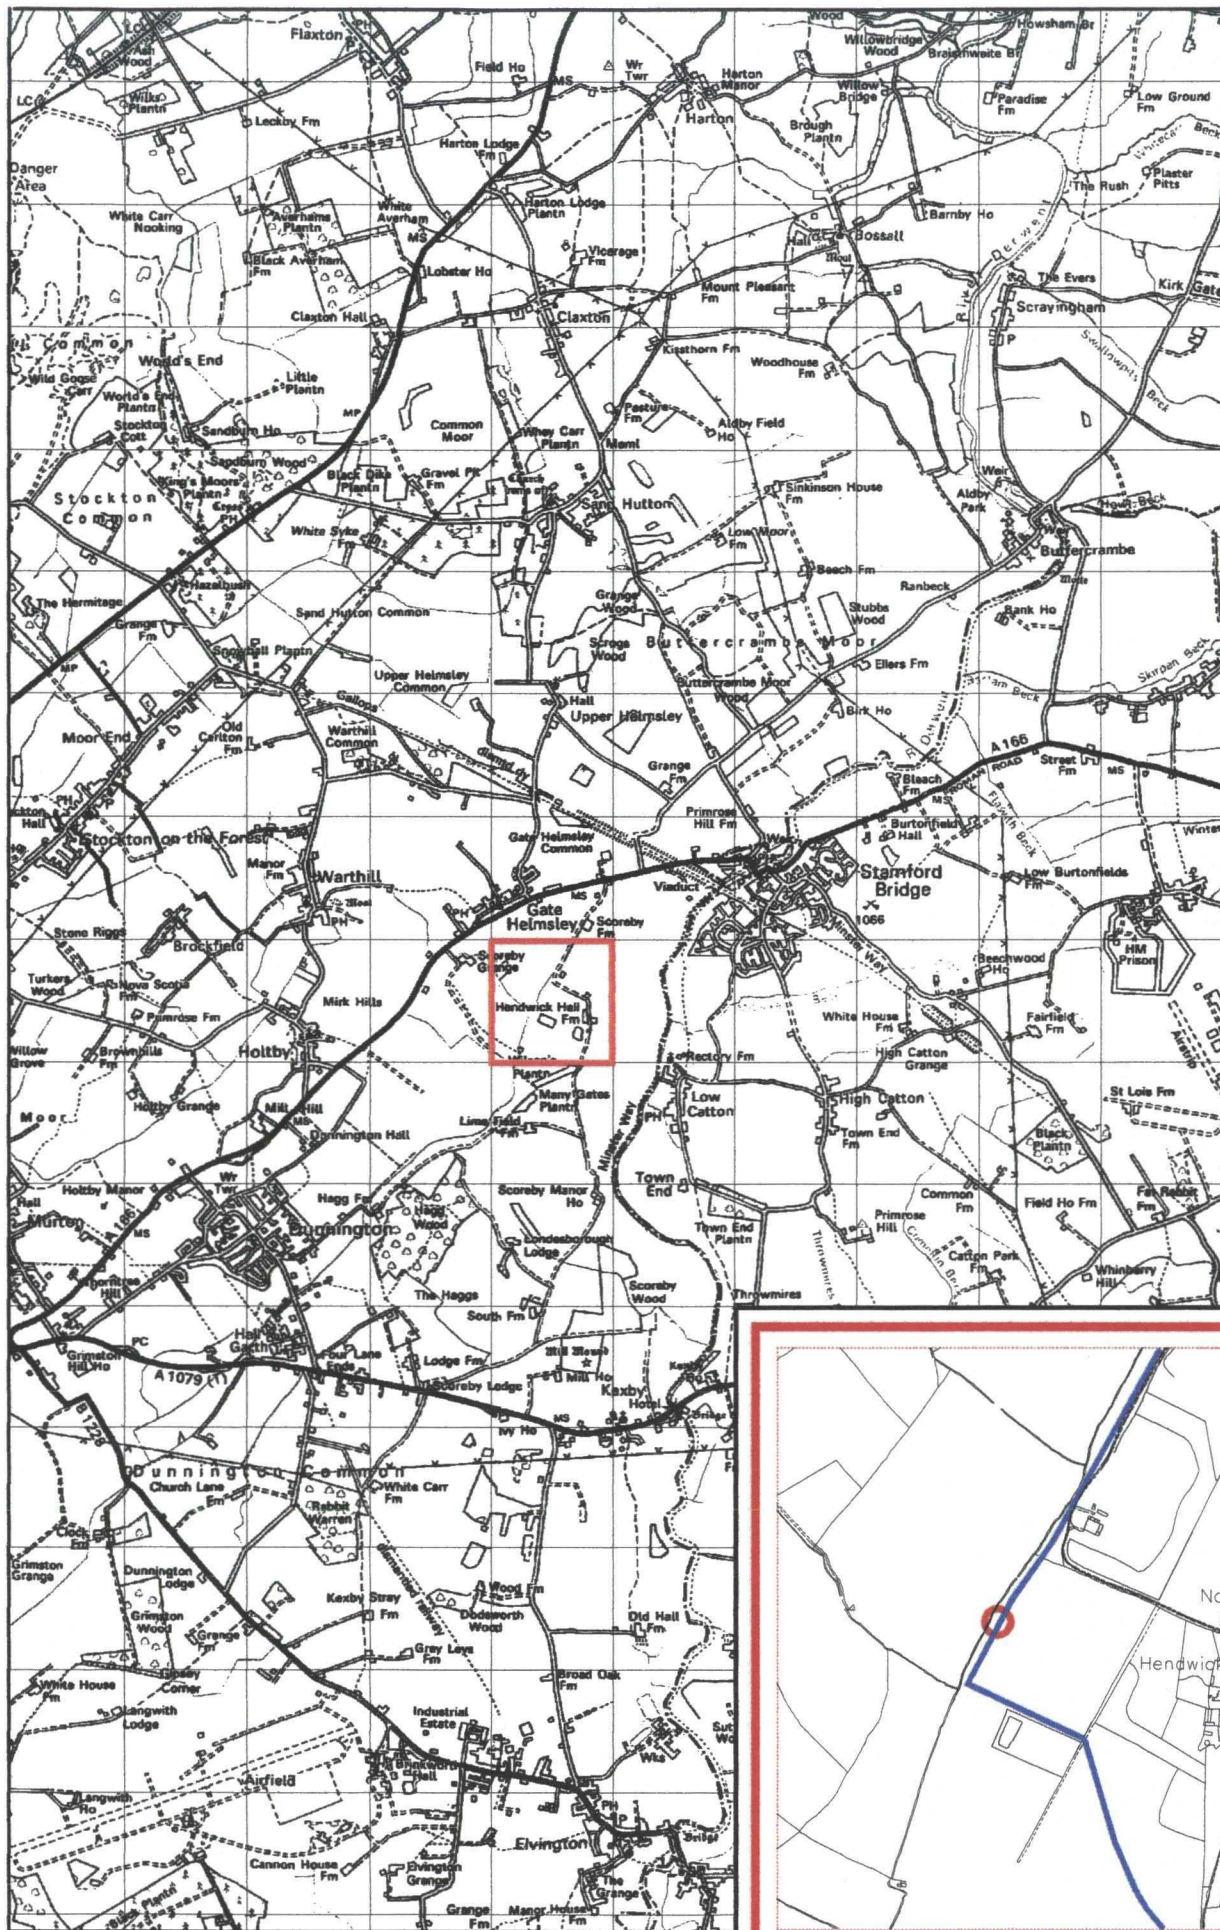
Figure 17. Location 15.

2.18 Location 15. Field to the west of North Cottage (Site Records: Field 33) Figure 17

2.18.1 Site Description: Linear Ditch

Shallow linear ditch running parallel with the western hedge. Artefacts all modern.

Interpretation: Modern field boundary

1. Inclusion in the Sites and Monuments Register. See above Section 2.1.2 and below Task 44.

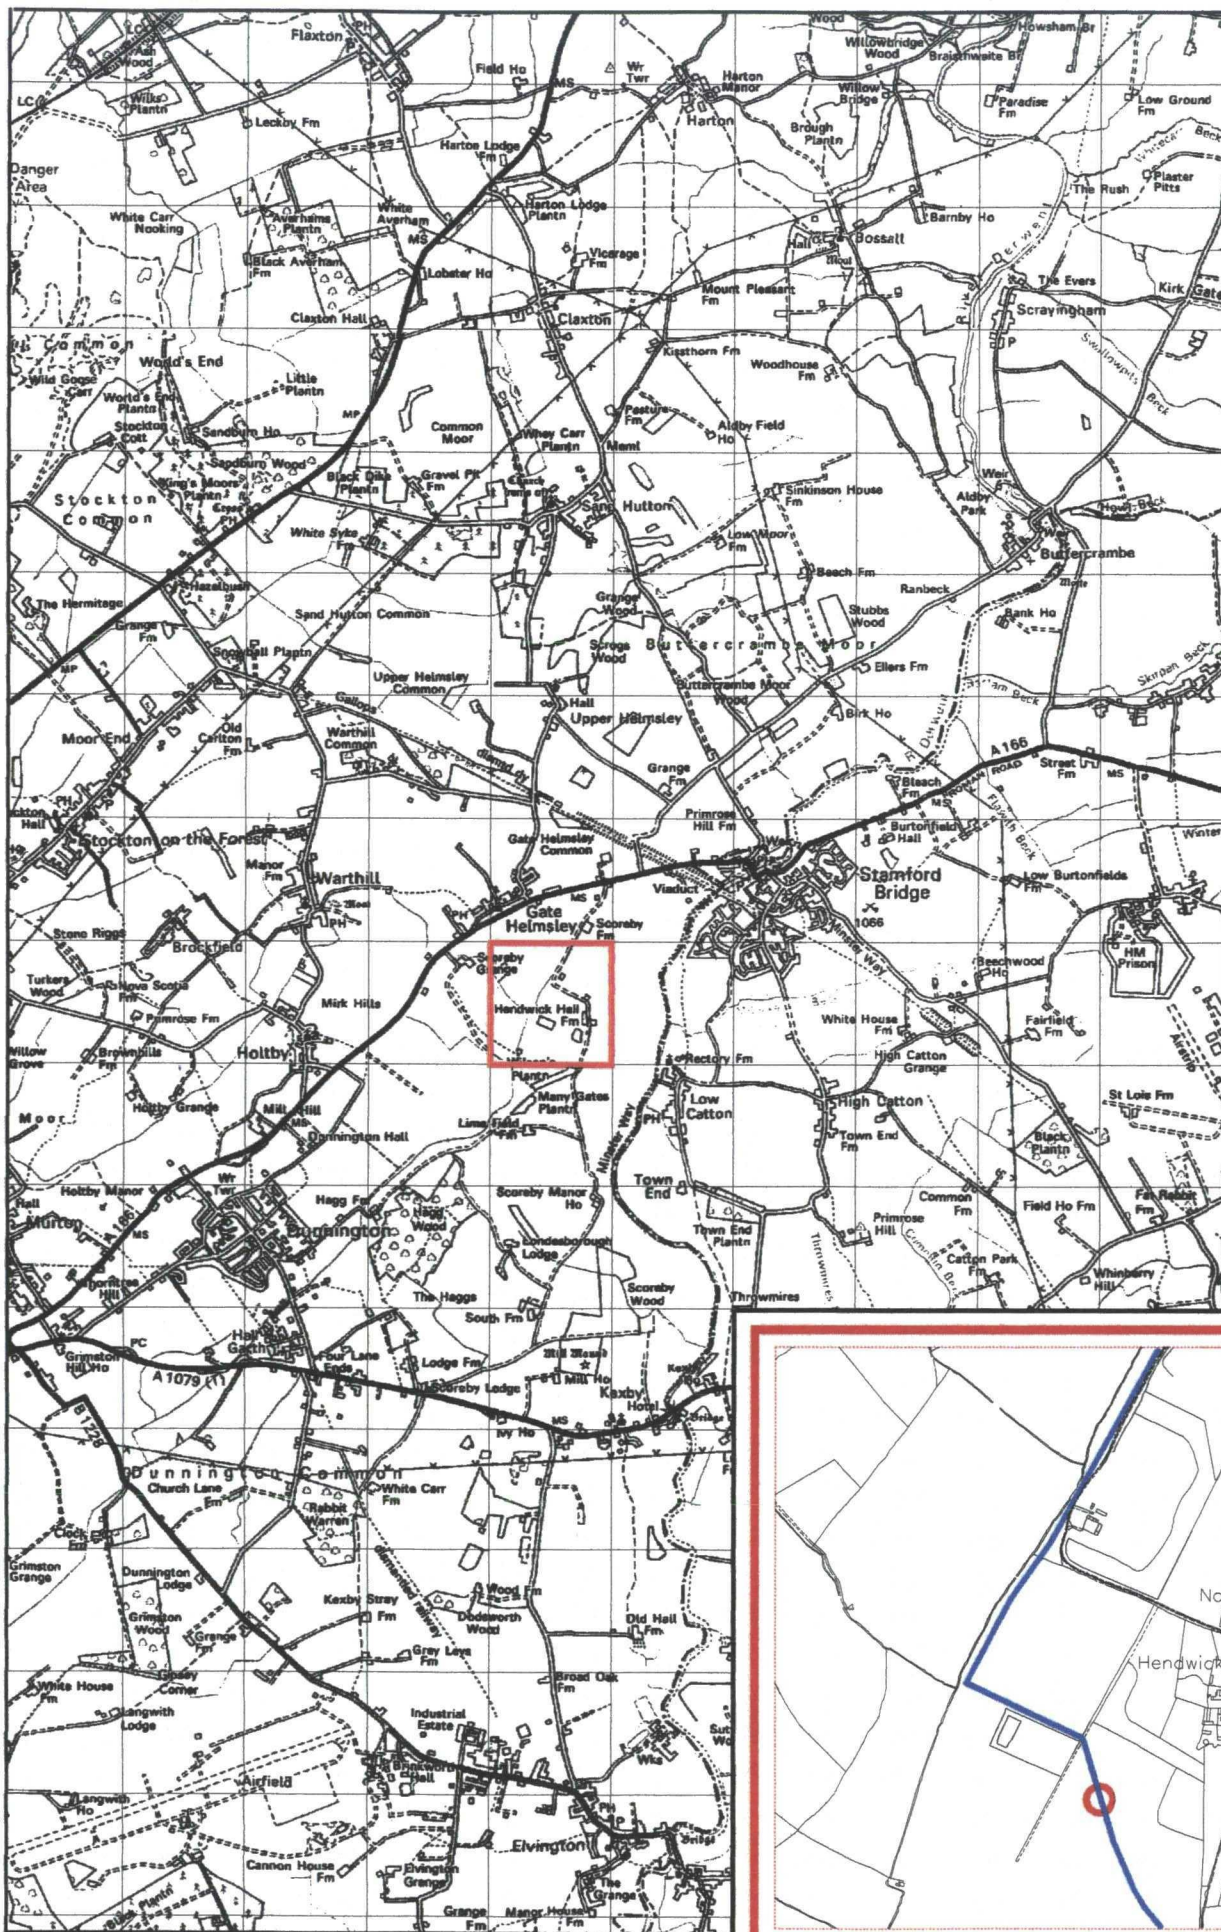
Figure 18. Location 16.

2.19 Location 16. Field to the south-west of Hendwick Hall Farm. (Site Records field 34) Figure 18

2.19.1 Site Description: Roman road section

Spread of white sand and loose cobbles, the full 15.00 metre width of the easement visible over an area of approximately 50 metres, in places up to 0.10 metre in depth. This feature was only visible as a heavily ploughed out surface smear. Observation of the deeper excavation at the time that the pipe was inserted into the ground showed that this deposit was all that remained. There was no evidence for either road side ditches or in-situ metalling. It was therefore not possible to undertake further more detailed work at this location. This road was recorded in the desktop report for this project as Item 15 and to the east, runs into the Roman civilian settlement adjacent to North Farm/Hendwick Hall Farm, (Item 14, Desktop Study).

Interpretation: Section through the Roman road which tracks in an easterly direction from York to Stamford Bridge. This is likely to be the same feature that was observed during the insertion of the drought relief pipeline from Elvington to Moor Monkton that was inserted during the summer of 1996. (Location 3, Yorkshire Water Pipeline, Nun Monkton to Elvington 1996).

1. Inclusion in the Sites and Monuments Register. See above Section 2.1.2 and below Task 47.

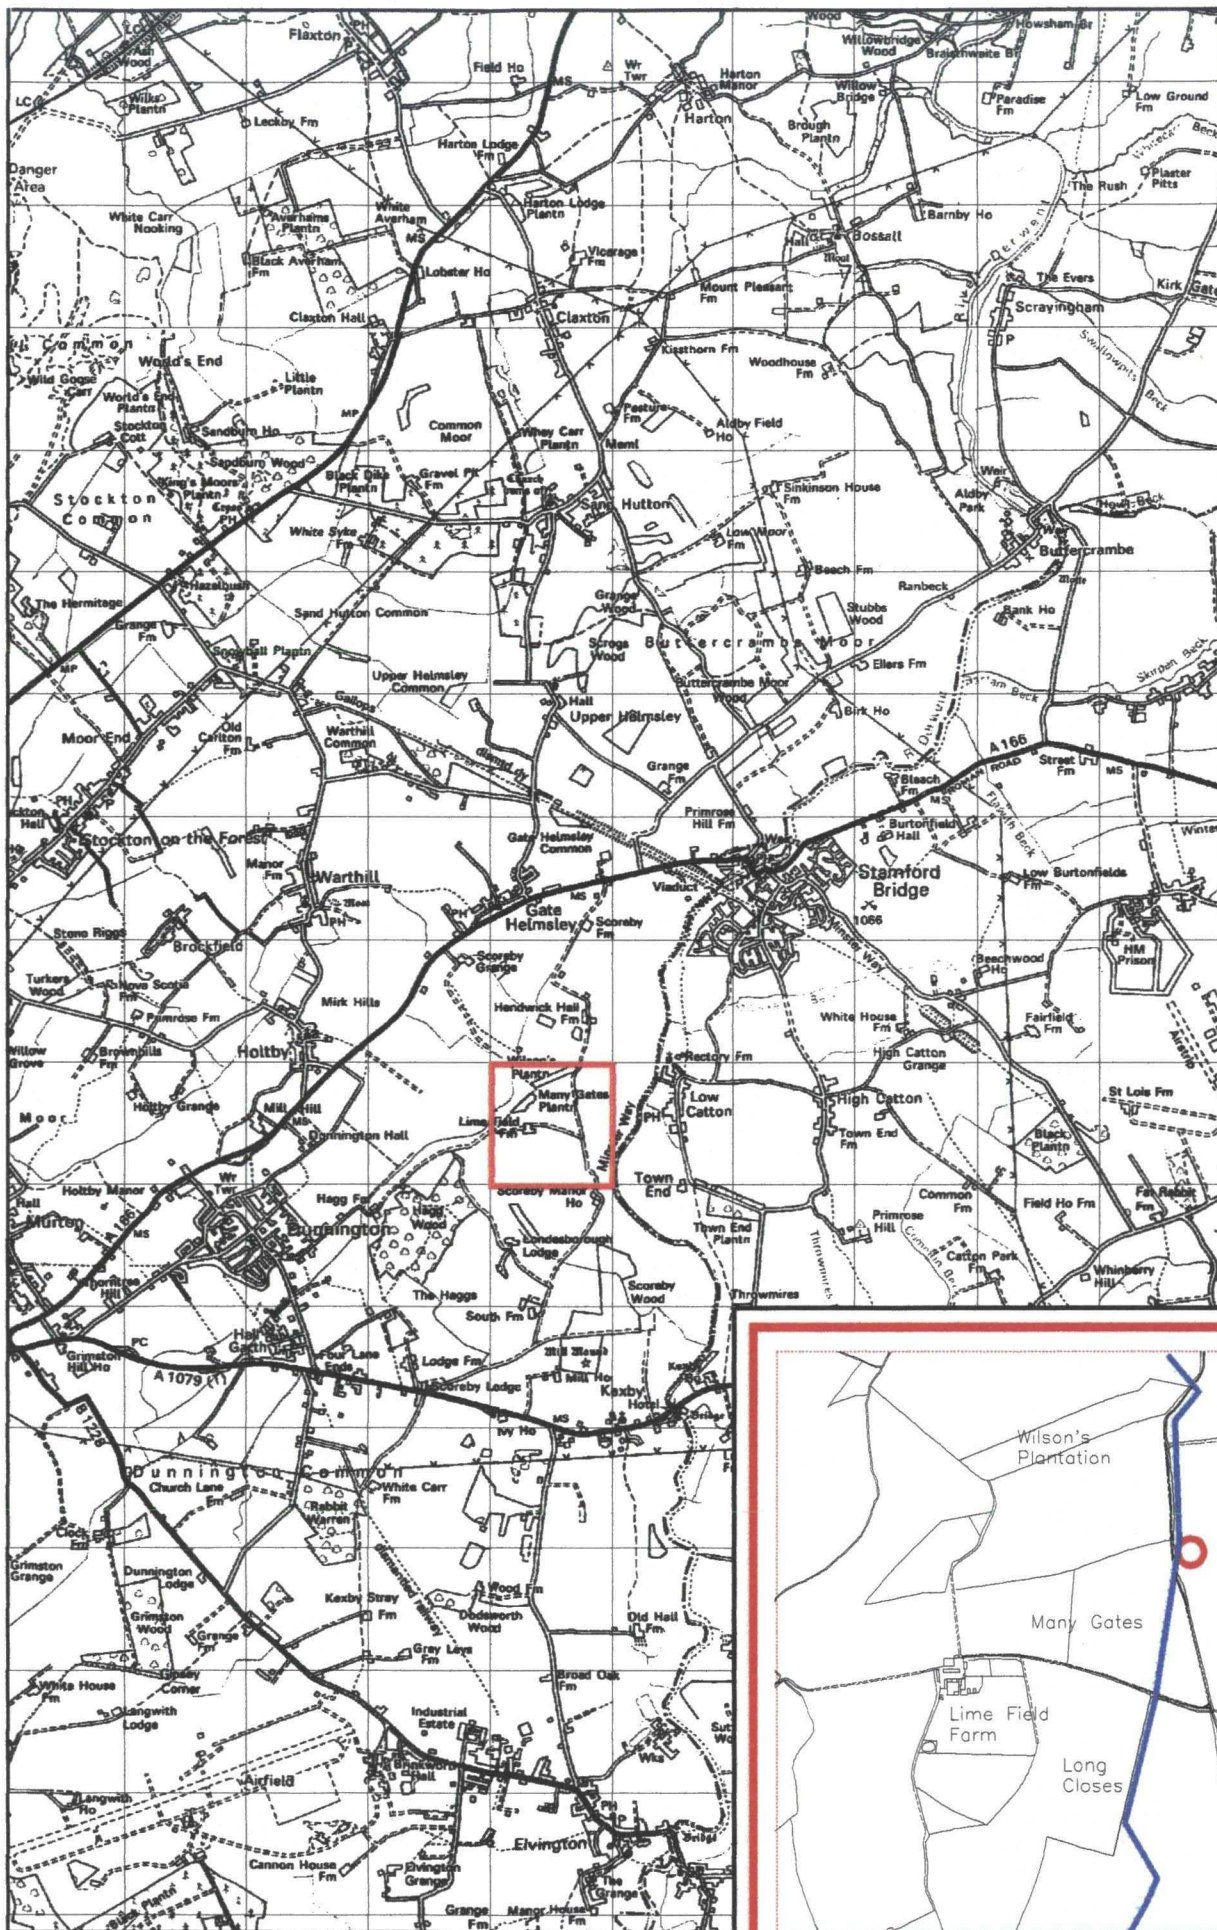
Figure 19. Location 17.

2.20 Location 17. "Seavy Closes" to the south-east of Wilson's Plantation (Site Records: Field 36) Figure 19

2.20.1 Site Description: Linear Ditch

Ditch running on a north-west - south-east alignment across the width of the easement. Width 0.85 metres, depth 0.30 metres with a 'U' shaped profile. No dating evidence. In close proximity to cropmark complex (Desktop Report - Item 17).

Interpretation: Undated field boundary

1. Inclusion in the Sites and Monuments Register. See above Section 2.1.2 and below Task 50.

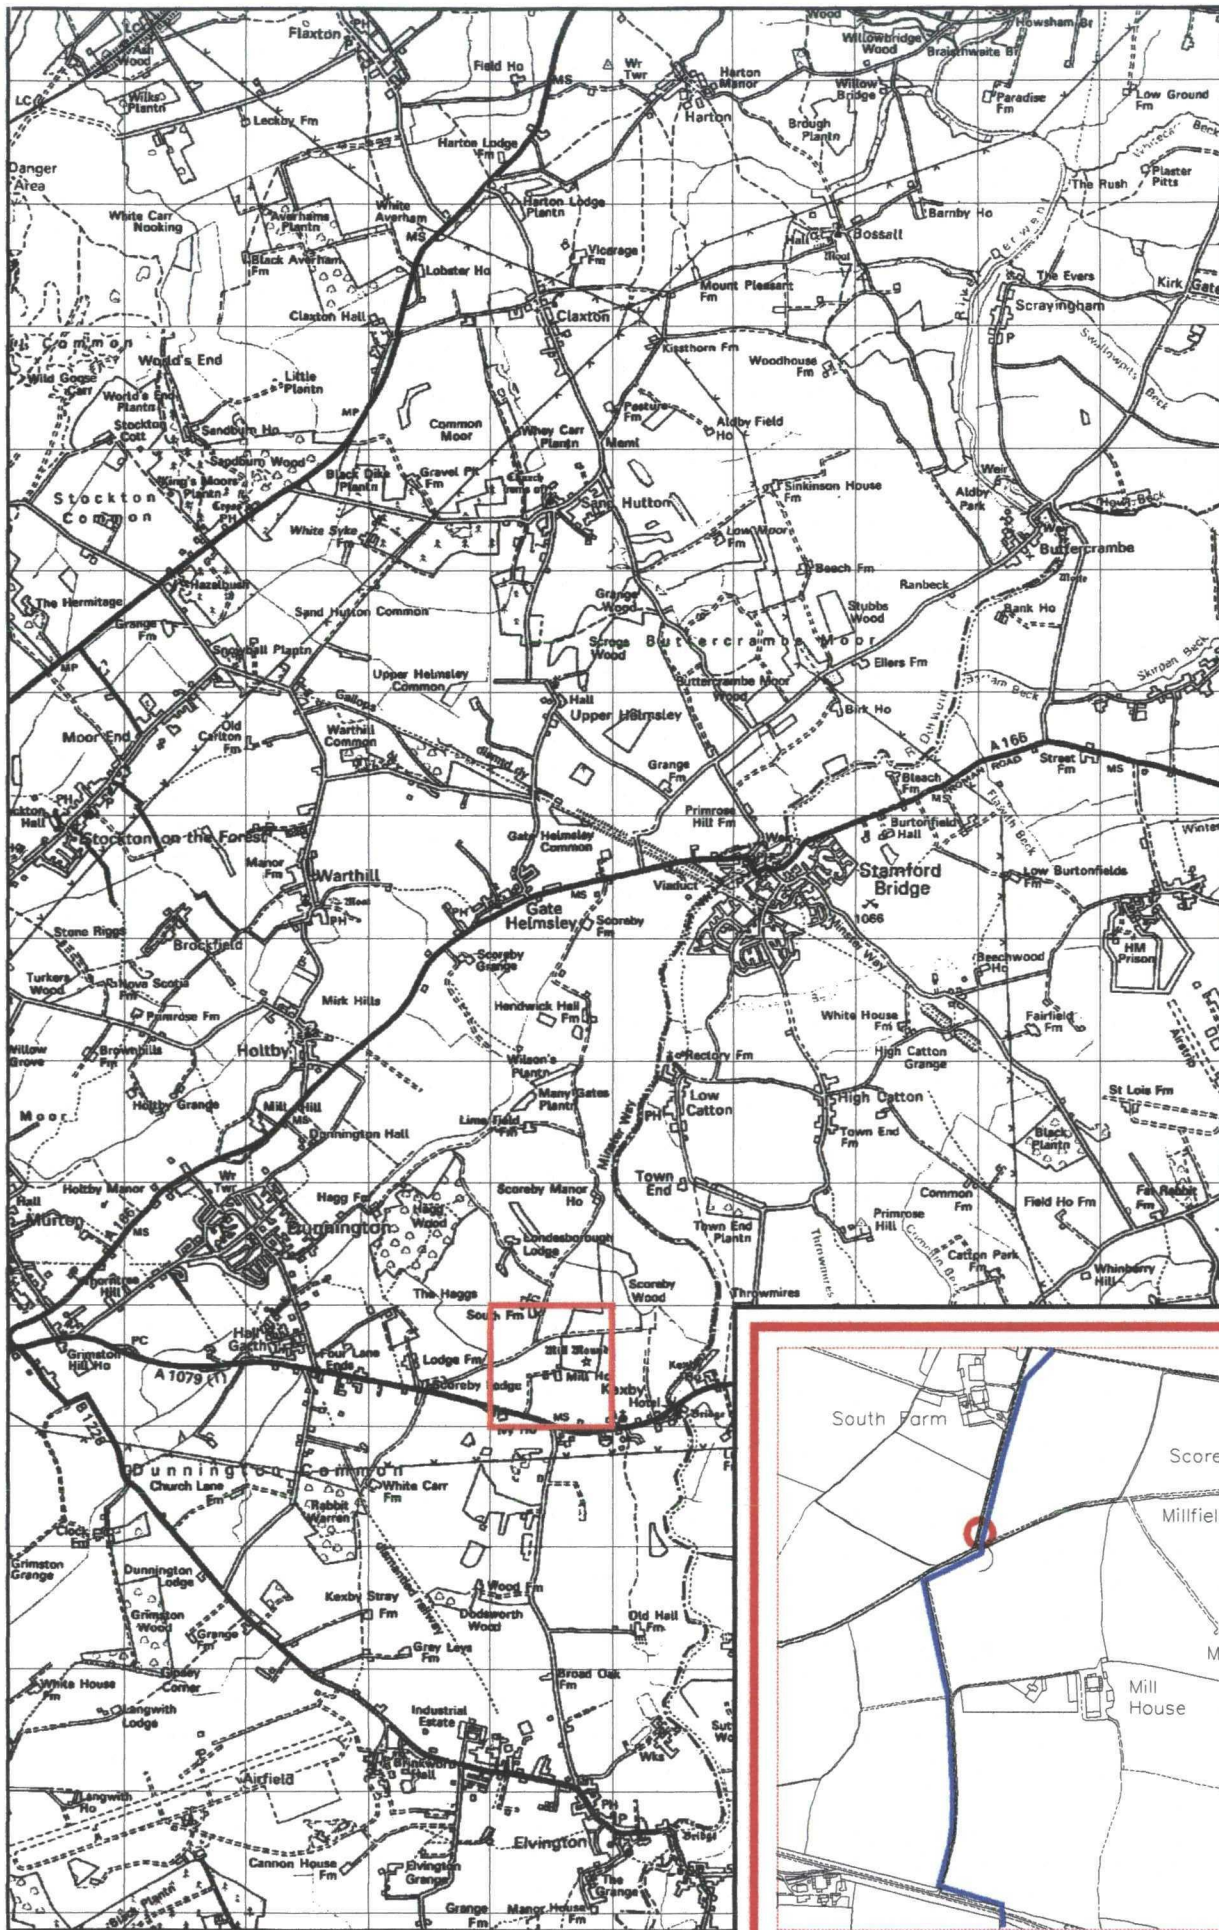
Figure 20. Location 18.

2.21 Location 18. Field to the south-east of South Farm (Site Records: Field 43) Figure 20

Narrow linear feature on a north-west - south-east alignment. 0.12 metres wide, 0.20 metres deep, extending from the eastern side of the easement for 4.20 metres before terminating. Filled with cobbles, and occasional tile and brick fragments. Land drain.

Interpretation: Post medieval land drain.

1. Inclusion in the Sites and Monuments Register. See above Section 2.1.2 and below Task 53.

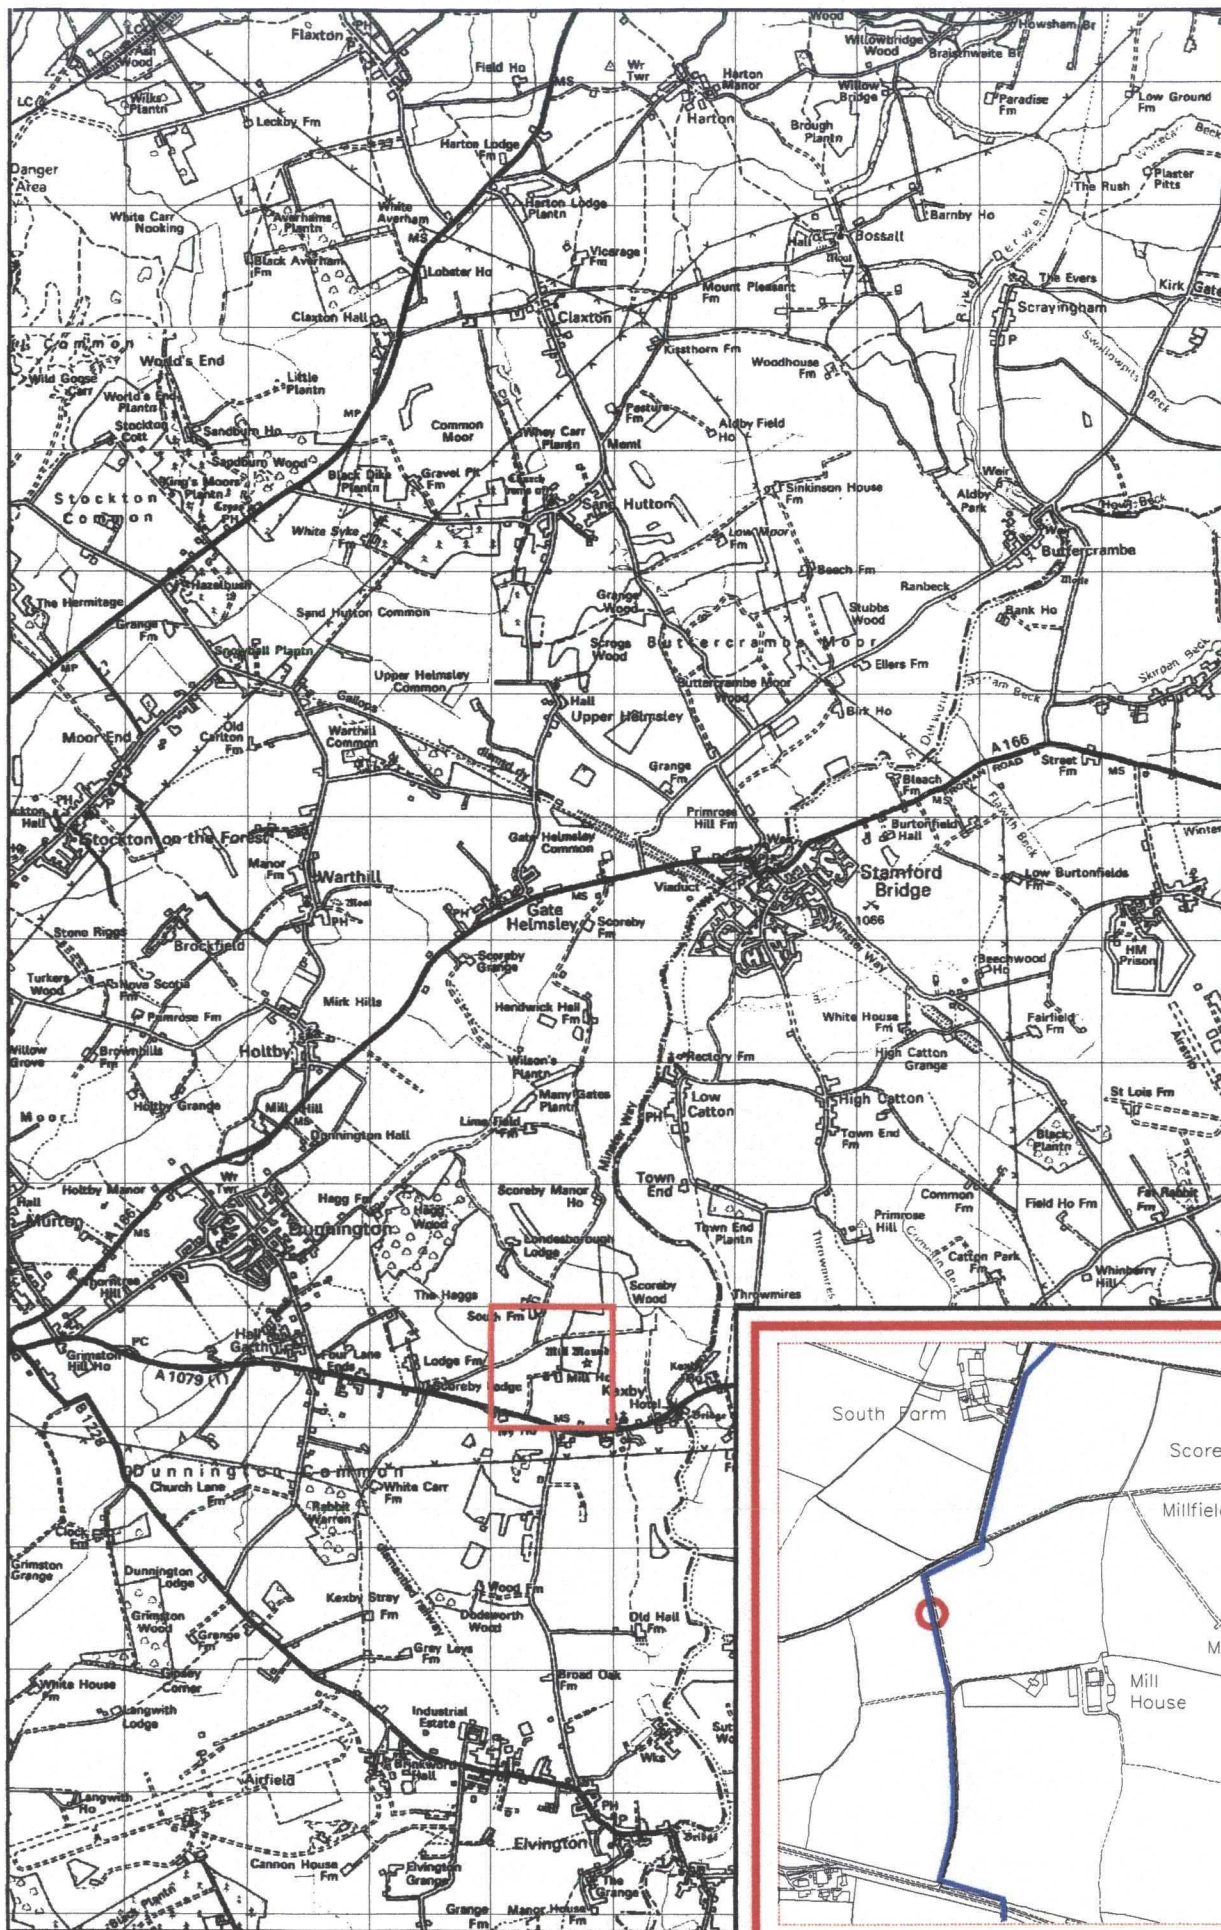
Figure 21. Location 19.

**2.22 Location 19. Field to the north west of Mill House Farm. (Site Records: Field 45)
Figure 21**

Linear ditch, running wsw - ene 1.00m wide

Interpretation: Undated field boundary

1. Inclusion in the Sites and Monuments Register. See above Section 2.1.2 and below Task 56.

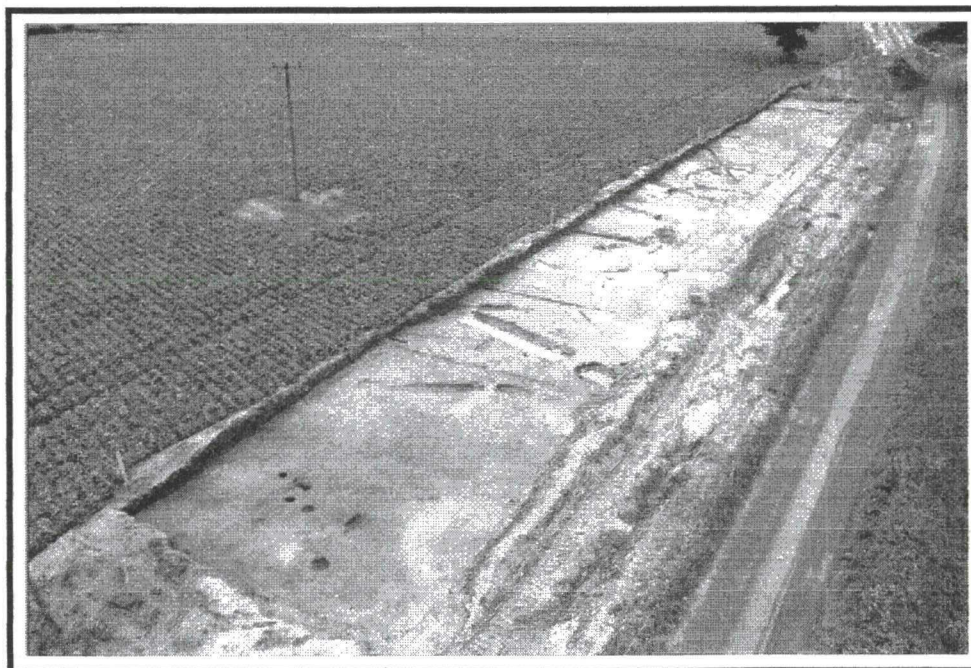
Plate 1: Mill House Farm, Kexby. YORYM:1997.61

This was the one site along the length of the pipeline corridor where detailed archaeological excavation took place. Cut features were visible for in excess of a hundred metres across the full width of the easement. After agreement with BWEL, the eastern half of the easement was fenced off so that contractors plant did not disturb what were clearly fragile deposits and salvage recording took place over the course of a few days in the strip outside the fenced area. The pipe sections were subsequently inserted into this narrower working width once this salvage work had taken place. Thereafter, once observation of the topsoil strip was completed elsewhere, it was possible to undertake excavation within the fenced off area, during which time the archaeological features present were fully excavated.

This site consisted of a complex of medium sized shallow U shaped ditches, covering much of the area within the pipeline corridor at the northern end of this field. The most important elements were two curvilinear ditches, each enclosing an area up to approximately 5.80 metres. There were also a number of other ditches and gullies in association with these major elements. The structural features found in association with these ditches consisted of two pits and a number of possible post holes. Superimposed over these ditches were the remains of later medieval rig and furrow.
