SCARBOROUGH ARCHAEOLOGICAL AND
HISTORICAL SOCIETY

WATCHING BRIEF REPORT

SITE VINCENT'S PIER/LIGHTHOUSE PIER, SCARBOROUGH
NATIONAL GRID REF TA 04930 88578
SITE CODE LP06
DATE 18 SEPTEMBER 2006
MONITORING CARRIED OUT BY S M P Wood
REPORT BY S M P Wood

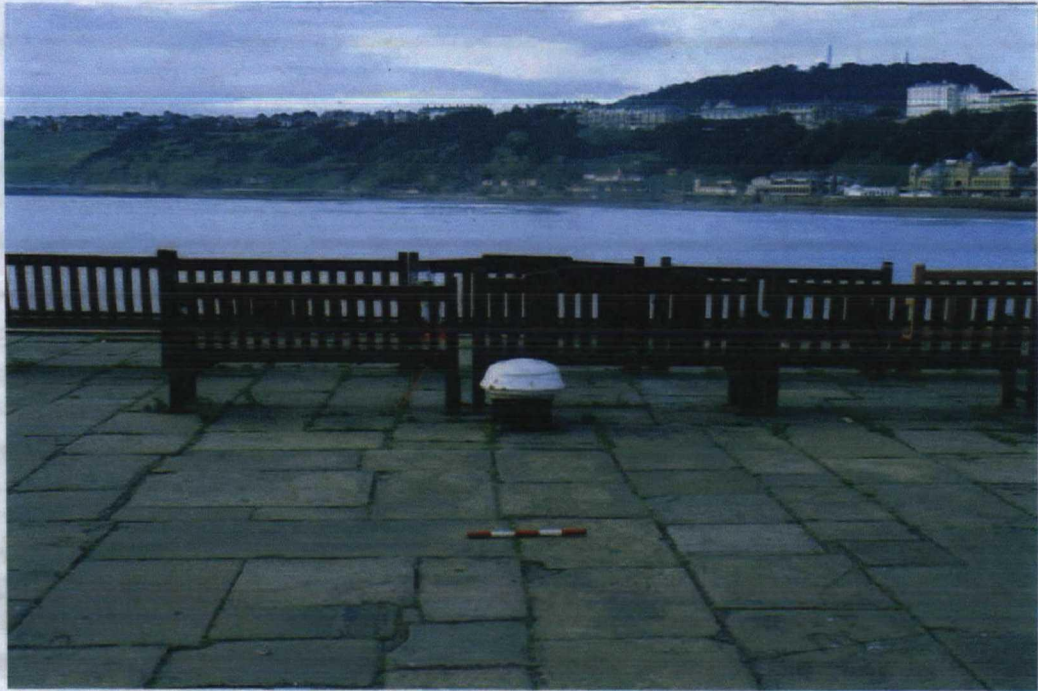
- 5.1 The trial trench was approximately one metre square excavated by both hand and machine to the south of the Lighthouse – photo 1.
- 5.2 The york stone slabs were taken up and found to be embedded into 7-10 cms of sharp sand which was itself sitting on a layer of lumpy, rough, pebbly concrete, which was not of a uniform evenness.

PHOTO 1 - VIEW SOUTH SHOWING THE LOCATION OF THE TRIAL TRENCH MARKED BY THE 500MM SCALE

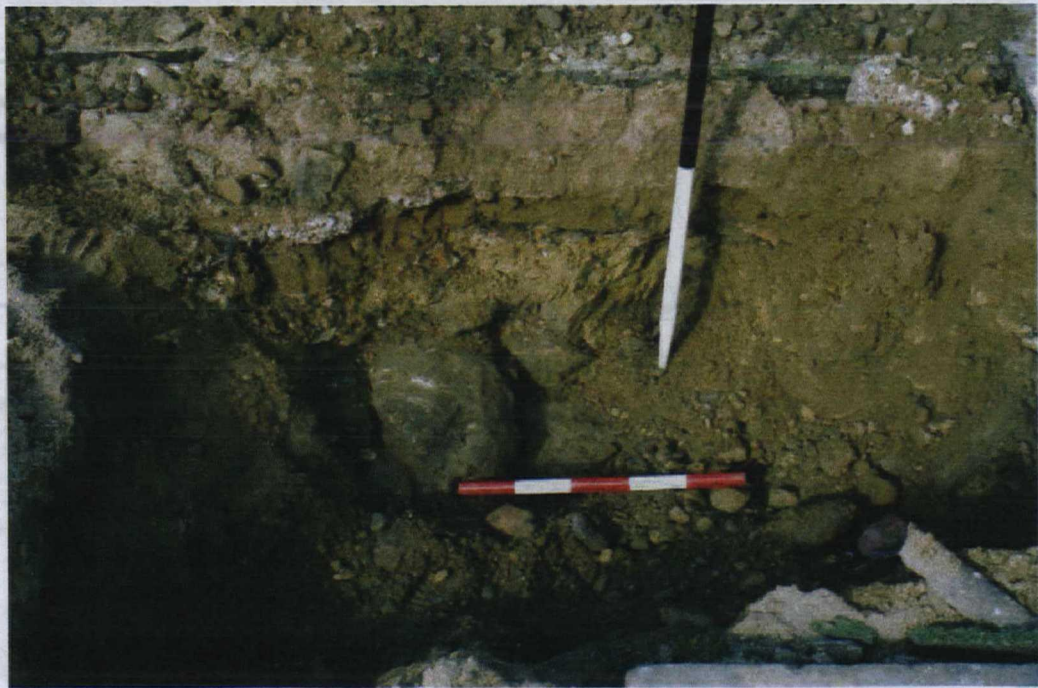
- 5.3 Underneath the concrete was a loose gravel mixed layer of stones rubble, pebbles and sand. Dating evidence found in this layer consisted of some sea worn red clay tiles - 19thC , a fragment of 19thC clay pipe, a piece of blue and white transfer print pottery circa 1880. The first two would be consistent with a pier extension date of circa 1840 – photo 2.

PHOTO 2 - SHOWING THE LOOSE UPPER FILL WITH RANDOM LARGER STONES SCALES 500MM WITH 100MM DIVISIONS AND LOWER PART OF 2M WITH 500MM DIVISIONS

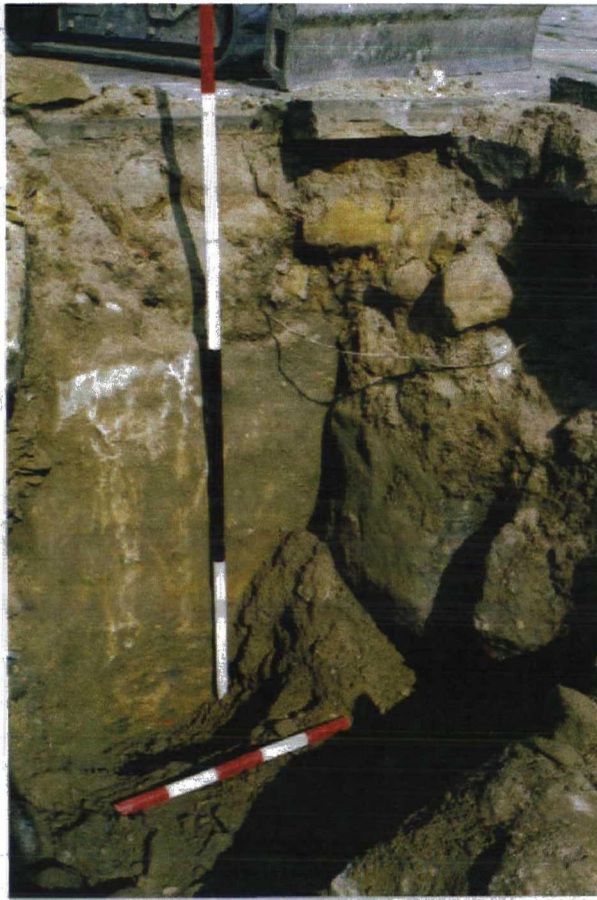
5.7 At the northern side of the trench a huge roughly hewn stone block was found, measuring approximately 1metre x 1metre in size. This large rough block of stone is 11 metres from the southern edge of the pier wall, and is central to each side of it. It was not clear whether it formed part of a larger structure but an initial interpretation of this is that it is the end of the Vincent Pier alignment which existed prior to the circa 1840 build of the Lighthouse pier extension referred to in 4.2 above. The alignment of the hewn block of stone and the rough front stones is parallel, with a metre between but at an angle to the square sides of the trench, the gap of a metre is filled with stones sand and rocks wetter at the bottom with some mussel shells mixed in. Photos 3 and 4

6.2 Of more interest is the large stone block at the northern end of the trench which may provide important archaeological evidence of the end of Vincent's Pier prior to the circa 1840 extension to form Lighthouse Pier. The nature of the trial trench did not allow further examination of this piece of masonry.

PHOTO 3 SHOWING THE LARGE BLOCK AT
THE NORTHERN END OF THE TRENCH
POSSIBLY THE EARLIER END OF VINCENTS
PIER

7.1 The watching brief indicated that the foundation works could potentially impact upon the end of a historic pier structure. If the large block at the northern end of the trench is to be removed or disturbed then it should be fully recorded and monitored. Excavation near this block should be monitored to ascertain whether it forms part of a structure and thus Vincent's Pier.

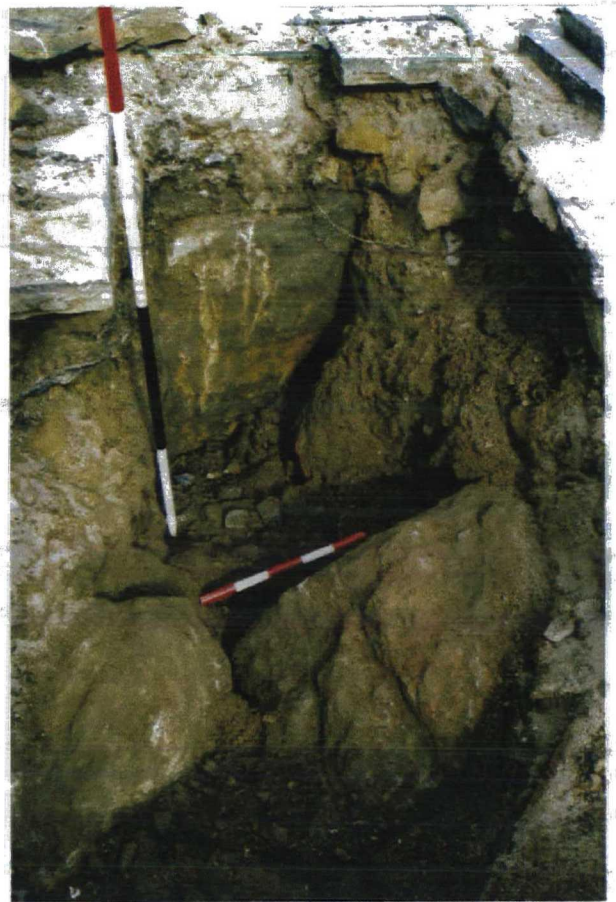
5.6 At the southern end of the trench were three very big stones which were acting as stabilising structure for the looser infill of stones and sand. They were not sitting on other rocks so did not form part of a structure. (Photo 4)

PHOTO 4 SHOWING THE
RELATIONSHIP BETWEEN THE
LARGE BLOCK AND THE THREE
SOUTHERN BLOCKS
