**Land at Boothby's Garage, Falconer's Road,
Scarborough,
North Yorkshire
TA 04223 88443**

Archaeological Evaluation

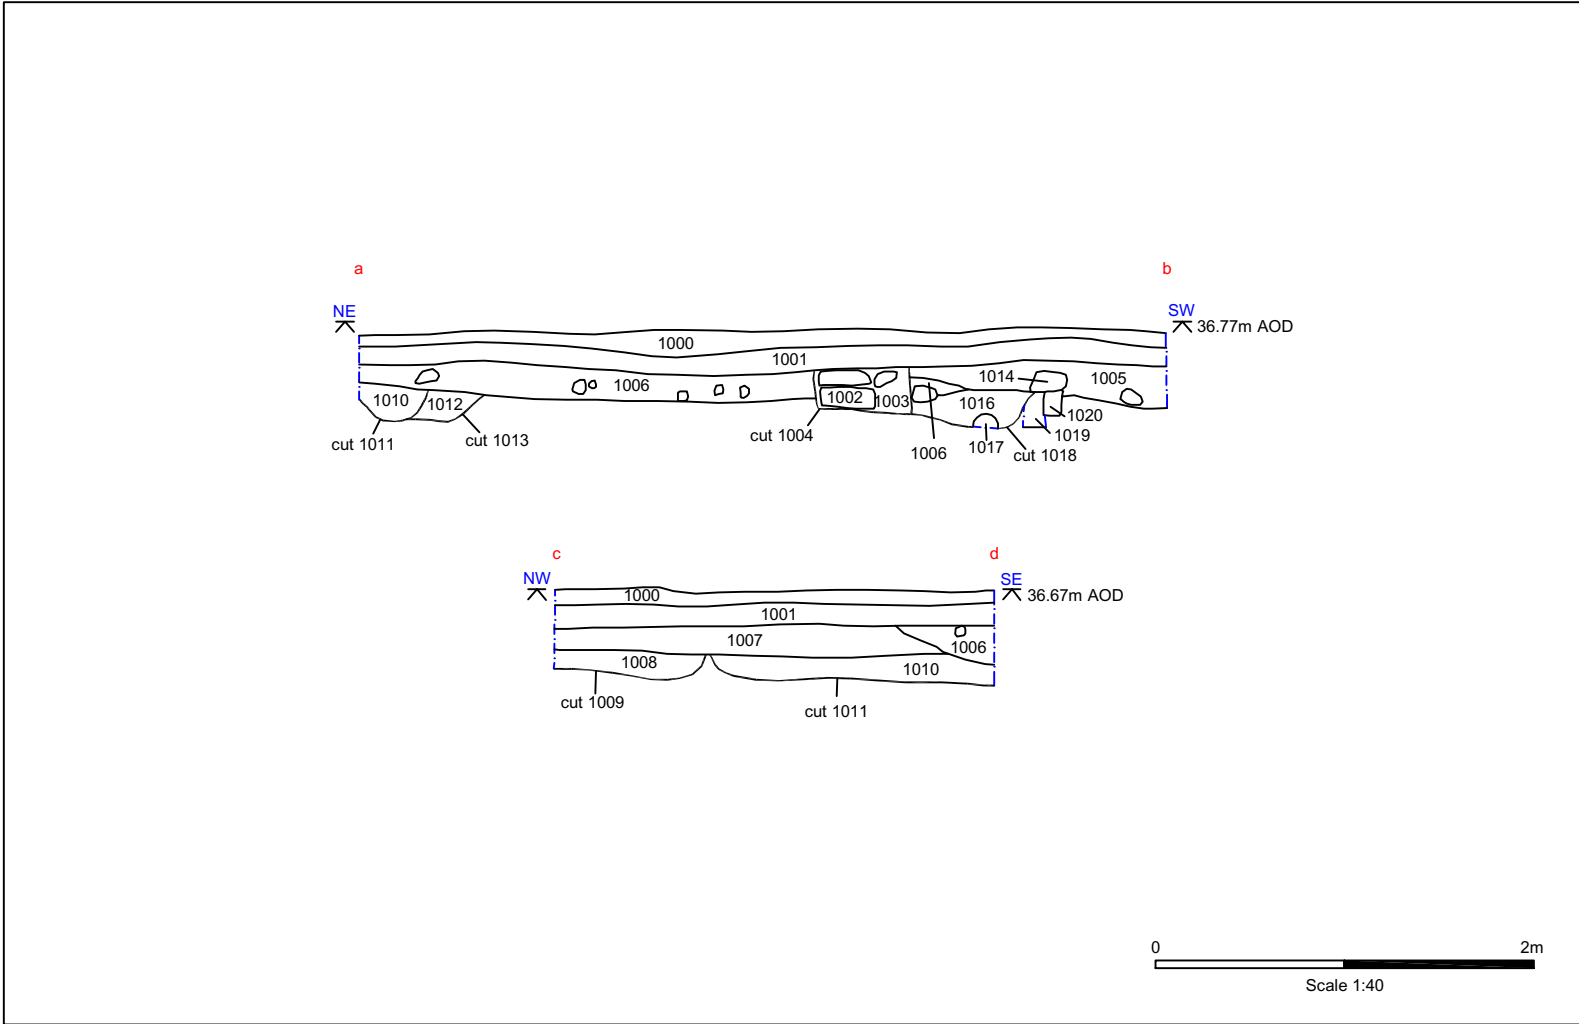
Figure 12. Evaluation Trench 1 Sections

7.1.5 The three undated cuts were overlain by three deposits: two of clay (1005 and 1007), and the other of rubble (1006). These deposits represented minor episodes of relatively recent dumping.

7.1.6 Wall 1004 was observed in the northern baulk of the trench, having terminated close to the limit of the excavated area. The wall survived as single course of mortared bricks, 0.30m in width, sitting within a construction cut (1004) that also contained Deposit 1003.

7.1.7 The entire trench was covered by a 0.10m thick layer of concrete (1000), and its rubble bedding-layer (1001).

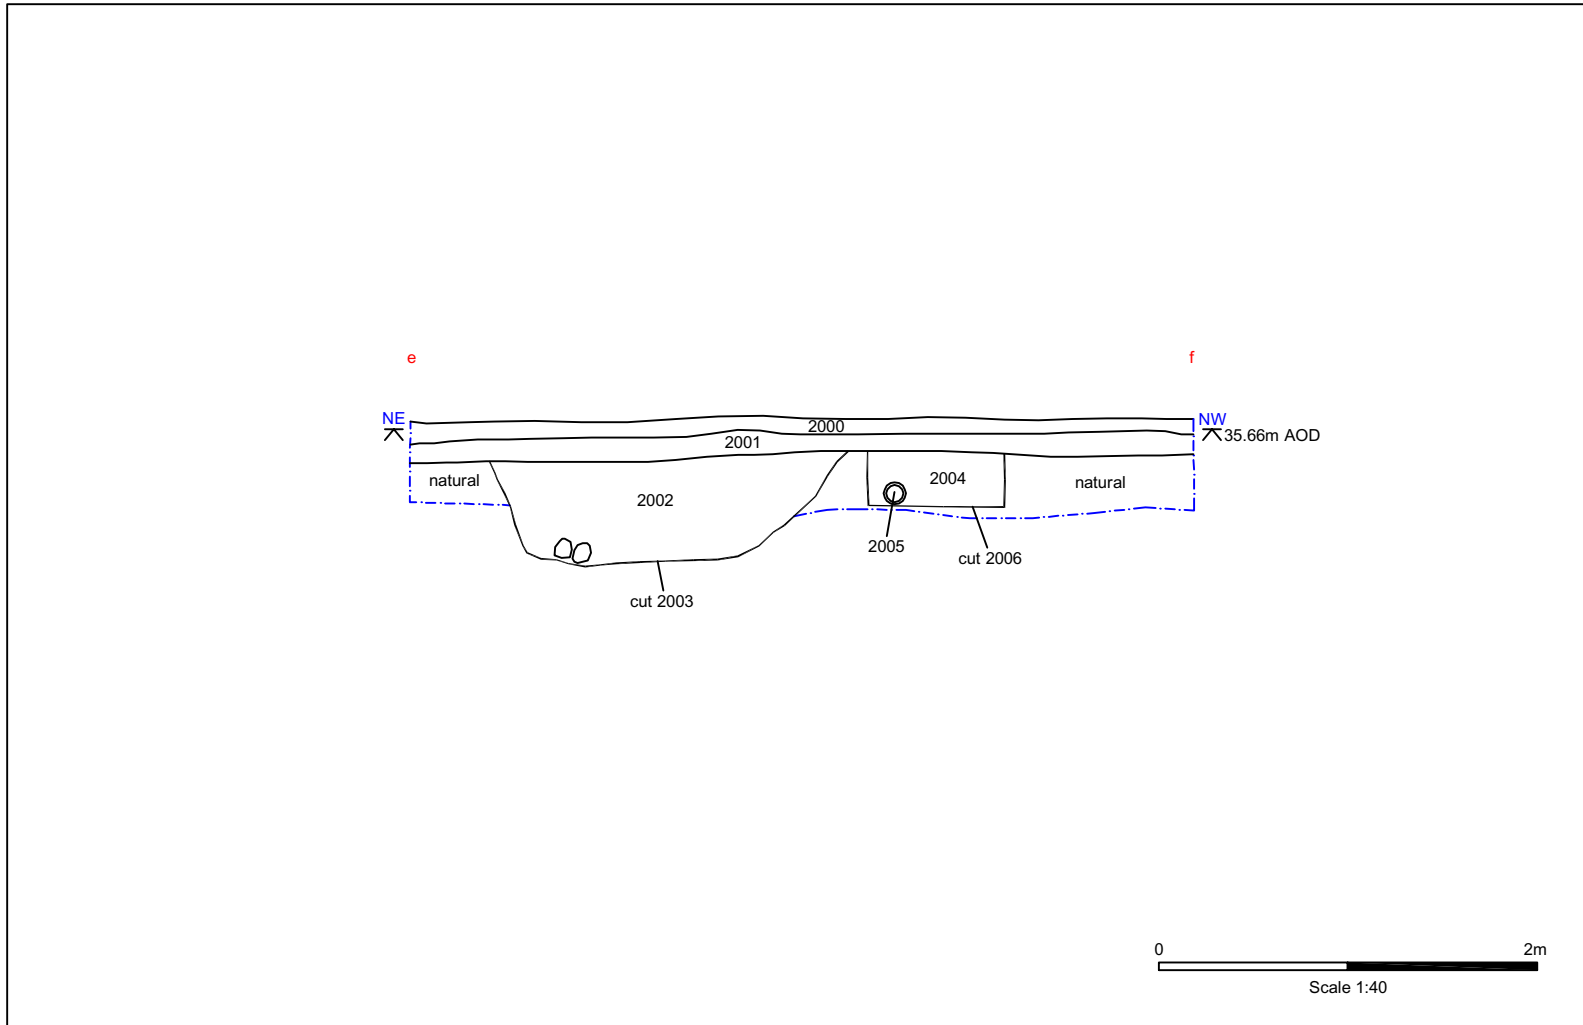
Figure 14. Evaluation Trench 2 Sections

7.2.3 A modern service trench (2006) was recorded in the trench's southern section, and contained a glazed ceramic drain pipe (2005) and a mixed deposit (2004). The sequence was completed by a deposit of hardcore (2001) that acted as bedding for the modern concrete surface (2000).

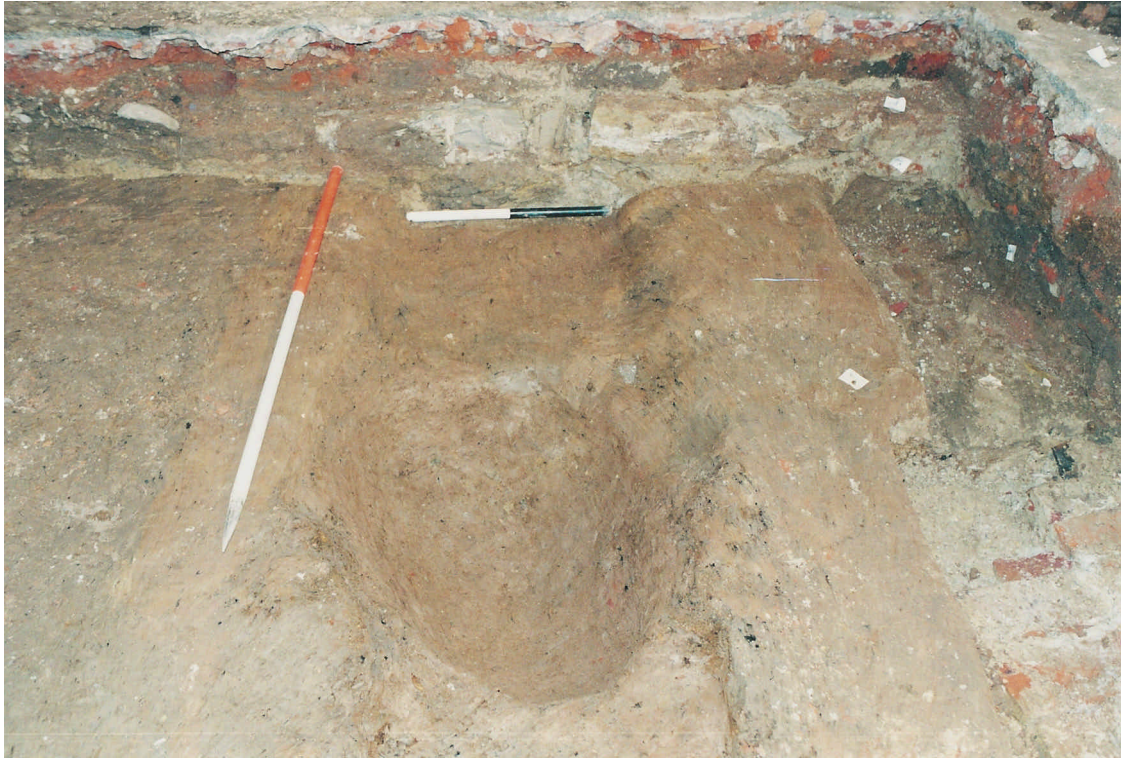
7.1.2 The three undated features lay at the north-east margin of the trench, and partly underlay the baulk. There were two pits (1009 and 1013) linked by a linear feature (1011); relationships between them were unclear, but they appeared to be contemporary. The features were shallow (between 0.07m and 0.11m deep), and filled with greyish brown clay (1008, 1012 and 1010 respectively).

Plate 1. Trench 1. Features 1009, 1011 and 1013. Facing North West

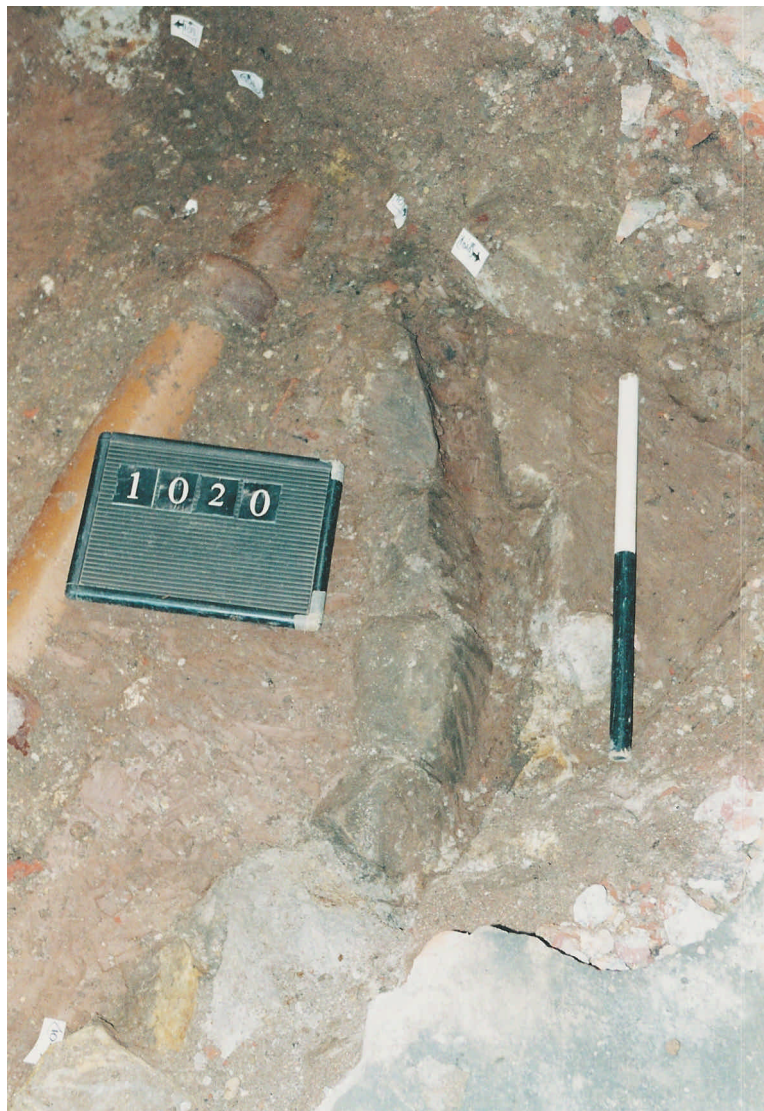
7.1.3 Drain 1020 ran across the south-western end of the trench on a rough east to west alignment. The drain consisted of flat limestone slabs, around 0.10m thick and 0.20m long, laid vertically to form a 0.20m wide channel. The slabs were bonded with brownish clay. The channel of the drain was filled by a deposit of grey clay (1019). There were no associated finds, but Drain 1020 was earlier than the ceramic drain (1018) described below.

7.1.4 Drain 1018 ran to the north of Drain 1020, and on a slightly more southerly alignment. It contained a salt-glazed pipe (1017), along with deposits of concrete (1016) and re-deposited clay (1015). A number of flat stones (1014) may have been disturbed capping stones from the earlier drain (1020).

Plate 2. Trench 2. Drains 1018 and 1020. Facing North West

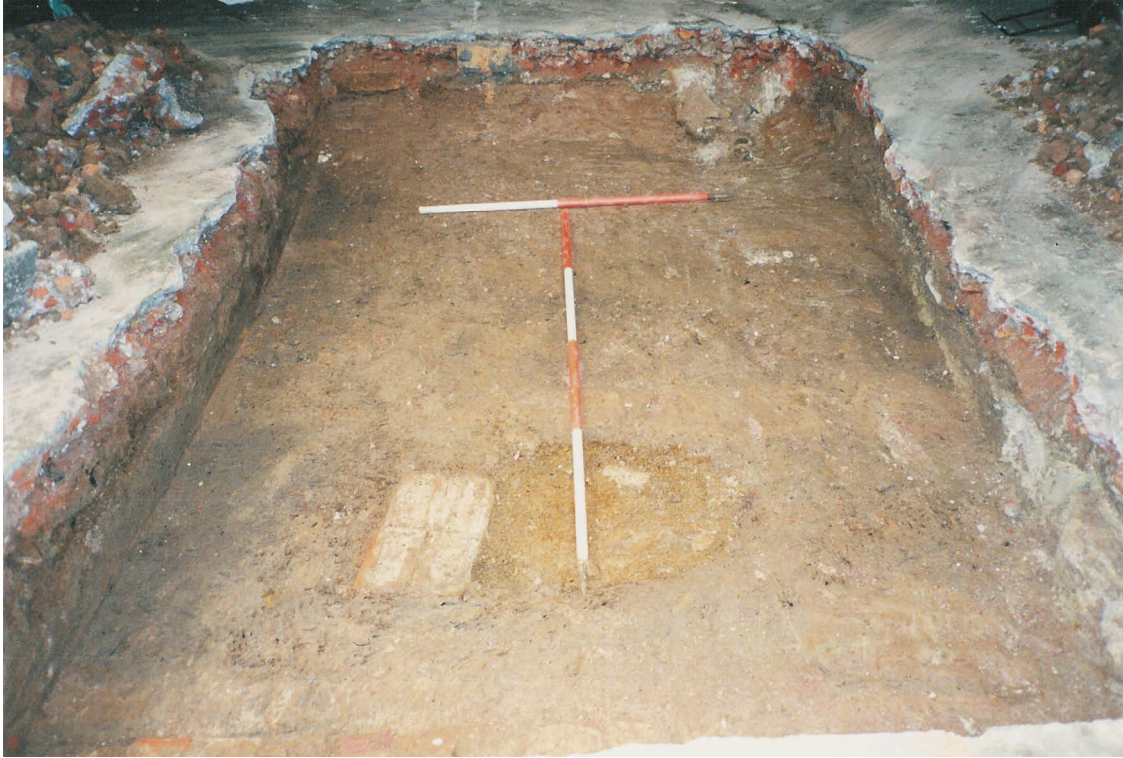
Plate 3. Trench 3. General View, Pre-Excavation. Facing South West

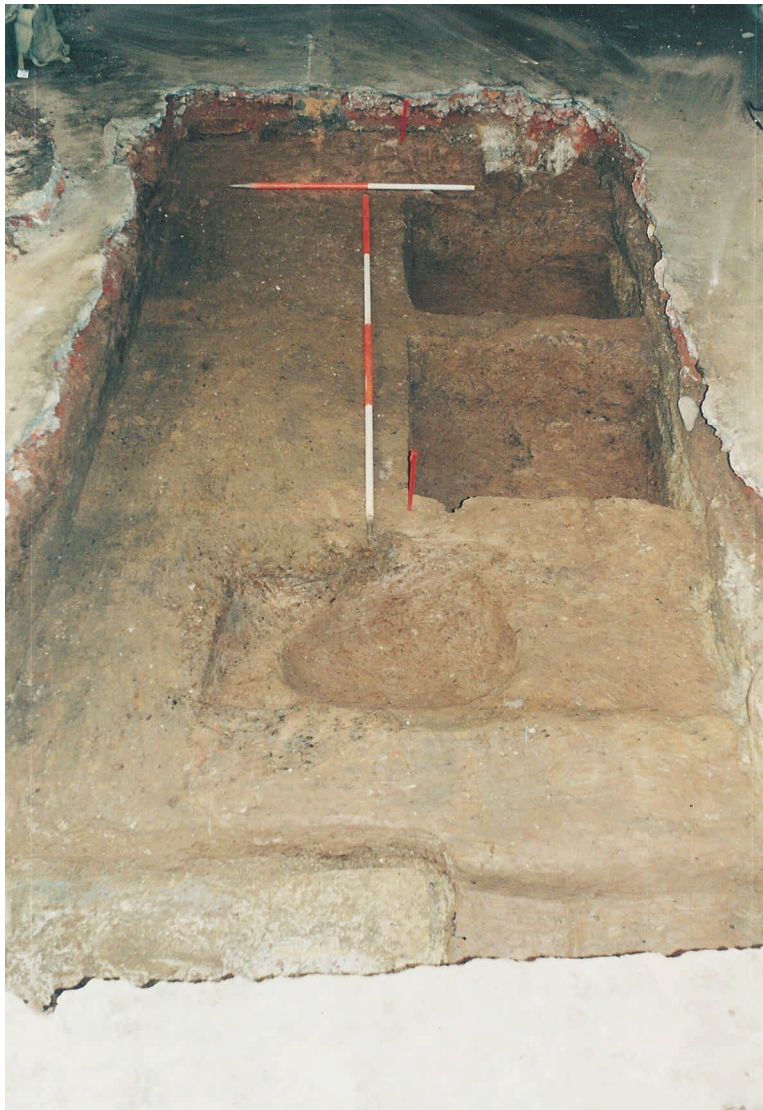
7.3.1 This trench was excavated in the south-eastern part of the site. Trench 3 was archaeologically the busiest of the excavated areas; in Phase A four parallel linear features (3009, 3011, 3016 and 3018) cut into the natural boulder clay, and were superseded in Phase B by two sandstone walls (3025 and 3019), and

Plate 4. Trench 3. General View, Post-Excavation. Facing South West

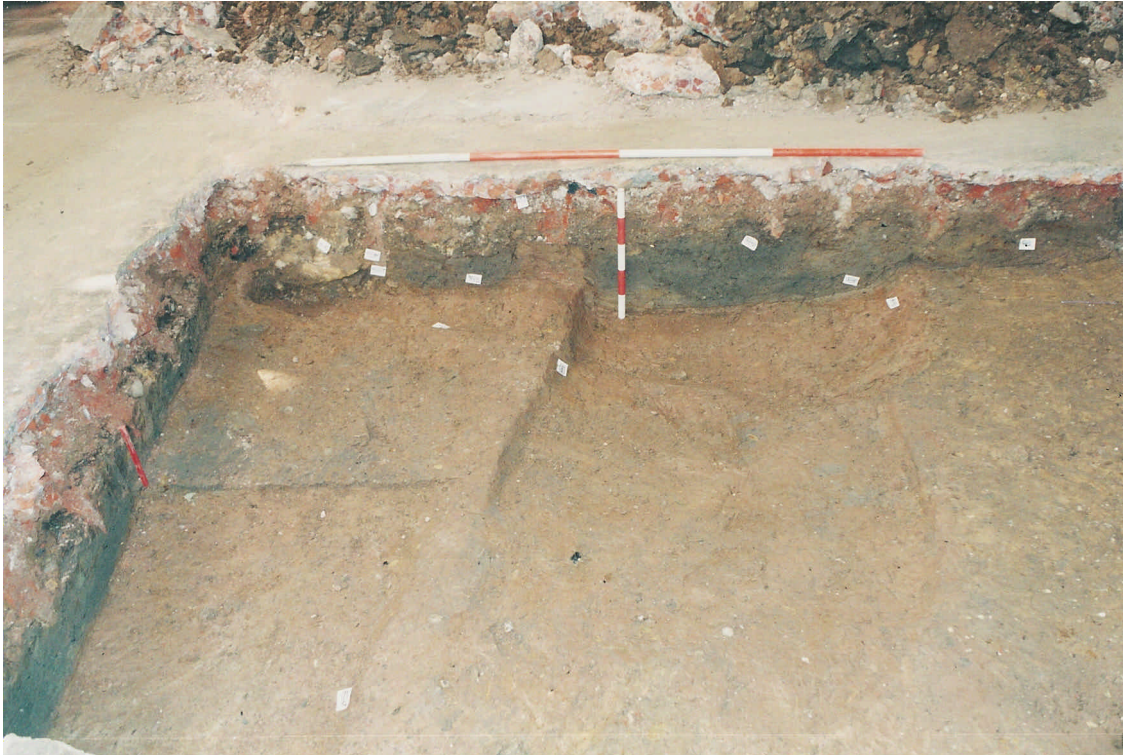
7.4.2 *Phase A (Fig. 19):* The stratigraphically earliest activity in Trench 4 was represented by two pits (4016 and 4017), and two postholes (4021 and 4022) that were situated at the western limit of the trench. Pit 4016 was c. 1.46m in length and 0.24m in depth. There were two fills, consisting of greyish brown clay (4012) at the base, and a darker silty clay (4025) at the top. There were no finds. Another rectangular pit (4017) continued the line of Pit 4016 to the south-west. It appeared to respect Pit 4016, and so is included at this point. Pit 4017 was 0.84m long, 0.36m wide and 0.22m deep. The fill (4013) consisted of grey plastic clay; there were no finds. The two postholes partly underlay the eastern baulk, and were truncated by a later linear feature (4005). The postholes were around 0.50m in diameter, with surviving depths of 0.21m (4021) and 0.26m (4022). Both fills (4014 and 4015) respectively were greyish silty clays, 4014 containing an early 18th century clay pipe fragment and a residual sherd of abraded Romano-British grey ware.

Plate 5. Trench 4. Pits 4016 and 4017, Linear Features 4005, 4006. Facing North West

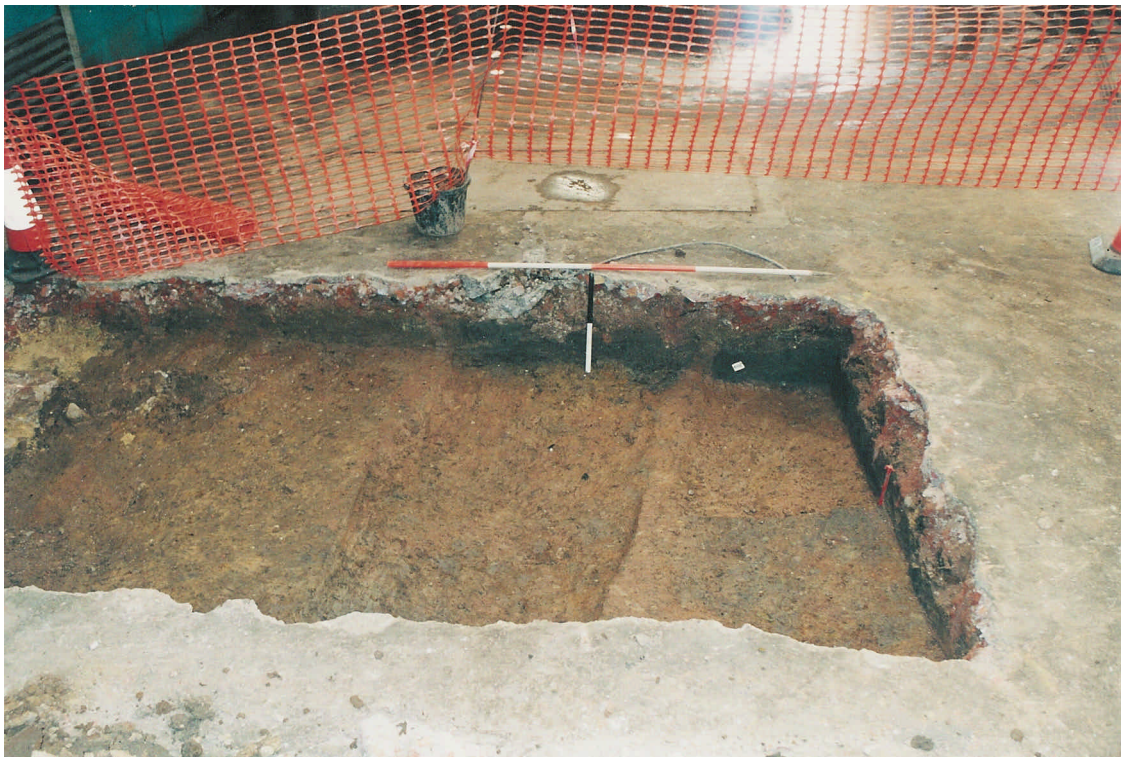
- 7.4.3 The northern edge of Pit 4016 was cut by a gully (4024) that ran on a north to south alignment across the north-eastern part of the excavated area. Gully 4024 was approximately 1m in width and 0.30m in depth. Neither the light yellowish brown clay lower fill (4023) nor the greyish brown upper fill (4003) contained any finds. Gully 4005, situated immediately to the south-west of 4024, also truncated Pit 4016. This gully had similar dimensions, and was filled by greyish brown clay (4002) and contained a sherd of Westerwald stoneware and two green glass bottle fragments, suggesting a late 17th/early 18th century date.

Plate 6. Trench 4. Linear Feature 4005. Facing South East

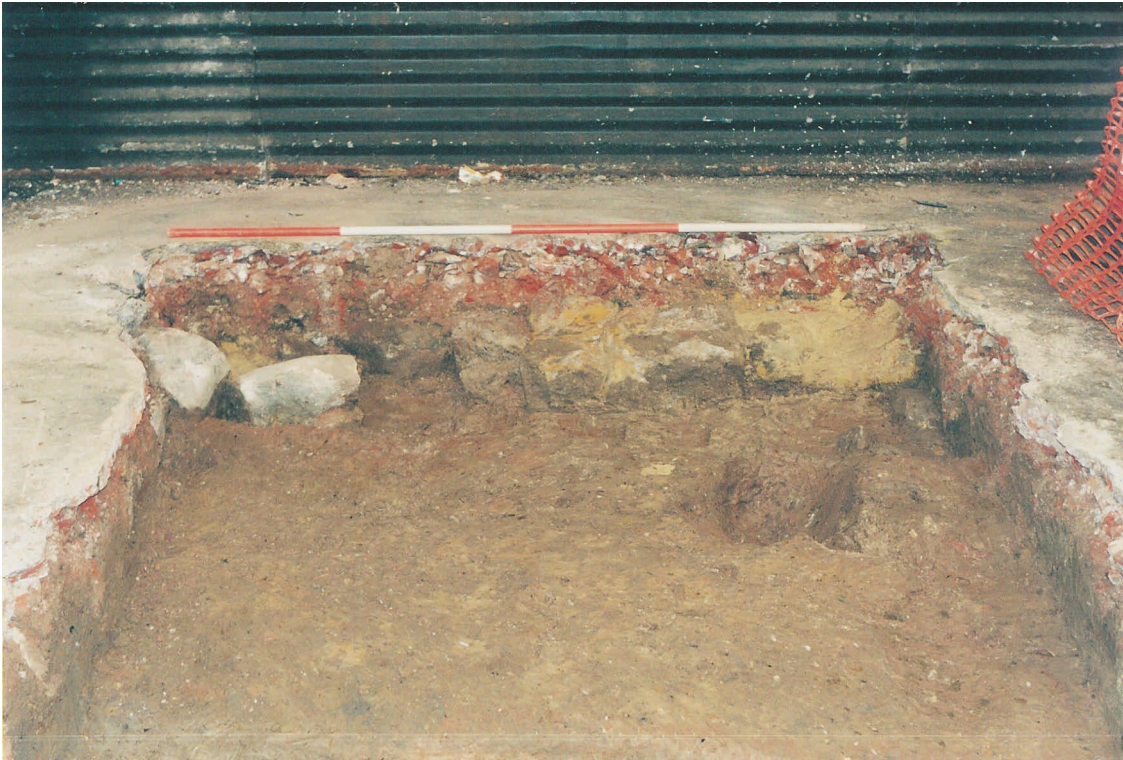
- 7.4.6 *Phase B (Fig. 20)*: Wall 4010 was composed of a single course of roughly squared un-bonded sandstone and limestone blocks. The lack of bonding shows that this was a foundation course, laid within a shallow construction trench (4011). The remainder of the construction trench was filled with greyish brown clay mixed with sandstone fragments (4009), which contained single fragments of green bottle glass and clay tobacco pipe, giving an 18th or 19th century date.

Plate 7. Trench 4. Wall 4010. Facing North East

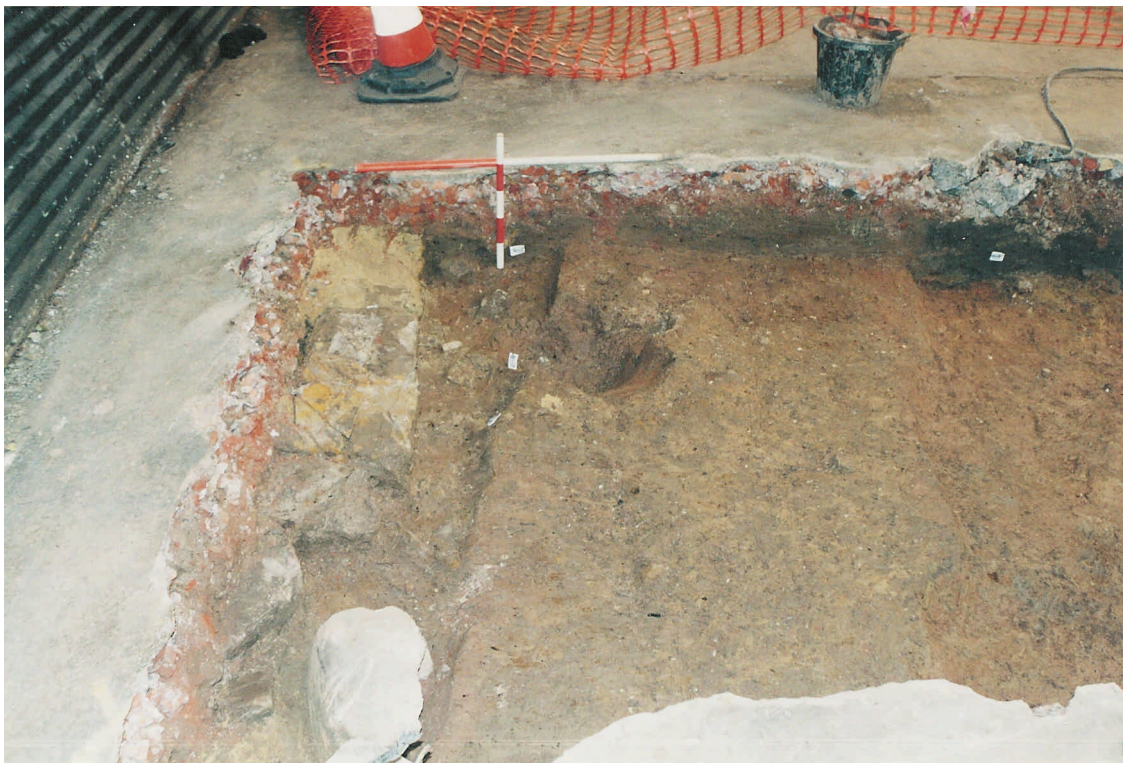
Plate 8. Trench 4. Wall 4010. Facing South East
