SCARBOROUGH ARCHAEOLOGICAL AND
HISTORICAL SOCIETY

WATCHING BRIEF REPORT

ROTUNDA MUSEUM
MUSEUM TERRACE
SCARBOROUGH

SITE ROTUNDA MUSEUM, SCARBOROUGH

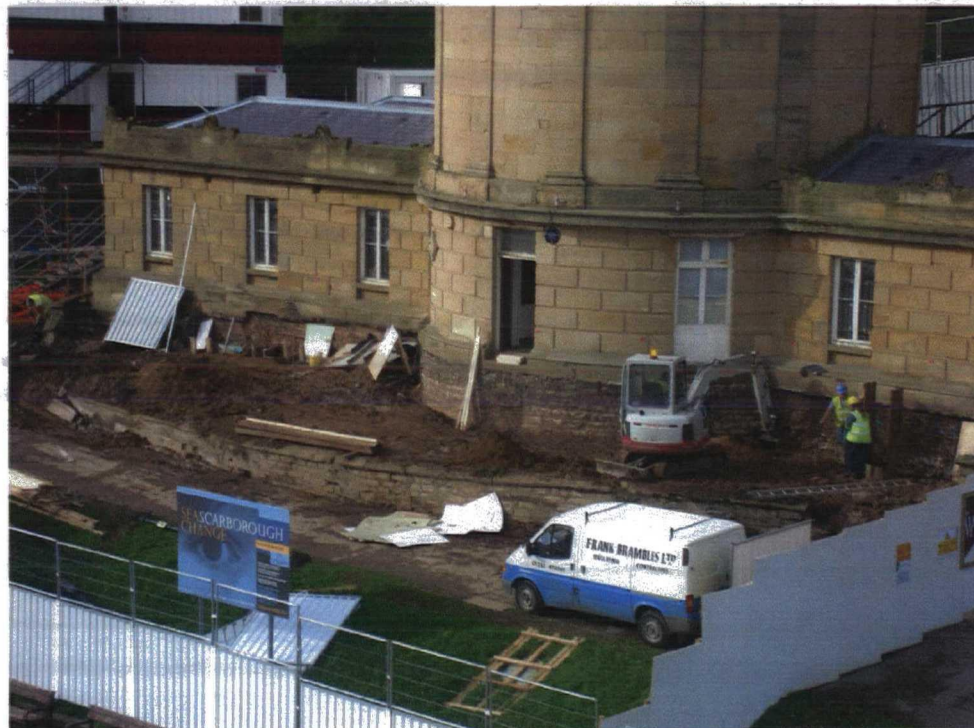
GROUND WORKS IN PROGRESS

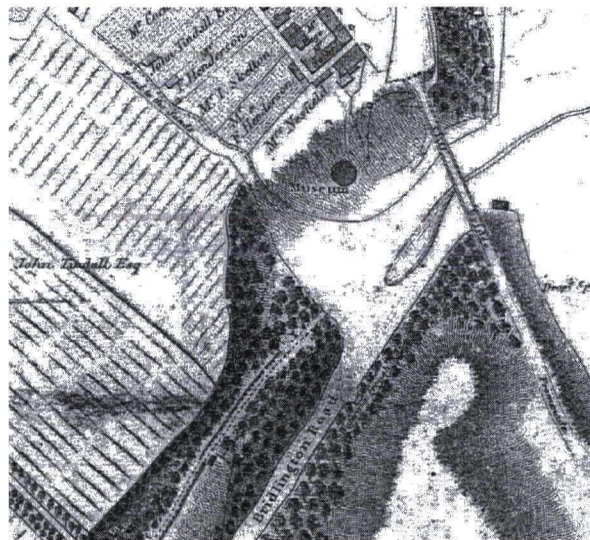
Figure 1 The Rotunda Museum in 1828 from John Wood's map

John Wood's map of 1828 shows the drum of the Rotunda in place although without the flanking wings which are a later addition. Museum terrace is not shown; again this is later. Woods map depicts the topography as a series of hachures indicating that the museum had been built into the steeply sloping cliff side. No other archaeological features are apparent from this map.
