SCARBOROUGH ARCHAEOLOGICAL AND
HISTORICAL SOCIETY

WATCHING BRIEF REPORT

WOOD END
THE CRESCENT
SCARBOROUGH

SITE **WOOD END , SCARBOROUGH**

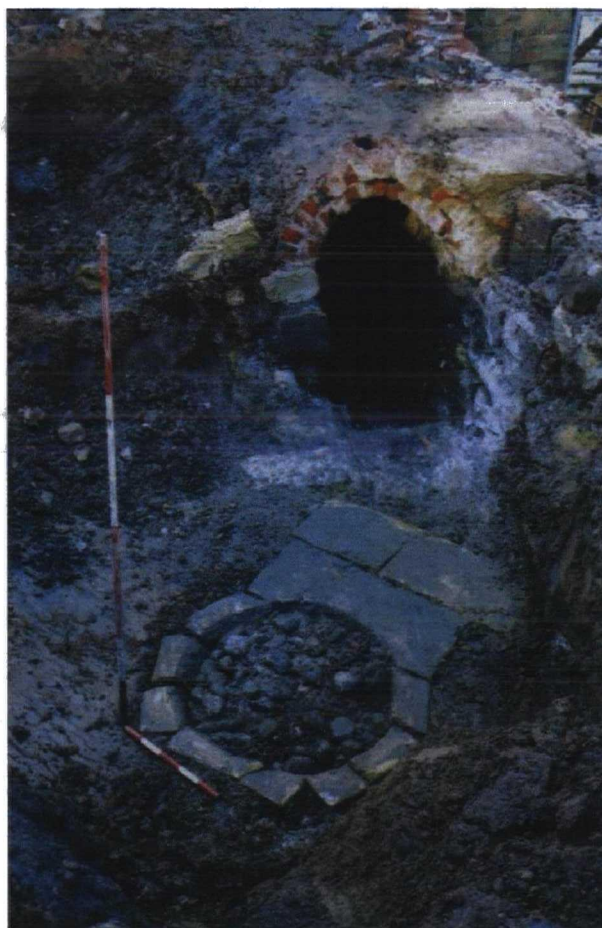
The base of the ice house and tunnel un-covered
during the excavation work

A circular footprint of shingle and pebble 1024 proved to be the upper part of the fill above F1025. F1026 was the stone threshold which led from the tunnel to the circular feature which proved to be the base of the ice house. F1028 revealed the circular sump of the ice house, the only remaining in situ feature left intact. - Photographs 9, 10 and 11 - Films XIX 6 & 37, XV 2, 11 & 25; F1027, 1032, 1035. The main features were a circular brick collar above a cut stone collar. These were in filled with oval natural cobbles set in a gravel, pebble mix over large heavy natural rocks which sat on a level layer of bricks bedded into a clay base.

century structural engineer and architect who moved to live in Wood End about 1836 and stayed until his death in 1856. Knowles may possibly have designed and built the house. He had done extensive civil engineering work in Dublin before moving to Yorkshire where he designed Sharow Church in 1825. The ice house had gone by 1892 and little remained its structure, indeed the previous existence of an ice house was virtually forgotten about. The arched brick and stone passage way leading from the cellar to the ice house and forming an access for transport of the ice to the kitchen service area in the cellar (under the conservatory), had survived. It was in remarkable condition, having been bricked up from the cellar area and covered over with a deep deposit of clay in the garden area. 4.5 metres along from this passage the central circular sump for the drainage of residue water from the ice mass, was intact.

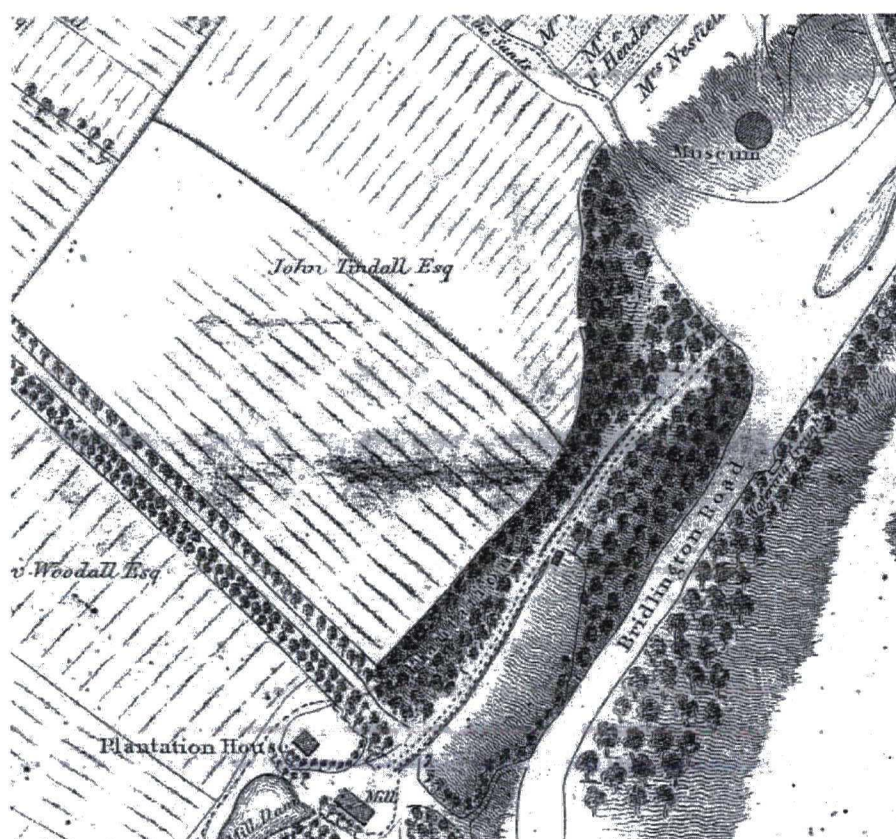
ANNEX 3

Extract from John Wood's map of 1828 showing the rigg and furrow

John Woods map of 1828 (Annex 3) is the first large scale one and this shows the site as part of two large fields apparently crossed by rigg and furrow but containing no obvious structures or archaeological features. This was not long before William and John Barry and John Uppleby acquired the two large fields from John Tindall, a Scarborough ship-builder and employed the York Architects Richard Hey Sharp and Samuel Sharp to design and lay out the area we now know as The Crescent. Building started in 1833 with the segment of terrace east of York Place now called Belvoir Terrace. The building of Wood End was started in 1835 (we know this from a pencilled inscription found under a floorboard during building works in 1948). It is a five bay, plain classical building with some Grecian details. It is shown on Tyson's map of 1842 but in no detail.

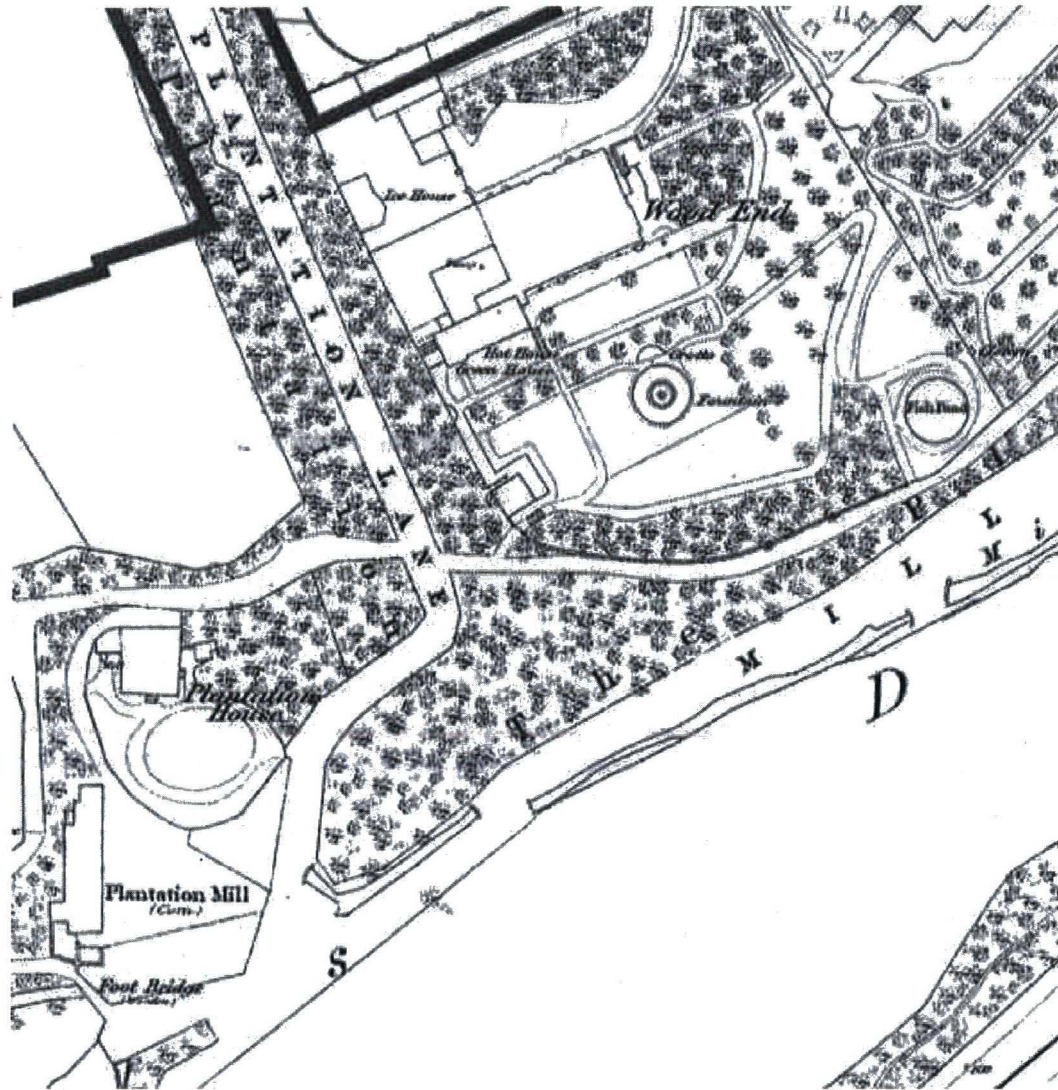
ANNEX 4

Extract from Ordnance Survey 1852 Scale 1:1,056

The ice house is clearly shown against the boundary with Plantation Hill
The pump within the then inner courtyard marks the position of the well F2001

The first map to show Wood End in any detail is the 1852 Ordnance Survey plan of Scarborough at a scale of 1:1056 (5' to a mile) (Annex 4). This shows what is referred to in the Conservation Plan as the rear service yard occupying the space between what was to become the vivarium and the north boundary wall to the site (the retaining wall to 15 The Crescent). The service yard was bounded to the east and west by walls which as part of this monitoring were given the context number F1003. The east wall already had its characteristic 'dog leg' which existed to the present day. The garden was occupied by a number of small structures or dividing walls – the map is not clear on this point – but critically in the south west corner an Ice House is

shown. The above ground dimensions of this from the map were approximately 7metres by 4.5metres

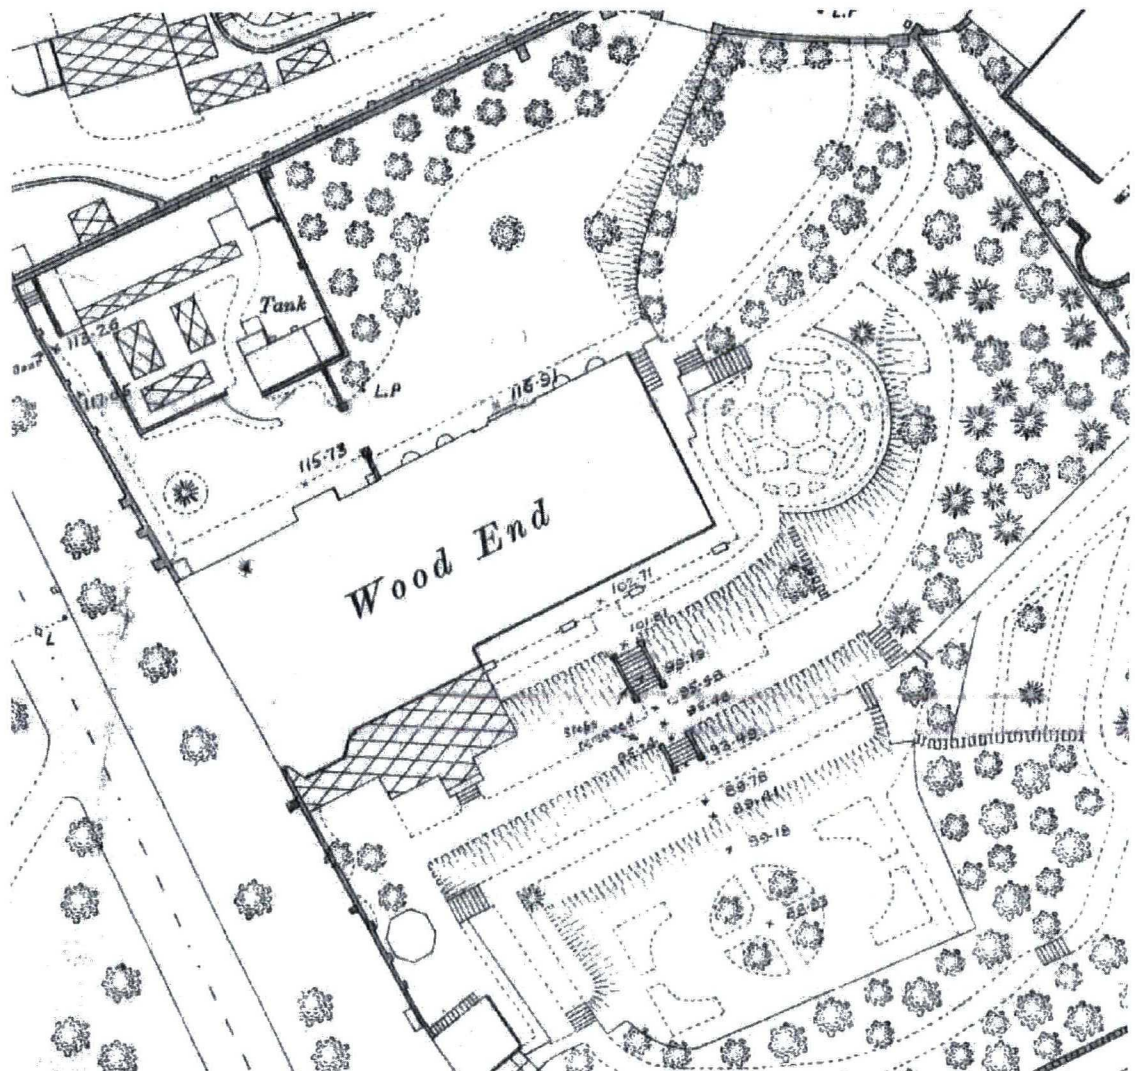
ANNEX 5

Extract from Ordnance Survey 1892 Scale 1:500

The ice house has gone and the rear service yard split into two the northern part surrounded by a wall and containing greenhouses, outbuildings and tanks

By the time of the publication of the 1892 Ordnance Survey plan at a scale of 1:500 (Annex 5) the ice house had gone. The garden had been divided into two with a cross wall to the south of one of the structures referred to above. The southern part of the garden (about a third) was presumably a kitchen garden judging by the layout on the map with a passage to the entrance gate in the west wall approached by steps. The new internal walls enclosed an area occupied by green houses (four) sheds and a tank.

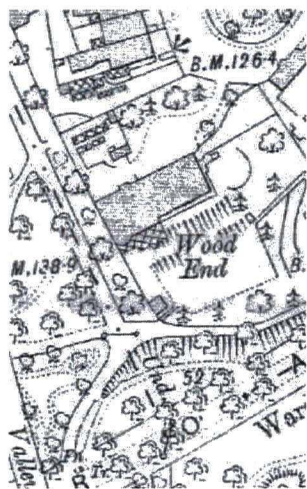
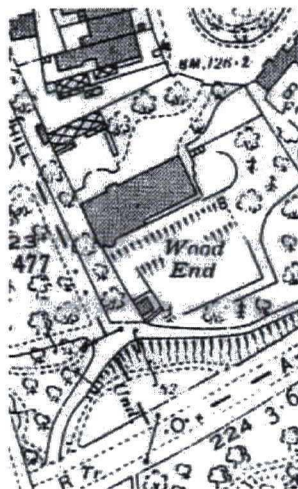
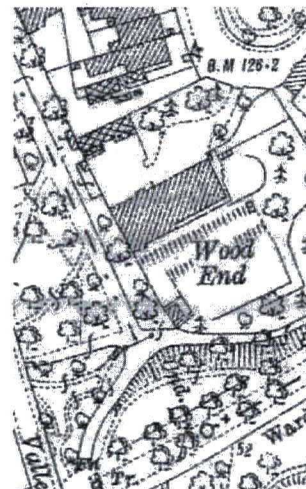
ANNEX 6

Extracts from 1:2500 scale Ordnance Survey maps of various dates

This form was still extant on the 1912 Ordnance Survey plan at a scale of 1:2500 although one greenhouse had gone, but by the time of the 1929 plan at the same scale the sheds, greenhouses and dividing walls had been swept away to be replaced by one large lean to greenhouse sited along the north boundary wall a situation which continued on the 1939, 1:2500 scale map (Annex 6) and the 1965, 1:1250 scale map and indeed until the greenhouse was demolished in 1994 (Annex 7).

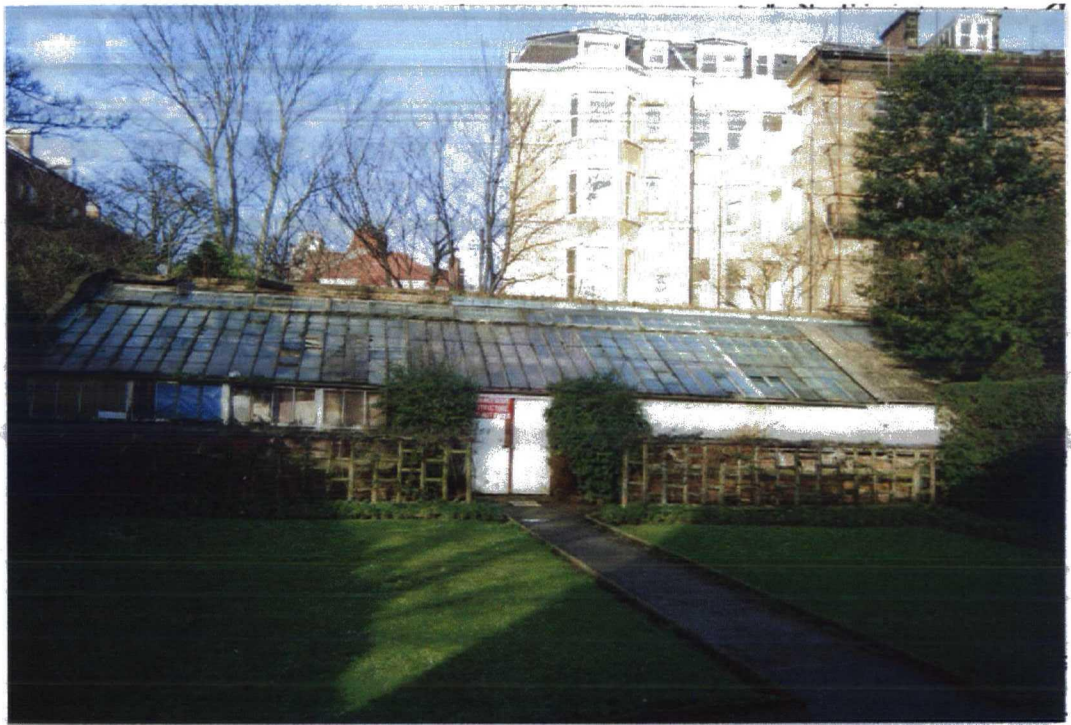
ANNEX 7

The rear garden in 1994 just prior to the demolition of the large lean-to greenhouse against the north retaining wall – this green house shown on the 1929, and 1939, 1:2500 scale OS maps and the 1965, 1:1250 scale map
