**44-46 Wheelgate  
Malton  
North Yorkshire  
SE 7877 7182**

**Archaeological Evaluation**

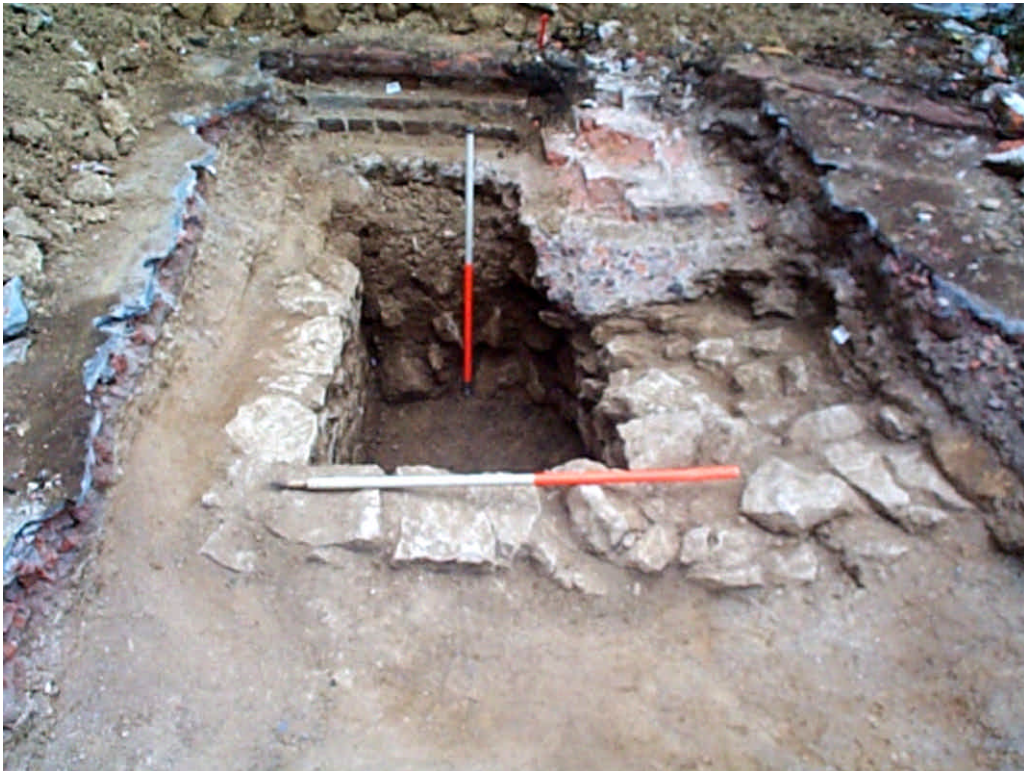
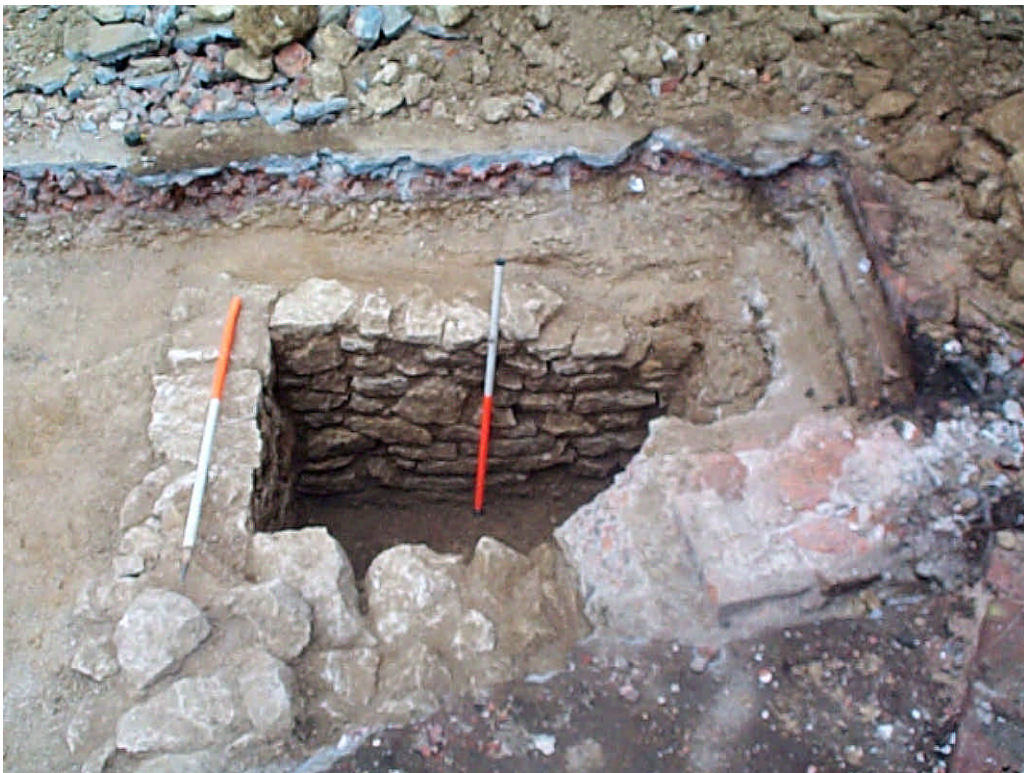
7.1.2 Wall 1010 ran on north-south alignment and extended beyond the northern limit of the trench; Wall 1011 formed its westward return, and extended beyond the western limit of the trench. Both walls were around 0.20m wide and composed of roughly squared limestone blocks, weakly 'bonded' with brown silty soil. At least ten courses were present, giving a height of c. 0.85m. The pit defined by the structure was not bottomed due to safety considerations. It was filled with layers of rubble (1003, 1005, 1006, 1007 and 1009), along with deposits of largely stone-free silt (1004 and 1008). Rubble deposit 1009 had the appearance of having been carefully laid, almost in courses, but was not interpreted as structural as it lacked the coherence of the other structures. Finds consisted of two 12-14<sup>th</sup> century Staxton ware sherds from Deposit 1007.

- 8.2 The stone-walled sunken chamber (1010) recorded in Trench 1 is paralleled by the Structure 4061 uncovered at the adjoining site in 2003 (42 Wheelgate - MAP 2003). Both of these structures were constructed flush up to the face of large pits sunk into the ground. At 42 Wheelgate the structure was tentatively interpreted as relating to a drainage system. At 44 Wheelgate, Structure 1010 was at least 2m wide and 2m long, with a depth in excess of 1m – which would be massive dimensions for a culvert. Given that there was no evidence that the interior walls had been sealed to make them waterproof, and that the structure was deliberately backfilled with rubble rather than deposits that were water-borne or organic in nature, the possibility is that a cellar is represented. Medieval *camerae* or cellars are known locally, e.g. the excavated example at Wharram Percy (Andrews and Milne eds. 1978), and indeed one need look no further than the cellar of the Cross Keys Inn, almost directly opposite the site on the western side of Wheelgate (Robinson 1979, no. 166). Although the

- 8.3 The dating of Structure 1010 is securely provided by the two sherds of 12-14<sup>th</sup> century Staxton ware found within one of the backfill layers. The sherds are large, unabraded and join together – factors that indicate that they became buried in the cellar soon after being broken.

**Plate 1.** Trench 1. Structure 1010/1011. Facing North

**Plate 2.** Trench 1. Structure 1010/1011. Facing West

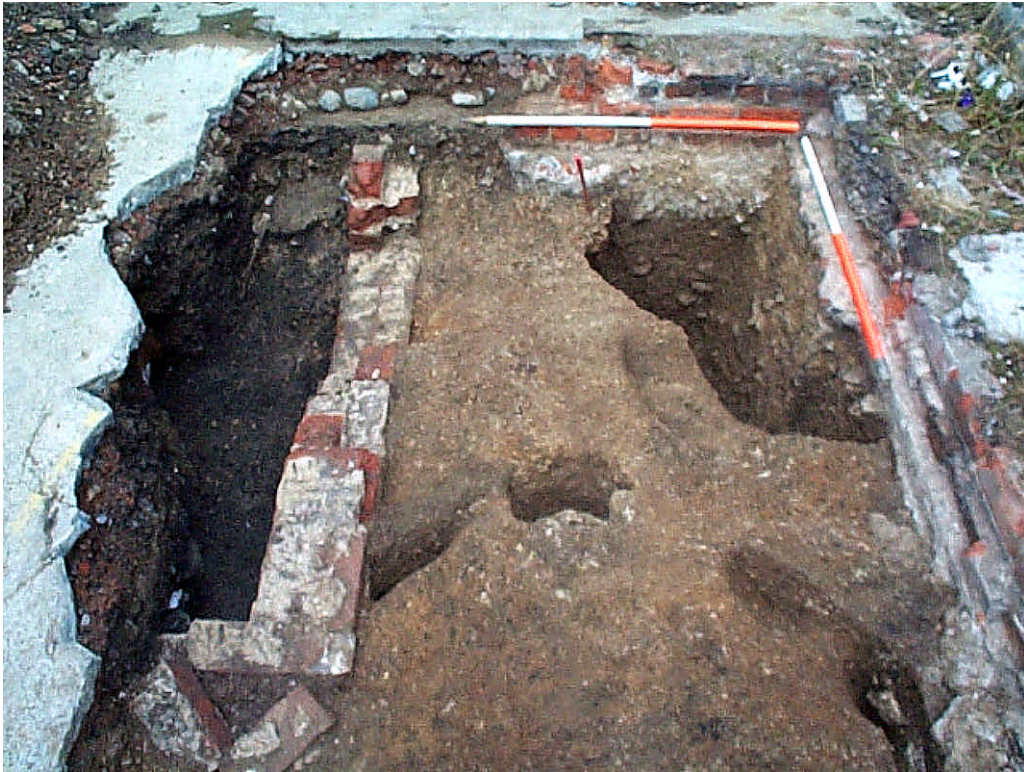
7.2.1 Trench 2 was located in the central part of the proposed development area. Machining ceased at the surface of the yellowish brown coarse sandy silt natural, which was cut by a medieval pit (2019) and two undated (possibly medieval) postholes (2023 and 2025). There were also a number of relatively recent brick walls and drainage features.

**Plate 3.** Trench 2. General View. Facing West

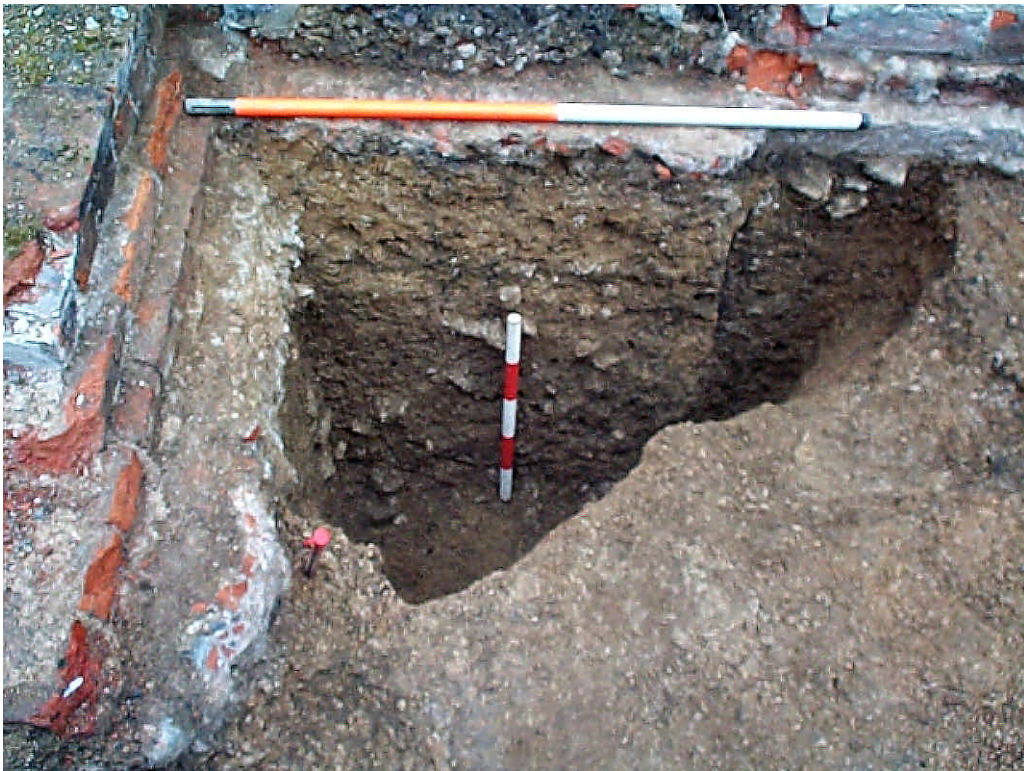
7.2.2 Pit 2019 was situated in the north-western part of the trench and was truncated on its western and northern sides by later concrete foundations. The surviving segment of the pit was 1.30m long and 0.50m wide; it was excavated to a depth of 0.70m, but full excavation was not possible due to the narrowness of the pit. The pit's edges were vertical and it was filled by a mixed deposit of dark greyish brown silty coarse sand, interspersed with occasional lenses of slumped natural. Finds were represented by 12/13<sup>th</sup> century sherds and animal bone fragments.

**Plate 4.** Trench 2. Pit 2019. Facing North

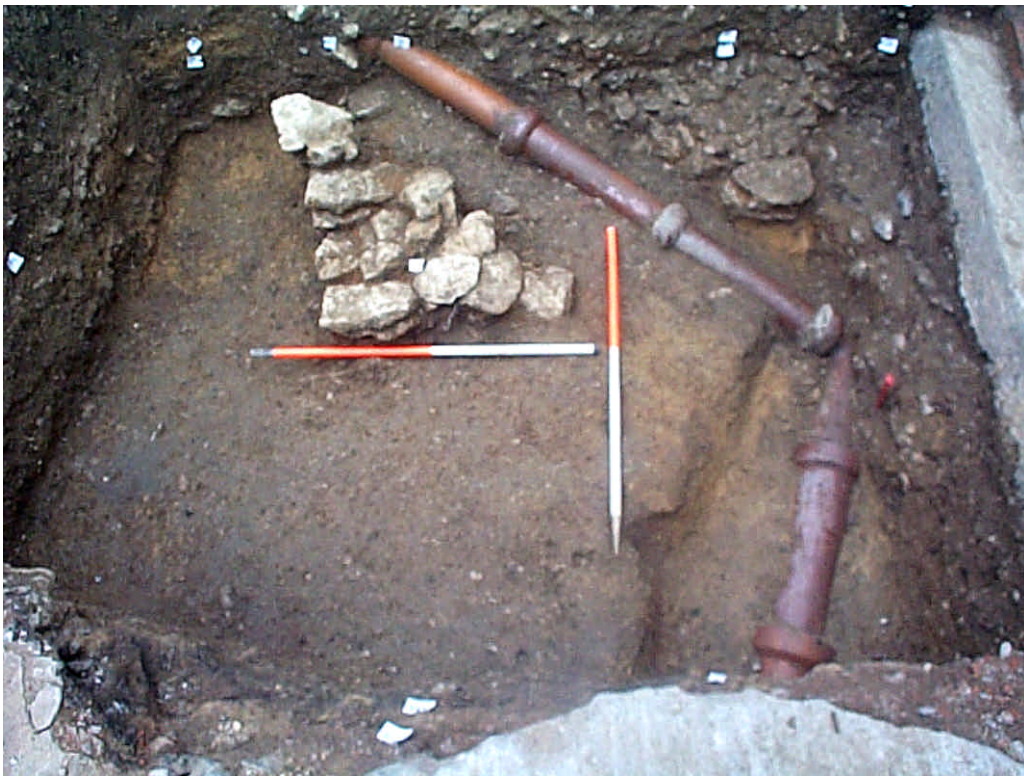
- 7.3.4 The next phase of activity marked a definite change from the previous pit-digging. A limestone wall (3013) was erected over the filled-in pits. Although Structure 3013 was severely cut away by later service trenches, enough remained to show that it was aligned roughly south-east to north-west (i.e. approximately in line with the present site boundaries), and that it returned to the north (where its remnants were recorded as 3025). The structure consisted of a maximum of three courses of roughly squared limestone blocks, randomly coursed and bonded with brown silty clay. The individual blocks were around 0.28m long, 0.14m wide and 0.08m high. A group of randomly laid limestones (3024) butted up to Structure 3025 from the west; to judge by the small extent that had survived truncation within the excavated area it is likely that this represented a rubble infill within the structure, perhaps as bedding for a floor or surface.

**Plate 5.** Trench 3. Structure 3013/3025 and Deposit 3024. Facing West

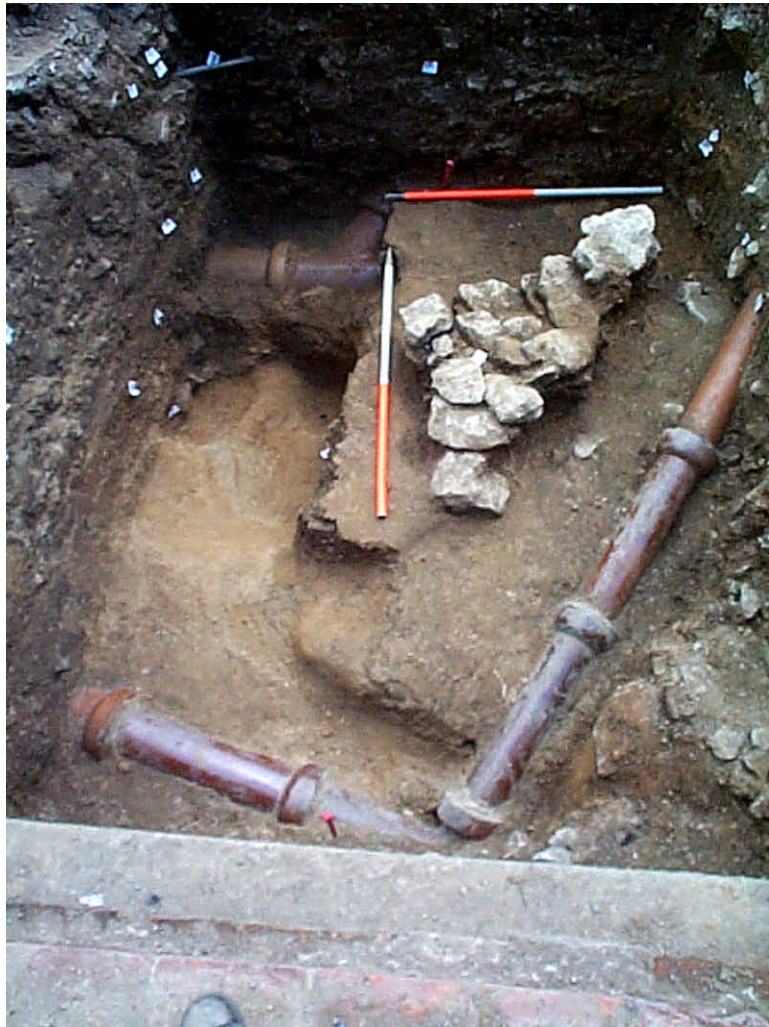
- 8.5 As at 42 Wheelgate, the site showed evidence of stone-walled medieval buildings (Trench 3, Structure 3013). Although badly truncated by modern drains, enough survived to suggest that Structure 3013 was a dwarf wall that supported a timber superstructure. The undated postholes found in Trench 3 hint that there were post-built structures also at the site. Alternatively, they could represent internal divisions within stone-walled buildings.

**Plate 6.** Trench 3. Structure 3013/3025 and Pits 3031 and 3025. Facing South
