***ARCHAEOLOGICAL WATCHING BRIEF at
TRINITY TOWER, MARKET PLACE,
RICHMOND, NORTH YORKSHIRE***

A report to the Richmond Town Manager

In connection with planning consent 1/92W/1261D/FULL

1st November 2006

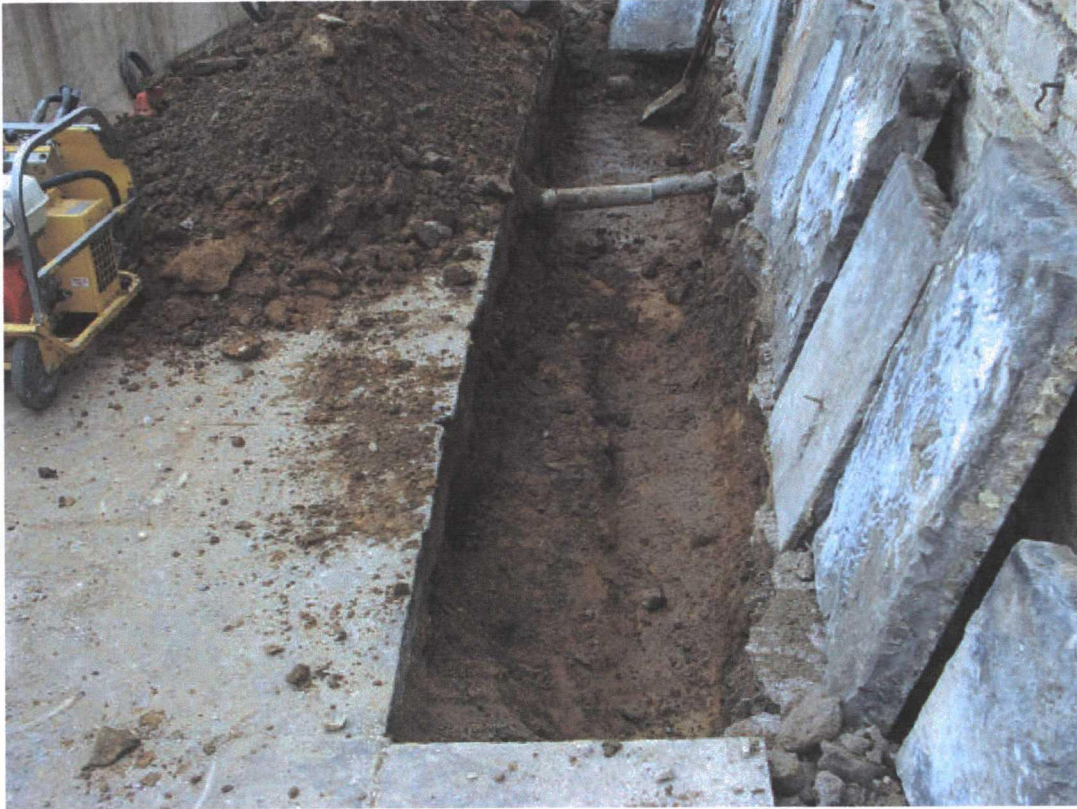
Fig. 2

A continuous watch was kept during the excavation of a trench around the southern, western and northern sides of the tower. Results were everywhere consistent. Very substantial paving slabs were removed; these were up to 10 cms thick, and overlay a further 10-12 cms of concrete. This overlay a black, dirty deposit, 20 cms thick, of clay loam mixed with ash, cinders and other rubbish, containing 19th/20th century chinaware and bottles. This in turn directly overlay the natural undisturbed subsoil, a rather sandy orange clay. Trenches were excavated to a total depth of 60 cms.

Typical trench, showing natural clay at bottom.
