WALLERTHWAITE FARM

MARKINGTON

ARCHAEOLOGICAL WATCHING BRIEF

REPORT
DECEMBER 2005

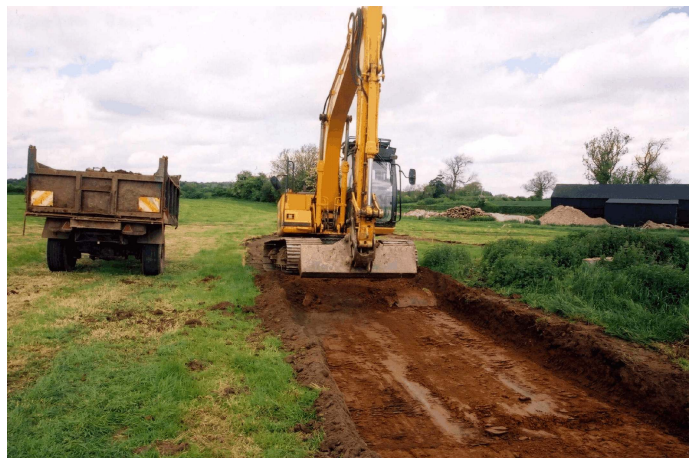
Plate 1 Topsoil removal along access road

A fairly uniform layer of topsoil allocated C1000 was removed over the entire length of the forked access road (Figure 2, Plate 1, Table 1). It consisted of a friable dark greyish-brown sandy clay with occasional mixed pebbles, rare fragments of ceramic building material (CBM) and charcoal flecks. The layer was heavily disturbed by root action, but was consistent to a depth varying between 0.2m and 0.5m. C1000 overlay an overburden (C1001) of reddish-brown sandy clay with inclusions of large rounded cobbles, frequent angular stones and rare flecks of charcoal and limestone. Towards the northern end of Intervention 1, the topsoil layer had been heavily disturbed and contained large reinforced concrete lumps, CBM and modern metal debris. No archaeological remains were evident within this area, and natural subsoil was not encountered.

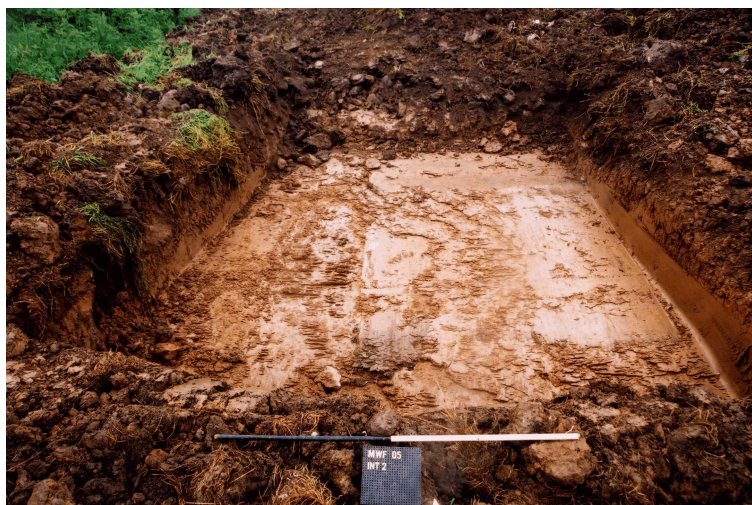
Plate 2 Possible subsoil in Intervention 2

0.4m in depth. Following the removal of C1003, a possible natural subsoil (C1004; Plate 2) was encountered made of a dark reddish-brown clay with occasional angular gravel and cobbles and was seen to a depth of 1.7m in section. No archaeological remains were encountered during monitoring.
