**Westfield Way  
Norton  
North Yorkshire  
SE 8049 7169**

**Archaeological Evaluation Report**

*Nine evaluation trenches were excavated in December 2006 at land to the east of Westfield Way, Norton, North Yorkshire, in order to evaluate the archaeological potential of the site in advance of development for warehousing and light industry.*

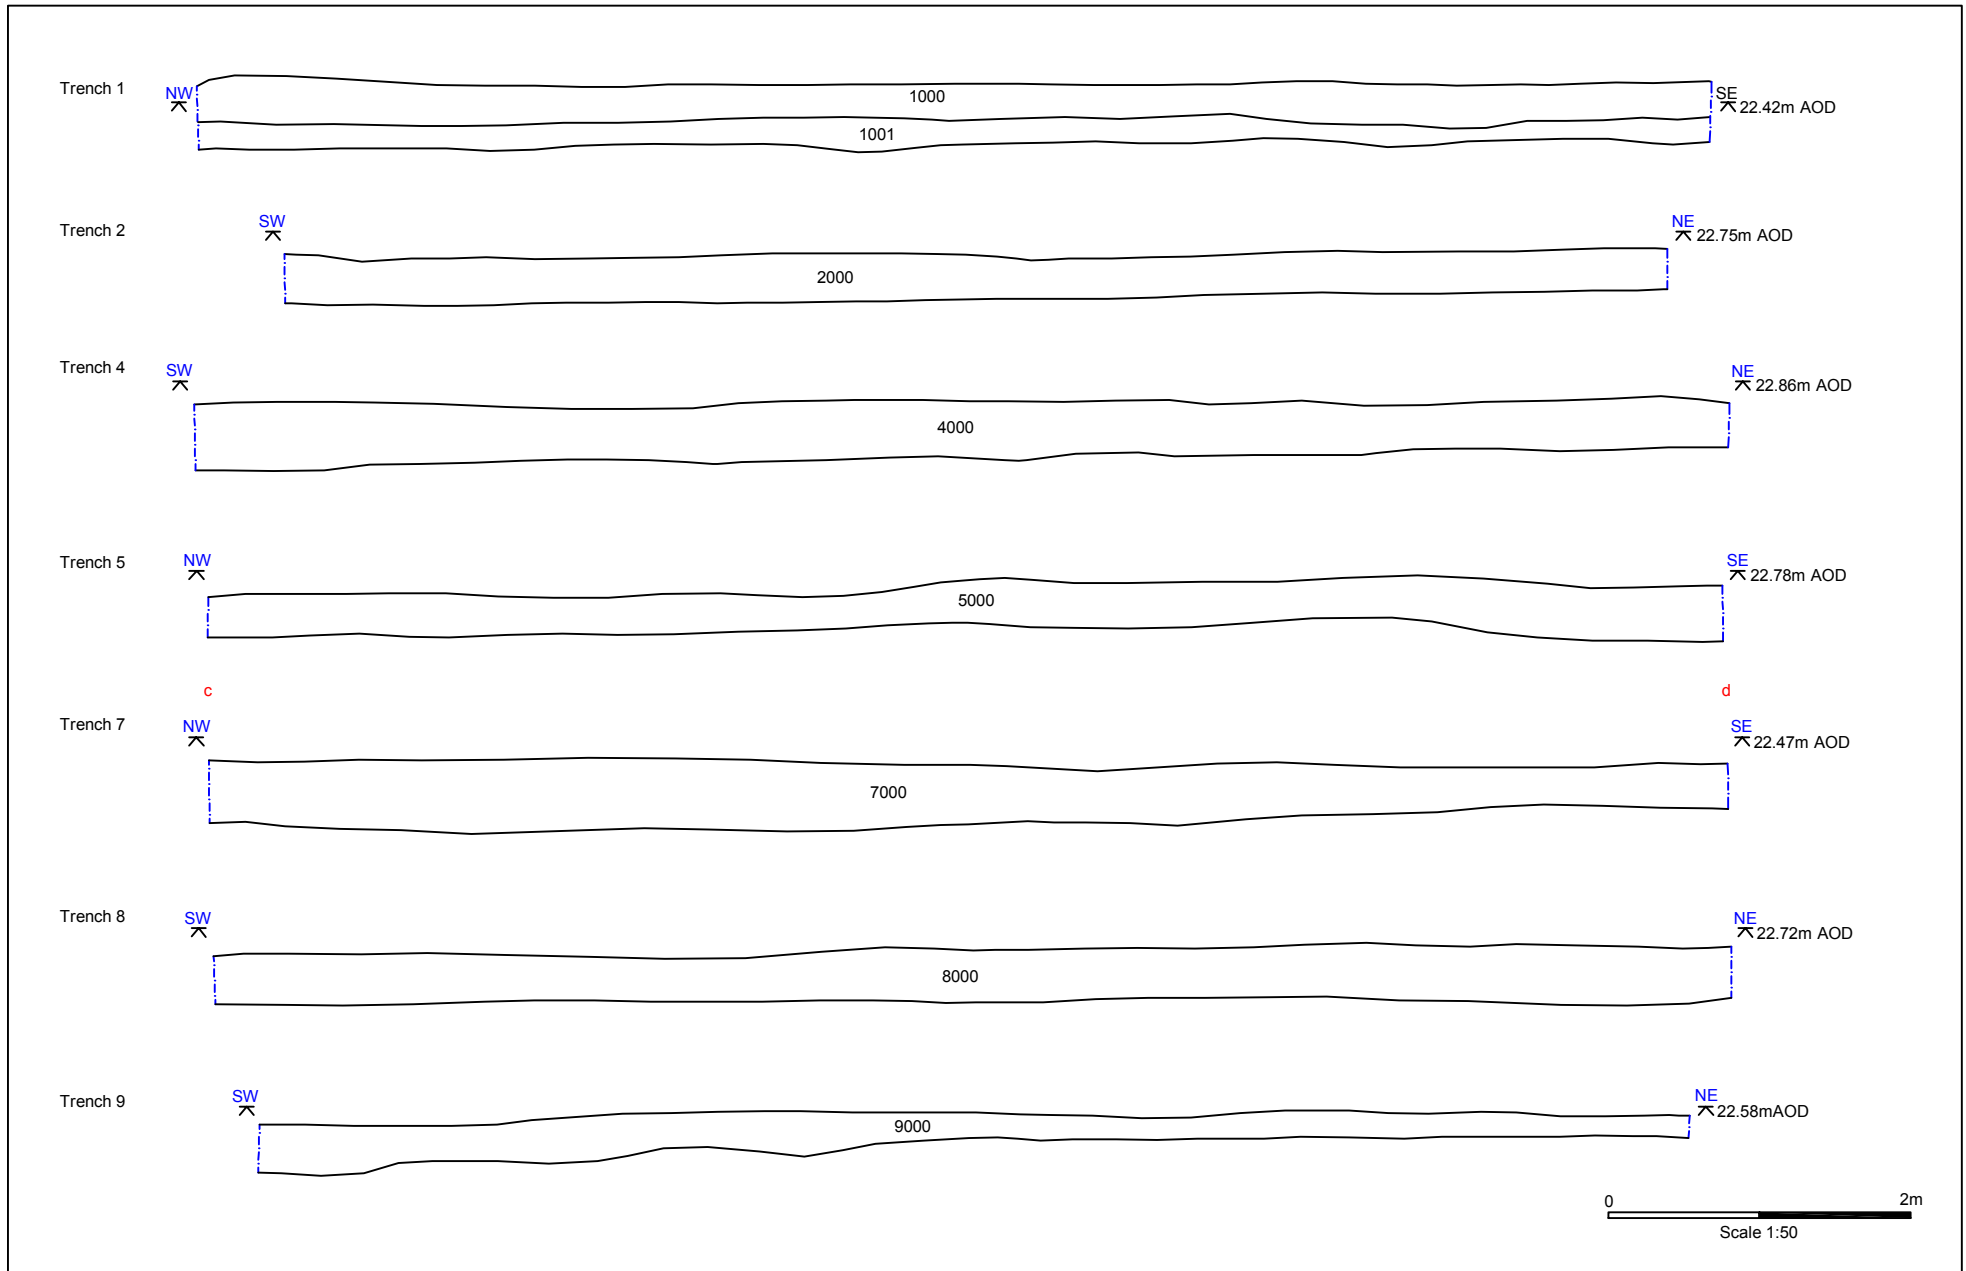
**Figure 5.** Trenches 1-2, 4-5, and 7-9 Sections

7.1.2 No archaeological features were present, either cutting, or above, the natural, which was overlain by a 0.20m deep yellowish brown sandy silt subsoil deposit (1001). The remainder of the trench was covered by a 0.26m deep modern ploughsoil (1000). There were no finds.

7.2.2 The natural clay was sealed by a 0.28m deep layer of modern ploughsoil (2000). There were no finds.

7.4.2 No archaeological features or finds were present, the natural being covered by a 0.30m deep layer of modern ploughsoil (4000). There were no finds.

7.5.2 The only features present in the trench consisted of a ceramic land drain (5001) and a deep modern plough scar (5002) that ran on a parallel north-south alignment along the length of the trench. A 0.28m deep layer of modern ploughsoil (5000) overlay the natural. There were no finds.

7.8.2 The natural deposits (8001) consisted of yellowish brown clay that was firmer and more plastic than that in the other trenches, occurring at an elevation of c. 22.20m AOD. The only features present consisted of northwest-southeast aligned modern plough marks. The natural deposits were masked by a 0.28m deep layer of modern ploughsoil (8000).

7.9.2 No archaeological features or finds were present. Modern plough marks scarred the surface of the natural, and ran parallel to the adjacent hedge. The entirety of the trench was covered by a 0.30m deep layer of modern ploughsoil (9000).

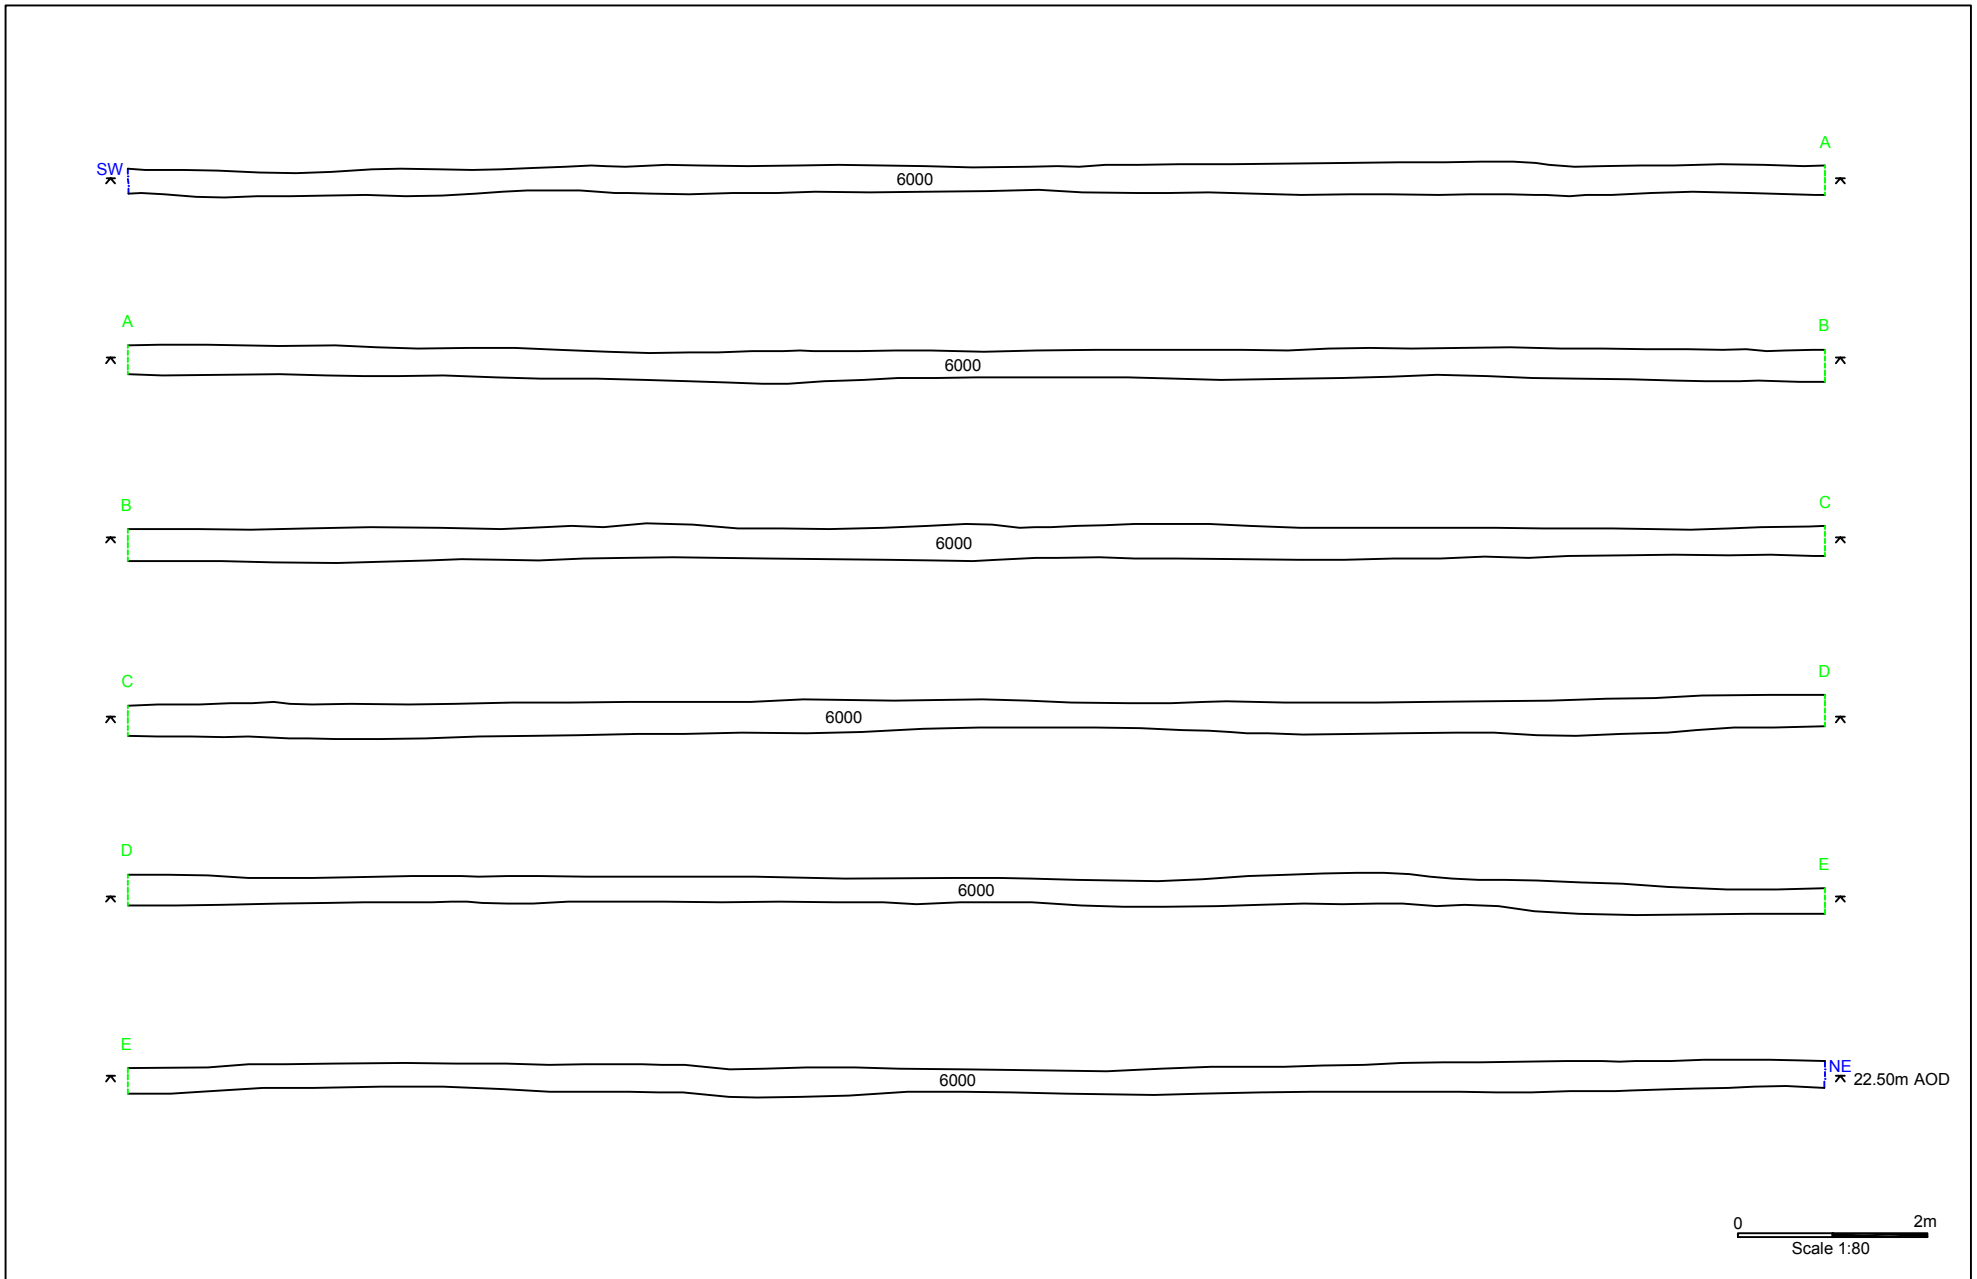
**Figure 6.** Trench 6 Section

7.6.2 Natural deposits consisted of yellowish brown silty clay (6001) with lenses of chalk gravel, were located at an elevation of c. 22.30m AOD. No archaeological features were present, the surface of the natural being broken only by two ceramic field drains and occasional modern plough scars. The entire trench was covered by a 0.30m deep layer of modern ploughsoil (6000).

8.4 Trench 6, which spanned as much of the site from west to east as was feasible to examine failed to reveal the Norton Three Dikes, and in that respect backed up the findings of the geophysical survey. The Dikes were sectioned in 1993 at a location c. 800m south of the present site, and were found to be relatively shallow features, each about 3m wide (CBA 1993, 35) – certainly no features of this sort were present in the evaluated area of the site. At the risk of over-speculating, a number of factors could account for the absence of the Dikes: they may have been removed by ploughing, they could pass further to the west or there is a gap in the Dike system at this point. Definitive answers can only be supplied by further research outside the scope of this evaluation.

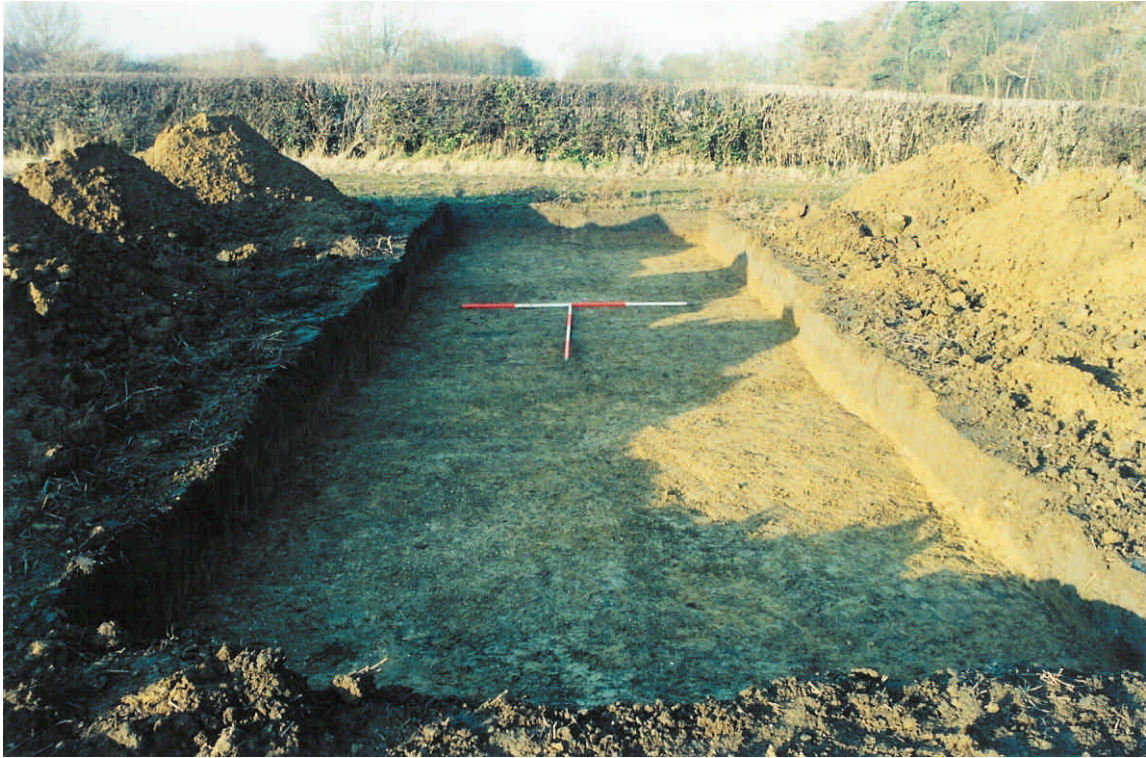
**Plate 1.** Trench 1. Facing North West

7.1.1 Trench 1 measured 10m x 3.40m in size and was situated at the northern limit of the site in order to intercept a southwest to northeast linear anomaly of possible archaeological origin. Natural deposits consisting of yellowish brown sandy clay (1002) were encountered at the base of the trench at a height of 22.15m AOD.

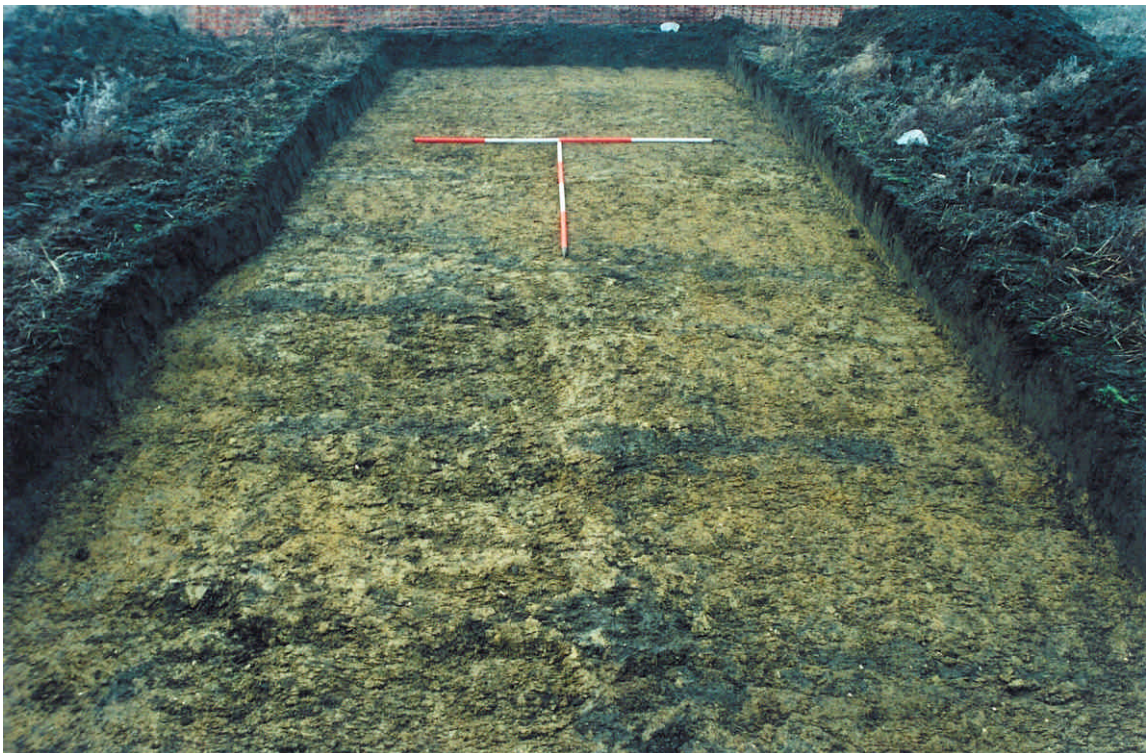
**Plate 2.** Trench 2. Facing North East

7.2.1 Trench 2 was 10m x 3.30m in size and was situated 40m to the south of Trench 1 at the location of a southeast to northwest aligned geophysical anomaly of possible archaeological origin. Sandy clay natural deposits (2001) lay at an elevation of c. 22.25m AOD. The natural was cut by a series of north to south-aligned modern plough scars.

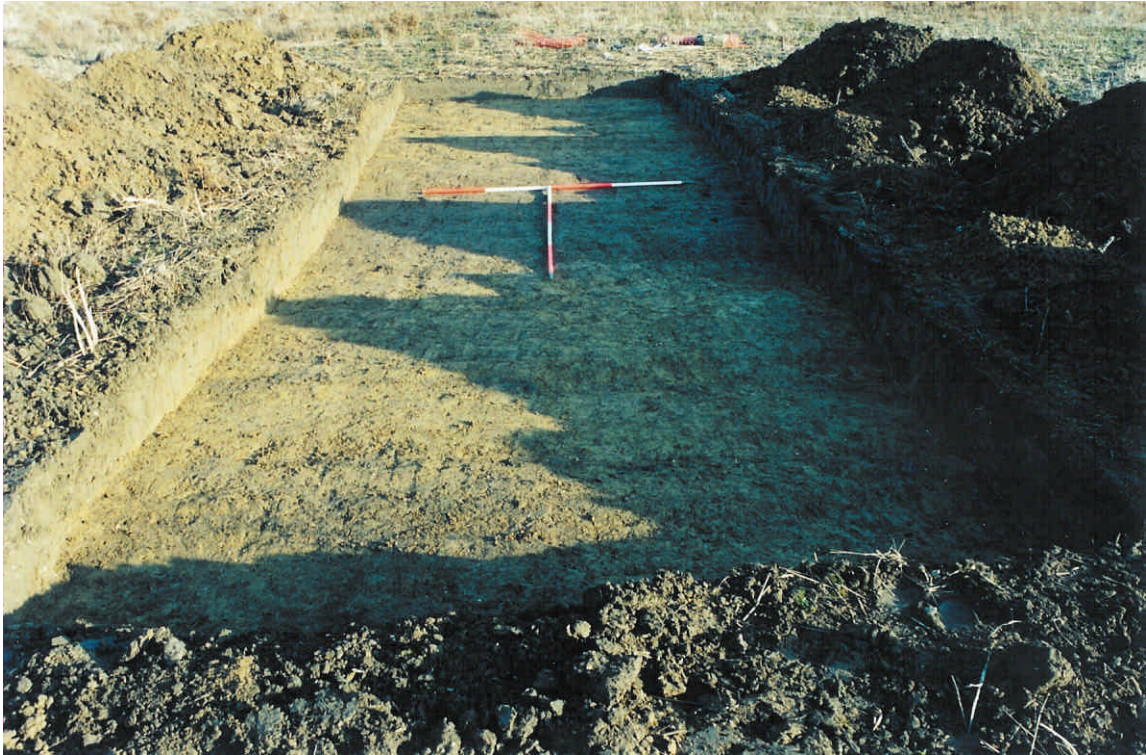
**Plate 3.** Trench 3 Pre-Excavation. Facing North East

7.3.1 Trench 3 was excavated in the north-western area, c. 75m to the southwest of Trench 2, being 10m x 3m in size and intended to evaluate a geophysically 'blank' area. The natural sandy clay (3003) lay at an elevation of c. 22.30m, and was cut by a northwest to southeast aligned linear feature (3002).

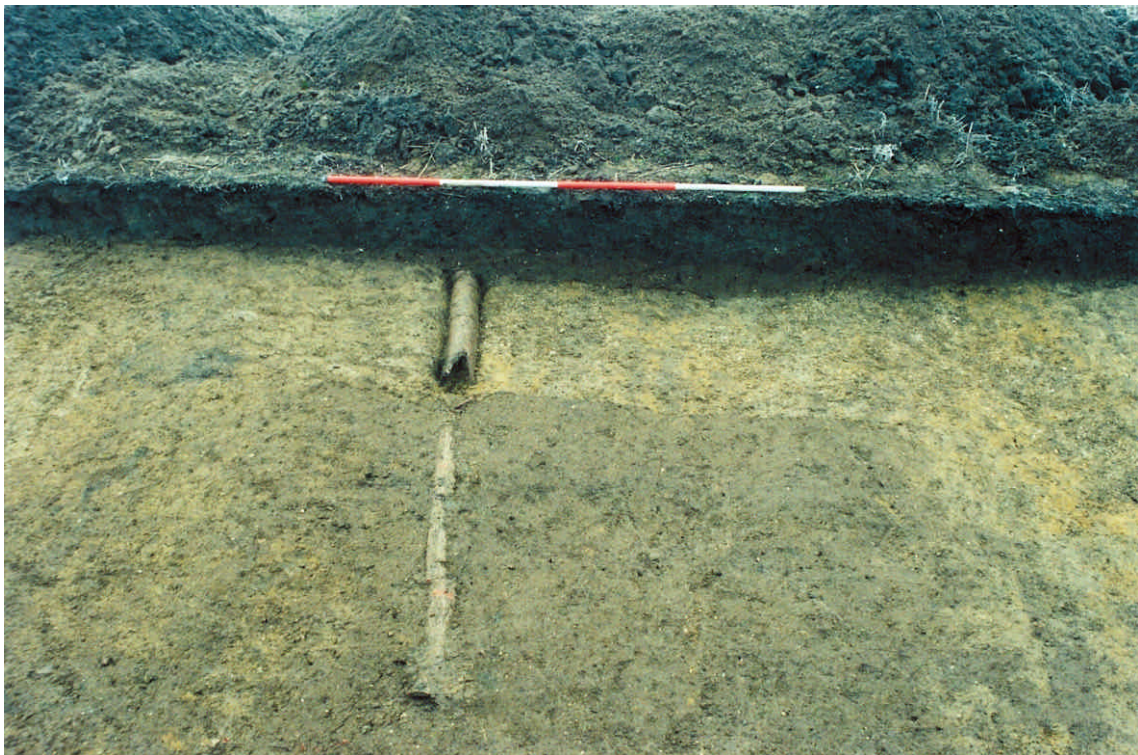
7.3.2 Linear Feature 3002 was present across the entire width of the trench and was 2.16m wide and 0.18m deep. It had gradually-sloping sides and a flat base. The pale yellowish brown silty sandy clay fill (3001) contained no finds, and was cut by a recent ceramic field drain, which was on the same alignment as the linear feature.

**Plate 4.** Trench 3. Linear Feature 3002 and Field Drain. Facing South East

8.3 Of the 'speculative' areas only Trench 3, at the northwest of the site, showed traces of archaeological activity in the form of a linear feature. The shallow, broad form of this feature is suggestive of a furrow, and as we have seen, this area was part of Norton's pre-enclosure arable field system. However, as no other features of this sort were found the only such feature found it is possible that a boundary ditch is represented, albeit in truncated form. Although there were no associated finds, the fact that the linear feature pre-dated a c. 19<sup>th</sup> century ceramic field drain gives a post-medieval date *at the latest* for it.

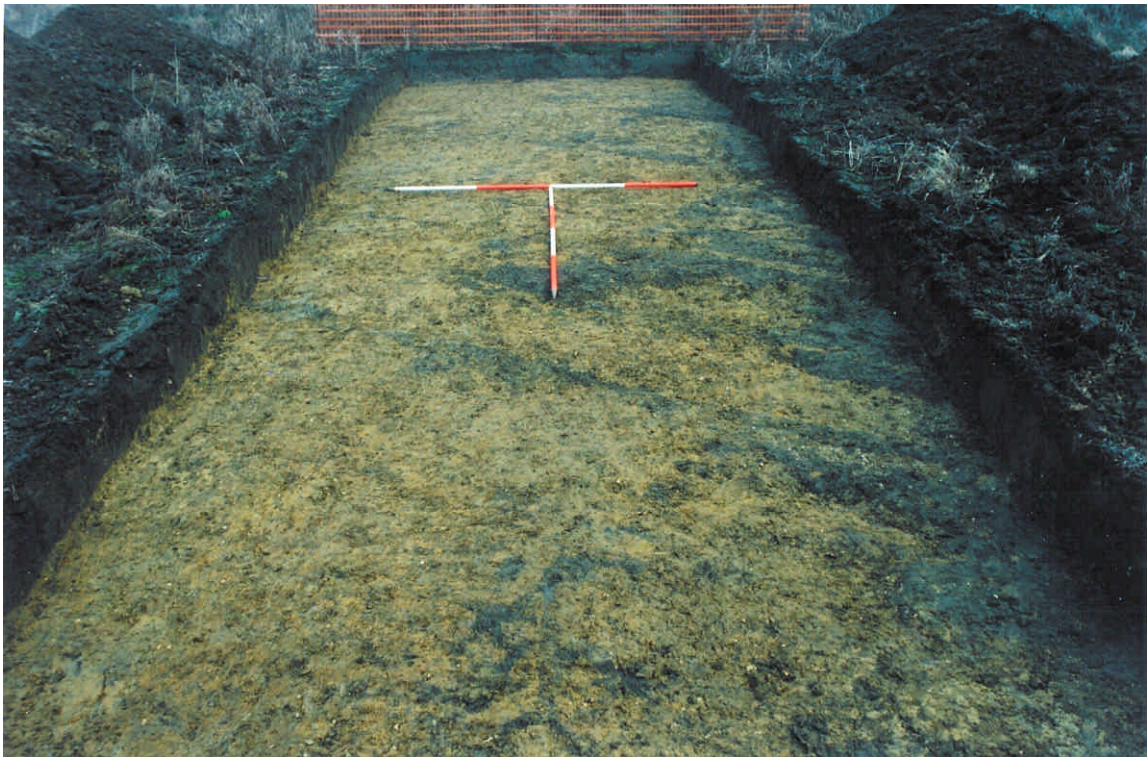
**Plate 5.** Trench 4. Facing South West

7.4.1 Trench 4 was located c. 80m east of Trench 3, was also 10m x 3m in size and positioned to examine a possibly archaeological located by the geophysical survey. Natural yellowish sandy clay deposits (4001) lay at a height of c. 22.3.0m AOD. The natural was cut by deep modern plough scars that ran approximately north to south.

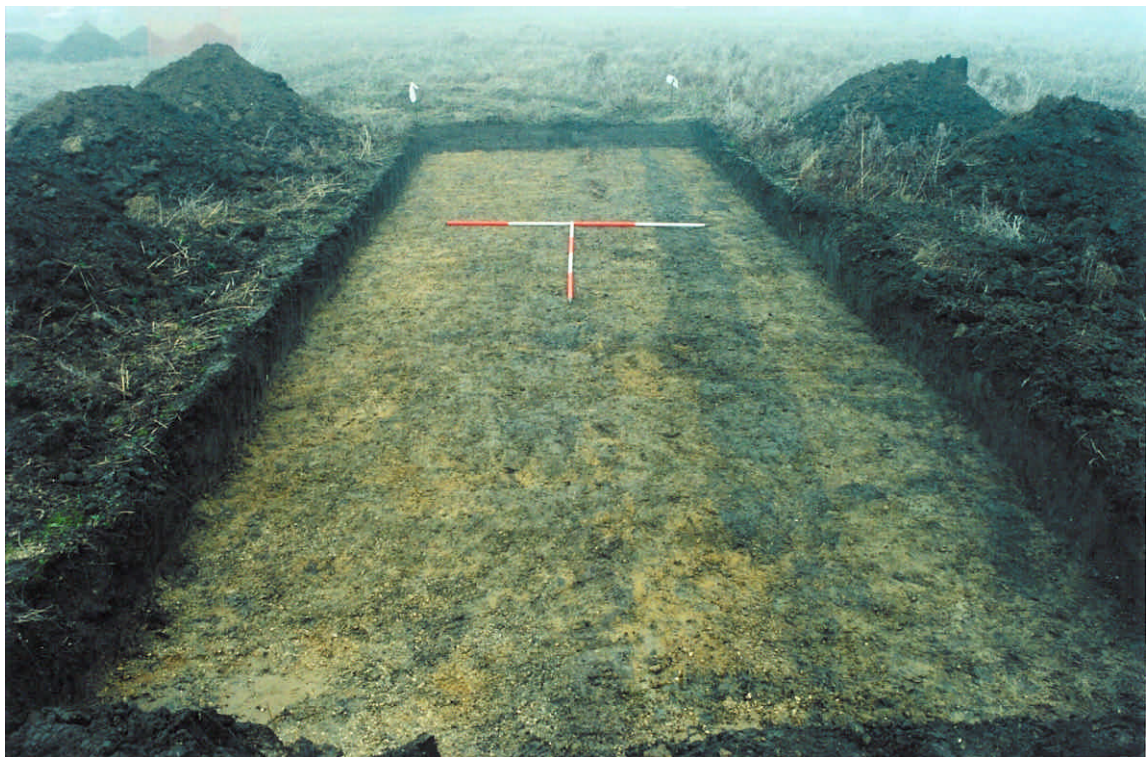
**Plate 6.** Trench 5. Facing North West

7.5.1 Trench 5 was situated in the north-western part of the site c. 20m southeast of Trench 3. Measuring 3.30m x 10m, this trench evaluated a geophysical anomaly of possible archaeological origin. Natural sandy clay (5003) occurred at an elevation of 22.30m AOD.

8.2 Anomalies 9 (Trench 5) and 10 (Trench 1) were similarly aligned and relatively narrow features that were interpreted as having a relatively recent origin. Not traceable within the evaluation trenches, it is possible that these were responses to deep furrows within the plough soil. Anomaly 11 (Trench 4) ran parallel to natural anomalies 1, 3 and 4, and as no archaeological element could be discerned for it, it too was probably of natural origin. Anomaly 13 (Trench 7) proved to be a recent field drain rather than a ditch of archaeological significance.

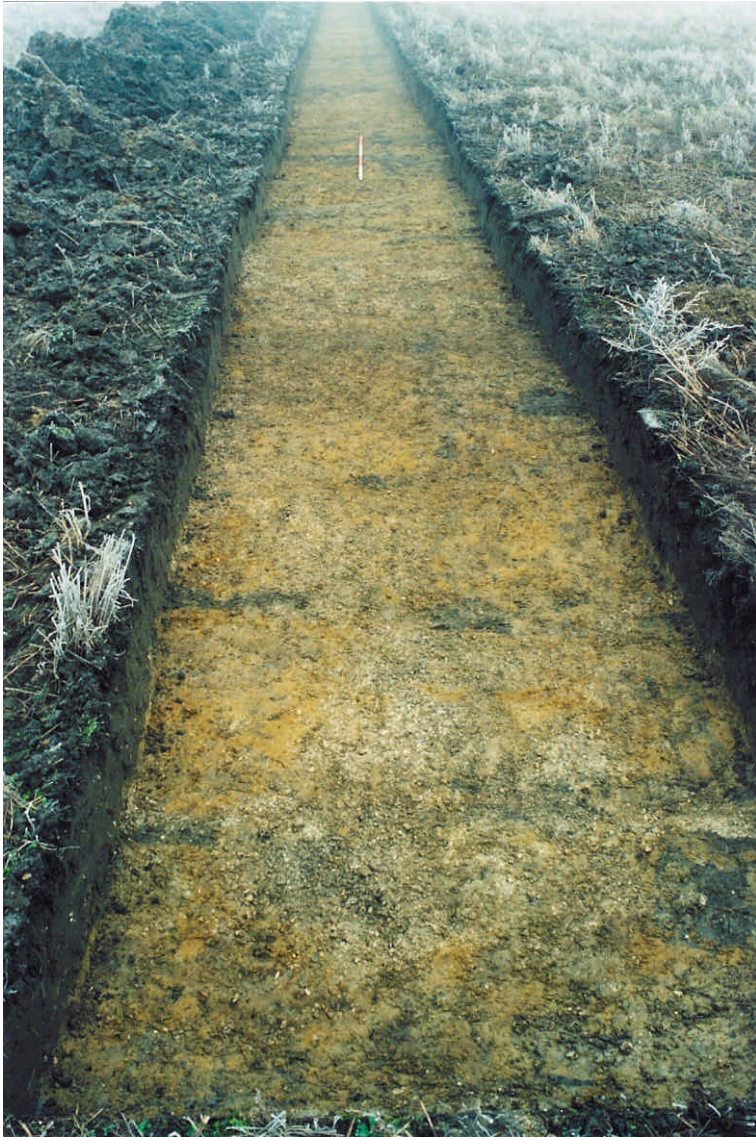
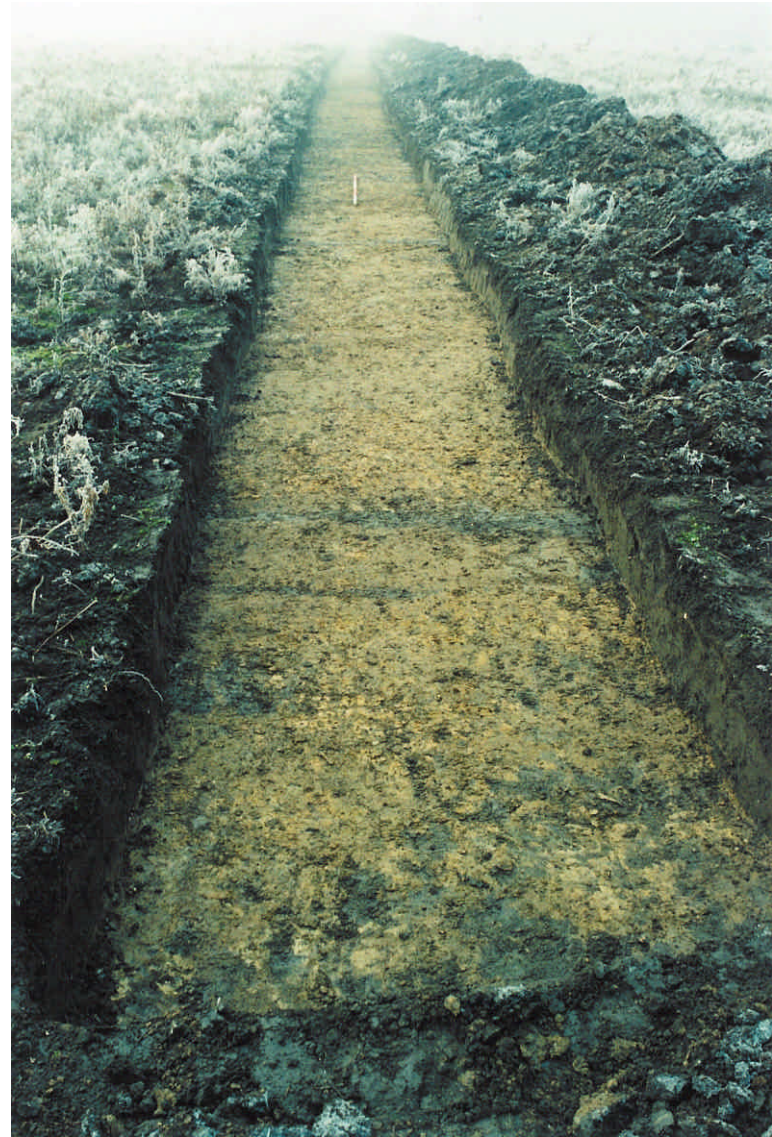
**Plate 7.** Trench 6. Facing North East

7.6.1 Trench 6 ran perpendicularly across central part of the field for a distance of 107m; a c. 5m margin was left at both ends end, because of services at the west and a flooded watercourse and pathway to the east. The purpose of this trench was to indicate either the presence or absence of the triple dyke system. Trench 6 was a nominal bucket's width wide (1.70m) with the provision to expand to 3m width should the triple dykes be present.

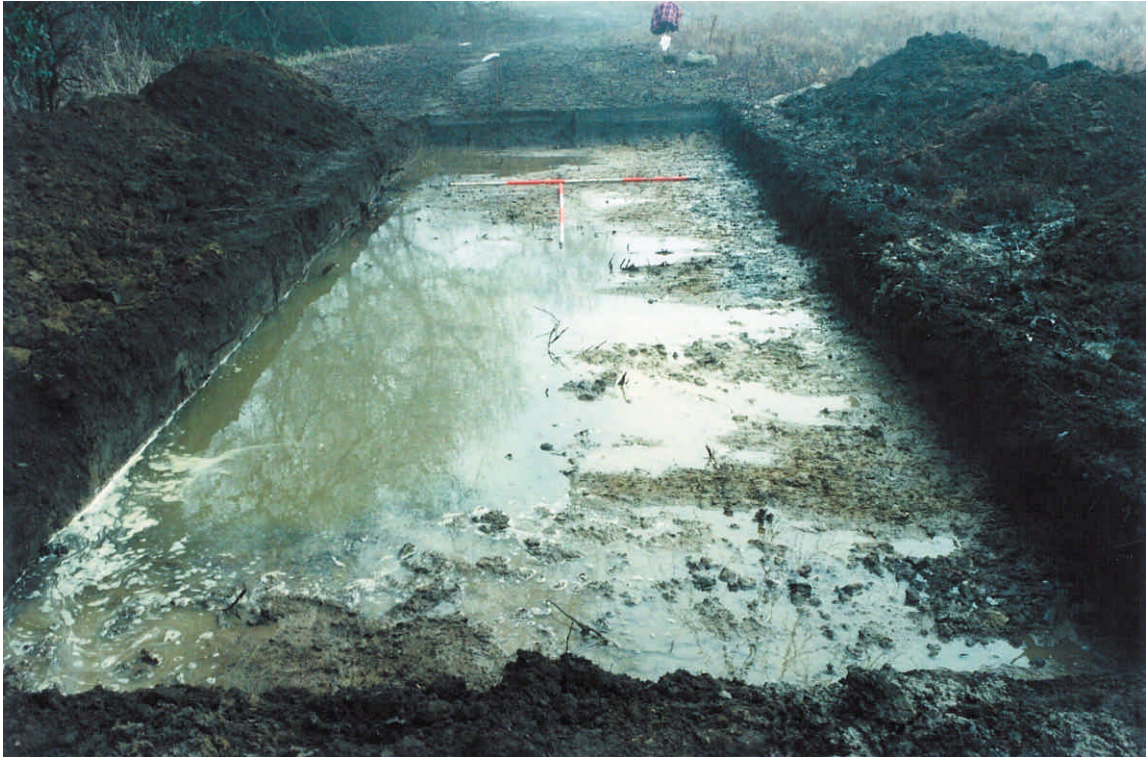
**Plate 9.** Trench 7. Facing South East

7.7.1 Trench 7 was located in the south-eastern part of the site, adjacent to the eastern boundary to examine a distinct linear anomaly identified by the geophysical survey. This trench was prone to flooding from the swollen stream situated immediately to the east. After initial cleaning had allowed examination of the trench it rapidly became water-logged. The trench measured 3.50m x 10m in size.

7.7.2 Natural deposits consisted of pale yellow silty clay (7002), which was cut at the northern part of the trench by a modern limestone-filled field drain (7001). The drain was 0.40m wide and cut perpendicularly across the trench on a south-west to north-east alignment. Modern ploughsoil (7000) covered the surface of the natural to a depth of 0.40m.

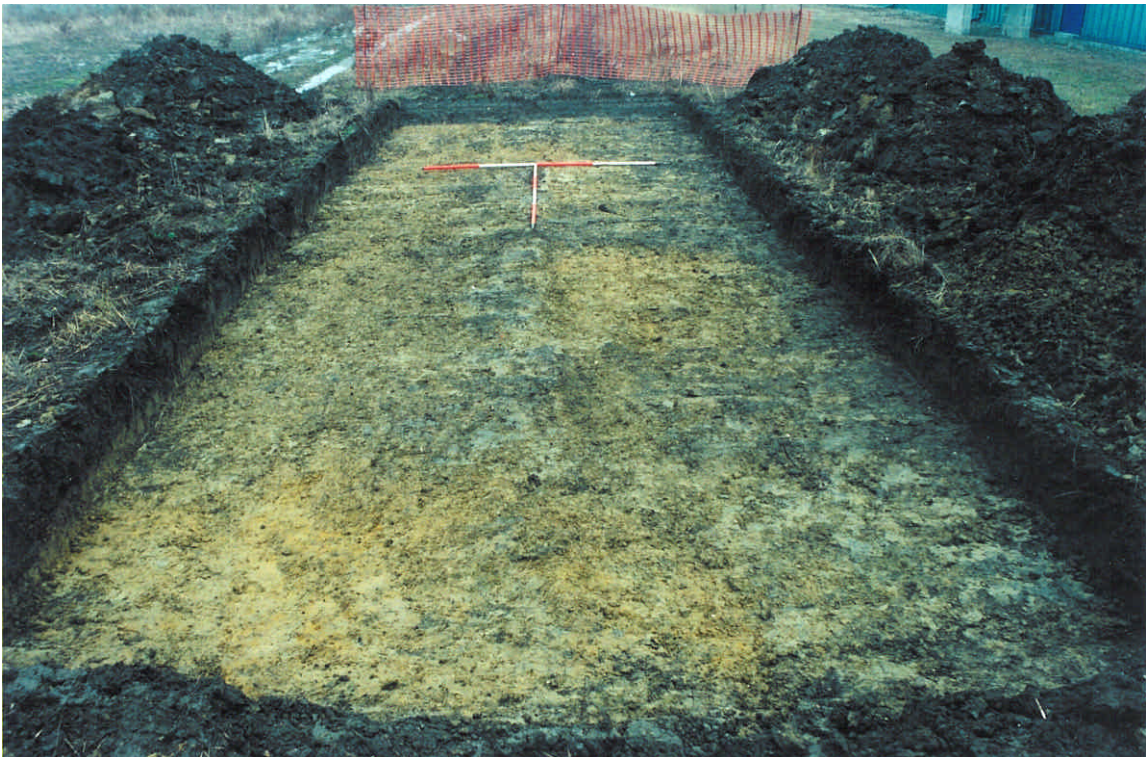
**Plate 10.** Trench 8. Facing North East

7.8.1 Trench 8 was positioned in the south-western part of the site immediately north of the modern warehouse recently built in this part of the field. (It was not possible to excavate this trench in the originally intended position to the south of the warehouse because of the need to avoid a landscaped area.) Trench 8 was a speculative trench excavated to evaluate an area that lacked any geophysical responses. It measured 3.30m x 10m in size.

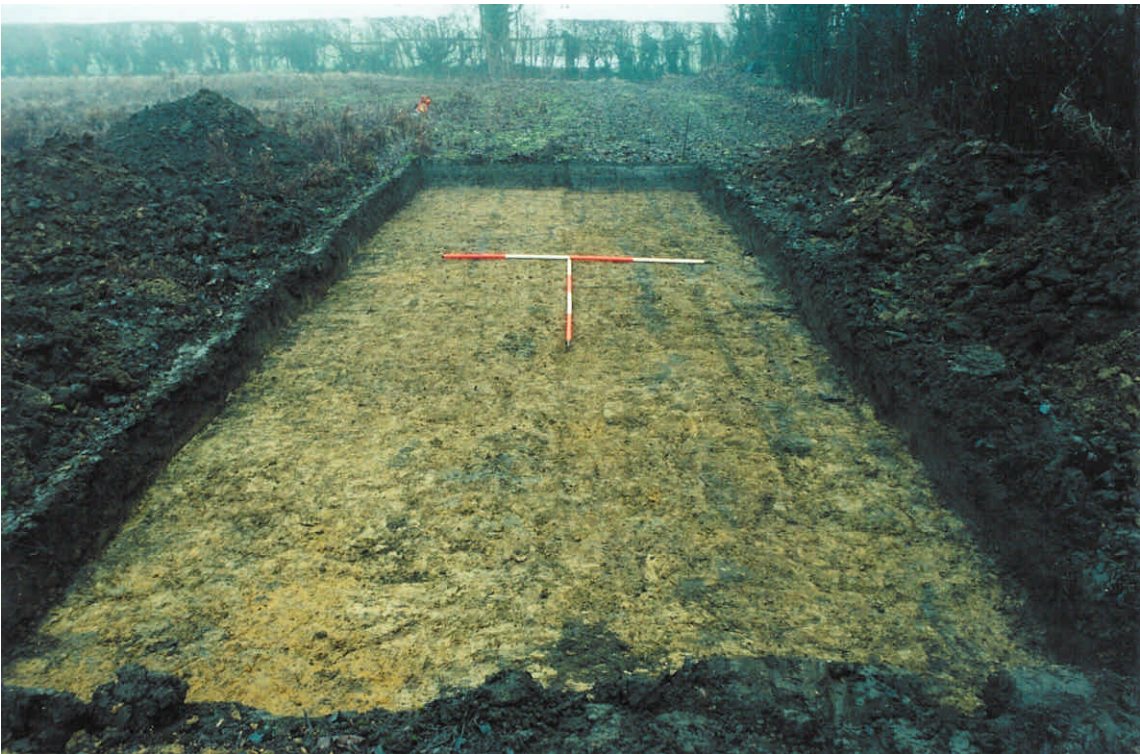
**Plate 11.** Trench 9. Facing North East

7.9.1 Situated in the far southeast corner of the site, Trench 9 was a 3.30m x 10m area that evaluated a geophysically void area. Natural deposits, consisting of yellowish brown silty clay (9001), were present at an elevation of 22.10m AOD.
